***Report to Naidu Consulting (Pty) Ltd on the Results of a Geotechnical Investigation for the Proposed Upgrades to the Water Treatment Works at Tongaat, eThekweni Municipality, KwaZulu-Natal***

***Reference: 035-22.R01 Revision 0***

***Date: 08 February 2024***

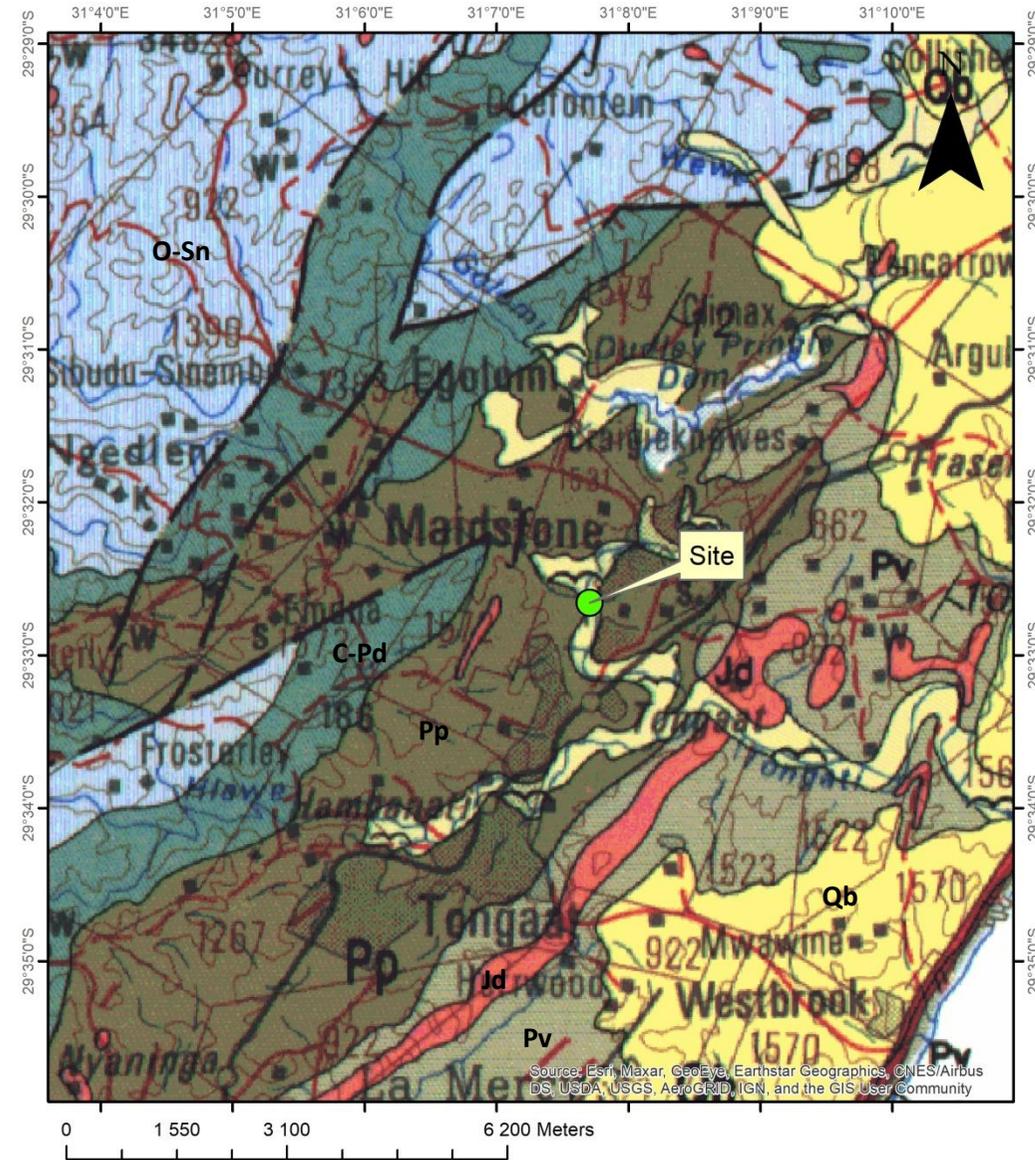
Extract from Geological Map 2930 Durban

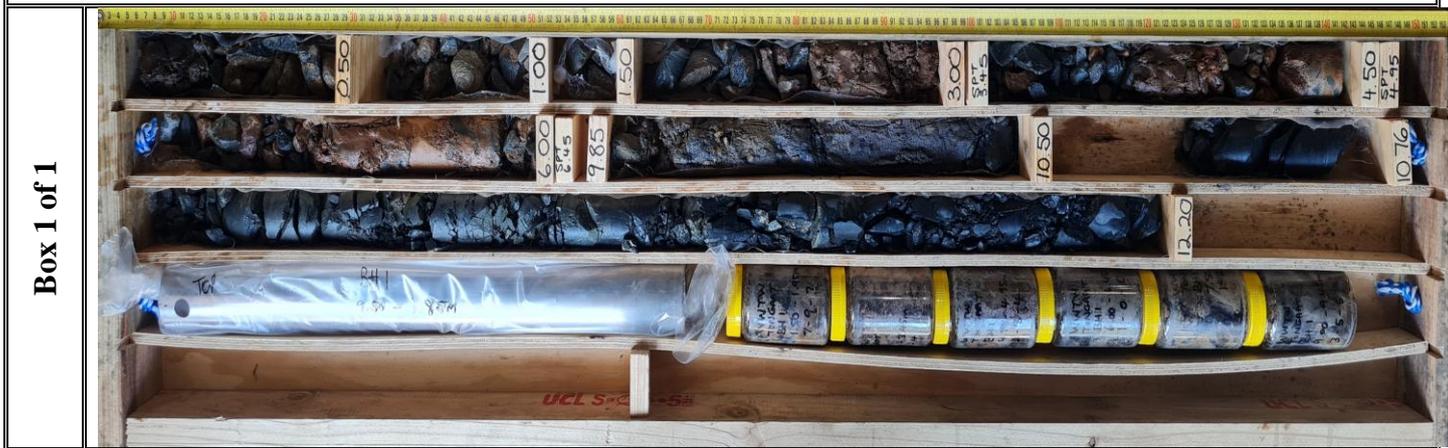
<b>CLIENT:</b>	Naidu Consulting (Pty) Ltd
<b>PROJECT:</b>	Geotechnical Investigation for Proposed Improvement to the Tongaat Water Treatment Works, Tongaat, eThekweni Municipality
<b>REFERENCE NO.:</b>	035-22
<b>BOREHOLE NO.:</b>	<b>BH 01</b>
<b>DEPTH:</b>	0.0m to 12.20m
<b>BOX NO.:</b>	Box 1 to Box 1

Continuous coring of three rotary core boreholes, designated BH1 to BH3, was carried out by TFI (Pty) Ltd at the above-mentioned co-ordinates within the footprint of the existing Water Works at the approximate positions shown in Figure 2 included in Appendix A.

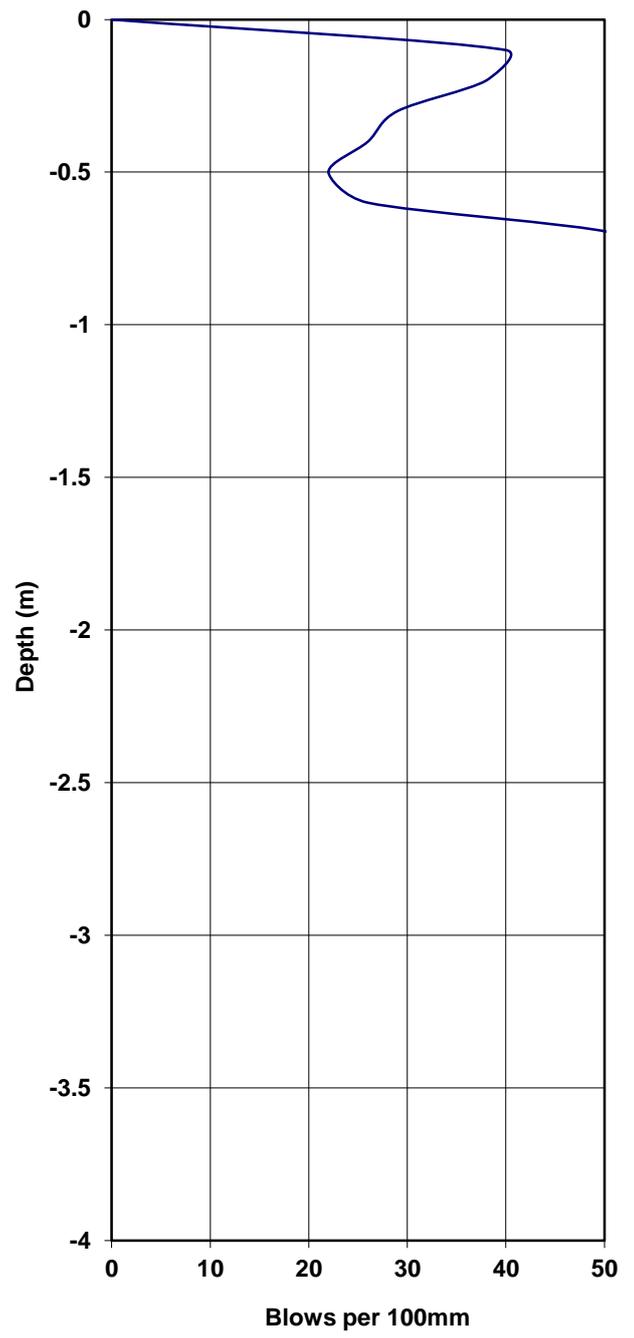
Depth (m)	Blows/100mm	Inferred Consistency	Shear Strength	CBR %
0				
0.1	40	Very Dense	>38 deg	>55
0.2	38	Very Dense	>38 deg	>55
0.3	29	Very Dense	>38 deg	>55
0.4	26	Very Dense	>38 deg	51
0.5	22	Dense	38 deg	42
0.6	26	Very Dense	>38 deg	51
	Refusal

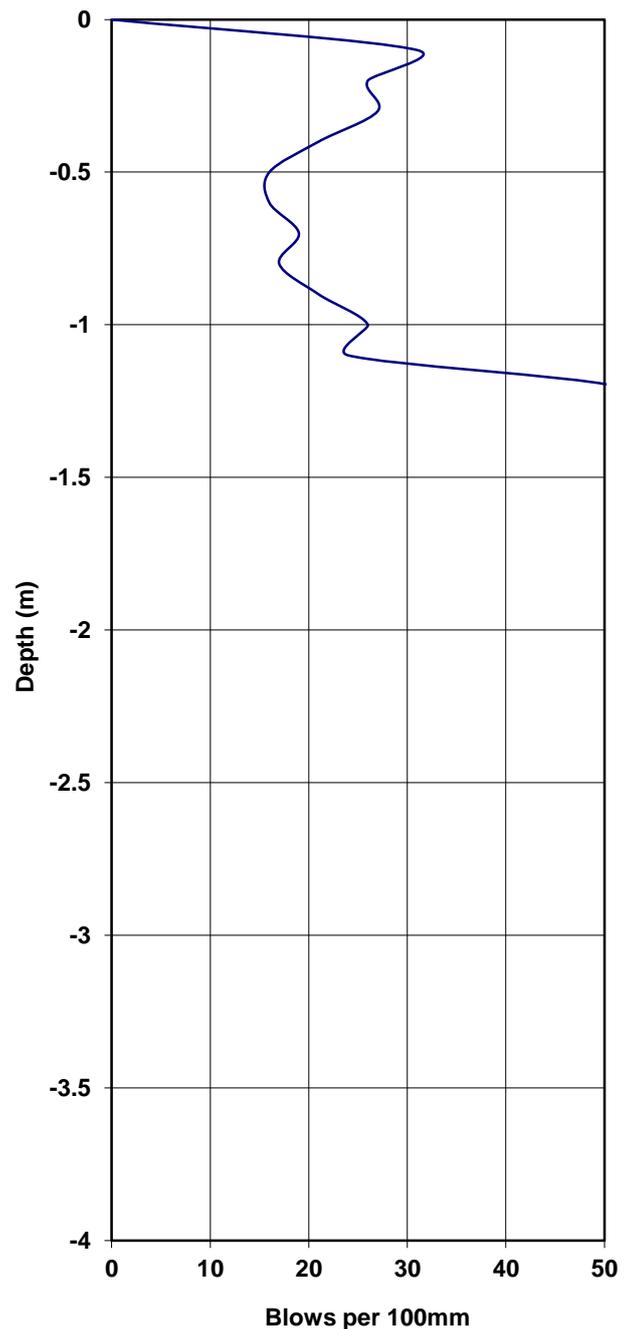
Depth (m)	Blows/100mm	Inferred Consistency	Shear Strength	CBR %
0				
0.1	31	Very Dense	>38 deg	>55
0.2	26	Very Dense	>38 deg	51
0.3	27	Very Dense	>38 deg	54
0.4	21	Dense	38 deg	40
0.5	16	Dense	37 deg	29
0.6	16	Dense	37 deg	29
0.7	19	Dense	37 deg	35
0.8	17	Dense	37 deg	31
0.9	21	Dense	38 deg	40
1	26	Very Dense	>38 deg	51
1.1	24	Dense	38 deg	47
	Refusal

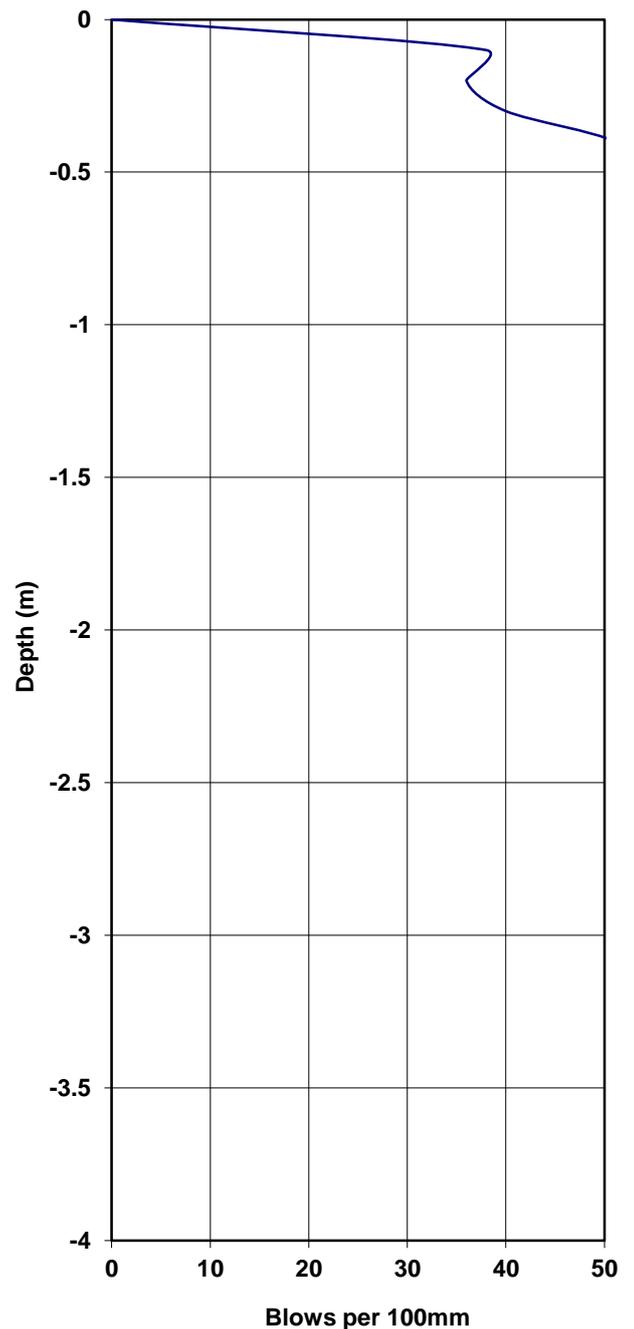
Depth (m)	Blows/100mm	Inferred Consistency	Shear Strength	CBR %
0				
0.1	38	Very Dense	>38 deg	>55
0.2	36	Very Dense	>38 deg	>55
0.3	40	Very Dense	>38 deg	>55
	Refusal

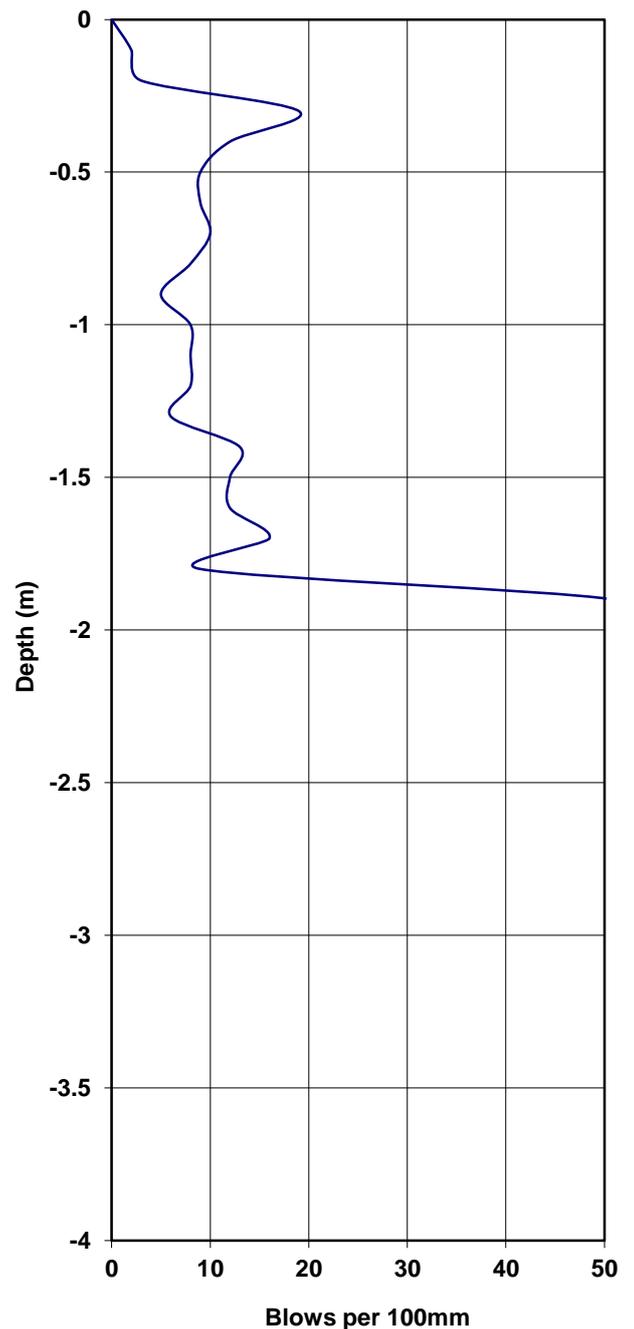
Depth (m)	Blows/100mm	Inferred Consistency	Shear Strength	CBR %
0				
0.1	2	Loose	<30 deg	3
0.2	3	Loose	<30 deg	5
0.3	19	Dense	37 deg	35
0.4	12	Dense	36 deg	21
0.5	9	Med.Dense	35 deg	15
0.6	9	Med.Dense	35 deg	15
0.7	10	Med.Dense	36 deg	17
0.8	8	Med.Dense	35 deg	14
0.9	5	Med.Dense	32 deg	8
1	8	Med.Dense	35 deg	14
1.1	8	Med.Dense	35 deg	14
1.2	8	Med.Dense	35 deg	14
1.3	6	Med.Dense	33 deg	10
1.4	13	Dense	37 deg	23
1.5	12	Dense	36 deg	21
1.6	12	Dense	36 deg	21
1.7	16	Dense	37 deg	29
1.8	9	Med.Dense	35 deg	15
	Refusal

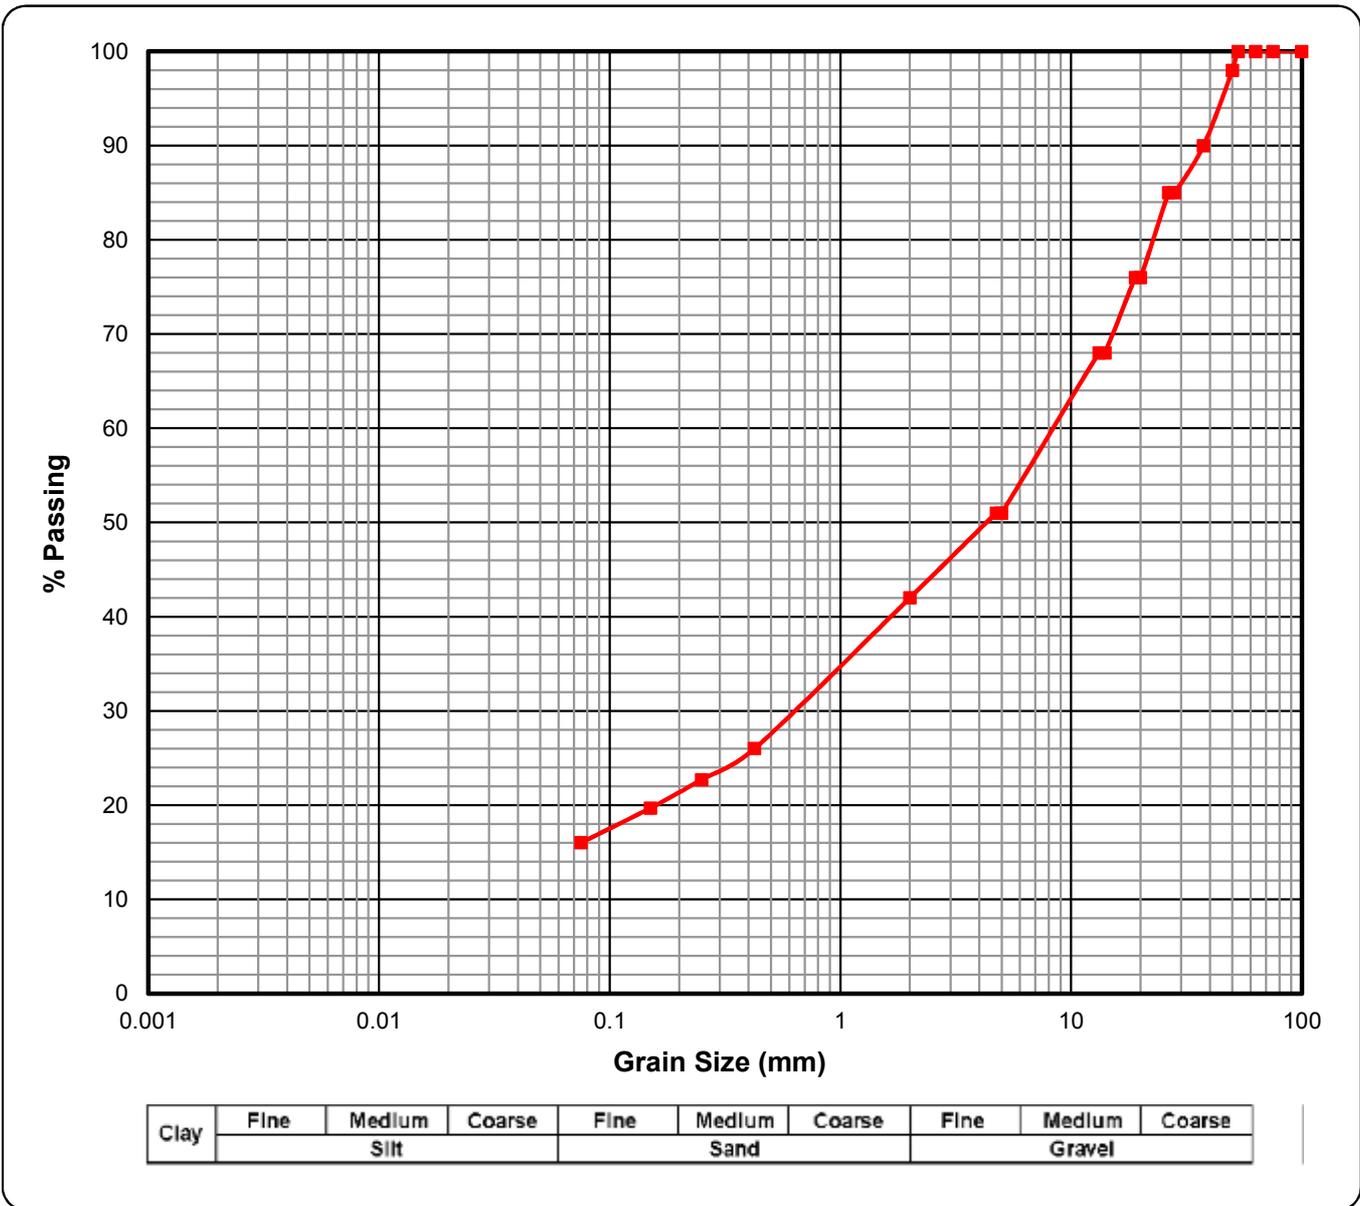
### Grading Curve for Sample T50224 – SANS 3001

**Thick Red Line is the Grading Curve (COLTO Classification = G6 (#)) (TRH 14 Classification = G6)**

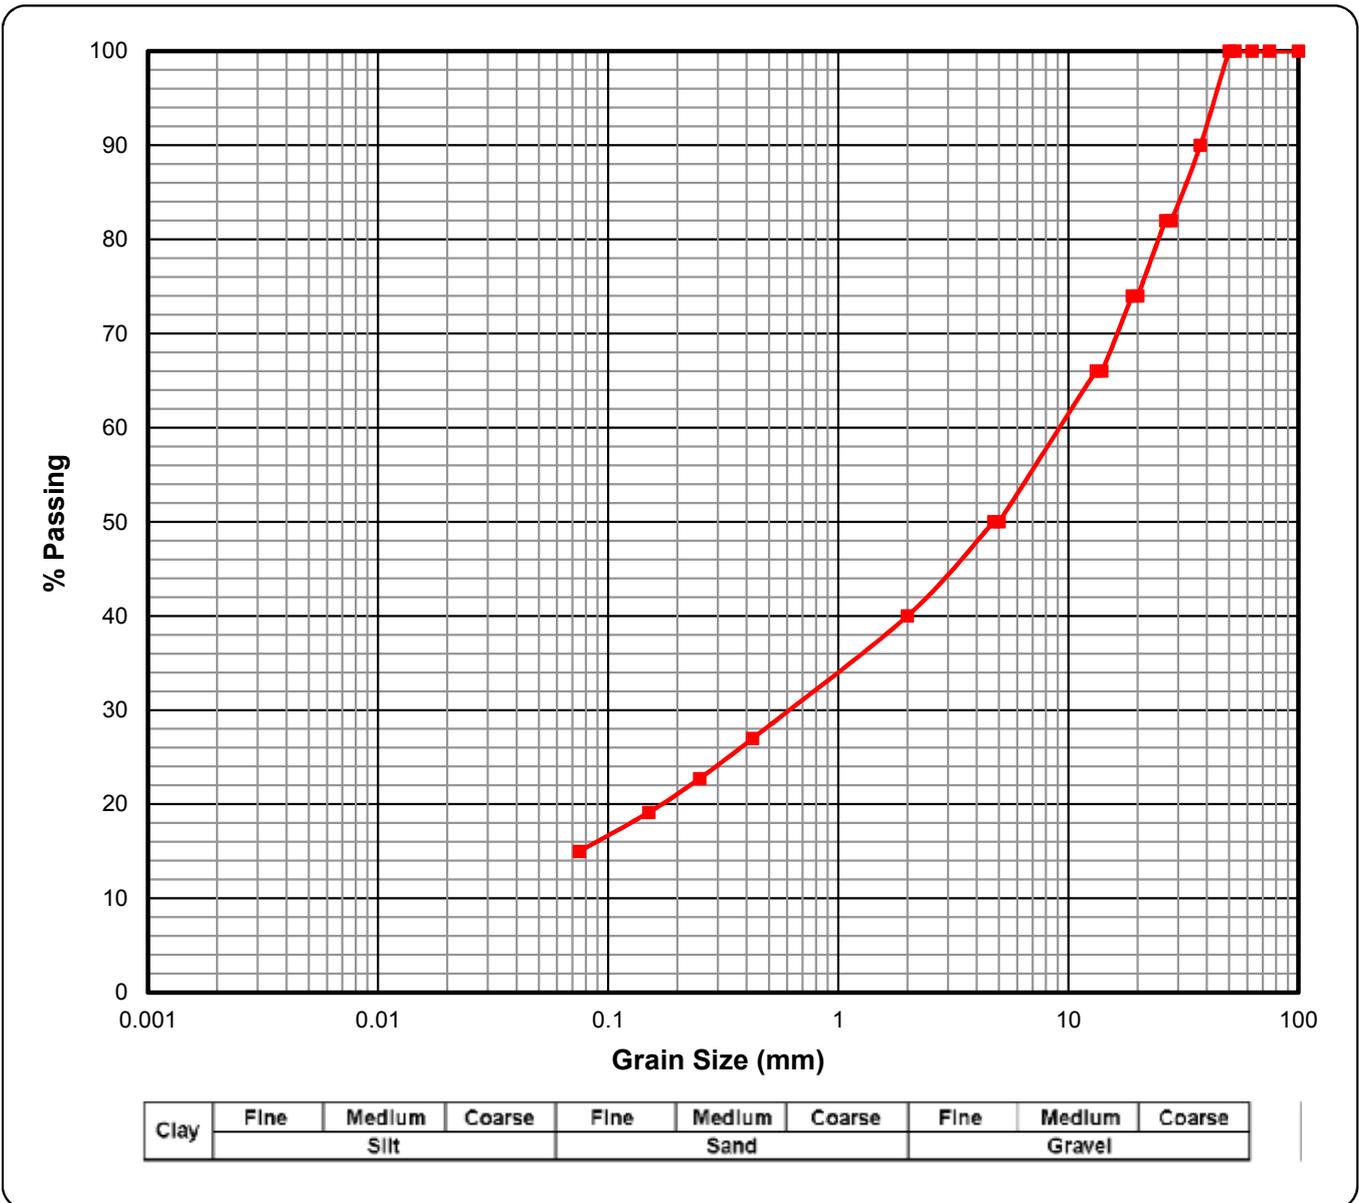
### Grading Curve for Sample T50225 – SANS 3001

**Thick Red Line is the Grading Curve (COLTO Classification = G6 (#)) (TRH 14 Classification = G6)**

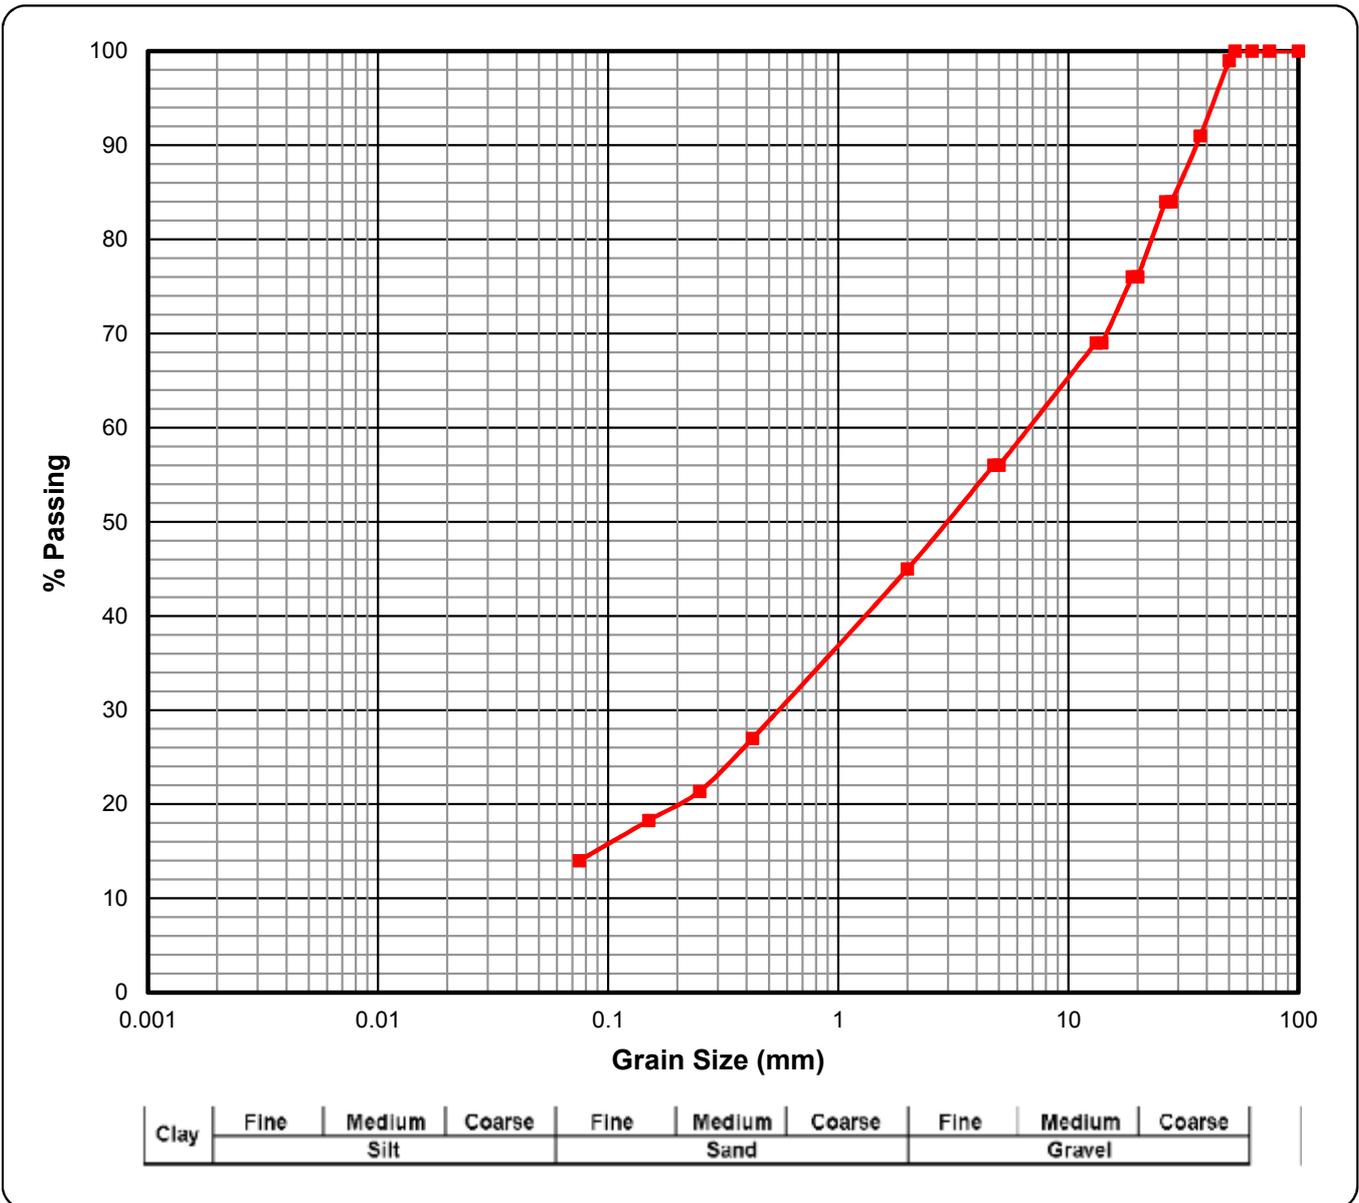
### Grading Curve for Sample T50226 – SANS 3001

**Thick Red Line is the Grading Curve (COLTO Classification = G6 (#)) (TRH 14 Classification = G6)**

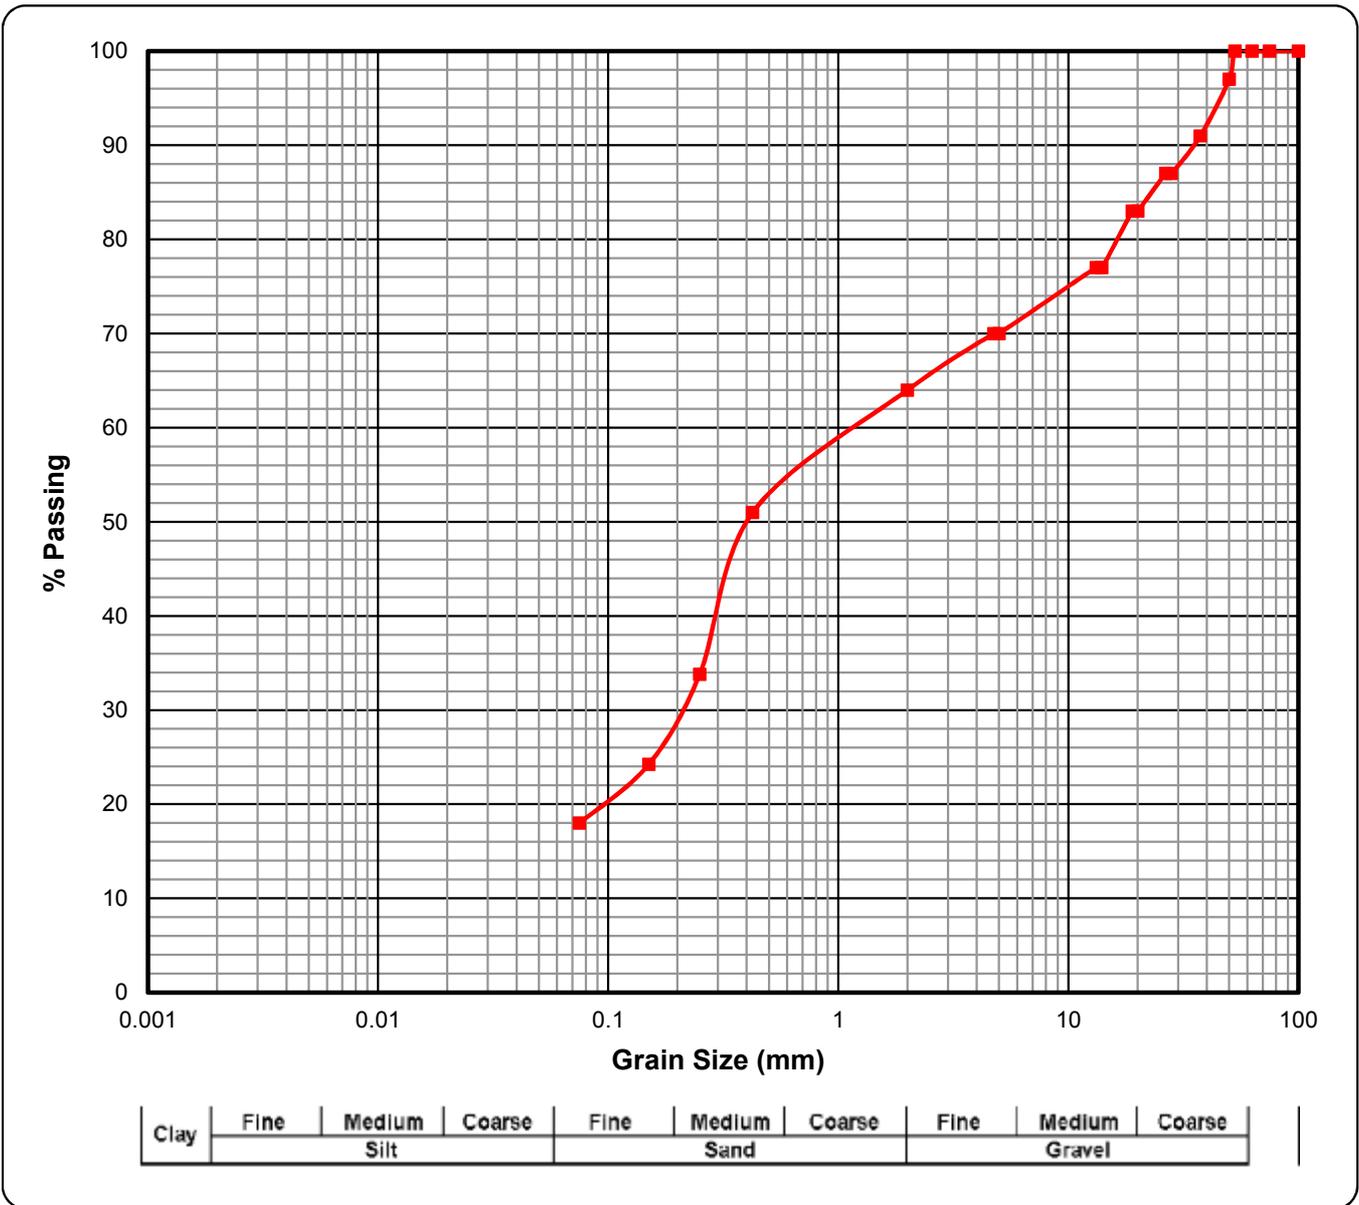
### Grading Curve for Sample T50228 – SANS 3001

**Thick Red Line is the Grading Curve (COLTO Classification = G7 (#)) (TRH 14 Classification = G7)**

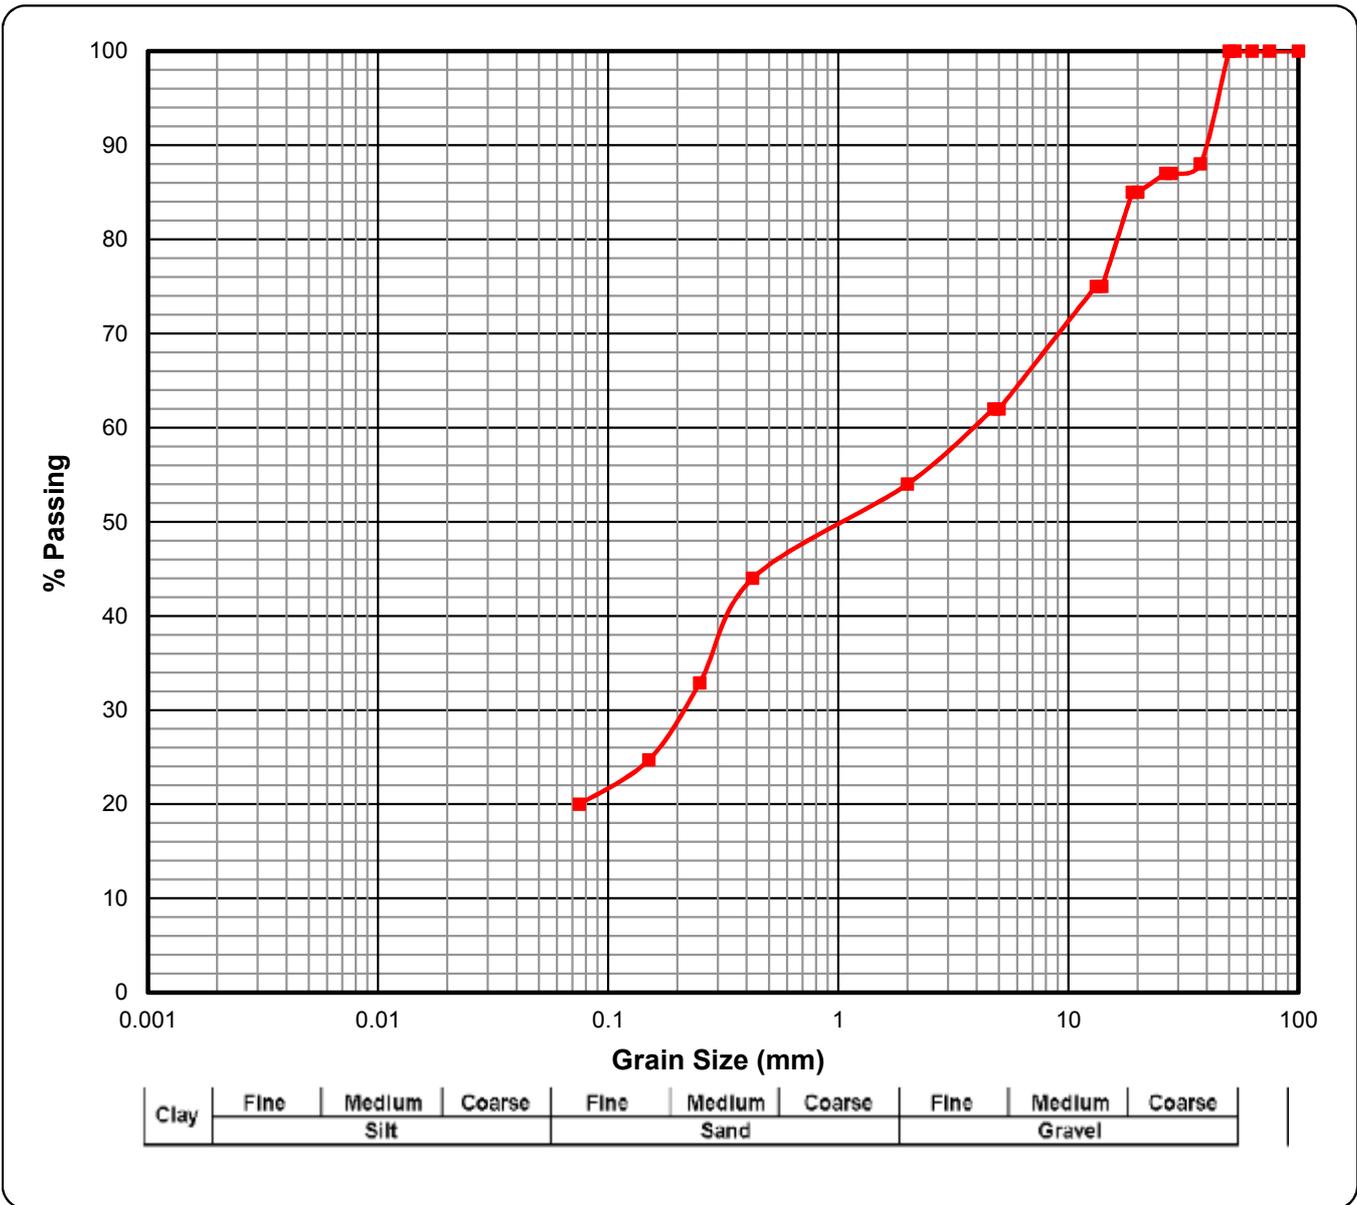
### Grading Curve for Sample T50229 – SANS 3001

**Thick Red Line is the Grading Curve (COLTO Classification = G9 (#)) (TRH 14 Classification = G10)**

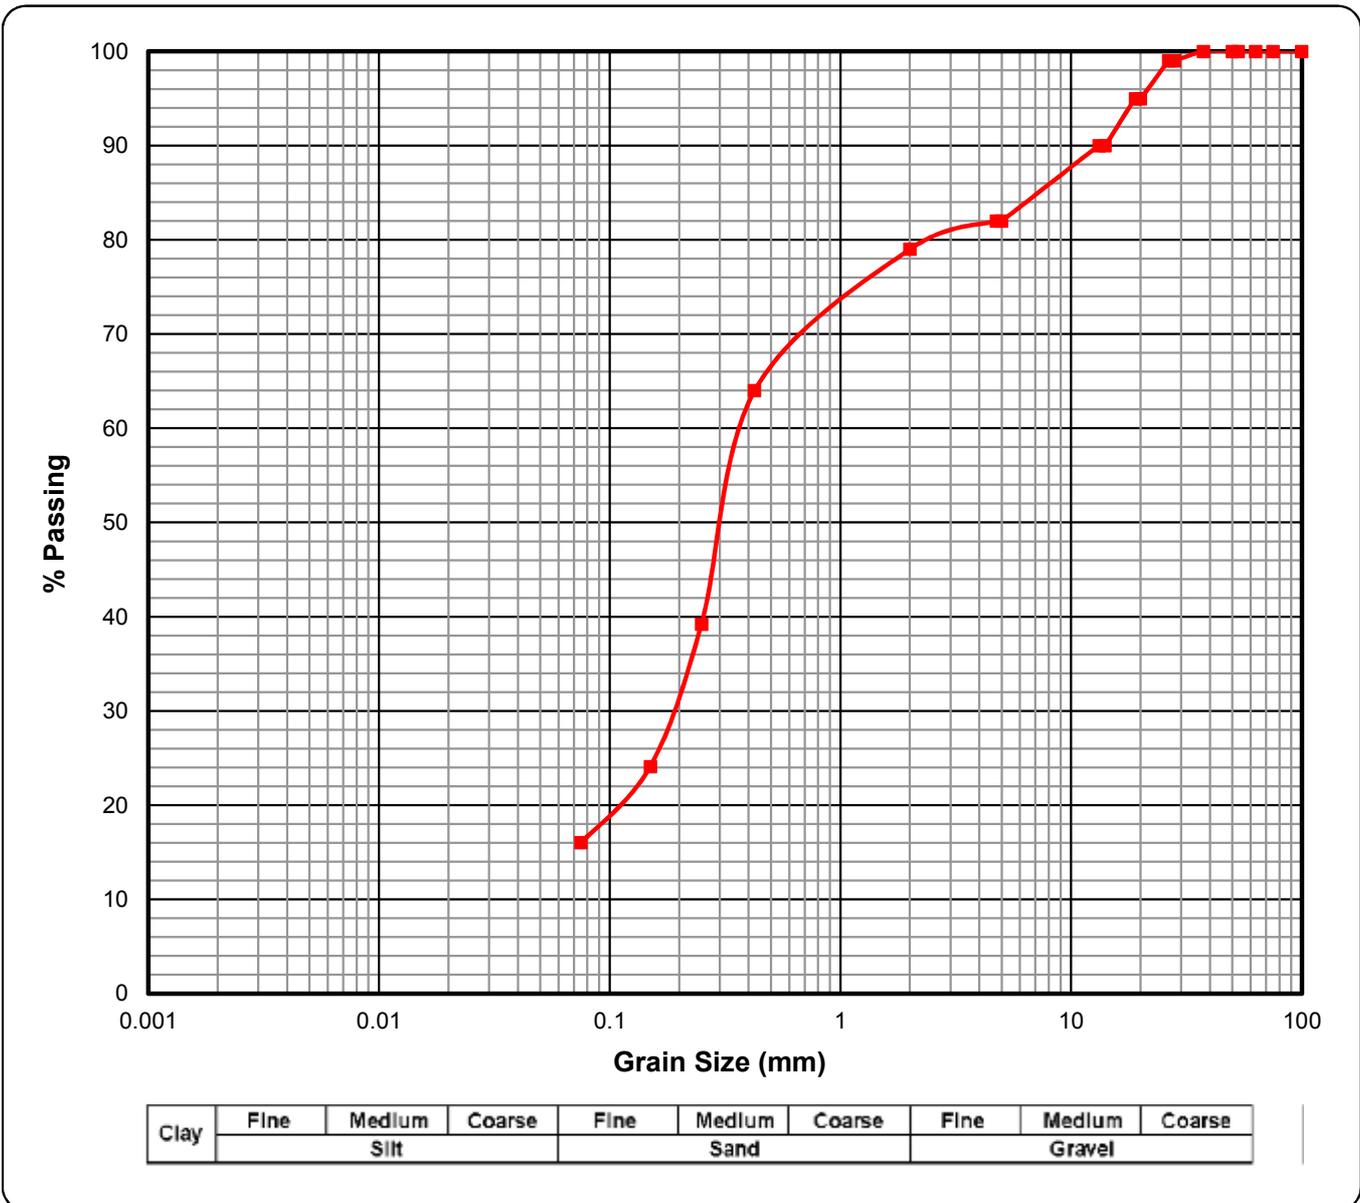
### Grading Curve for Sample T50230 – SANS 3001

**Thick Red Line is the Grading Curve (COLTO Classification = G6 (#)) (TRH 14 Classification = G7)**

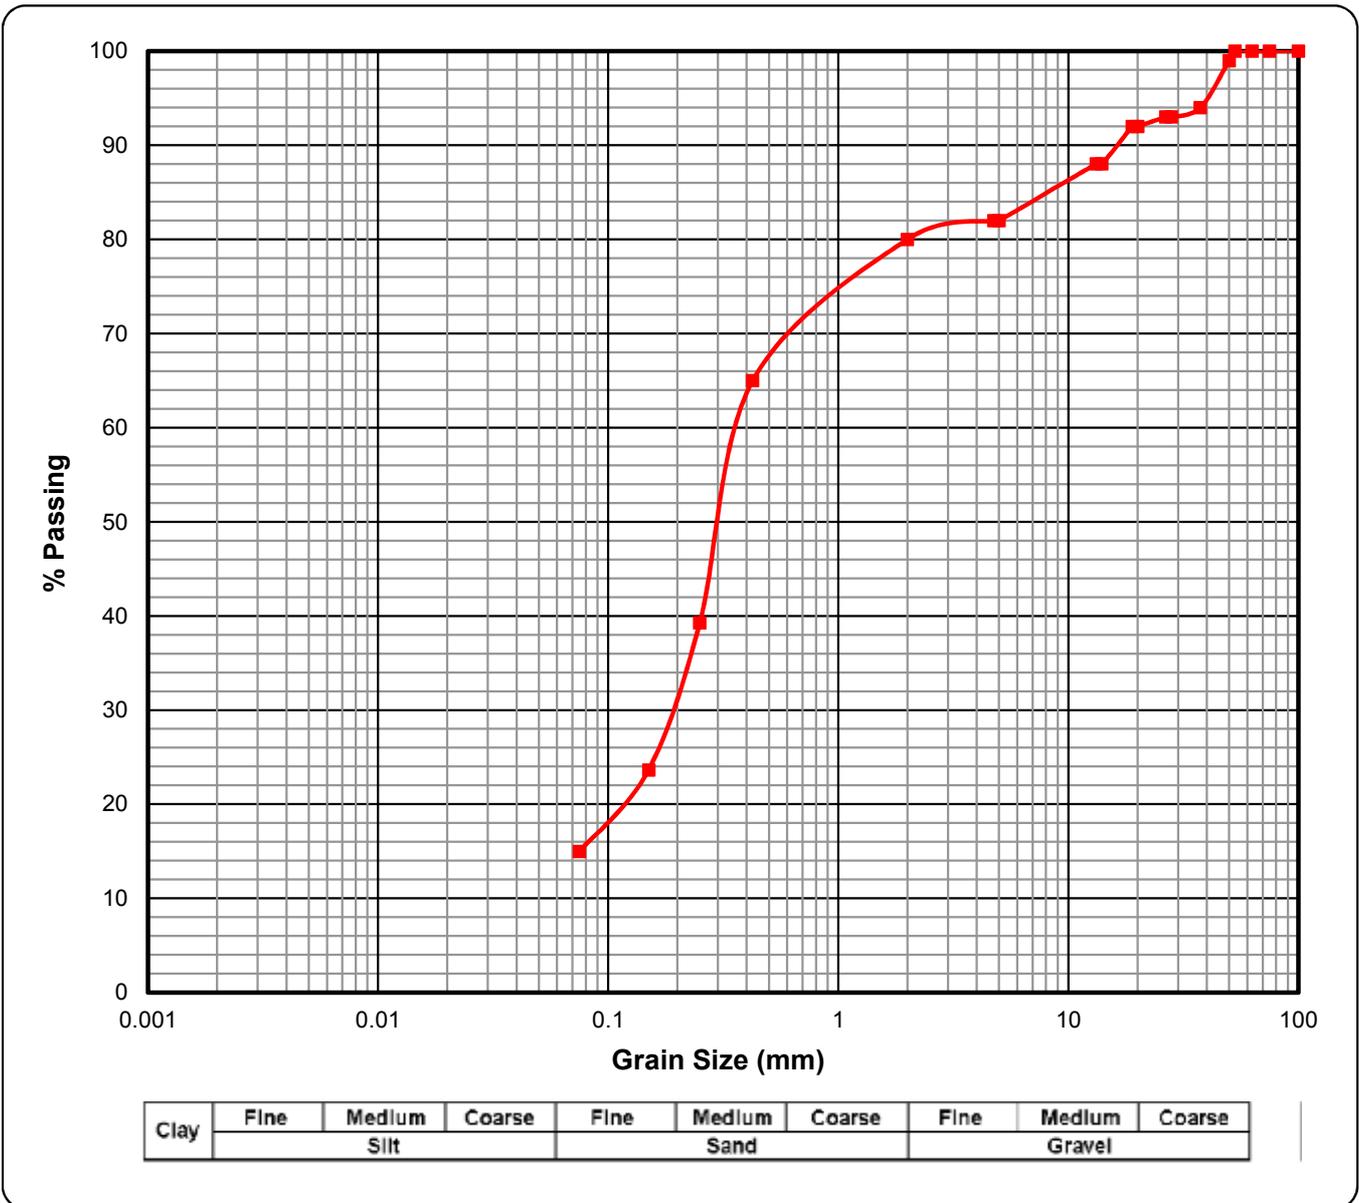
### Grading Curve for Sample T50231 – SANS 3001

**Thick Red Line is the Grading Curve (COLTO Classification = G7 (#)) (TRH 14 Classification = G7)**

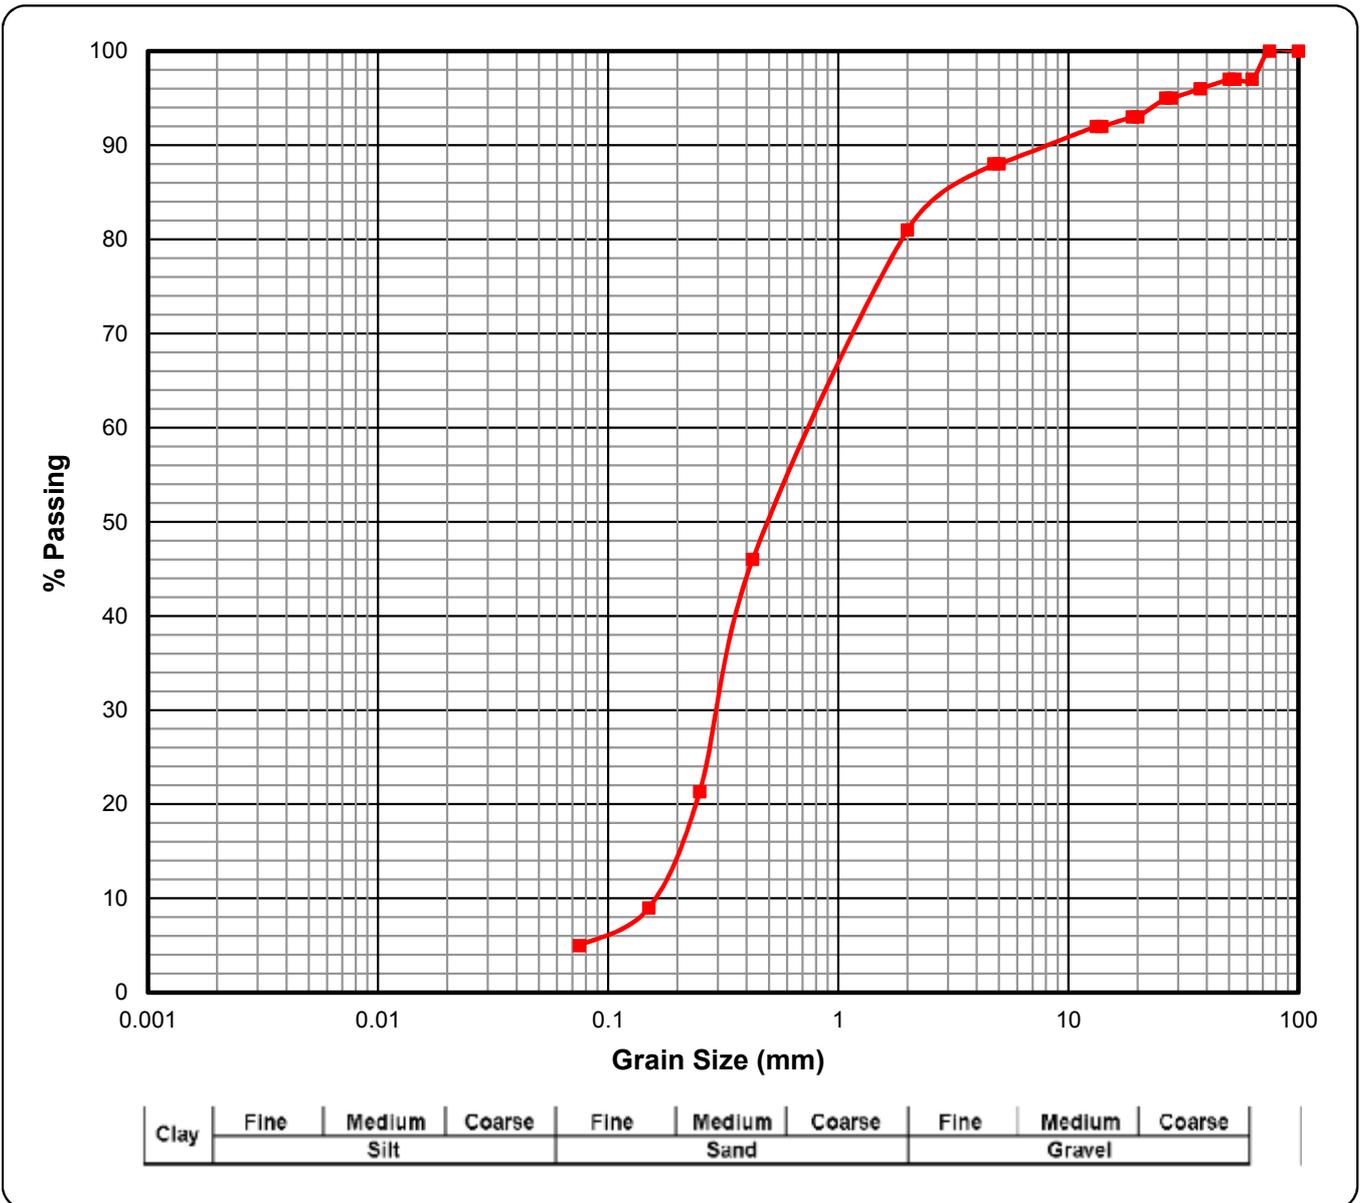
### Grading Curve for Sample T50232 – SANS 3001

**Thick Red Line is the Grading Curve (COLTO Classification = G6 (#)) (TRH 14 Classification = G7)**

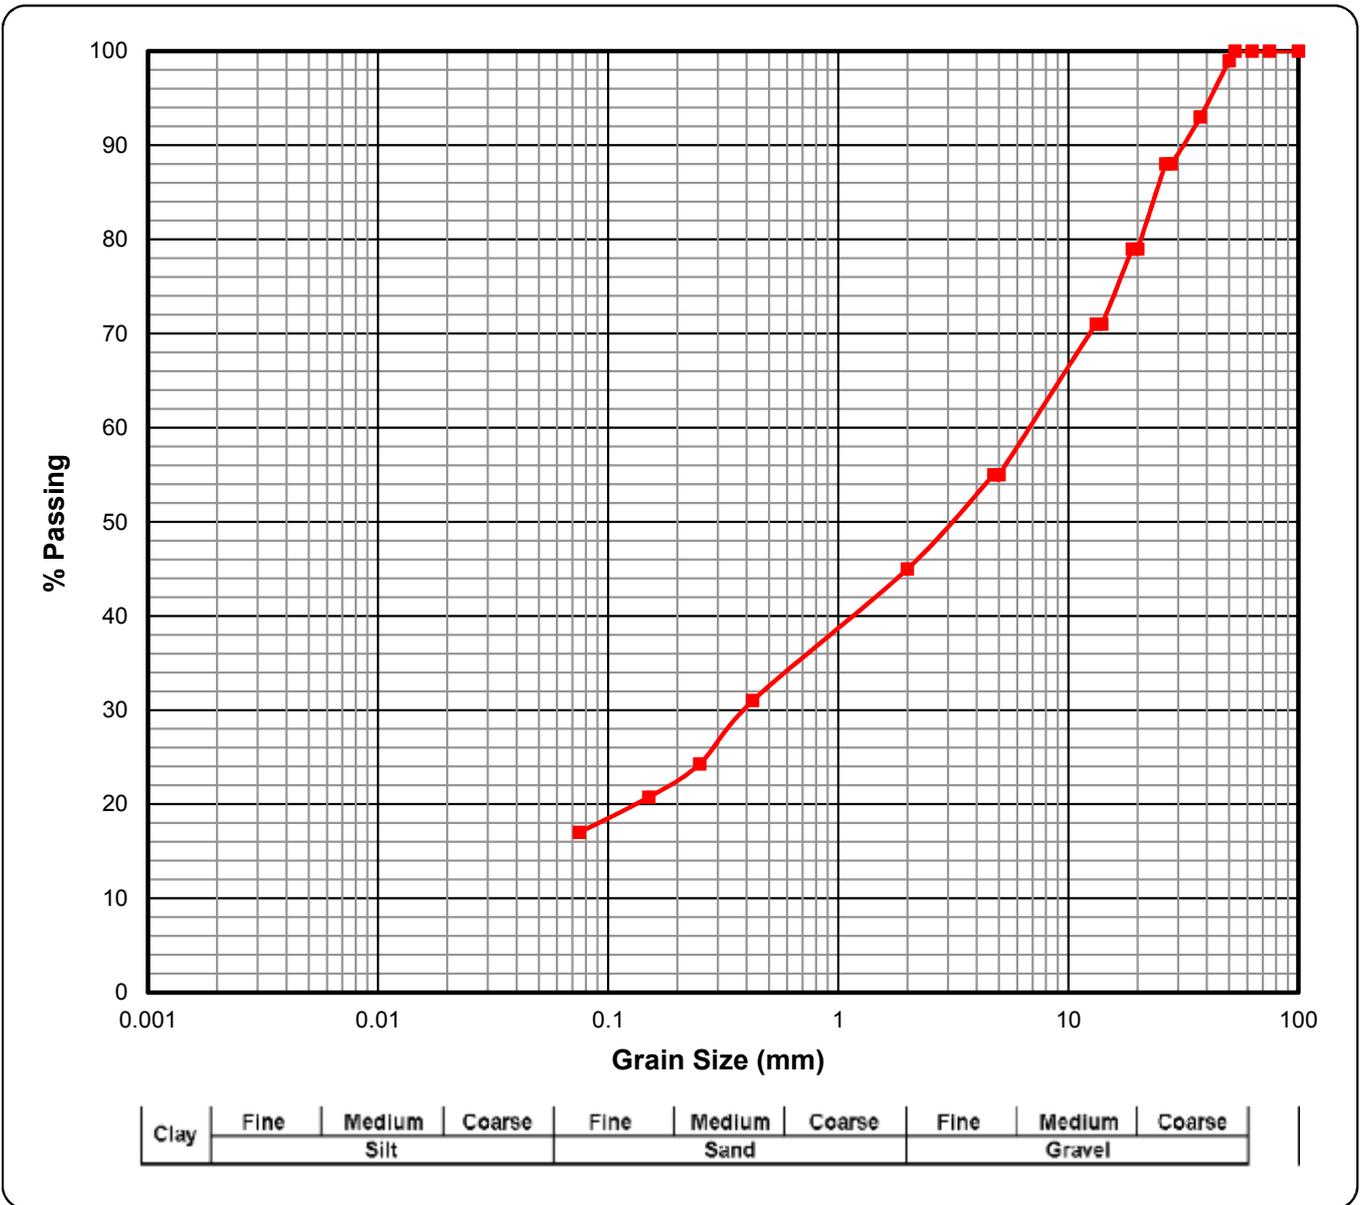
### Grading Curve for Sample T50234 – SANS 3001

**Thick Red Line is the Grading Curve (COLTO Classification = G6 (#)) (TRH 14 Classification = G7)**

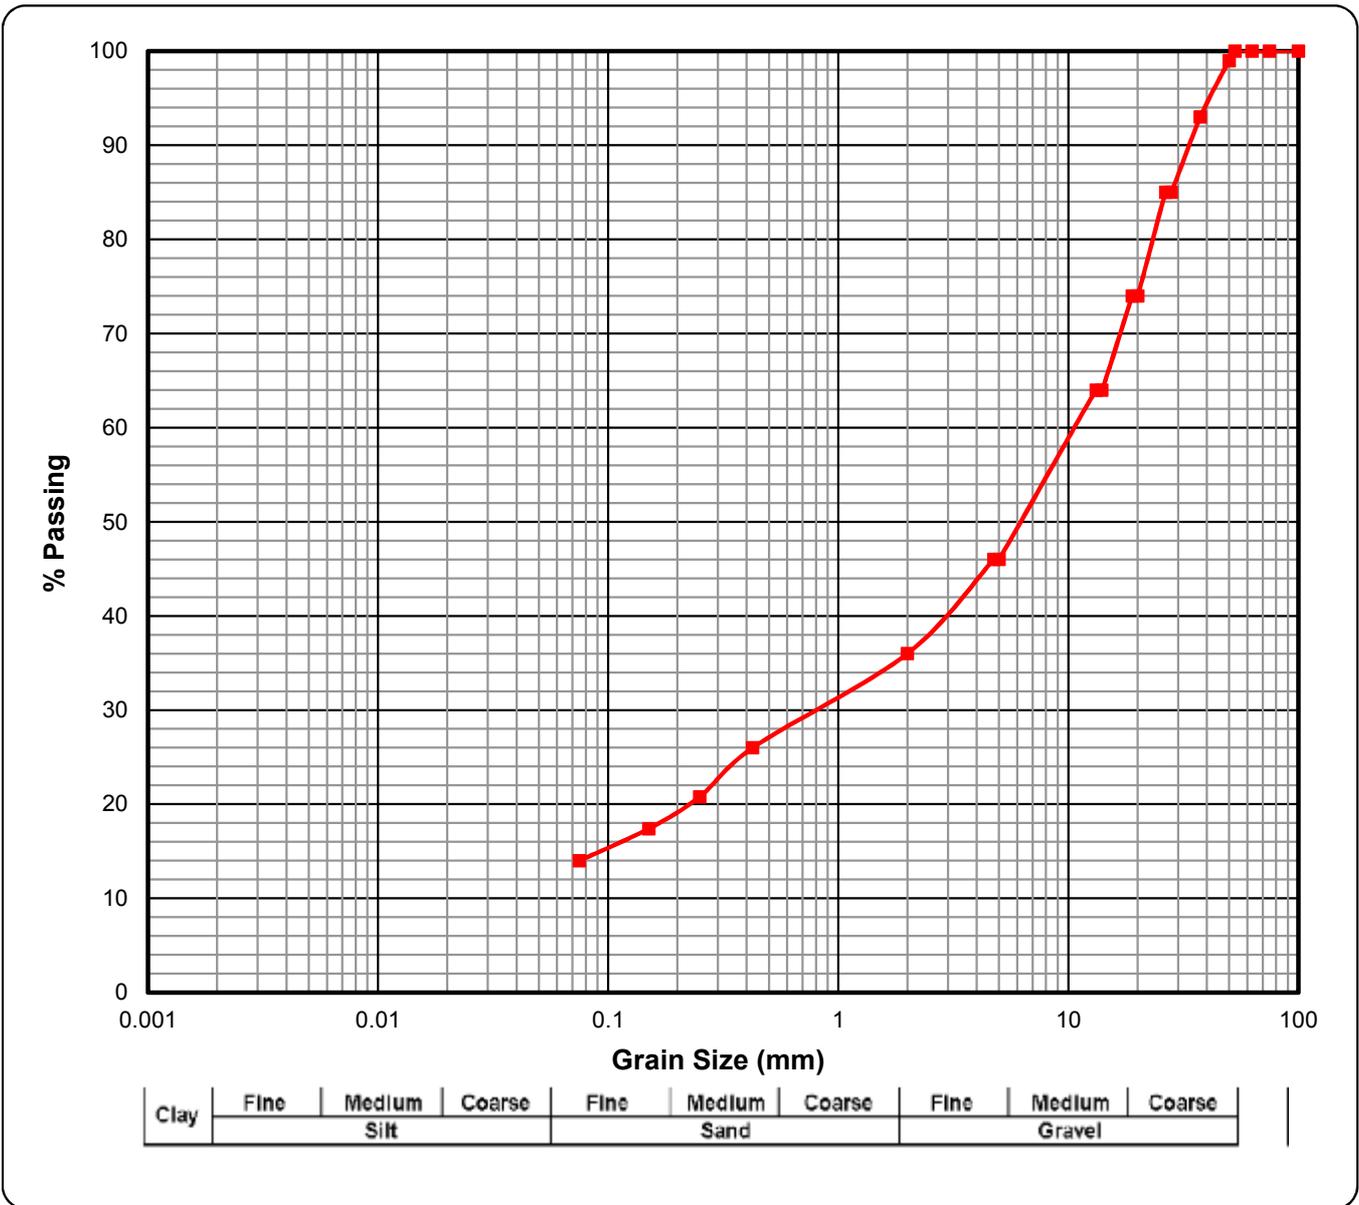
### Grading Curve for Sample T50235 – SANS 3001

**Thick Red Line is the Grading Curve (COLTO Classification = G6 (#)) (TRH 14 Classification = G7)**
