***Report to Naidu Consulting (Pty) Ltd on the Results of a Geotechnical Investigation for the Proposed Upgrades to the Water Treatment Works at Tongaat, eThekweni Municipality, KwaZulu-Natal***

***Reference: 035-22.R01 Revision 0***

***Date: 08 February 2024***

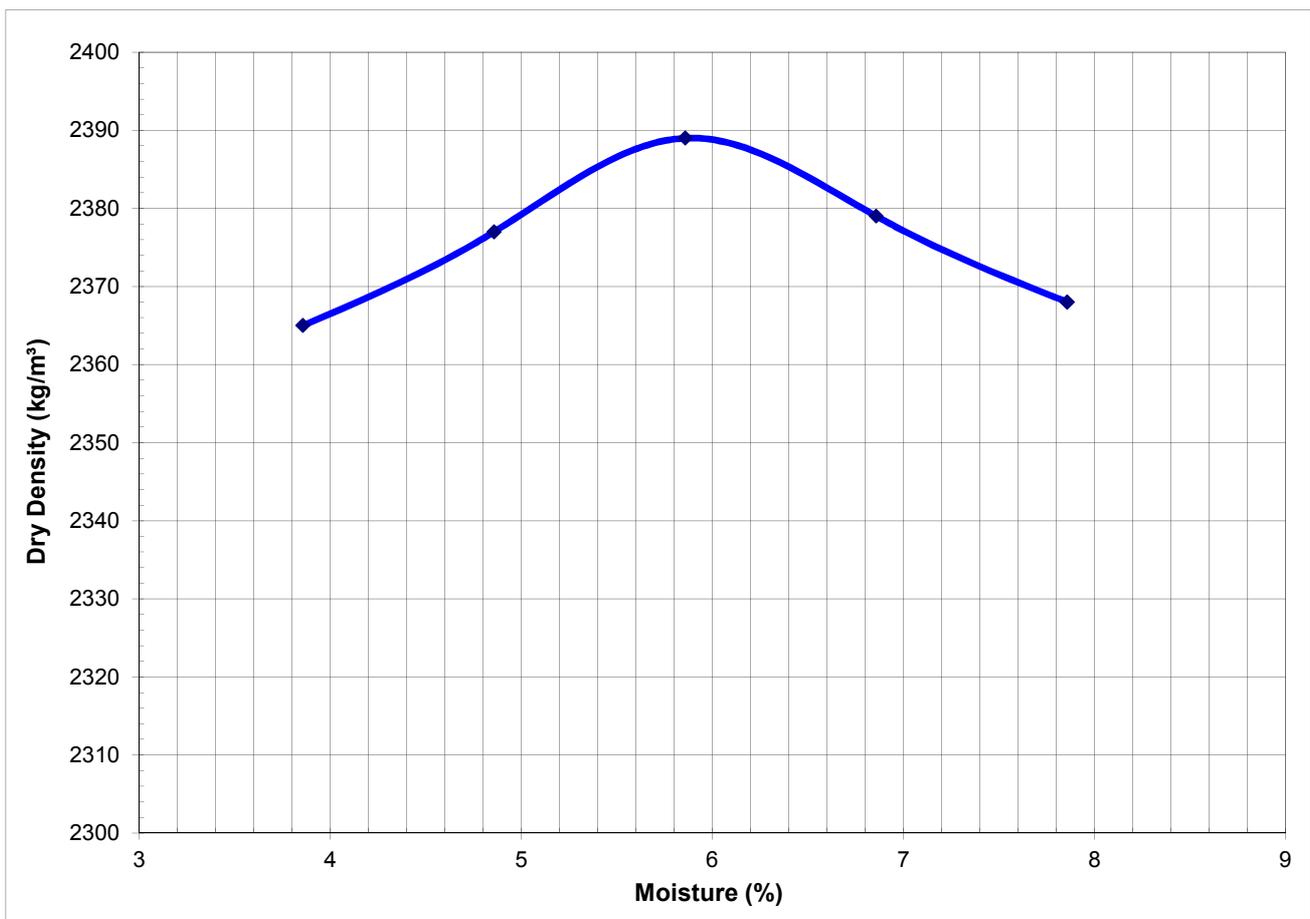
Moisture (%)	3.9	4.9	5.9	6.9	7.9
Dry Density (kg/m <sup>3</sup> )	2365	2377	2389	2379	2368

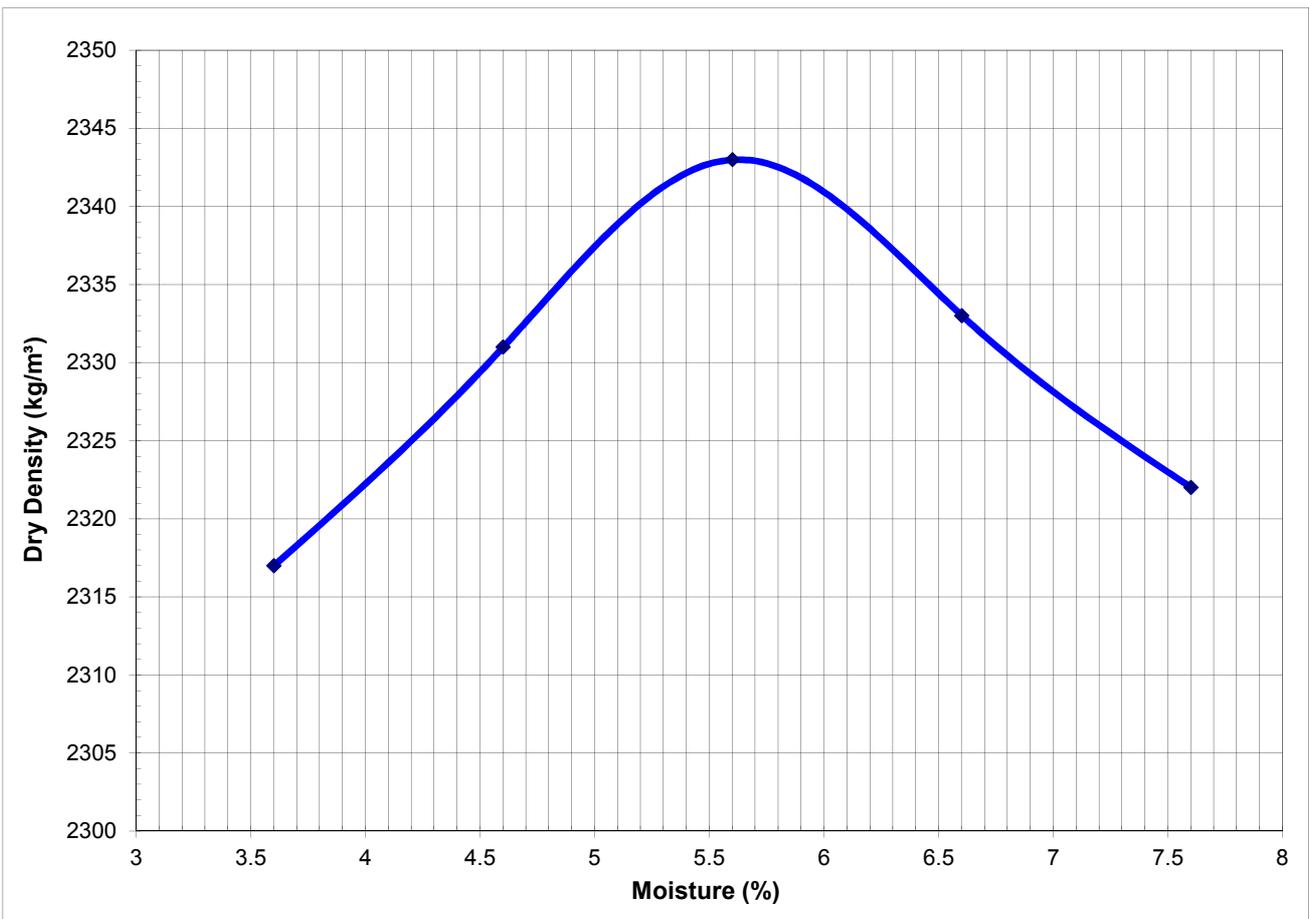
Moisture (%)	3.6	4.6	5.6	6.6	7.6
Dry Density (kg/m <sup>3</sup> )	2317	2331	2343	2333	2322
