PASSENGER RAIL AGENCY  
OF SOUTH AFRICA

# Geotechnical Interpretive Report for the Durban Lifting Shed

J42000-B-06-05-GEO-REP-0002-00

*November 2024*

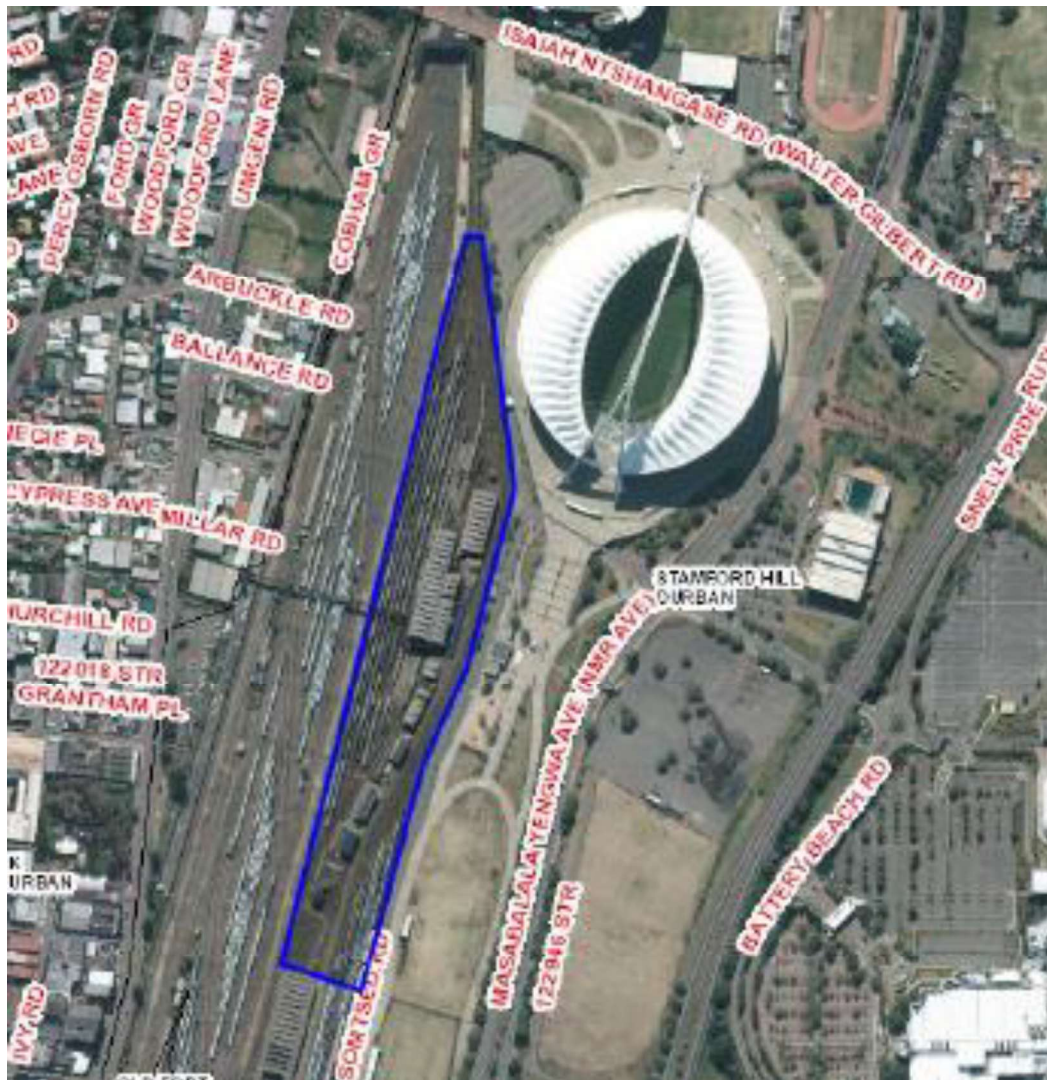
The PRASA Durban Lifting Shed facility is located some 3km north-north east of the Durban CBD, it is situated to the immediate south west of the Moses Mabhida stadium and accessible from Masabalala Yengwa Avenue near the Durban Station to the south of the site. The approximate centroid GPS coordinates of the facility and assessment area are as follows; 29°49'53.12"S; 31°01'41.07"E. The general location of the site is shown in Figure 1.

Figure 1: Site Location and extent of PRASA Lifting Shed facility (outline in blue).

The site is currently occupied by storage structures, office buildings, lifting shed/workshop, rails/tracks, decommissioned locomotives, parking bays and associated access roads for vehicles.

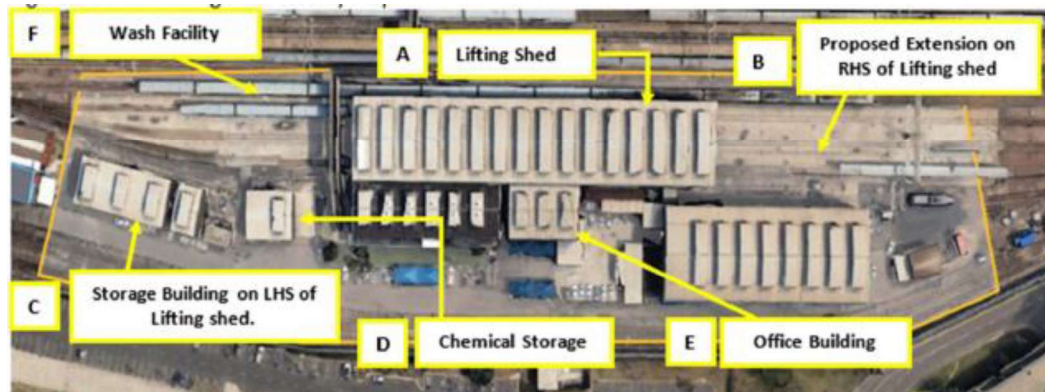
Figure 2: Location of various Facilities at the Durban Lifting Shed

The location of the various facilities is indicated in Figure 2.
