| | <b>Security Threat Assessment<br/>(STA) Report</b><br><br><b>CONTROLLED DISCLOSURE</b> | <b>Unique Identifier</b> | <b>240-147801103</b> |

## **SECURITY THREAT ASSESSMENT (STA) REPORT: Manogeng Switching Substation**

**a) Area or Address of Site** : Manogeng 400kV Switching Station

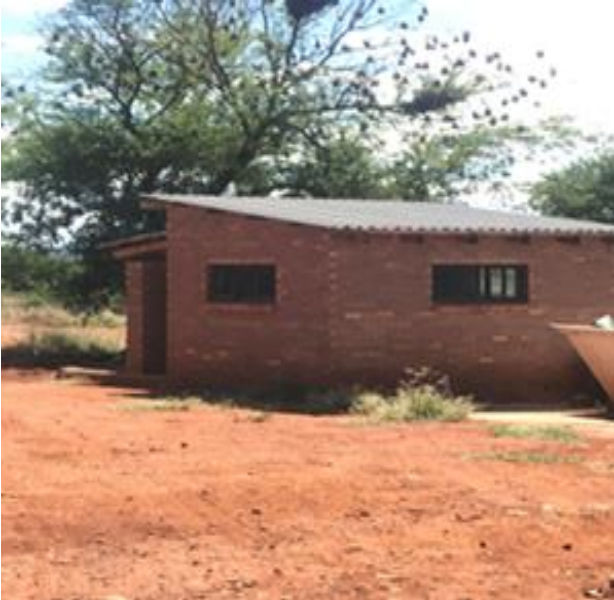
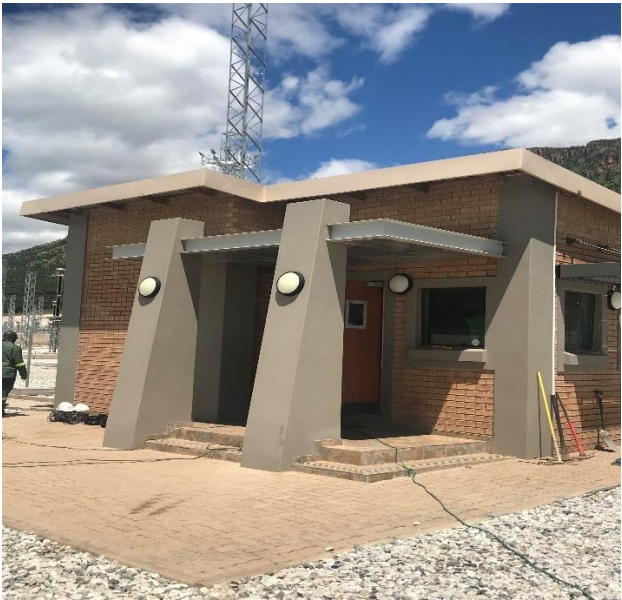
a) Guardhouse x 2

The Guardhouse/s at the first entrance and the substation entrance at Manogeng switching substation.

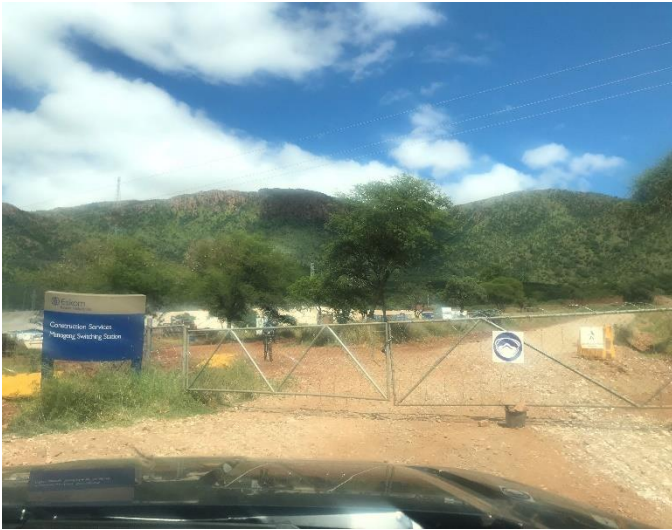
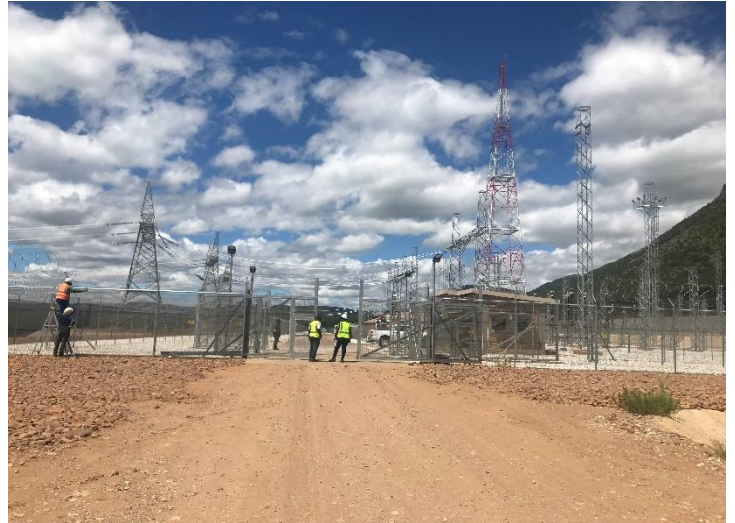
#### b) Main Gate/s to Site and Substation

The first gate provide access into the Site and the second gate provide access into the Substation.

| # | Security Measures Type | Recommendations |
|---|---|---|
| 3 | Perimeter Fence | <ul style="list-style-type: none"> <li>• The boundary fence from the main gate from the gravel road, surrounding the Substation, are partly razer blade and partly farm wired fence which poses a high risk for intrusion to get access to the paremeter fence of the Substation. Therefore the main gate perimeter fence lightning must be upgraded to ensure adequate visibility for security during perimeter patrol where the project equipments are stored.</li> </ul> |

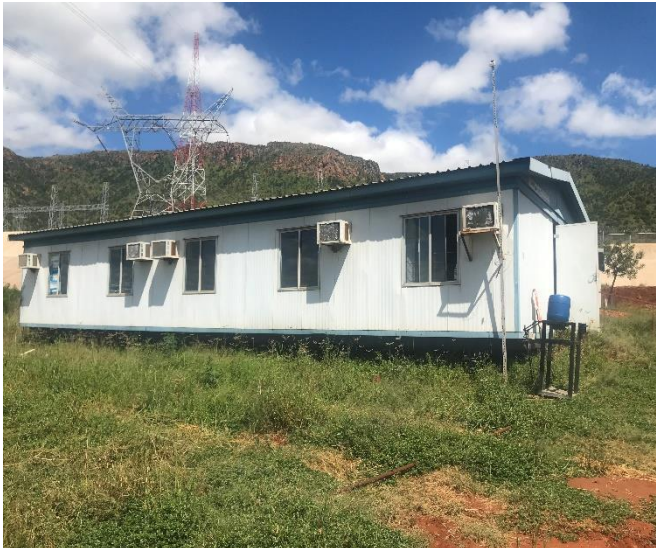
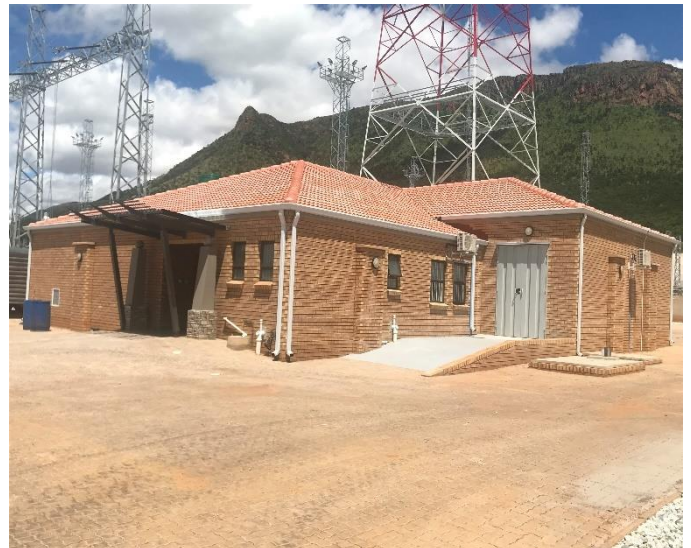
#### c) Site Office

This coble site office will soon be removed and the Site supervisor will move into the substation offices .

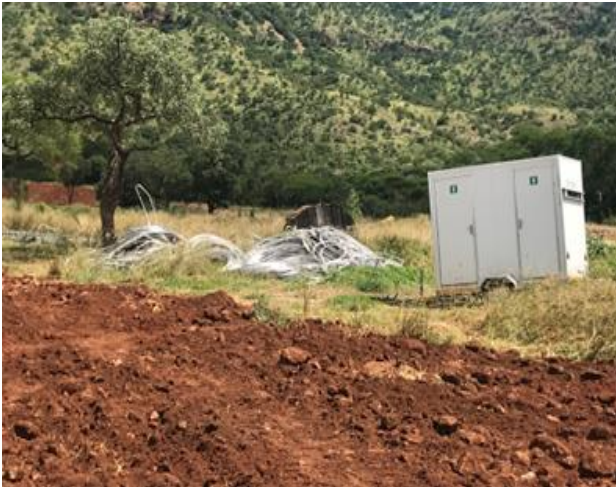
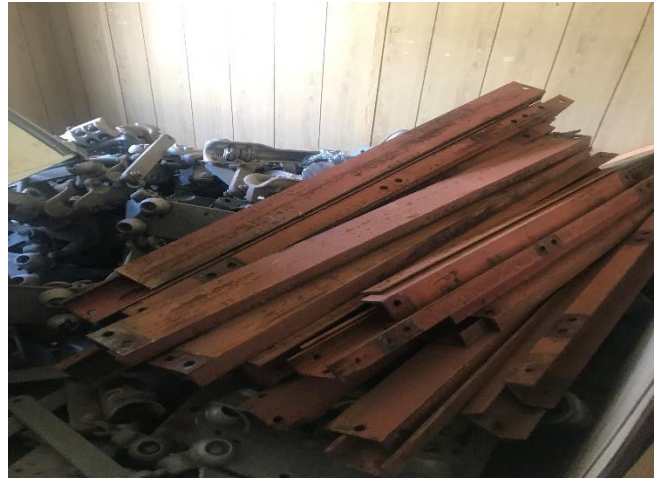
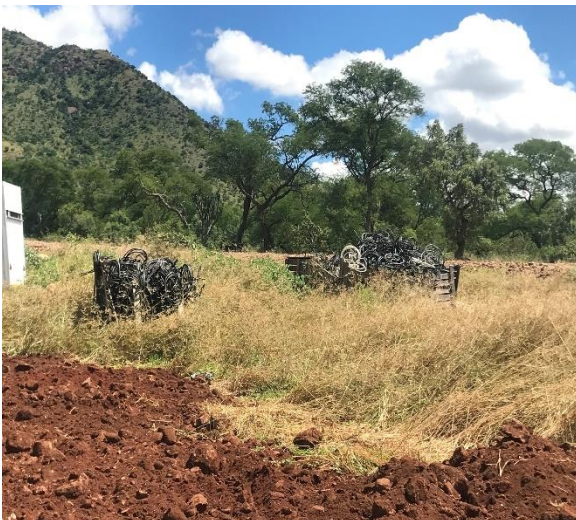
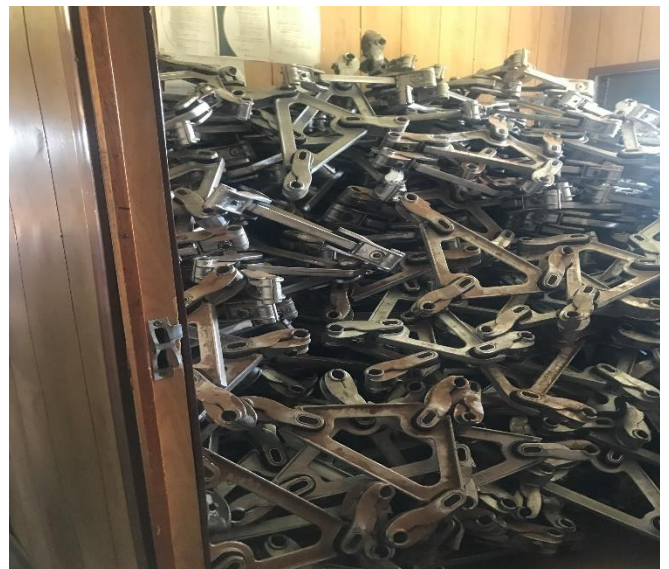
#### d) Scrap Metal

The Visible scrap material are from lines and will be removed from site, as cleaning process has already started.

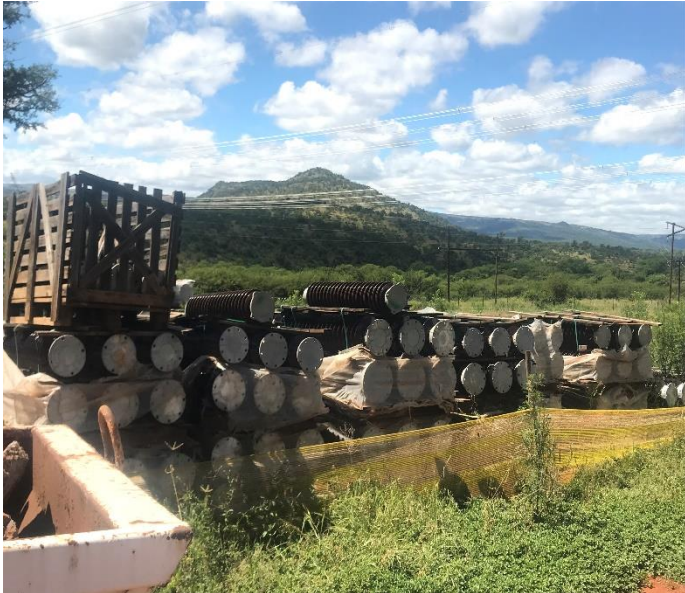
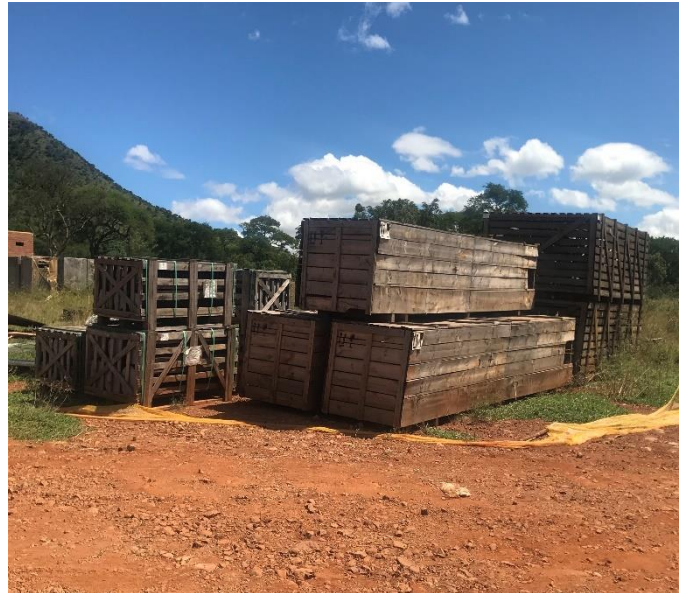
#### e) Project Material

Project Material that will be installed in the Substation.

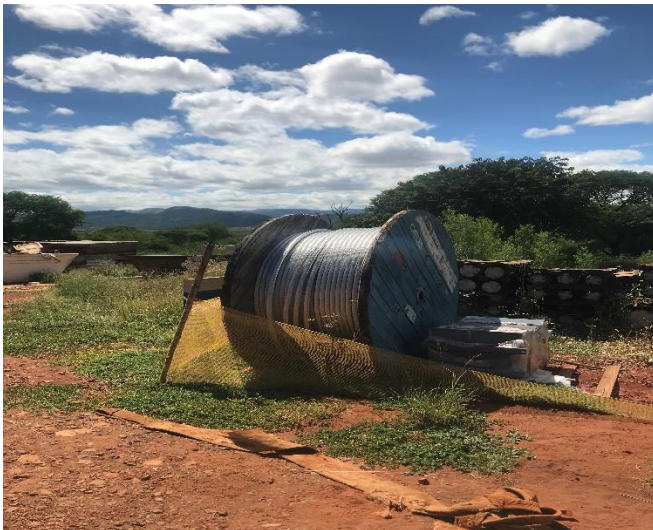
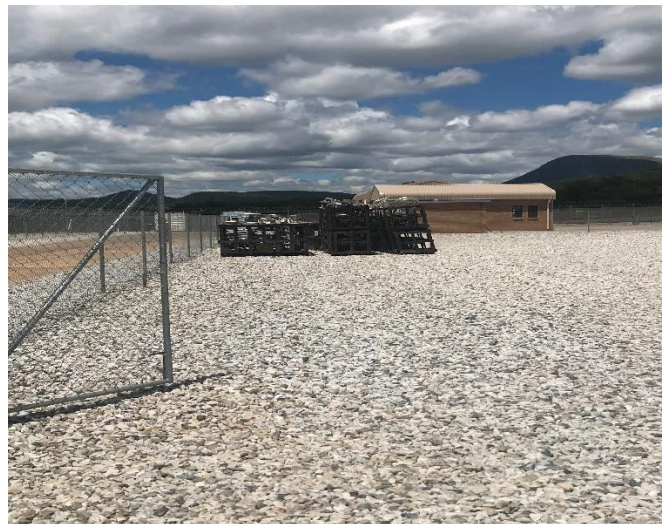
#### f) Project Material

Project Material in picture (e) and (f) will be removed from their positions into the Substation as the second picture in (f)

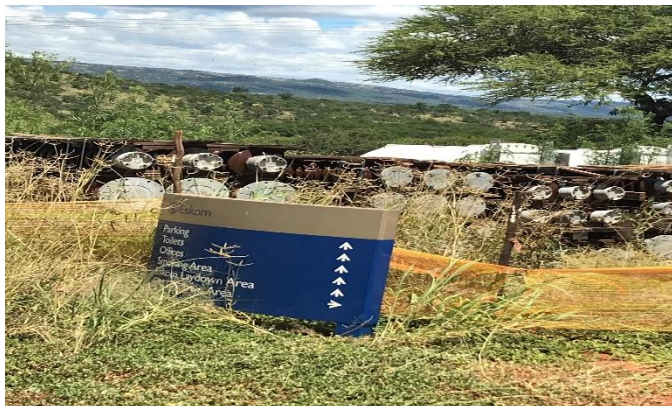
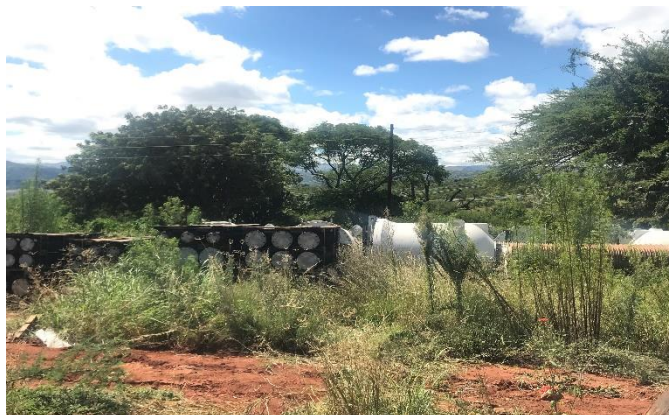
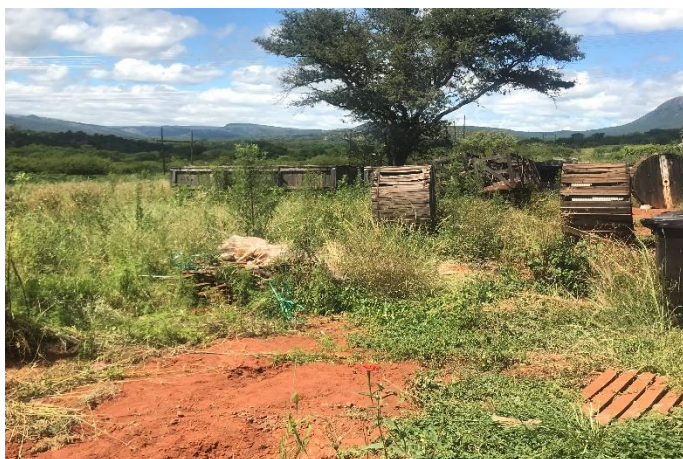
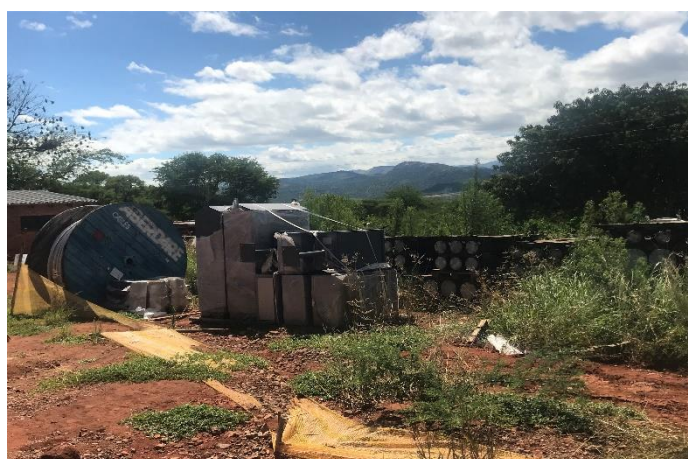
#### g) Project Material between overgrown vegetation

Project material laid previous lay down area overgrown with vegetation, contributing to visibility

| # | Security Measures Type | Recommendations |
|---|---|---|
| 4 | Vegitation | <ul style="list-style-type: none"> <li>• Regular vegetation management control to be done on a regular basis to minimise any risk or visibility obstructions during security patrols.</li> </ul> |
