BID NO: 11/2022

**HOLSLOOT DIVERSION WORKS: REHABILITATION AND LANDSCAPING IN  
THE HOLSLOOT RIVER, RAWSONVILLE**

### THE CONSTRUCTION OF A WEIR AND PIPELINE ALONG THE HOLSLOOT RIVER NEAR RAWSONVILLE, WESTERN CAPE.

GNEC REF: Holsloot Rehabilitation Report, Rawsonville, Western Cape.

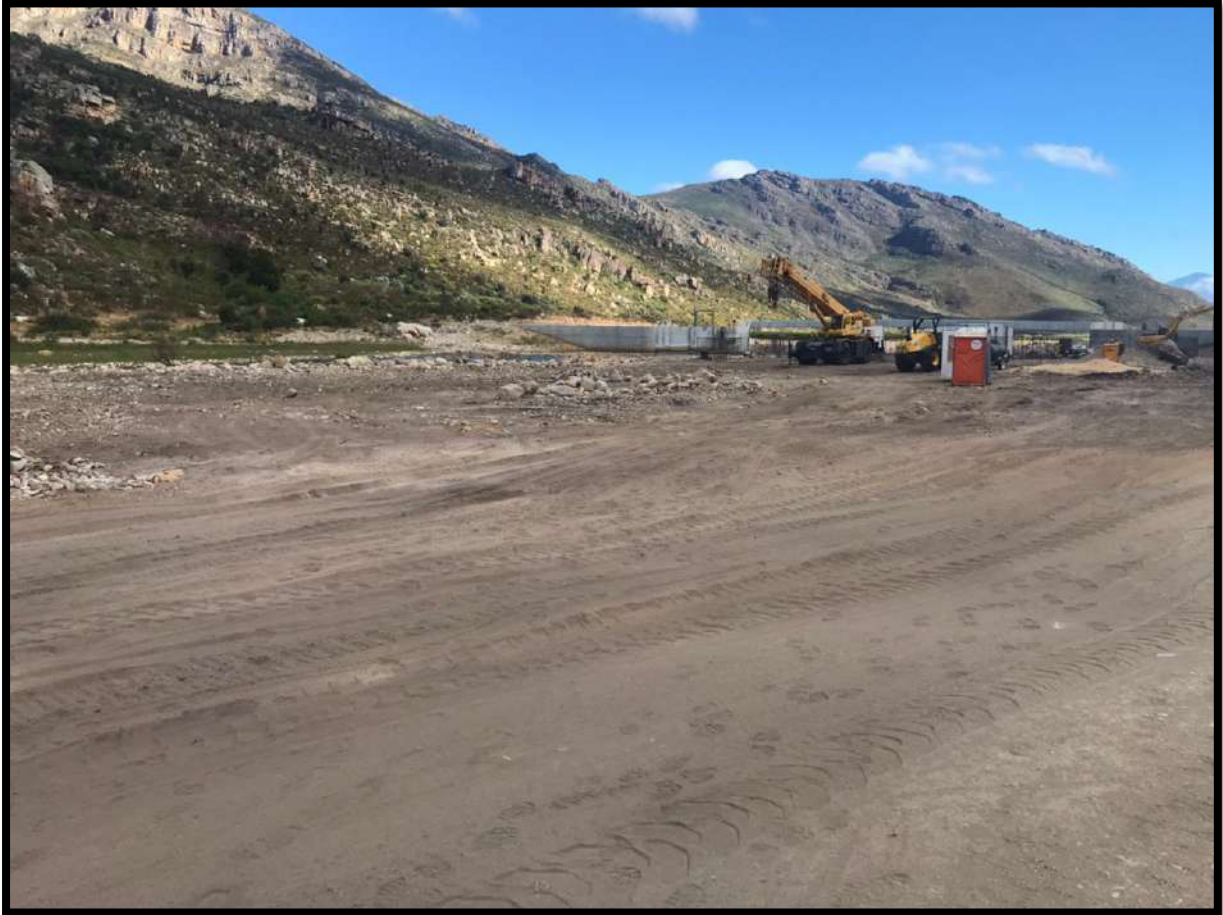
#### Area 1: Site Camp.

**FIGURE 3: DISTURBED AREA OF THE SITE CAMP.**

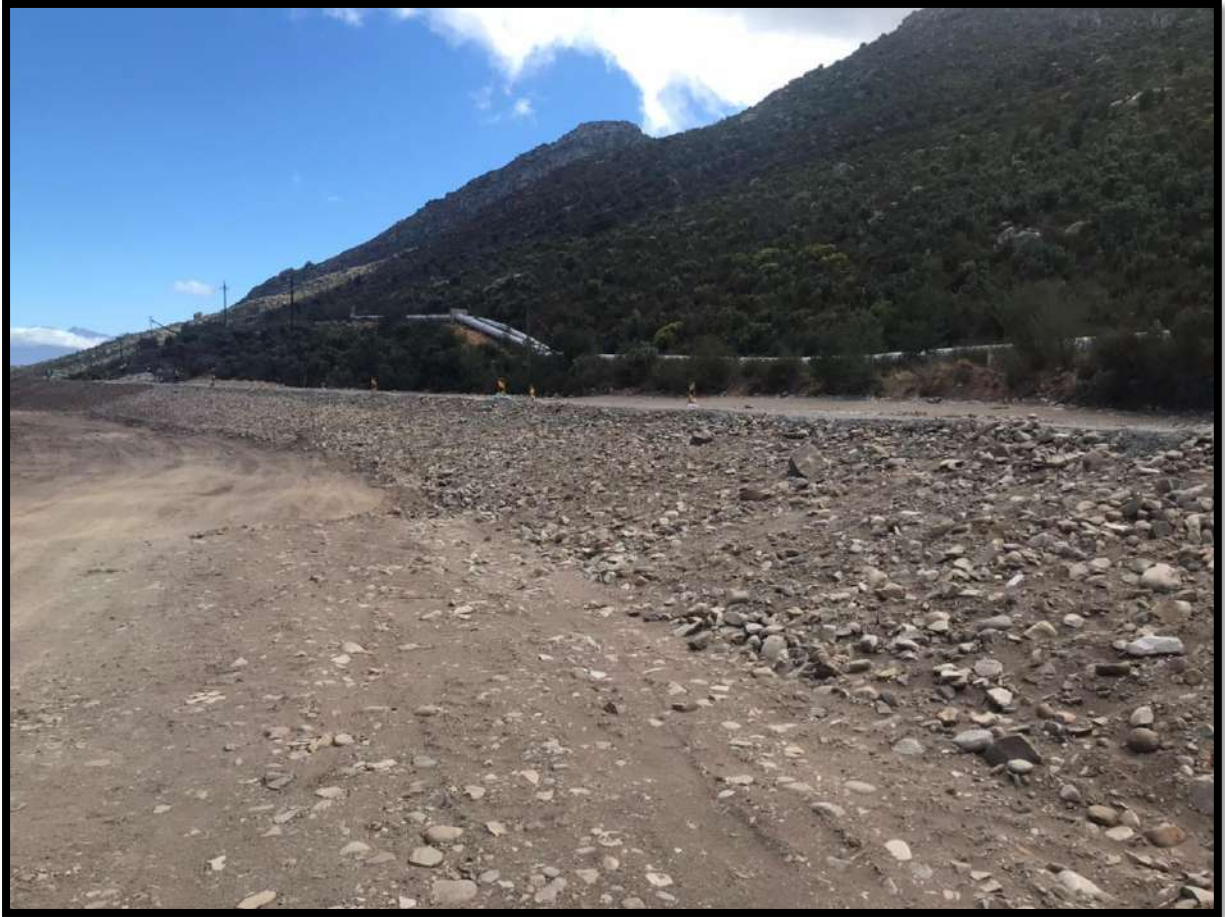
**Area 2: Embankment along Stettyns Road.**

**FIGURE 4: EMBANKMENT ALONG STETTYNS ROAD.**

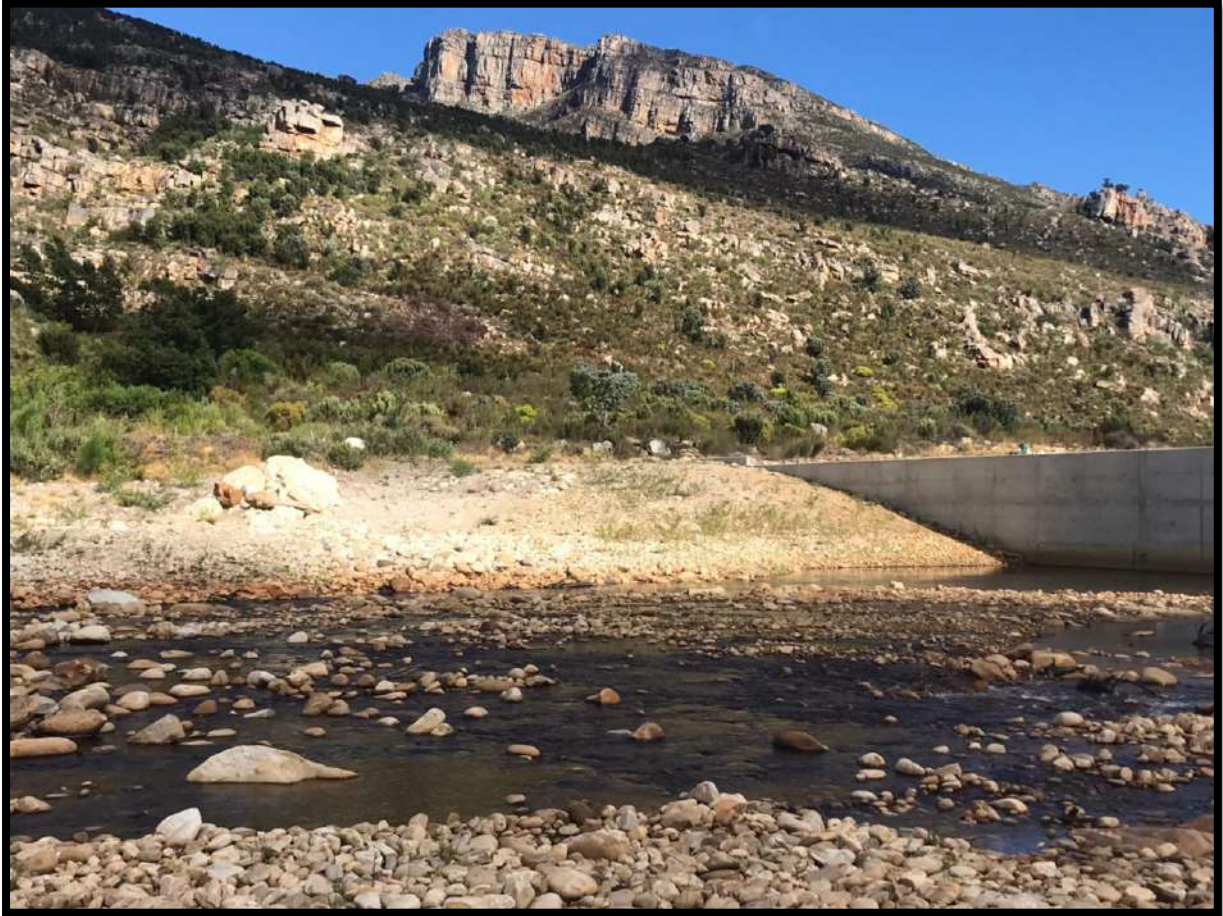
**Area 3: Upstream of weir; left embankment.**

**FIGURE 5: UPSTREAM OF WEIR; LEFT EMBANKMENT.**

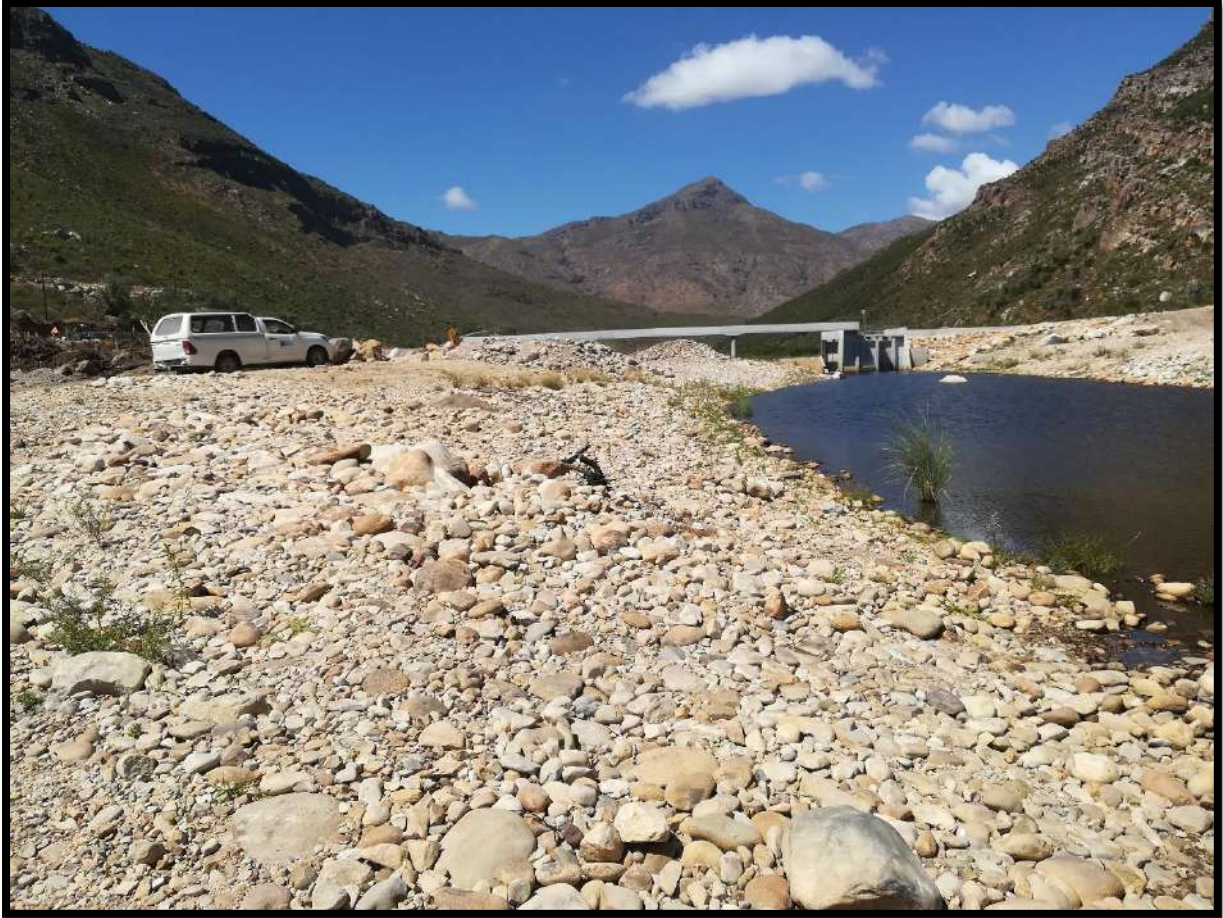
**Area 4: Downstream of weir; right embankment.**

**FIGURE 6: DOWNSTREAM OF WEIR; RIGHT EMBANKMENT.**

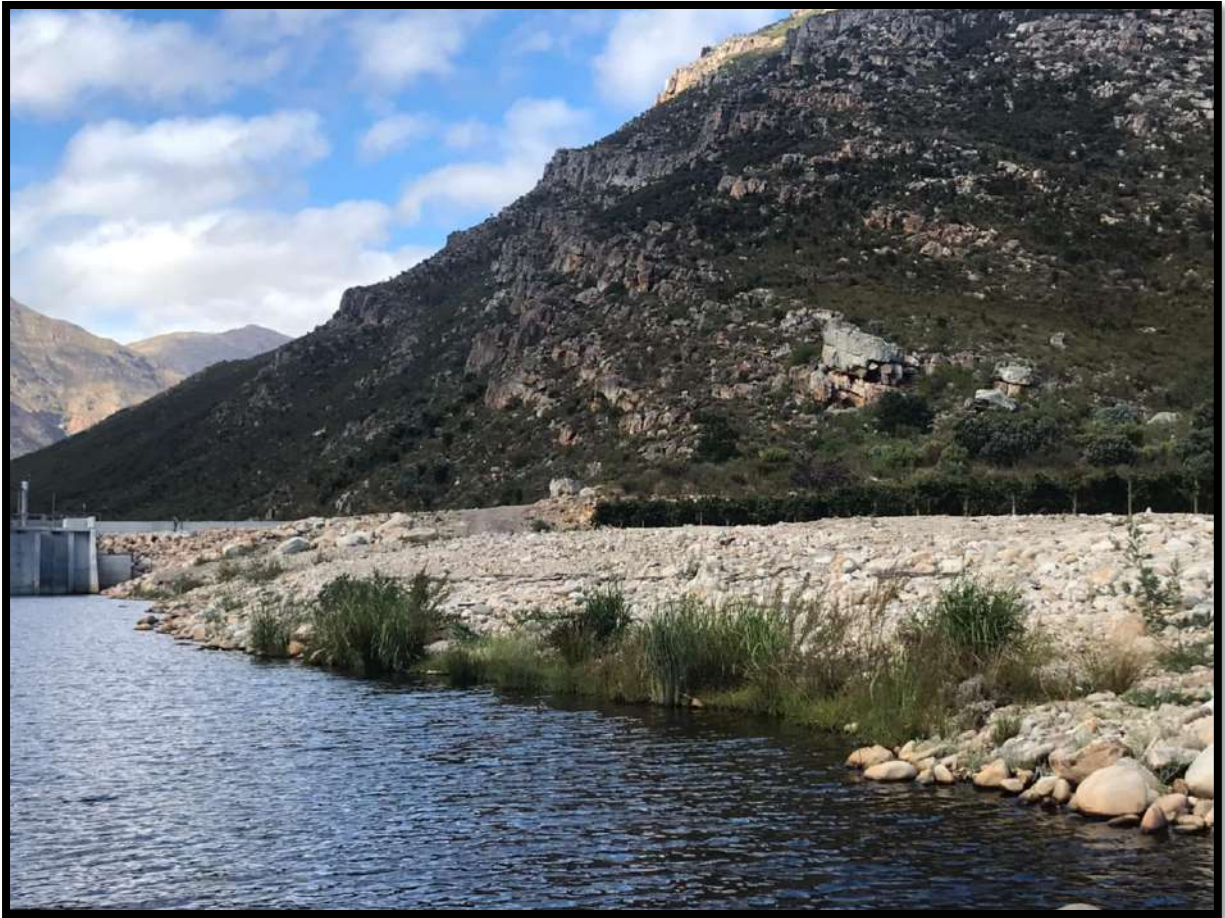
**Area 5: Downstream of weir; left embankment.**

**FIGURE 7 DOWNSTREAM OF WEIR; LEFT EMBANKMENT.**

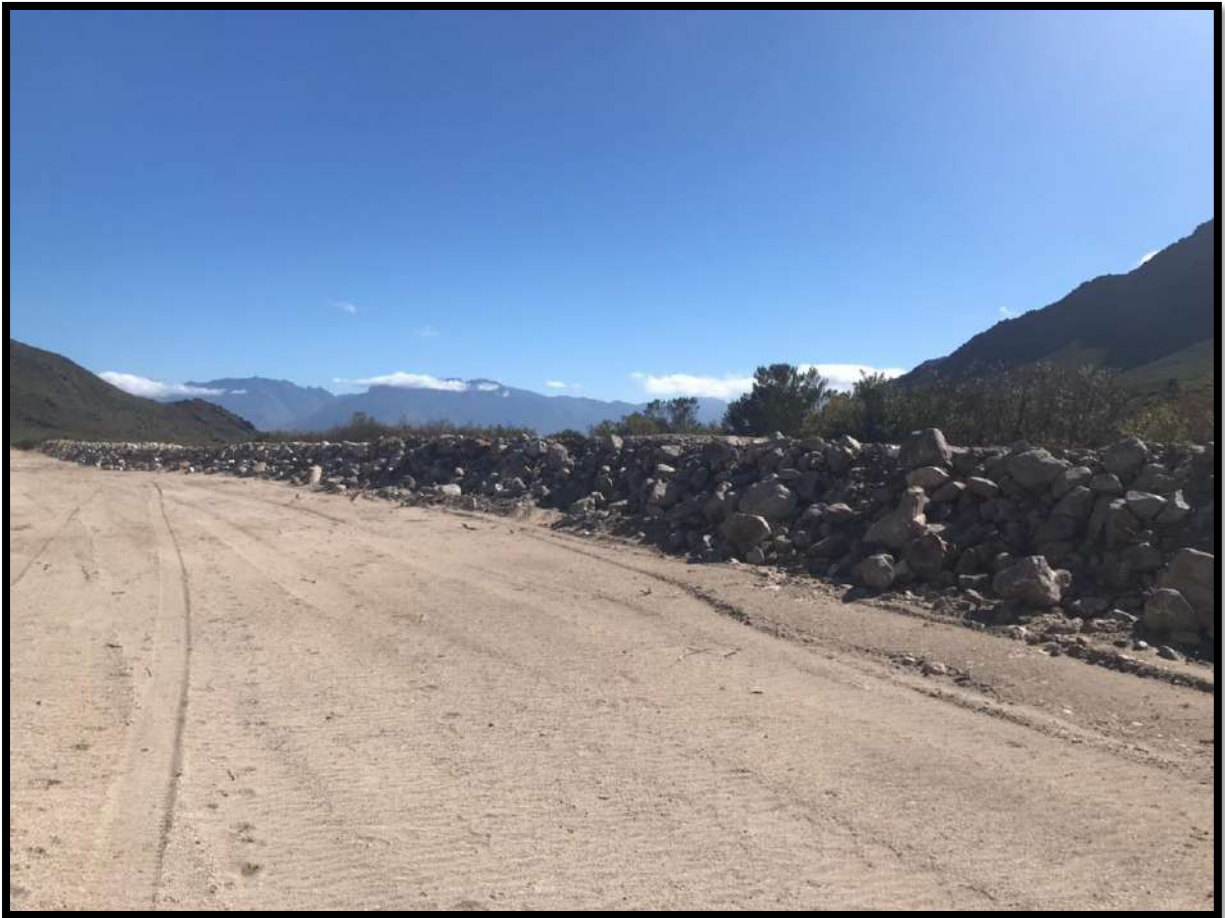
**Area 7: Water pipeline route.**

**FIGURE 9 DISTURBED WATER PIPELINE ROUTE.**

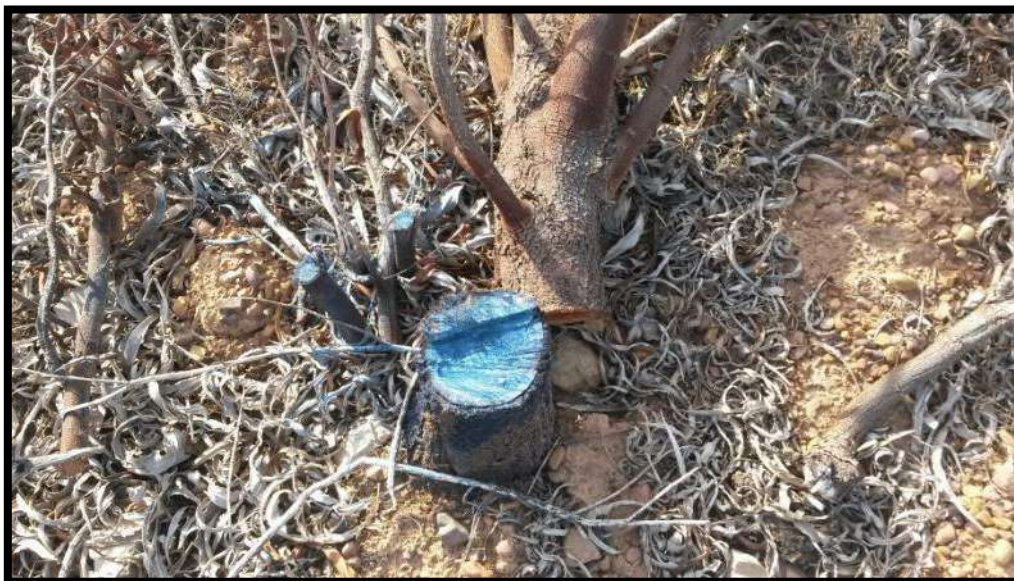
***The systemic poison needs to be prepared at a two percent solution.***

**FIGURE 10: EXAMPLE OF A CUT DOWN STEM TREATED WITH COLOURED SYSTEMIC HERBICIDE.**

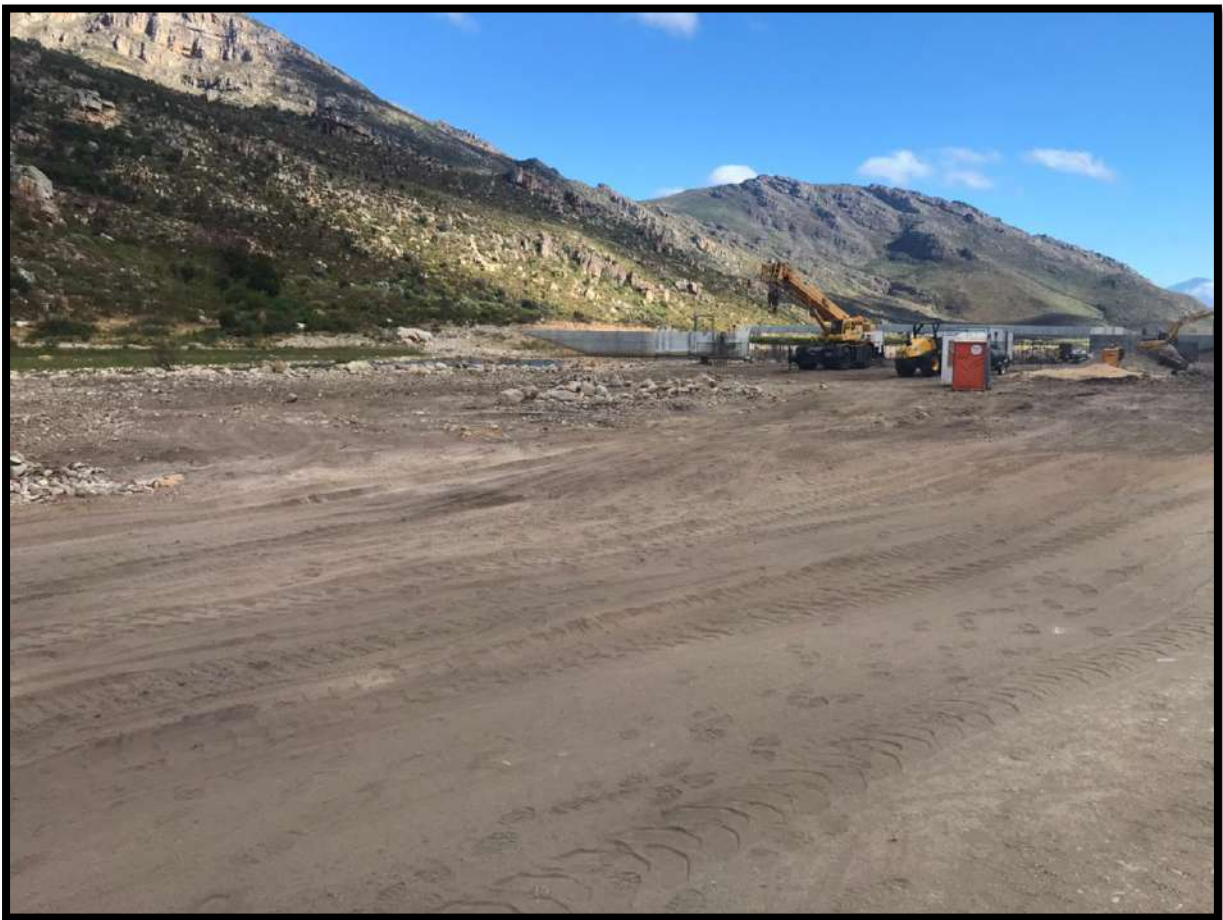
##### Area 1: Site Camp

**FIGURE 12: SITE CAMP AREA TO BE REHABILITATED.**

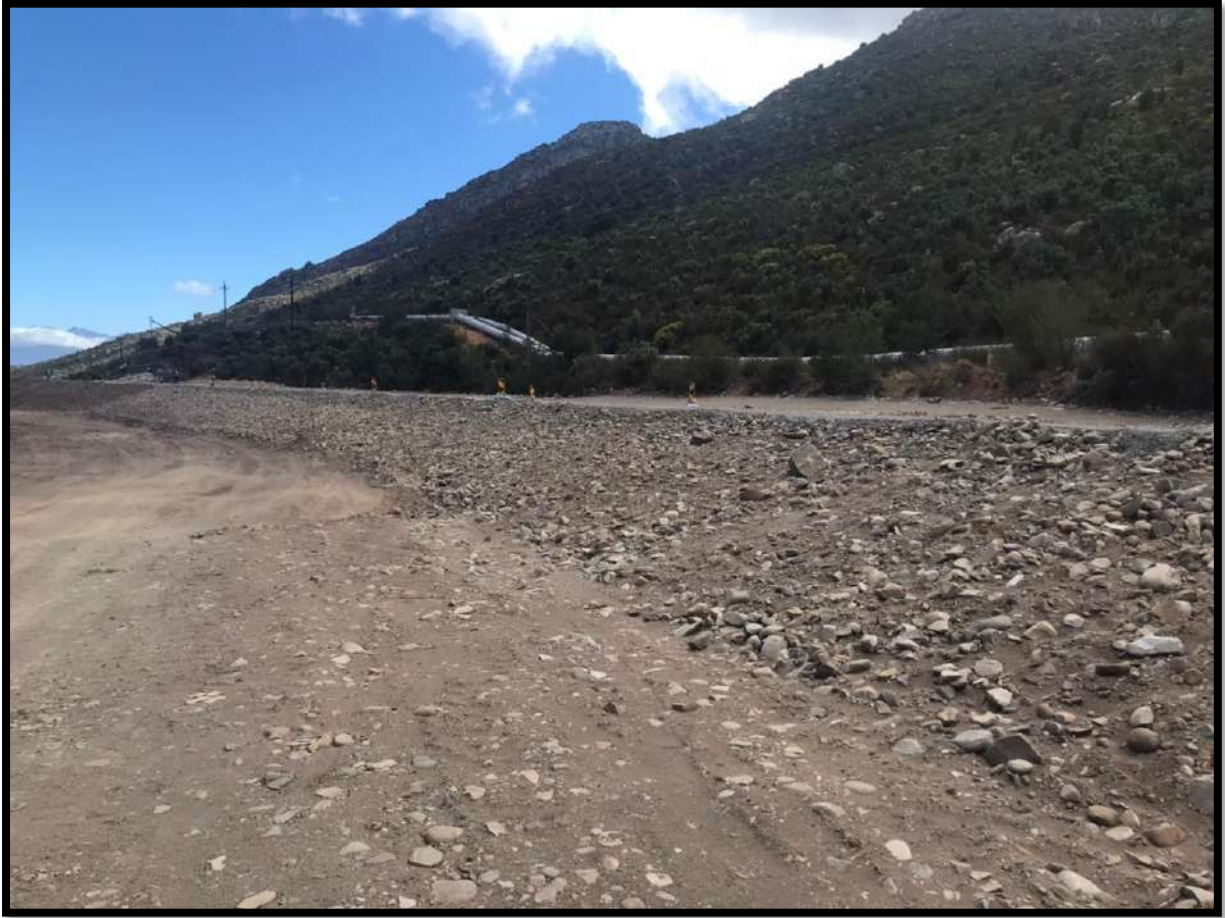
**Area 2: Embankment along Stettyns Road.**

**FIGURE 13: BARE EMBANKMENT ALONG STETTYNS ROAD.**

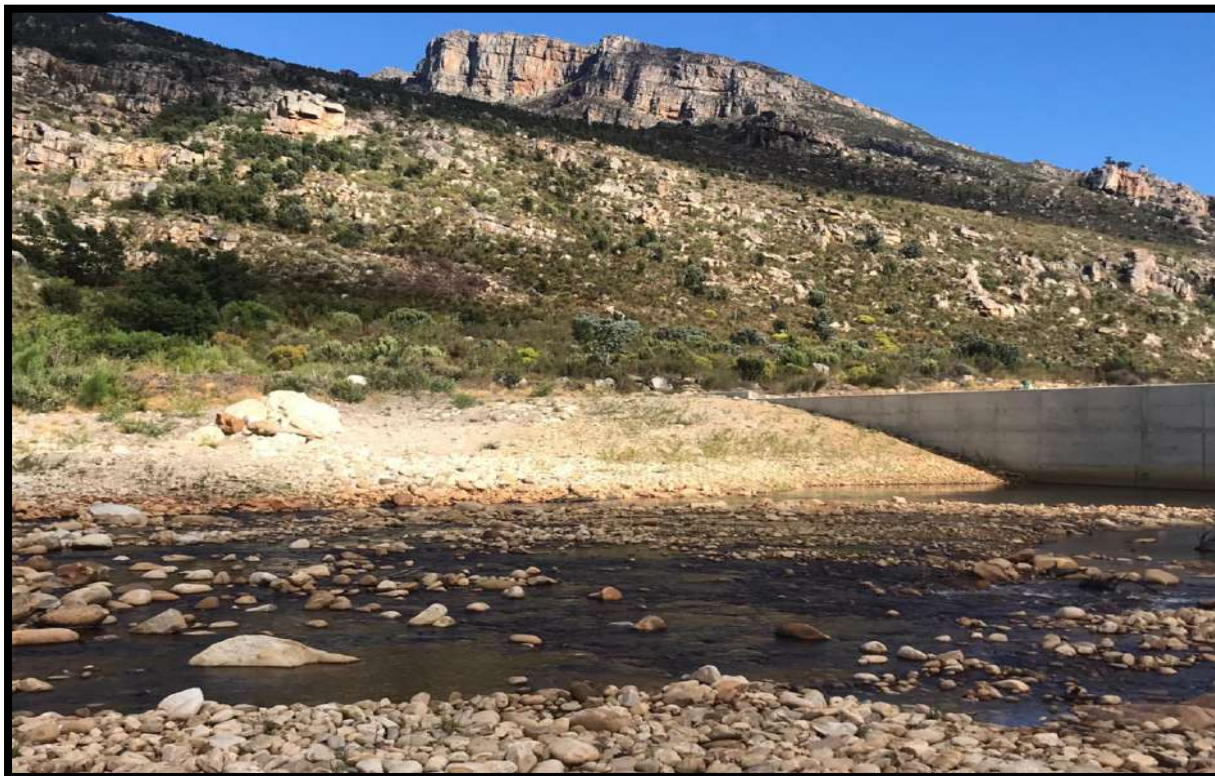
**Area 3: Upstream of weir; left embankment.**

**FIGURE 14: BARE EMBANKMENT; UPSTREAM OF WEIR; LEFT EMBANKMENT.**

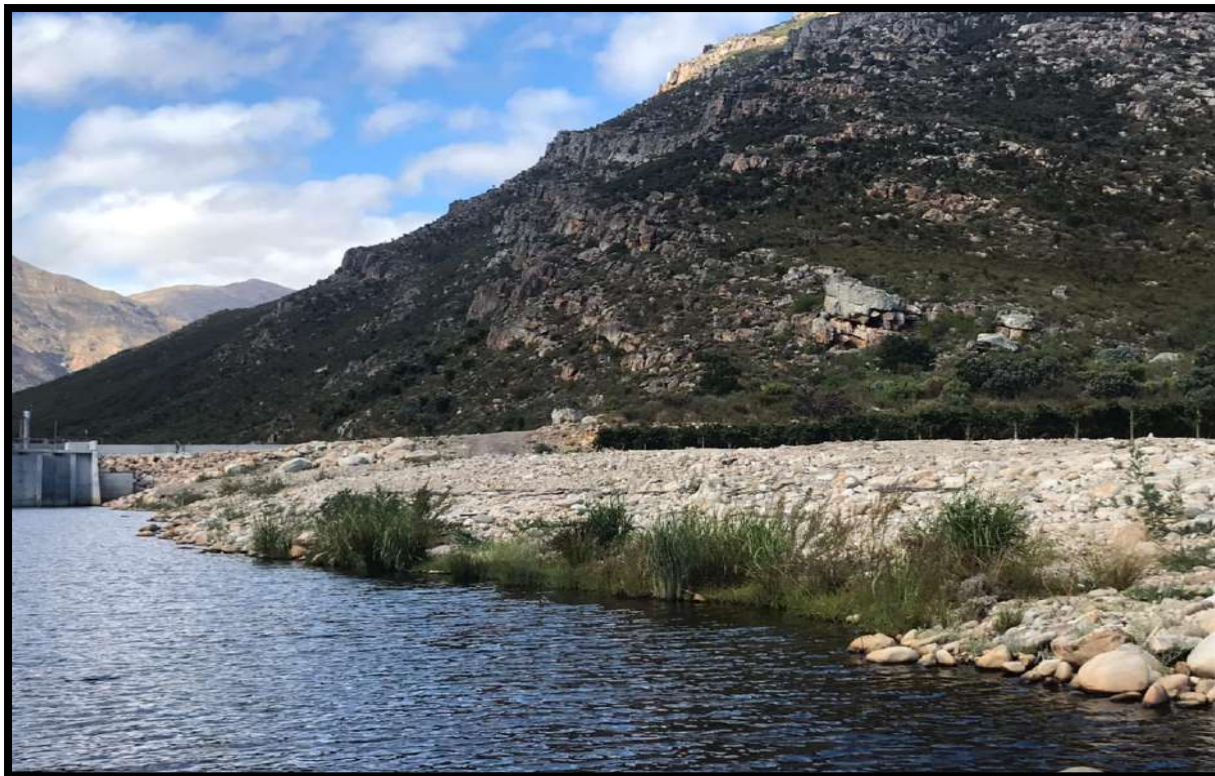
**Area 5: Bare embankment; downstream of weir; left embankment.**

**FIGURE 16 BARE EMBANKMENT; DOWNSTREAM OF WEIR; LEFT EMBANKMENT.**

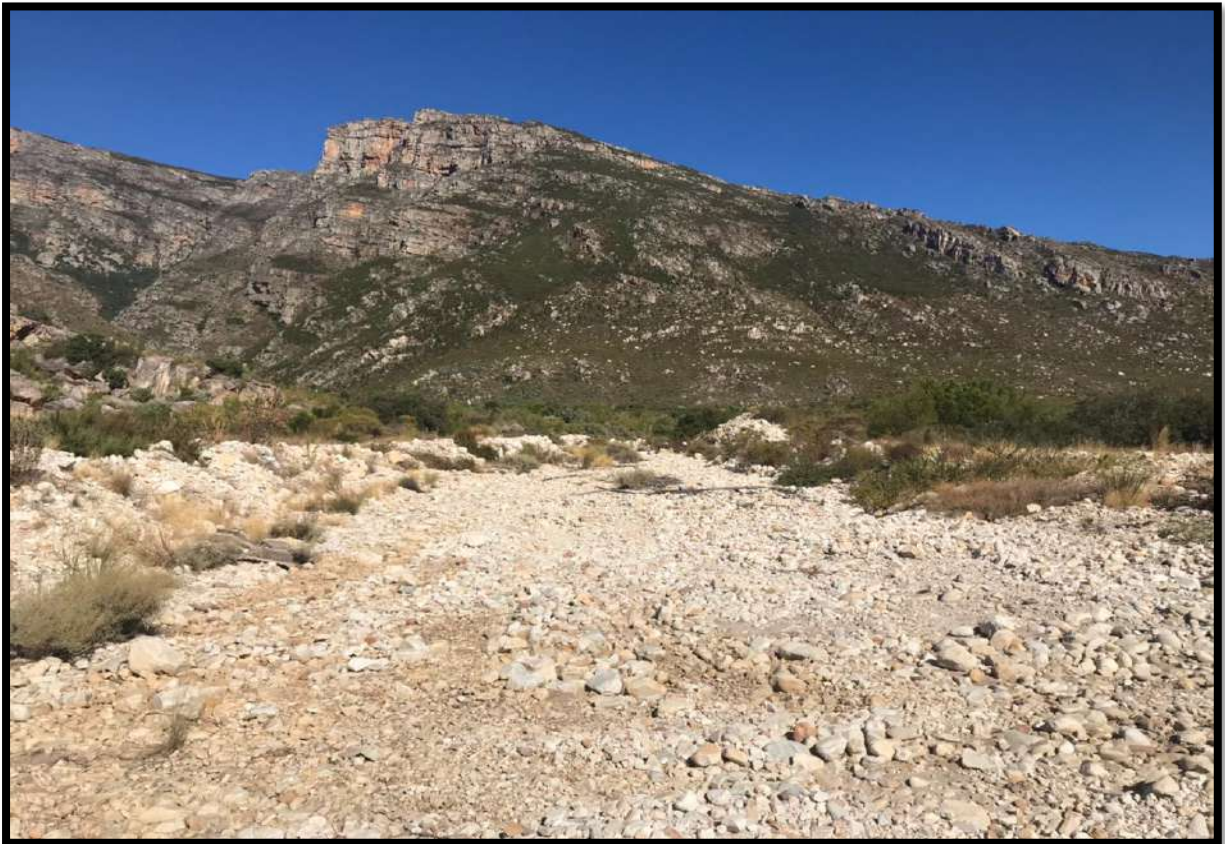
**Area 6: Tributary of the Holsloot River.**

**FIGURE 17 TRIBUTARY OF THE HOLSLOOT RIVER.**

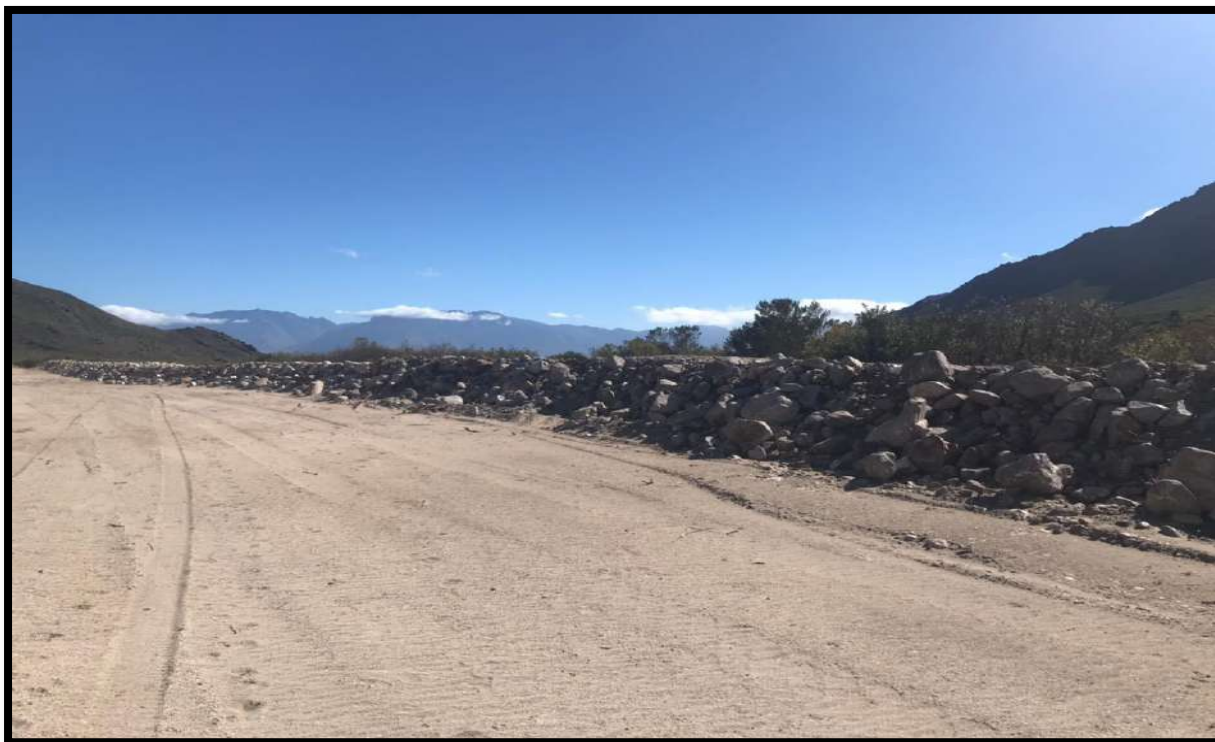
#### Area 7: Water pipeline route.

**FIGURE 18 BARE WATER PIPELINE ROUTE**

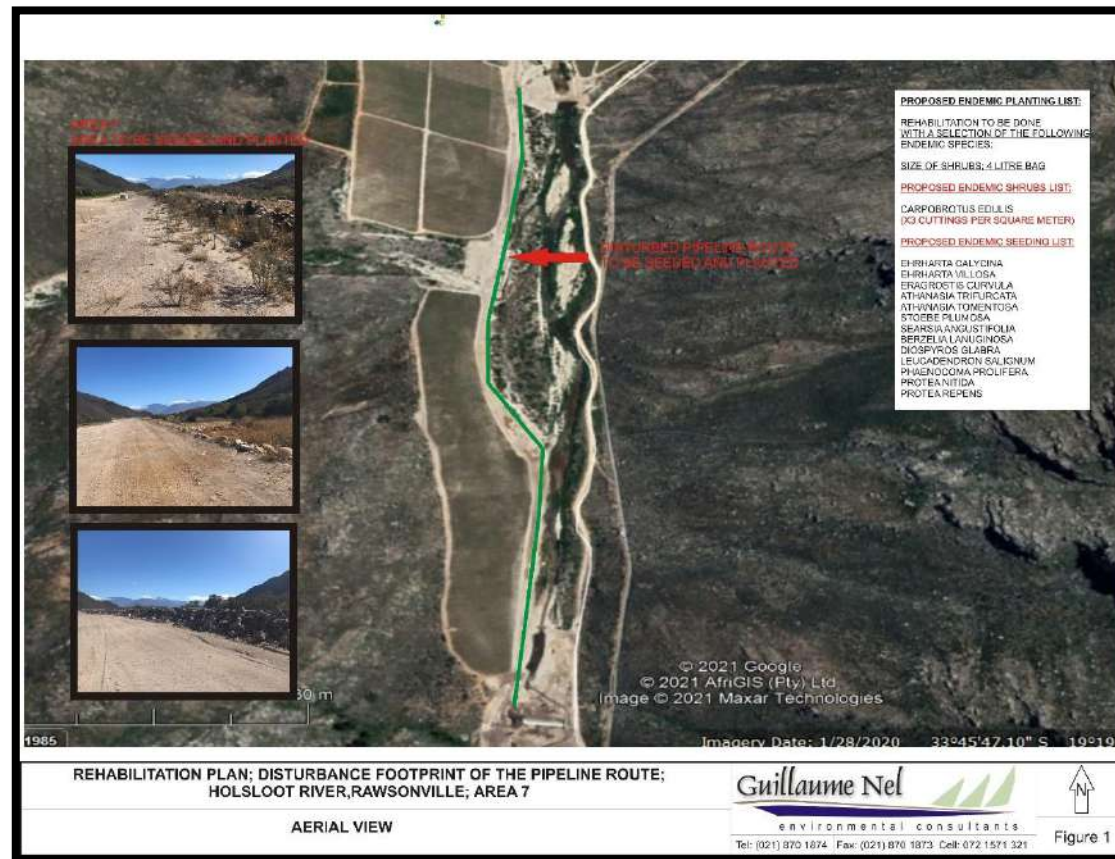
## 7 REHABILITATION PLAN; AREA 7

FIGURE 21: TRIBUTARY AREA REHABILITATION PLAN; AREA 7

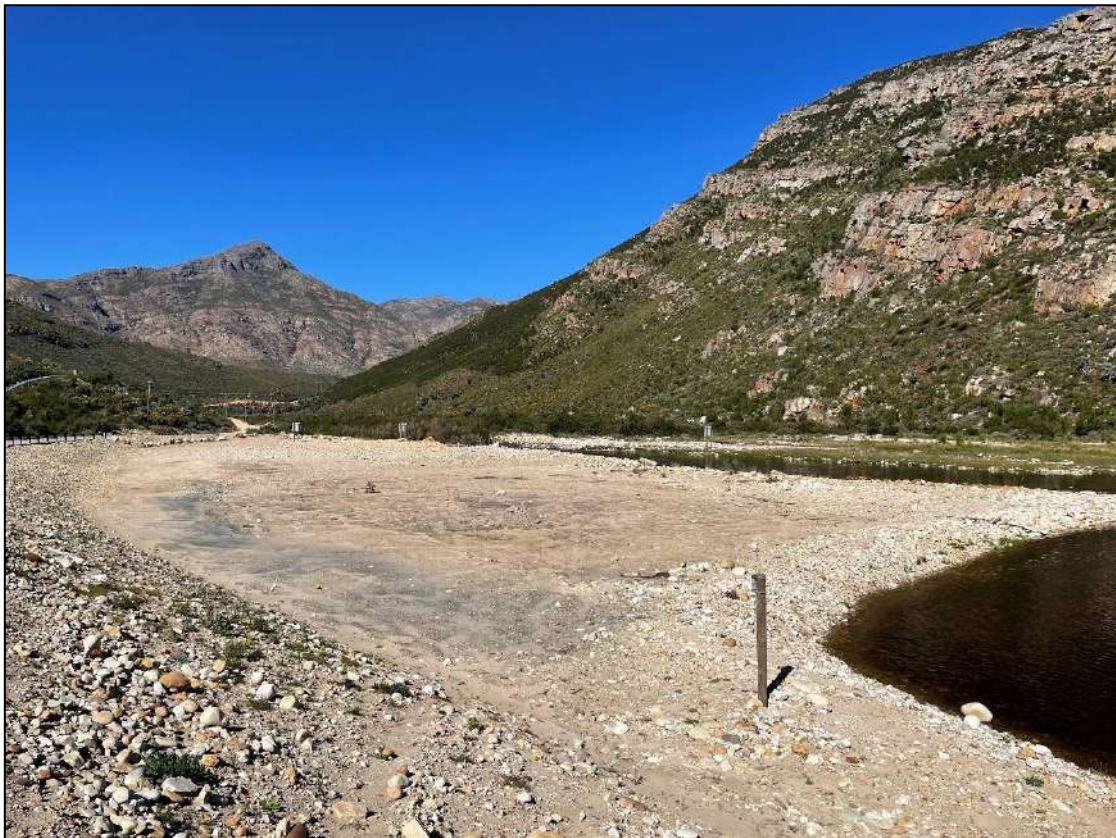
**Photo 1** Cleared area on the upstream side of the weir.

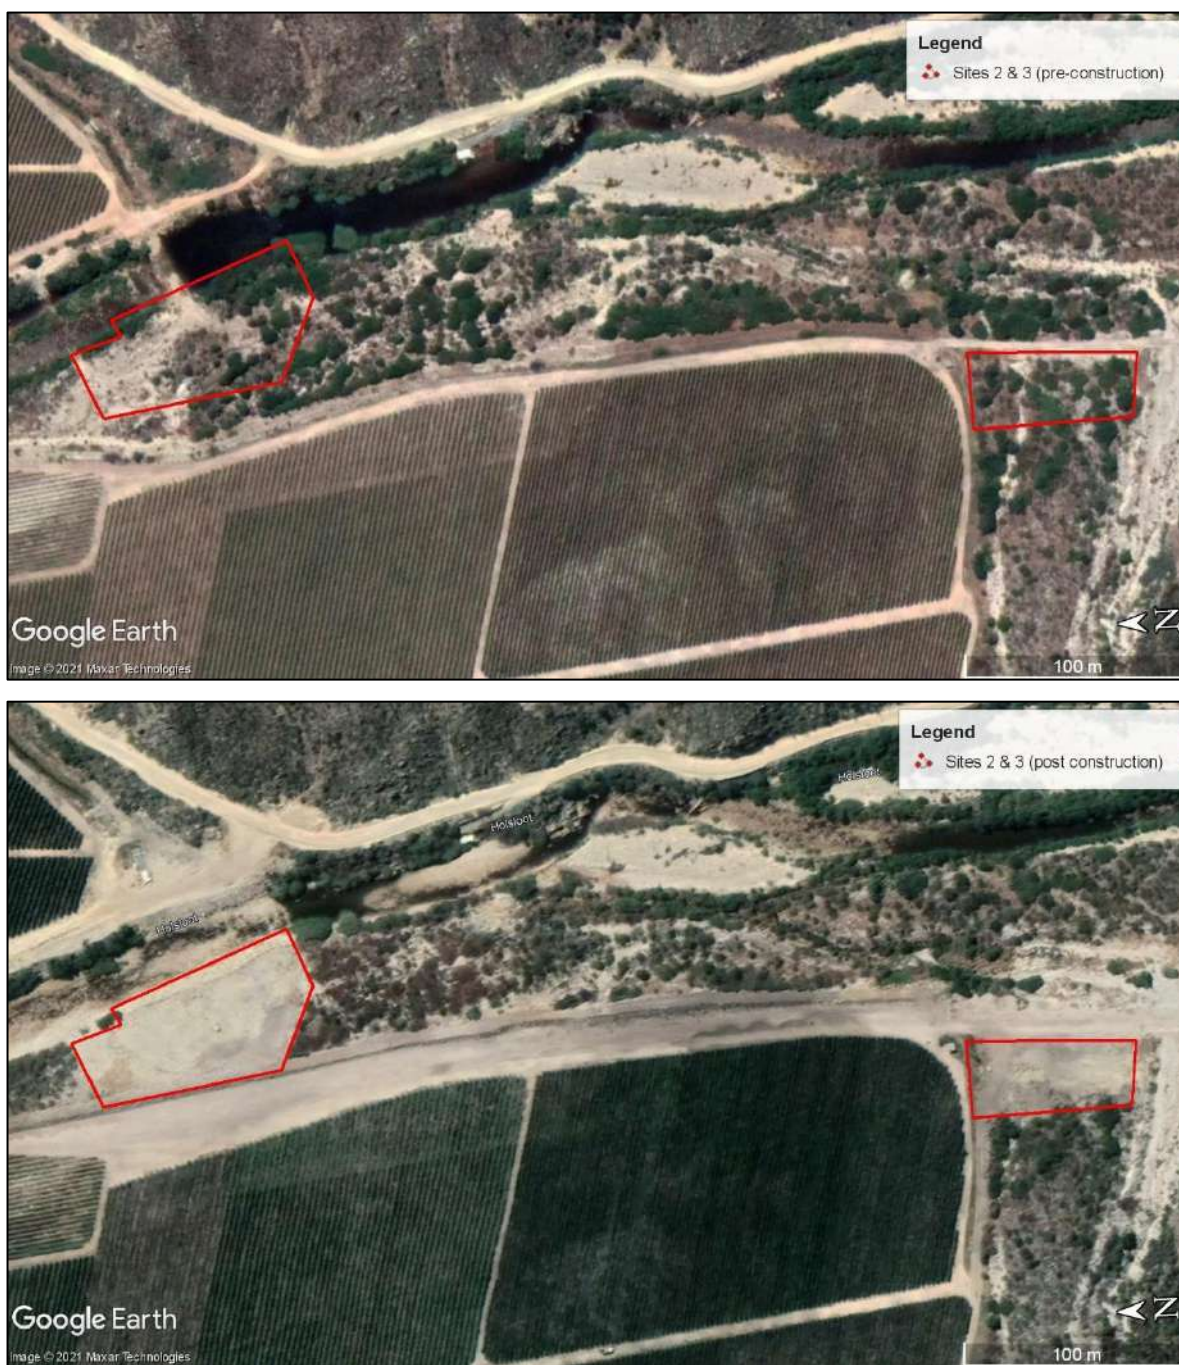
**Map 9** Google Earth images illustrating the state of Sites 2 and 3 before (Dec 2018) and after (Feb 2021) construction activities.

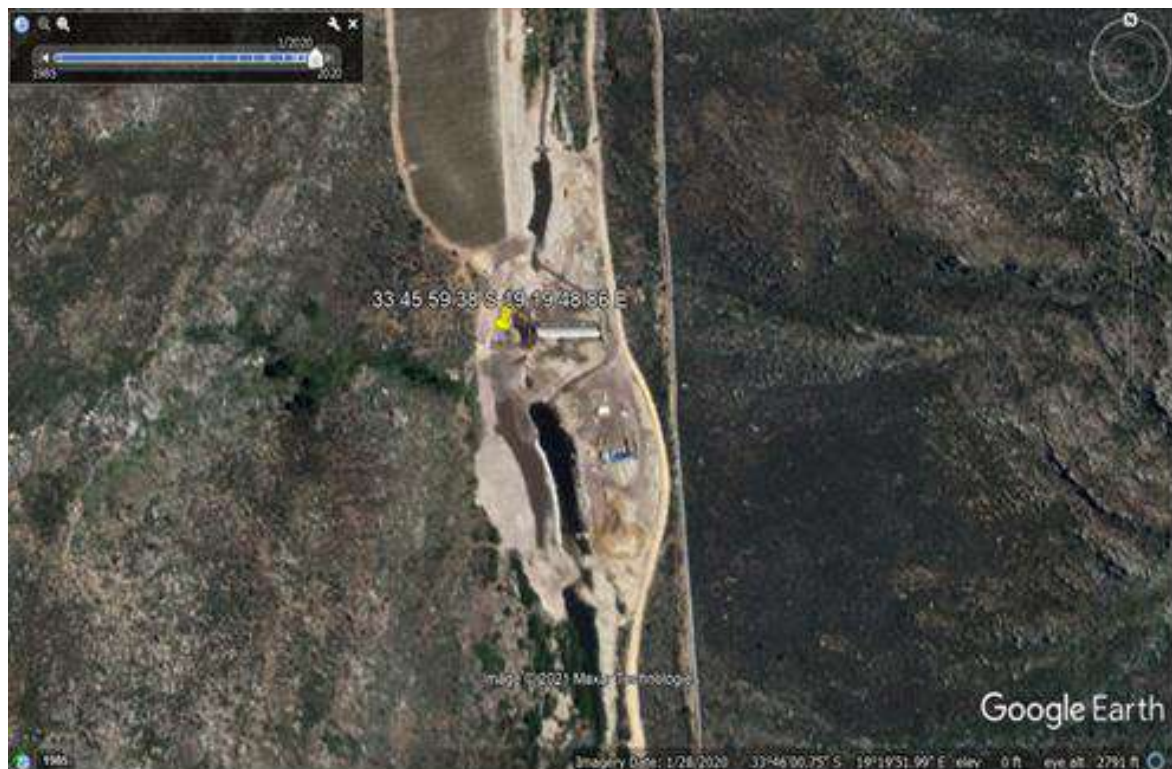
Aerial map 1: showing the development of the weir within the Holsloot River according to Google Earth Imagery 28/1/2020.

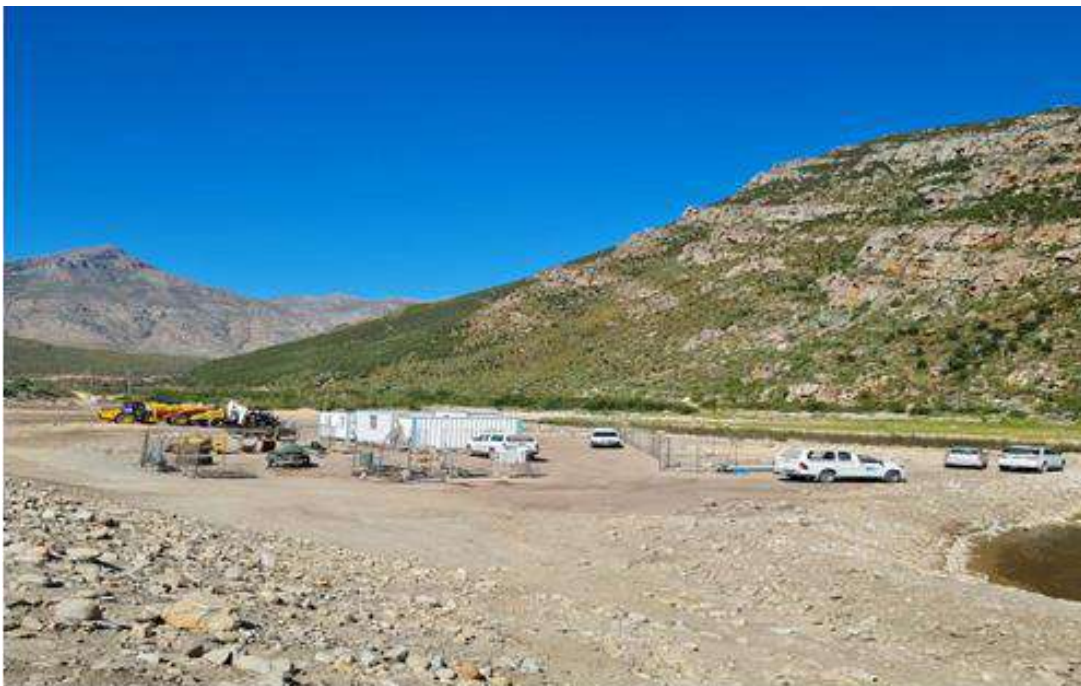
Photo 1: Construction site offices located above the newly constructed weir and related infrastructure \_not authorised in the approved EA

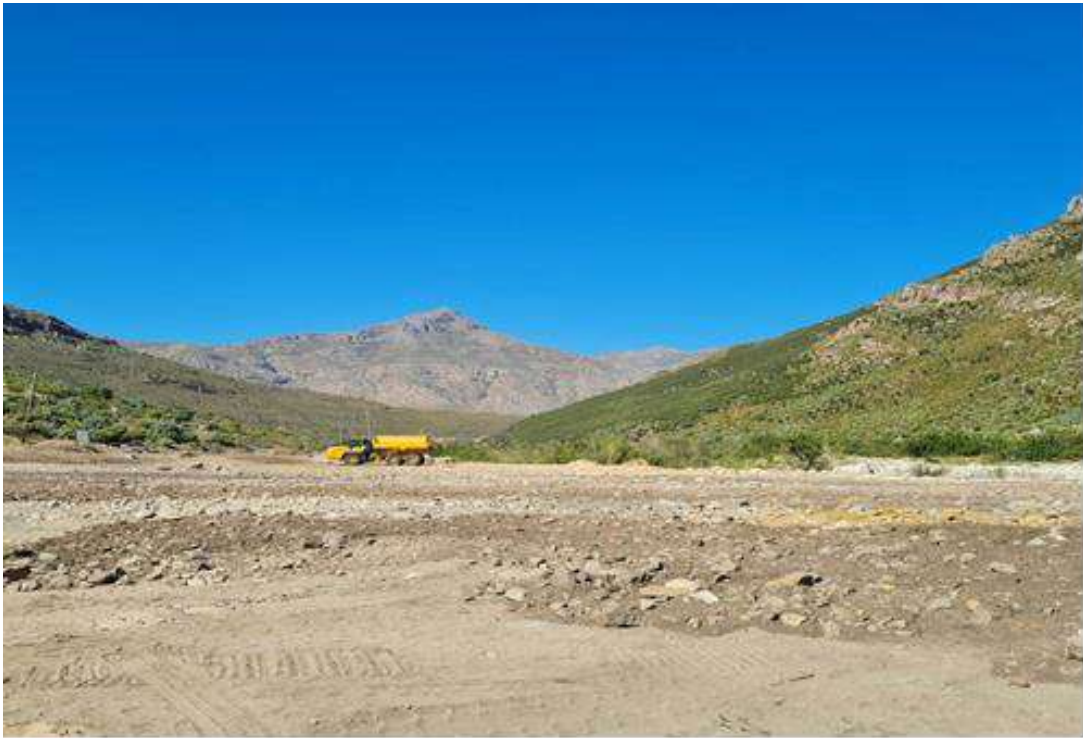
Photo 2: Area used for stockpiling material during the construction works which is currently being levelled \_ the activity not authorised in the approved EA.

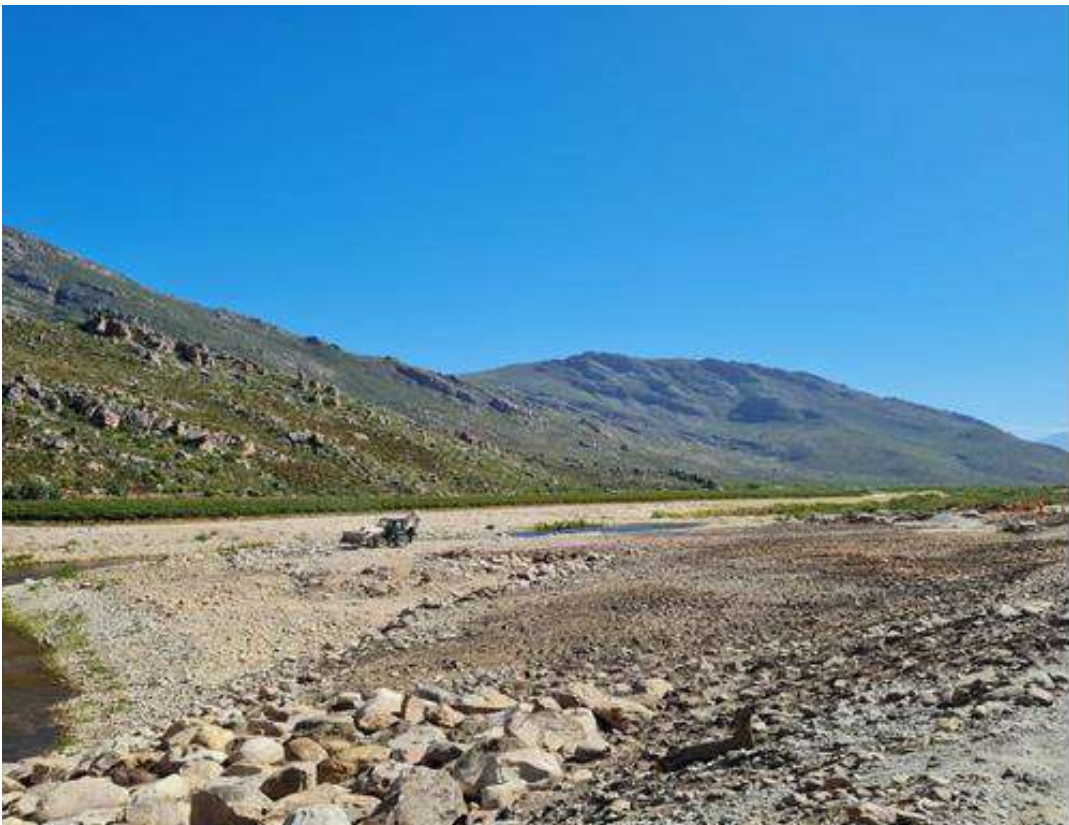
Photo 3: Alternate view of the infilling within the Holsloot River – digger loader used for the infilling and levelling of material (rocks).

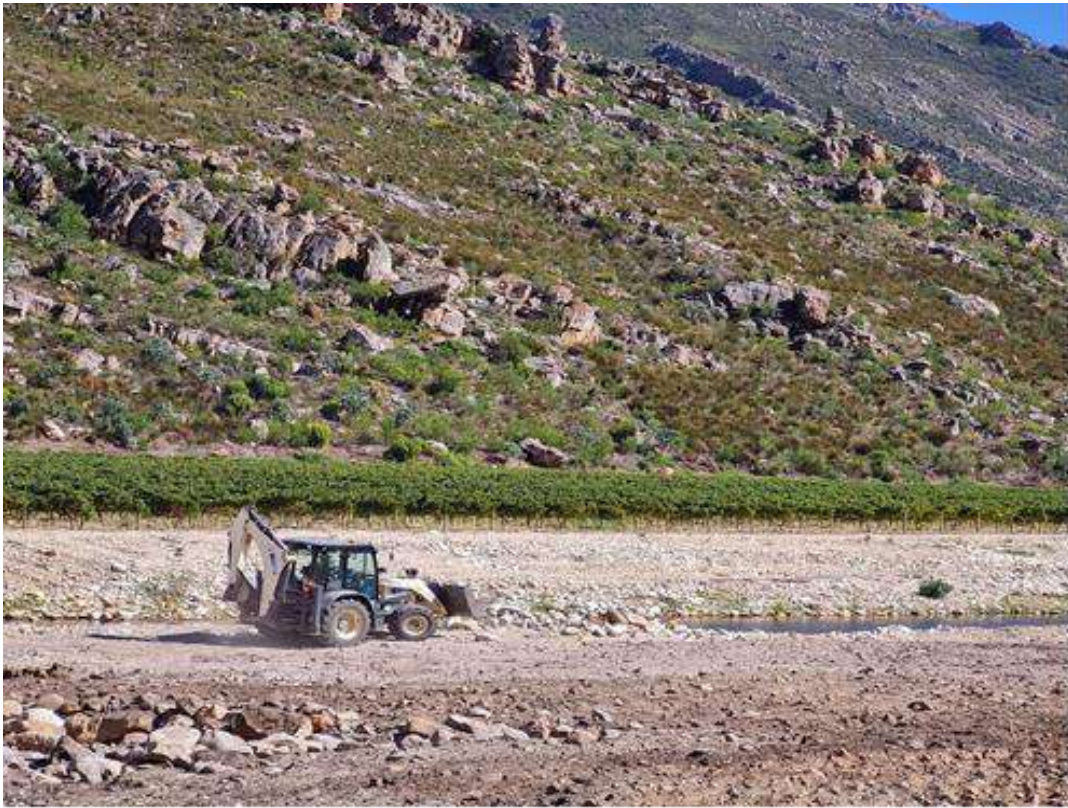
Photo 4: Heavy machinery levelling the infilled area within the river- the activity is outside the scope of the approved footprint.
