Request Chief Executive to approve the deviation for emergency work done on the 2 mini-substation transformers at Pudimoe Water Treatment Works.

## TECHNICAL REPORT

**Project name: Repair, Installation and Commissioning of Two 100kVA 22kV/400V Mini Substations**

**Location: Pudumoe Water Treatment Plant**

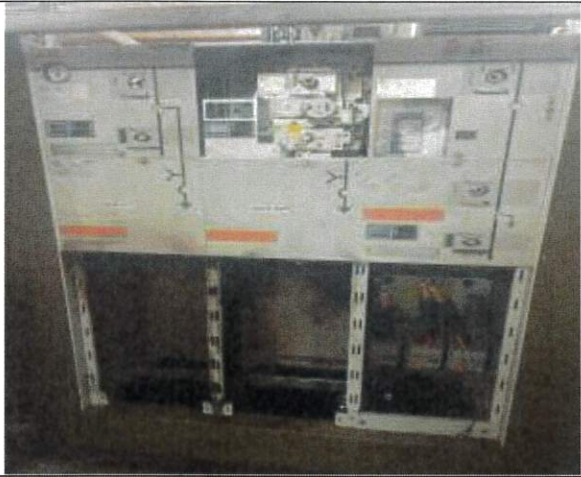
| Item | Description | Image | Date |
|---|---|---|---|
| 9.1.1 | Damaged 100KVA mini sub | | May 2024 |

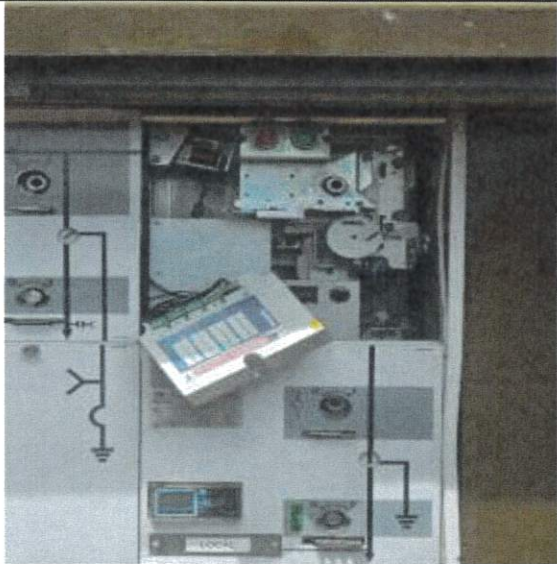
| Item | Description | Image | Date |
|---|---|---|---|
| 9.1.2 | 11KV Damaged HV switch gears | | May 2024 |

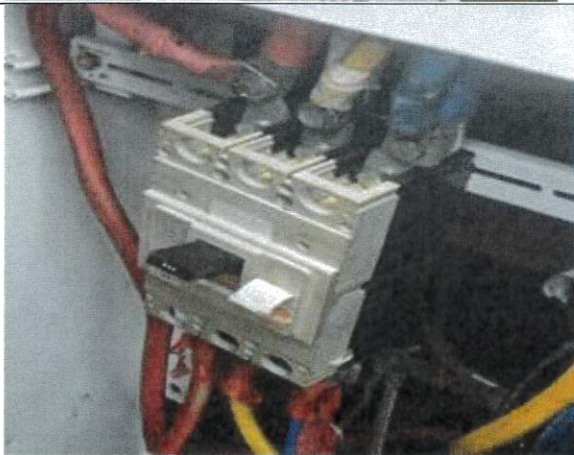
| Item | Description | Image | Date |
|---|---|---|---|
| 9.1.3 | 630amps Three phase breaker with loose connections | | May 2024 |

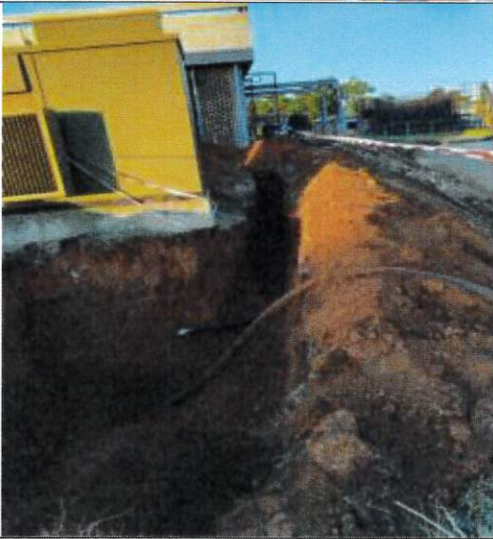
| 9.1.5 | Supply cable connection with open trench | | ?? |

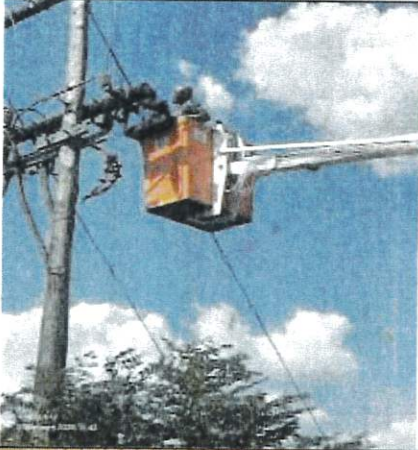
| 9.2.1 | Replacement of damaged links and fuses after installation of mini substation | | 27 January 2026 |
