Project
ECDOH PMU-2

2025 PRF-5
SS GIDA HOSPITAL

Title
WINDOW AND DOOR REPAIRS: KEY PLAN & SCHEDULES - HOSPITAL BUILDINGS

DRAWING No
240028-25PRF-05-250

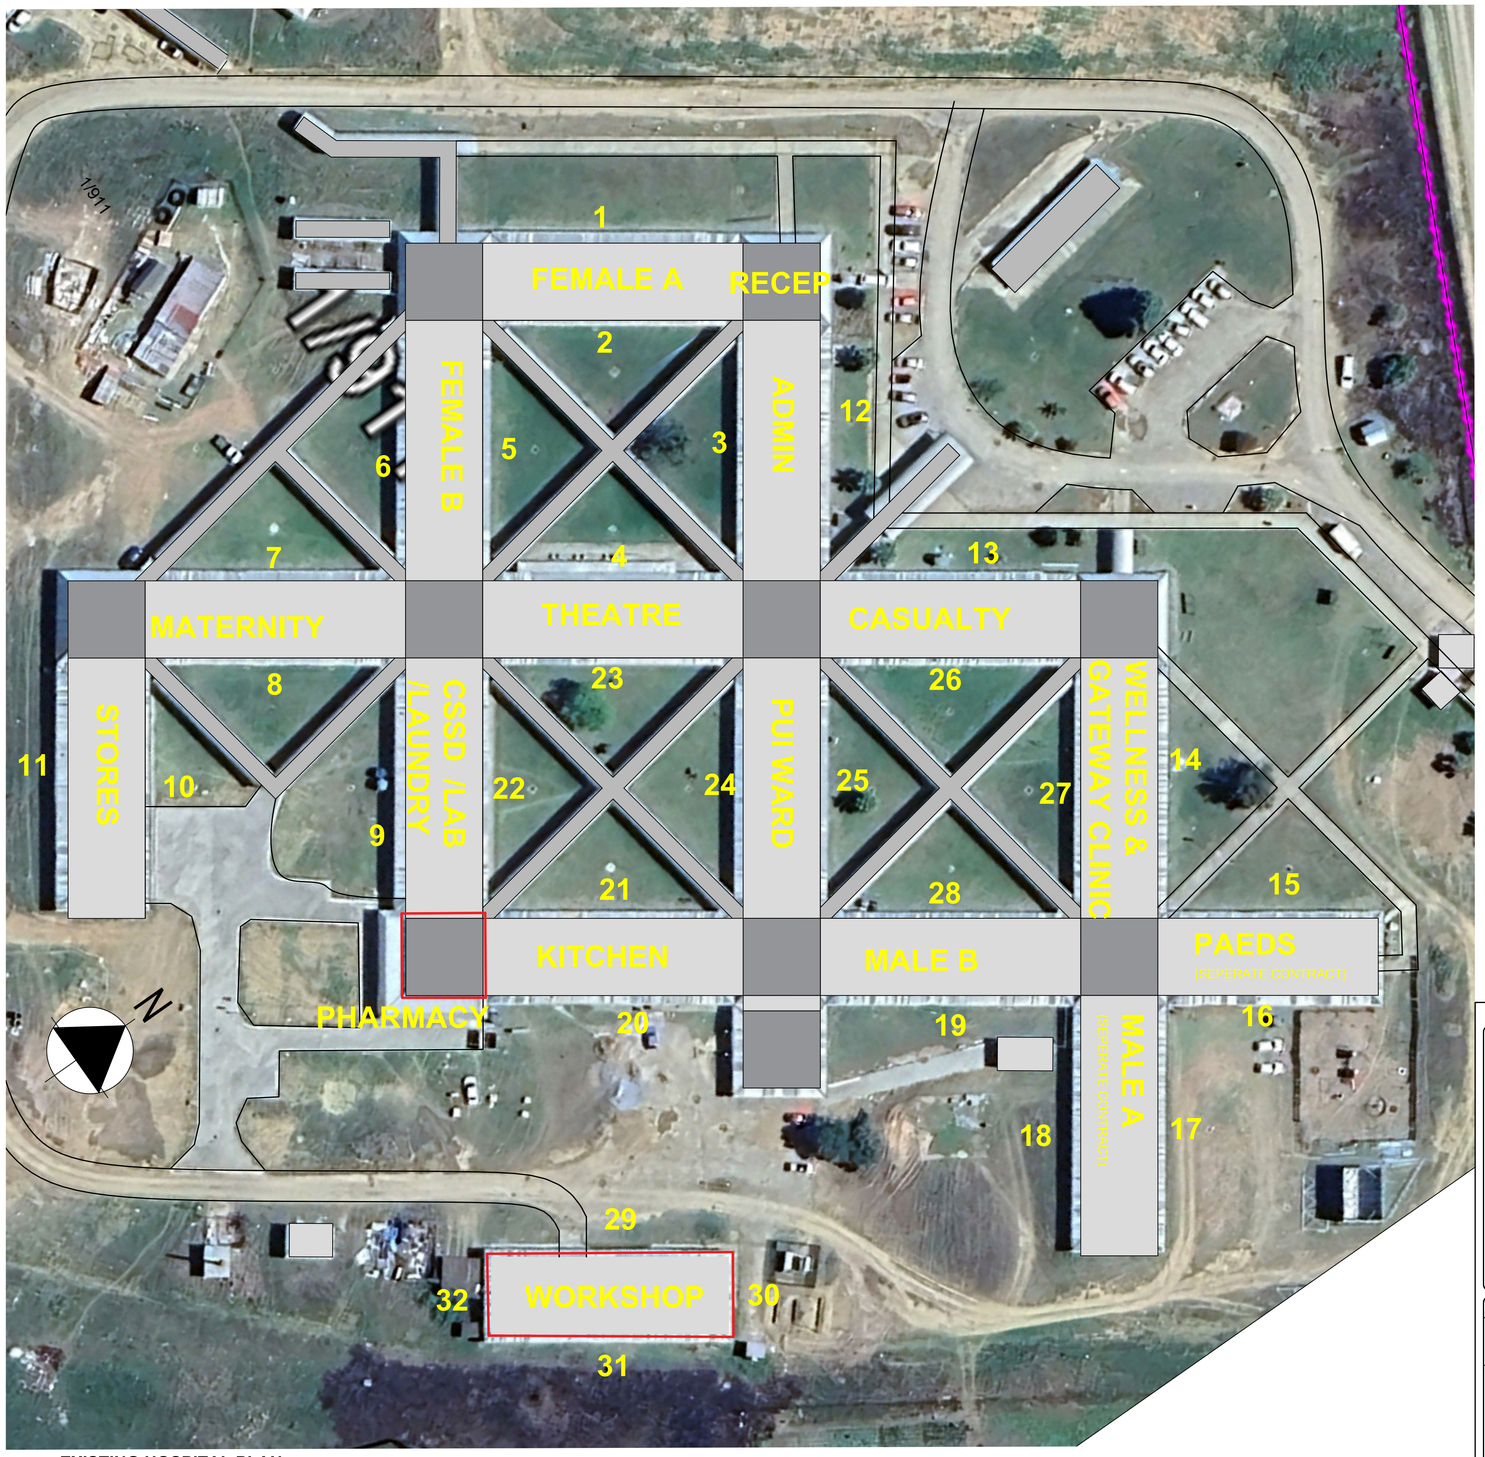
WINDOW SCHEDULE:
(GLAZING PANES TO BE REPLACED)
SCALE 1-50

TOTAL OF BROKEN PANES		TOTAL OF BROKEN PANES		TOTAL OF BROKEN PANES		TOTAL OF BROKEN PANES	
01	Top		Top		Top		Top	
	Middle		Middle		Middle		Middle	
	Bottom		Bottom		Bottom		Bottom	1
02	Top		Top		Top		Top	
	Middle		Middle		Middle		Middle	
	Bottom		Bottom	1	Bottom		Bottom	
03	Top		Top		Top		Top	
	Middle		Middle		Middle		Middle	
	Bottom		Bottom	1	Bottom		Bottom	
09	Top		Top		Top		Top	
	Middle		Middle		Middle		Middle	
	Bottom		Bottom	1	Bottom		Bottom	
24	Top		Top		Top		Top	
	Middle	2	Middle		Middle		Middle	
	Bottom	2	Bottom	3	Bottom		Bottom	
25	Top		Top		Top		Top	
	Middle		Middle		Middle		Middle	
	Bottom	1	Bottom		Bottom		Bottom	
27	Top		Top		Top		Top	
	Middle	2	Middle		Middle		Middle	1
	Bottom	3	Bottom	6	Bottom		Bottom	2
28	Top		Top		Top		Top	
	Middle		Middle		Middle		Middle	
	Bottom	1	Bottom	1	Bottom		Bottom	
29	Top		Top		Top		Top	
	Middle		Middle		Middle	1	Middle	
	Bottom		Bottom		Bottom		Bottom

32	Top		Top		Top		Top	
	Middle		Middle		Middle		Middle	
	Bottom		Bottom	2	Bottom		Bottom	
	TOTAL BROKEN PANES	11		15		1		4
							Total broken panes	31

All broken glass is to be replaced with 6,38mm
Intruderprufe Clear NS glass OR
Obscure (Arctic Snow) glazing
to match existing.
