Geotechnical Investigation Report for Osborn Senior Secondary School as Part of the Implementation of Sanitation Programme at Various Schools in the Eastern Cape Province

iLZ_26_056_Osborn SSS

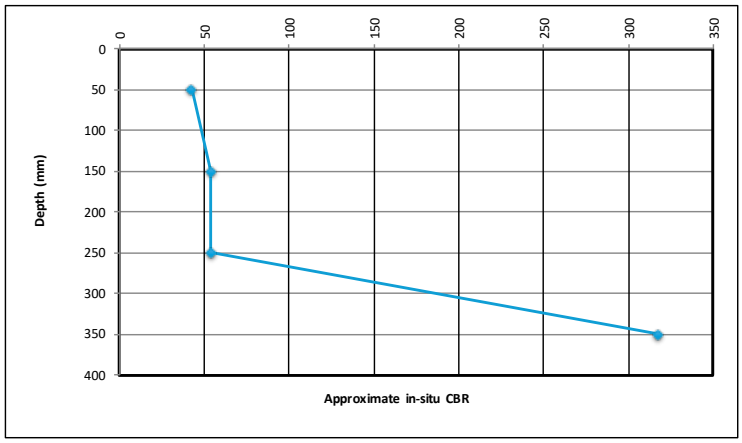
Project Name **Osborn SSS**
Date 2026/06/11 **DCP No.** 1
Hammer size 8kg with 20mm point
Applied Factor : 1 times Terzaghi's value

Reading No.	Layer From	Layer To	Average Layer Depth	DCP DN Blows/100mm	Level Below NGL mm	DCP penetration mm/blow	Equiv. SPT N Value	Approx In-situ CBR	Approx EASBP kPa
1	0	100	50	2	50	50	2	3	43
2	100	200	150	3	150	33	4	5	54
3	200	300	250	3	250	33	4	5	54
4	300	400	350	20	350	5	24	56	318

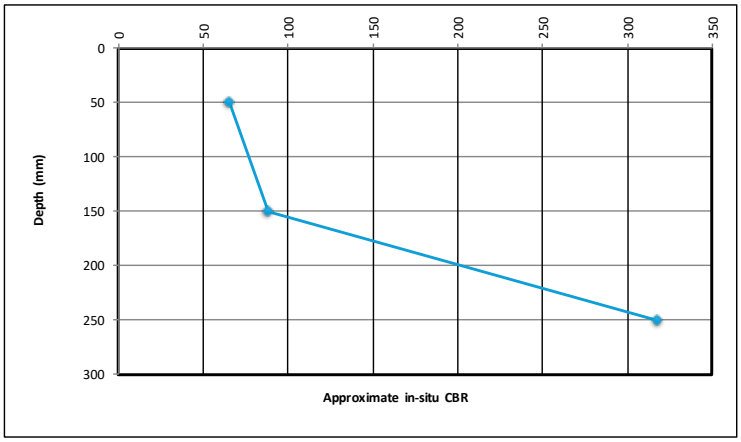
Project Name **Osborn SSS**
Date 2026/06/11 **DCP No.** 2
Hammer size 8kg with 20mm point
Applied Factor : 1 times Terzaghi's value

Reading No.	Layer From	Layer To	Average Layer Depth	DCP DN Blows/100mm	Level Below NGL mm	DCP penetration mm/blow	Equiv. SPT N Value	Approx In-situ CBR	Approx EASBP kPa
1	0	100	50	4	50	25	5	7	66
2	100	200	150	6	150	17	7	12	88
3	200	300	250	20	250	5	24	56	318
