Report Name : Port of East London Grain Elevator
Substations Electrical Condition Assessment

Grain Elevator Substations Conditional Assessment

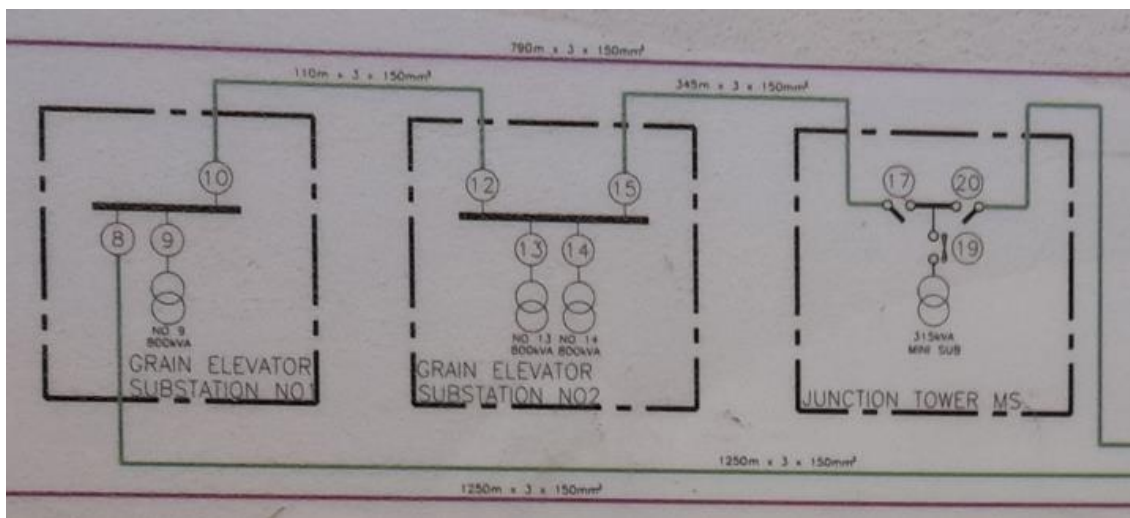
6.2.1.1 The grain elevator is currently fed from three substations (i.e. Grain Elevator Substation 1, 2 and junction tower MS). All three substations are connected in a ring type arrangement via 150mm² paper insulated (PILC) cable and fed from the Main Substation. All three substations contain oil circuit breakers and oil cooled transformers. Substation 1 is located at the basement, substation 2 is located at the 12th floor, and junction tower MS is located at the quayside. The transformers are located adjacent to the MV switchgear room.

Figure 1 Port of East London Grain Elevator Substations Switching diagram
