CONDITION ASSESSMENT REPORT FOR THE KZN ~~ROWING~~ ASSOCIATION

Project Name : Condition Assessment (Ex-Lampro Shopfitters CC
(PTY)LTD)

Owner : Transnet National Ports Authority

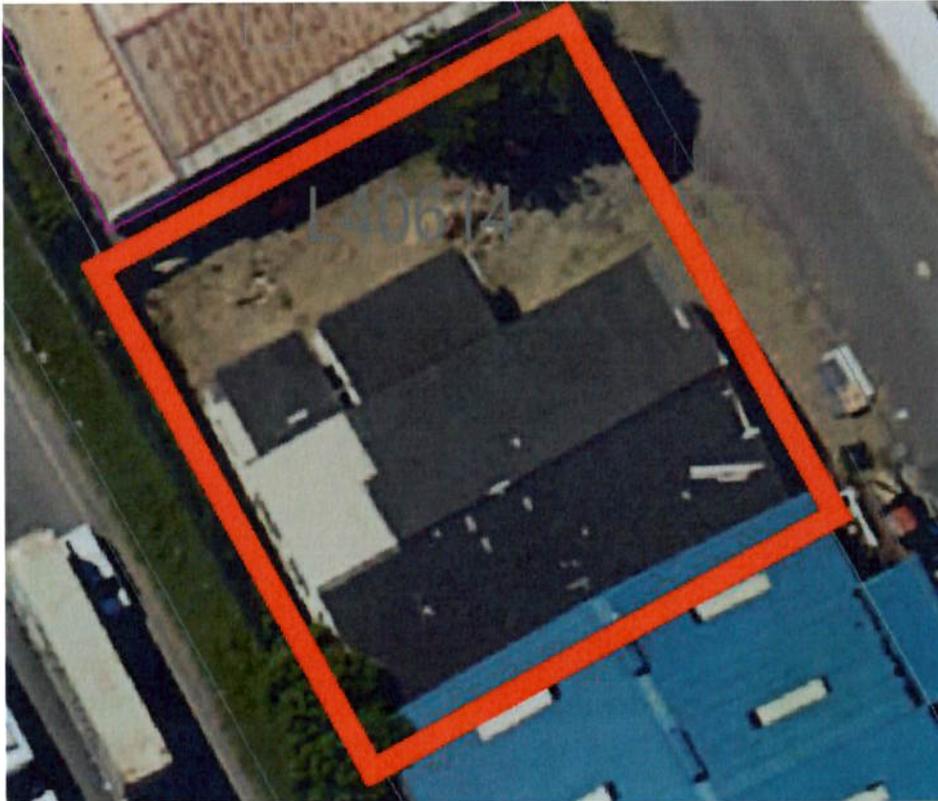
Figure 2: Site Layout

The property is in Grunter Gully which is predominantly a fishing wharf in Bayhead Precinct.

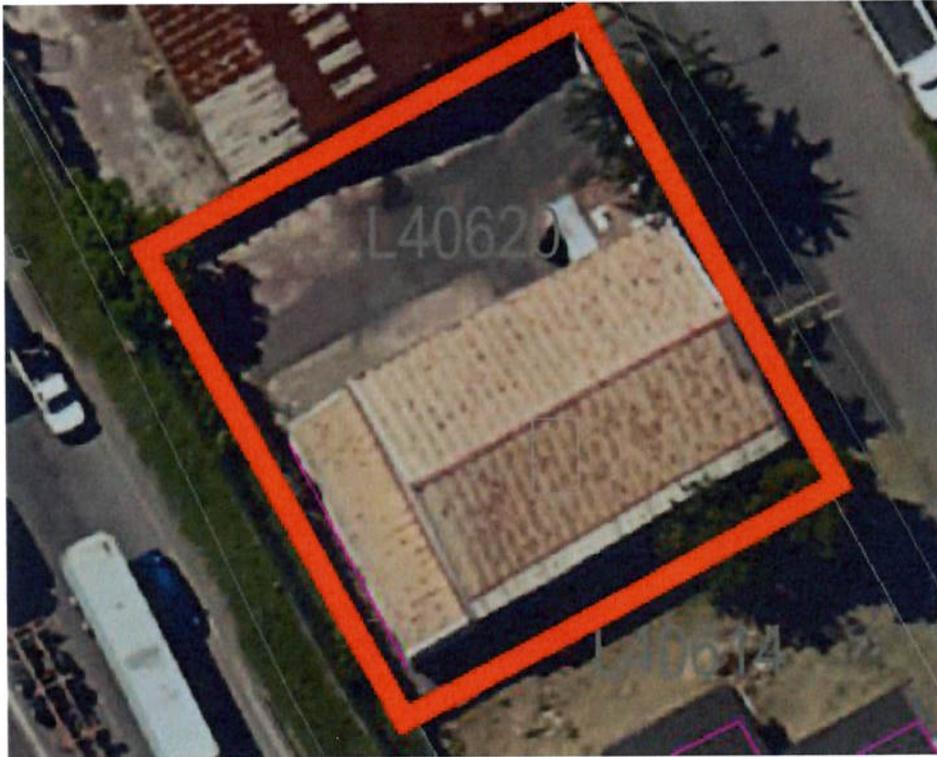
Figure 2: Site Layout

The property has a single building. The property is in Grunter Gully which is predominantly a fishing wharf in Bayhead Precinct.

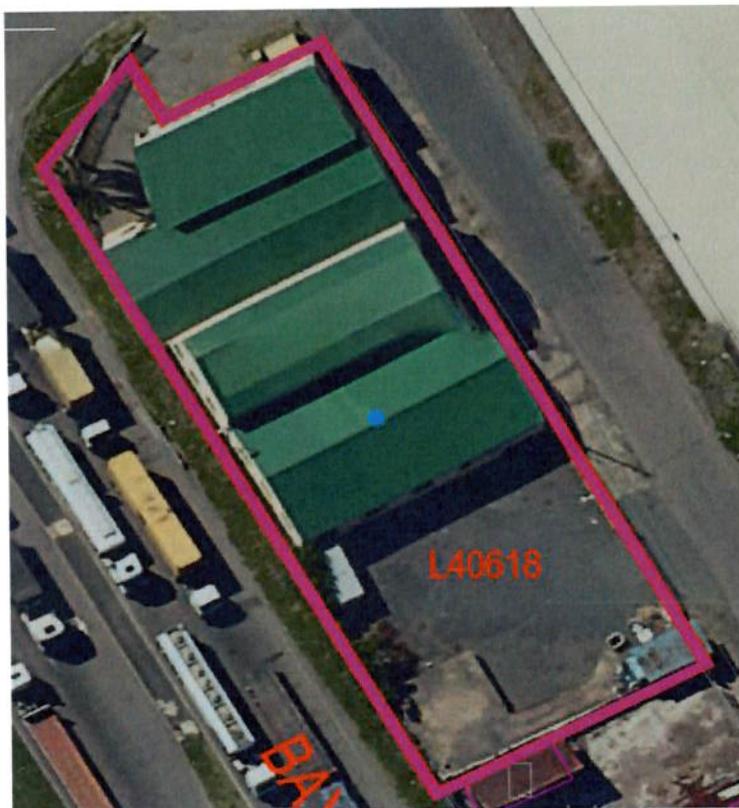
Figure 2: Site Layout

The property comprises several building structures that are interconnected to one another, the buildings are connected by a series of doors. The property is in Grunter Gully which is predominantly a fishing wharf in Bayhead Precinct.

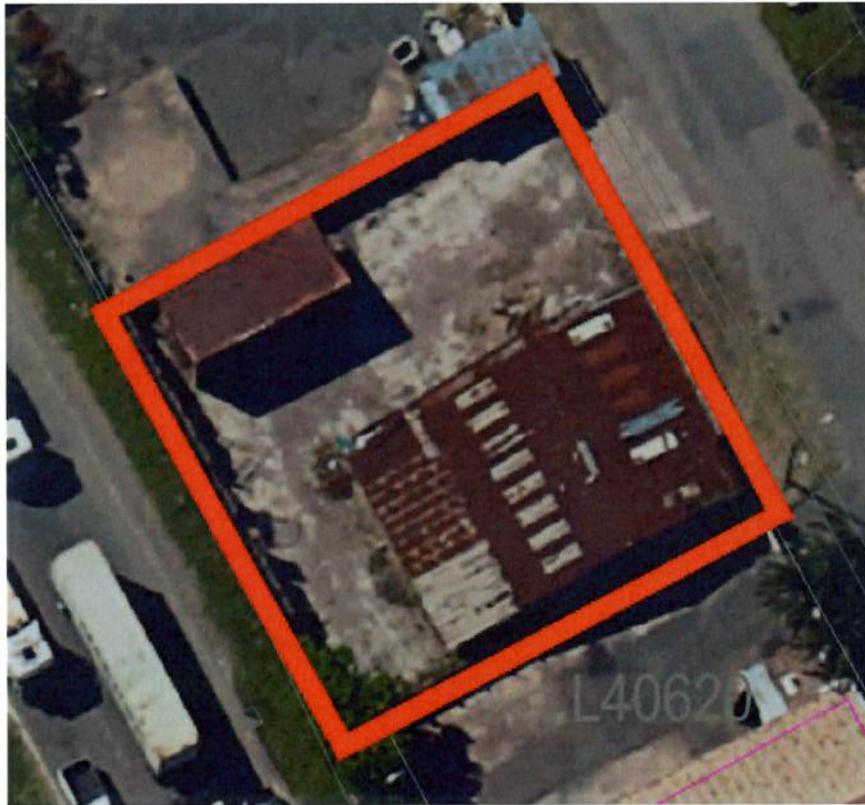
Figure 2: Site Layout

The property comprises of two structures. The property is in Grunter Gully which is predominantly a fishing wharf in Bayhead Precinct.

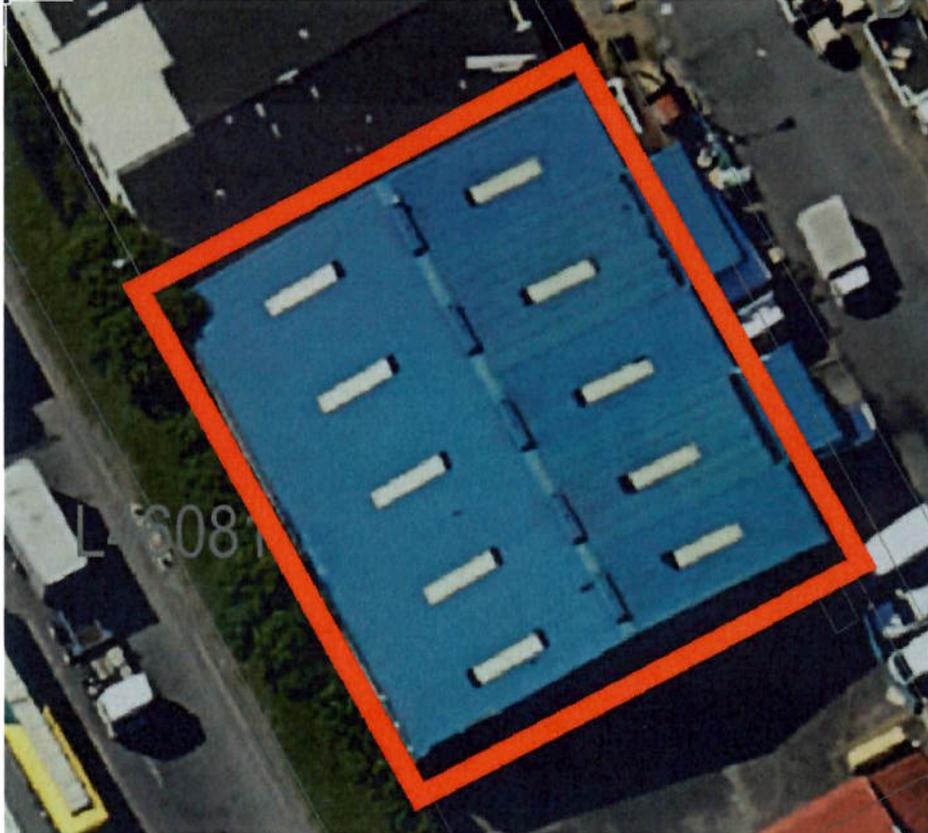
Figure 2: Site Layout

The property comprises one building. The property is in Grunter Gully which is predominantly a fishing wharf in Bayhead Precinct.
