| Eskom | Scope of Work | Transmission |

Title: **FOUNDATIONS
REHABILITATION -
NORTH EAST GRID** Unique Identifier: **240 - 47411023**
 Alternative Reference Number: **LES-GP-159**

| Eskom | Foundations Rehabilitation - North East Grid | Transmission |

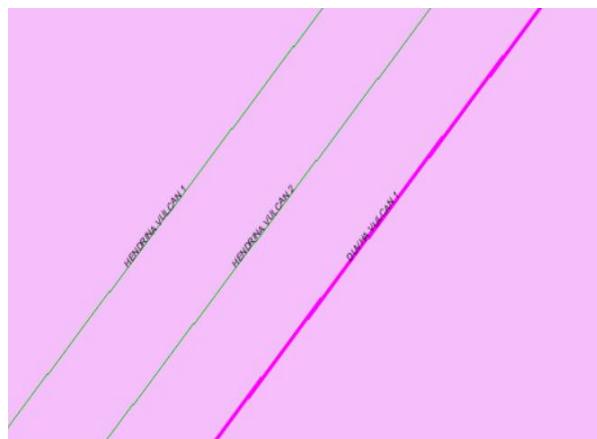
Figure 16: Duvha – Vulcan 1, Hendrina – Vulcan 1, Hendrina – Vulcan

The figure below shows the three lines Duvha – Vulcan 1 400kV, Hendrina – Vulcan 1 400kV and Hendrina – Vulcan 2 400kV, which run parallel to each other, the towers on these lines have the same defects as determined in the site visit. These defects include soil erosion that has caused scouring as shown on the figures 14 – 25. Moreover, the foundations concrete is cracked and the corroded rebar is exposed. A few of the towers are buried into the ground, whilst the other foundations are exposed. The detailed mitigation for the towers along these spans is detailed in section 3 of this report.
