VGI CONSULTING

**WALTLOO FUEL FARM STRUCTURES
GEOTECHNICAL INVESTIGATION**

Report No.: JW053/12/D328 – Rev 1

MARCH 2012

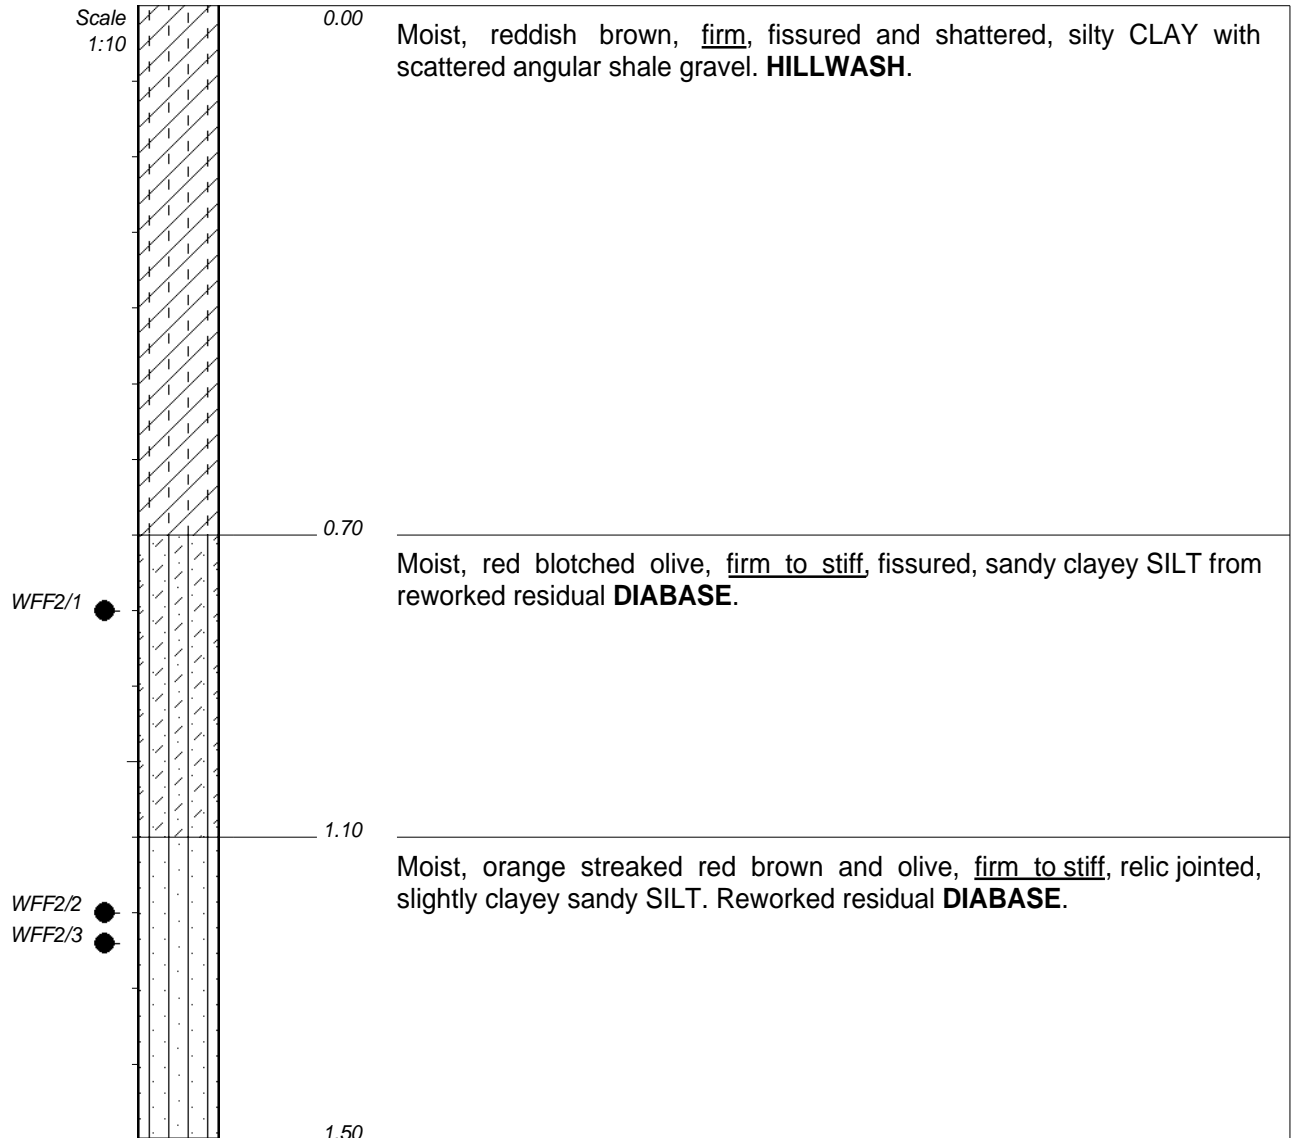
HOLE No: WFF 02

- 1) TP stopped at required depth.
- 2) No seepage or water table.
- 3) TP excavated by hand.
- 4) Indicator samples WFF2/1 taken at 0.8m; WFF2/2 taken at 1.2m.
- 5) Block sample WFF2/3 taken at 1.24m.

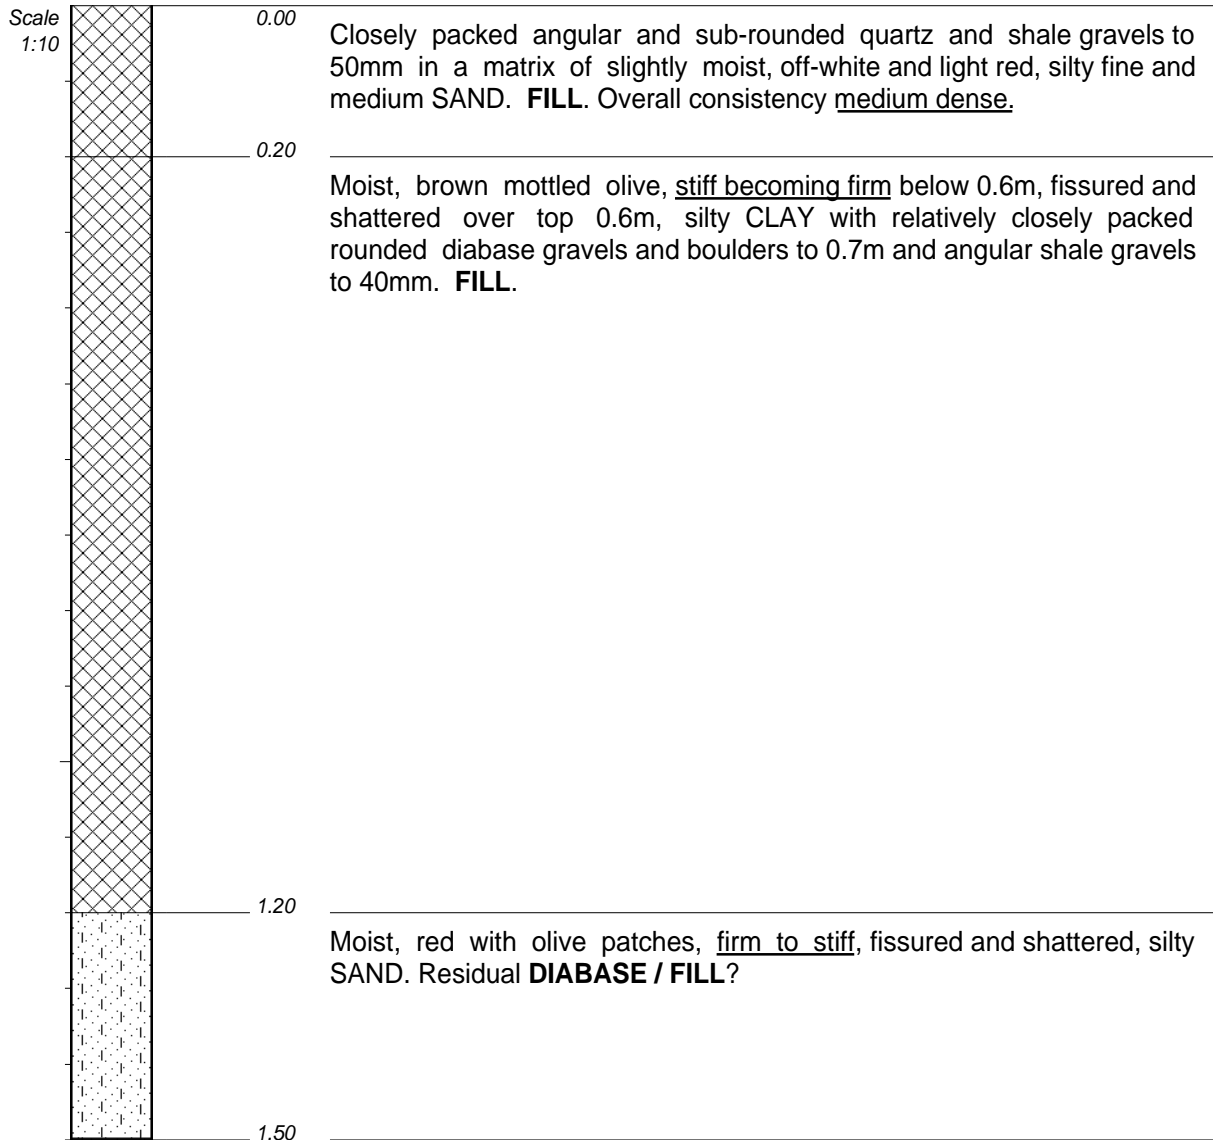
HOLE No: WFF 03

- 1) TP stopped at required depth, no refusal.
- 2) No seepage or water table.
- 3) TP excavated close to concrete reservoir.
- 4) No samples taken.

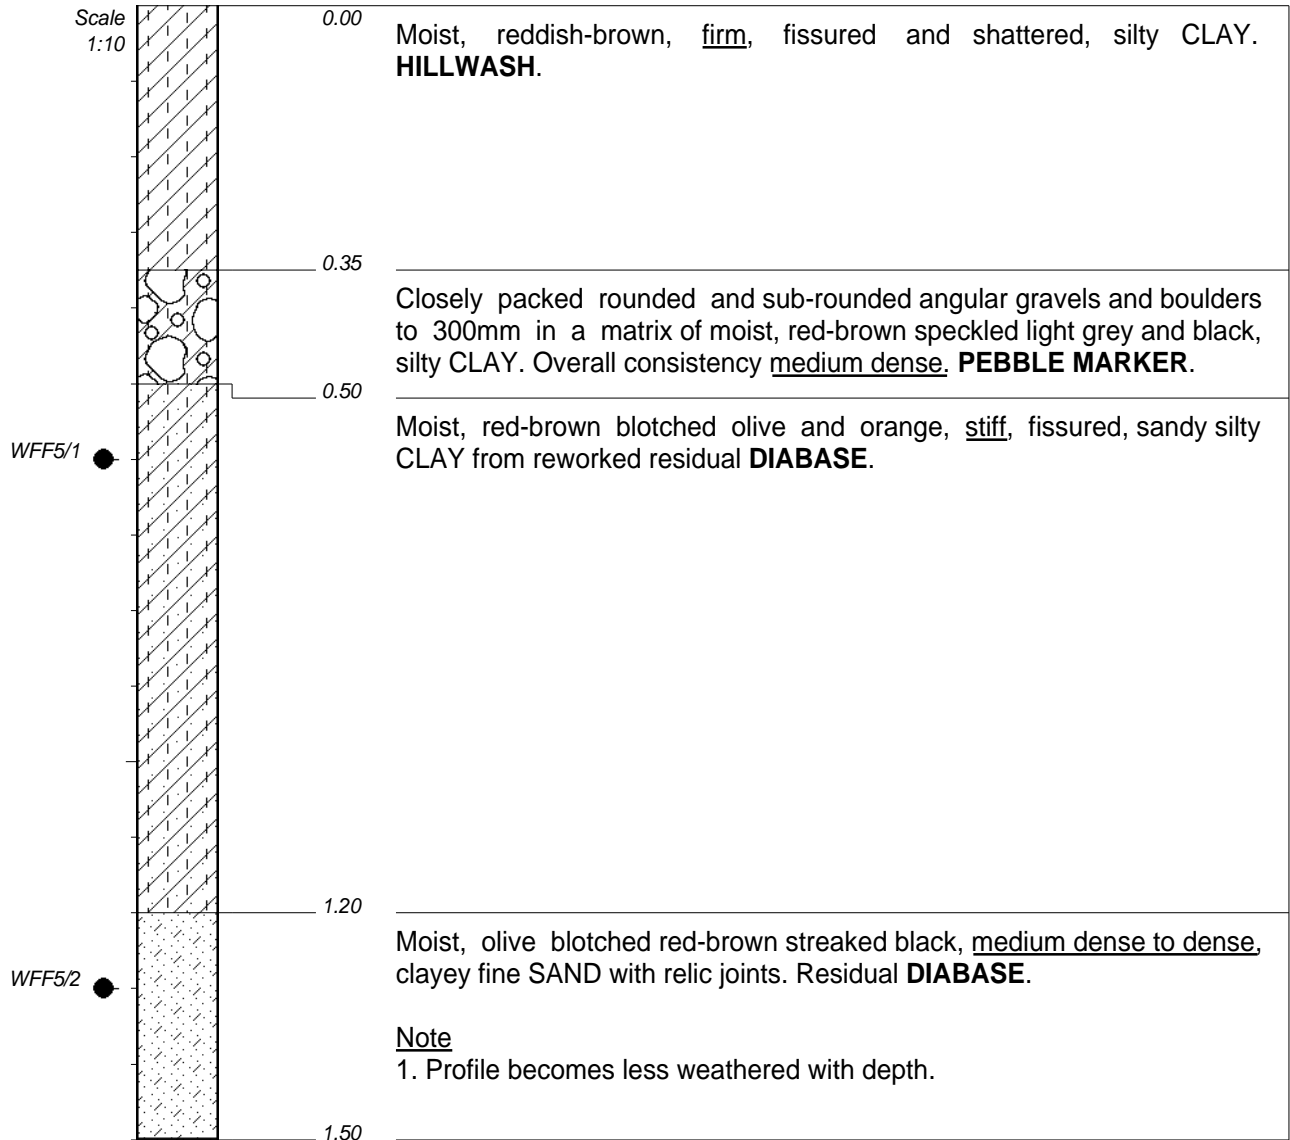
- 1) TP stopped at required depth, no refusal.
- 2) No seepage or water table.
- 3) Indicator sample WFF5/1 taken at 0.6m and WFF5/2 taken at 1.3m.
- 4) Testpit excavated by hand.

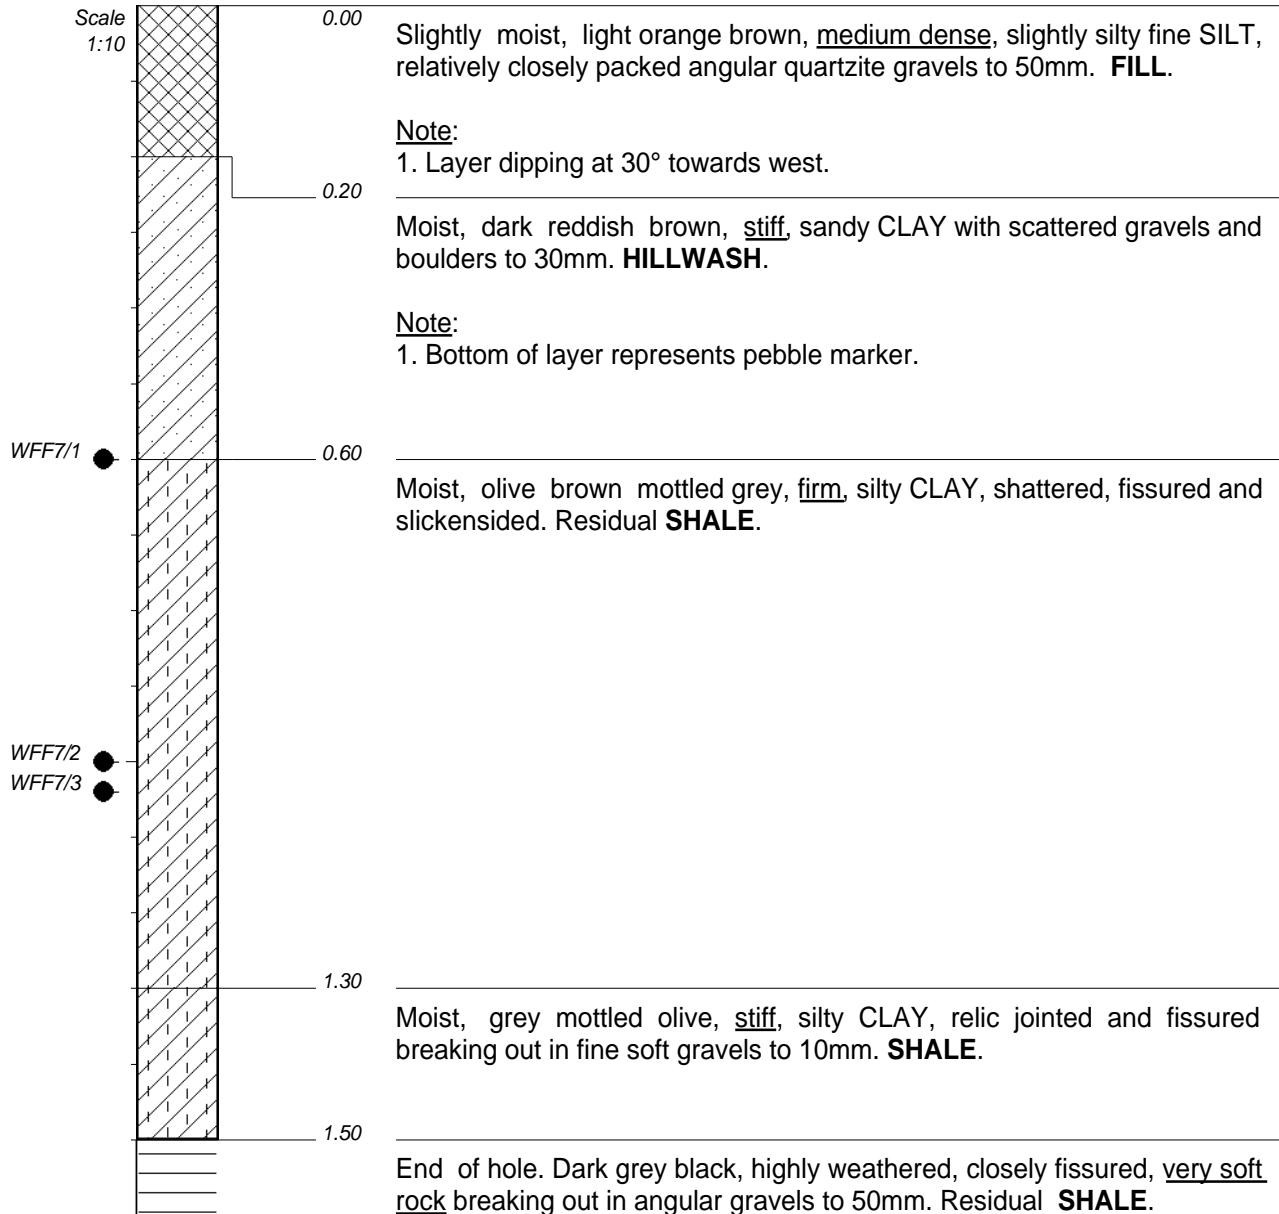
- 1) Testpit stopped at specified depth.
- 2) No seepage or water table.
- 3) Indicator samples WFF7/1 taken at 0.6m and WFF7/2 taken at 1.0m.
- 4) Block sample WFF7/3 taken at 1.04m.
