**COMPLETION OF CONSTRUCTION OF
ETHANDAKUKHANYA 24HR COMMUNITY
HEALTH CENTRE (CHC), MKHONDO
LOCAL MUNICIPALITY**

Architects Due Diligence Report:
TECHNICAL ASSESSMENT

AUGUST - 2025

Prepared for:
National Department of Health

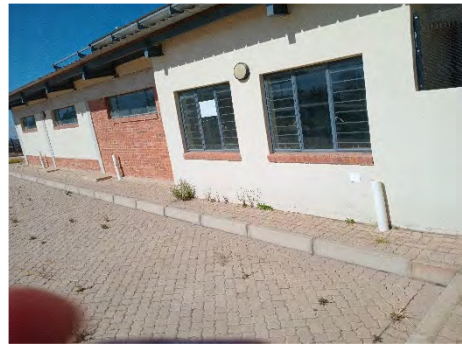
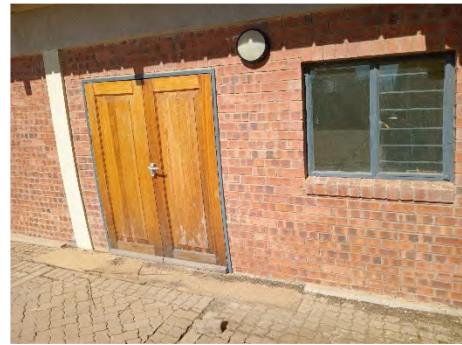
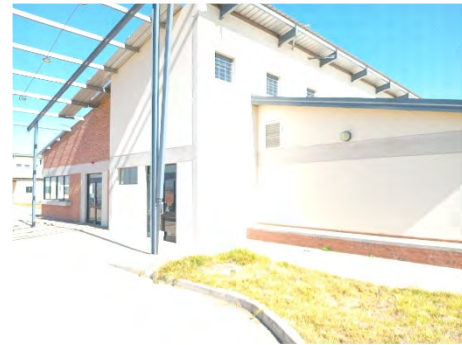
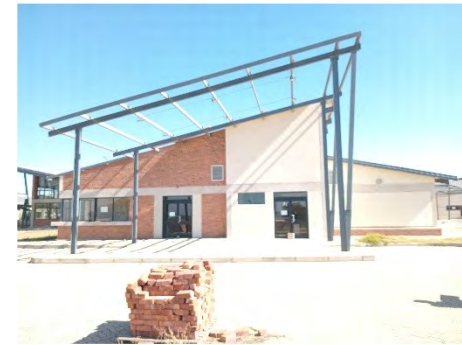
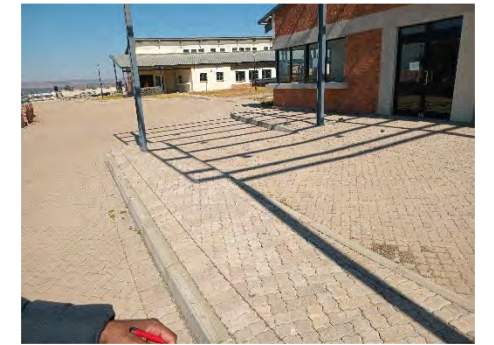
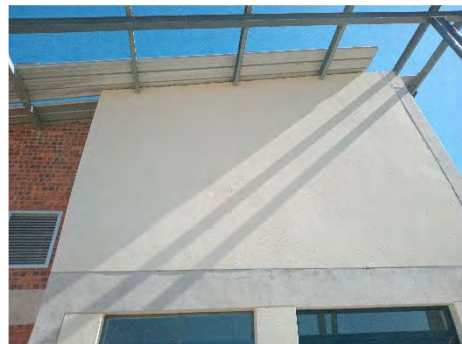
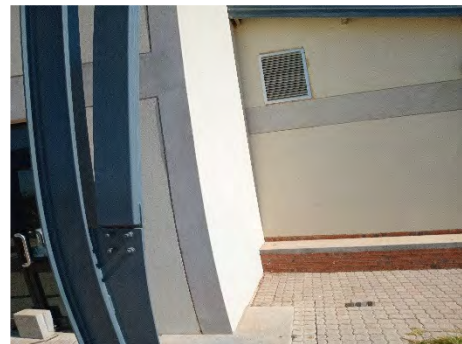
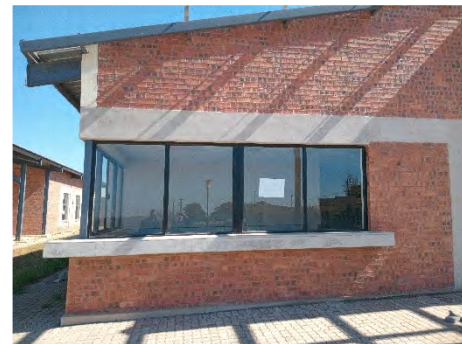
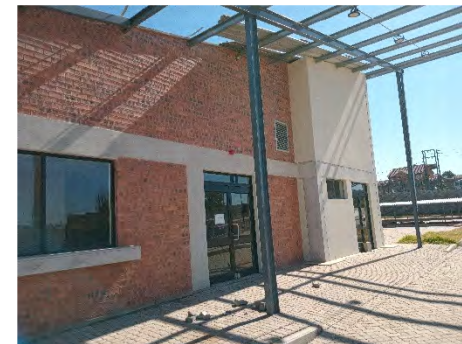
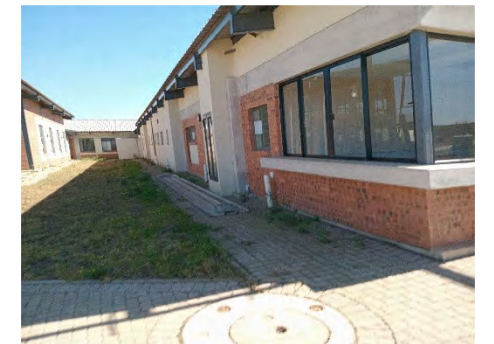
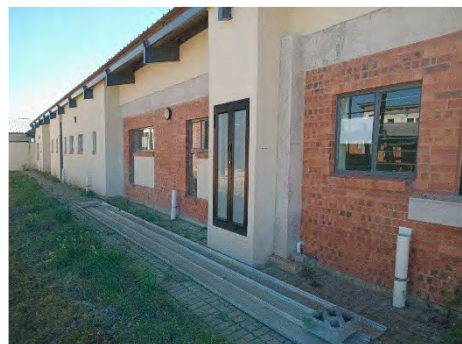
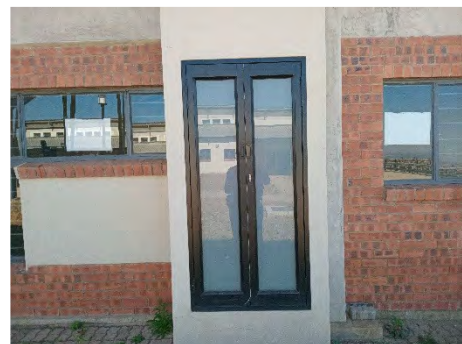
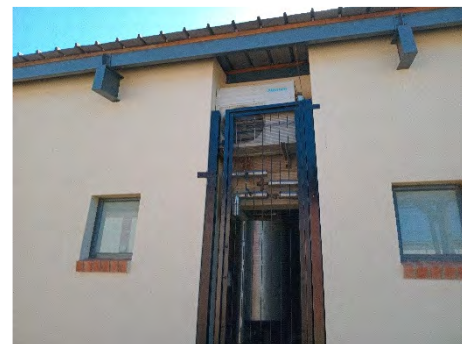
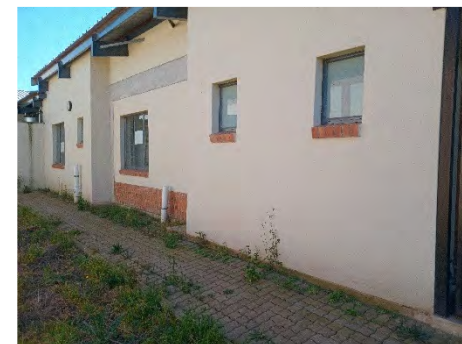
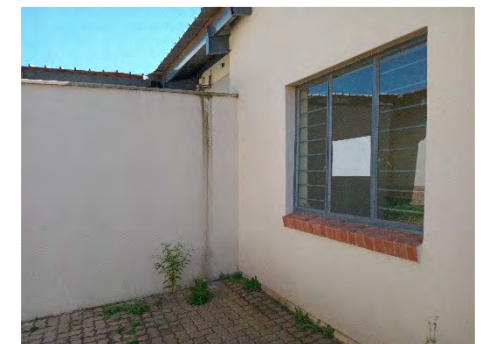
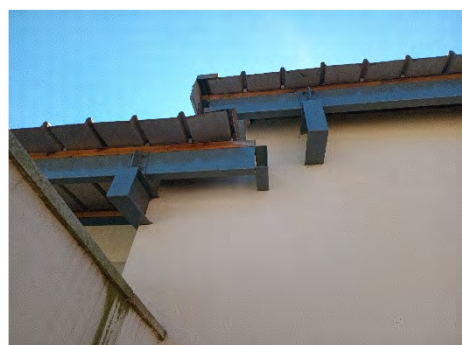
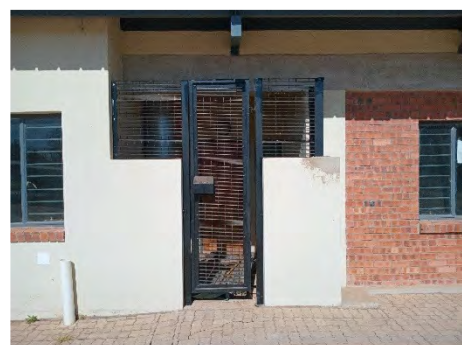
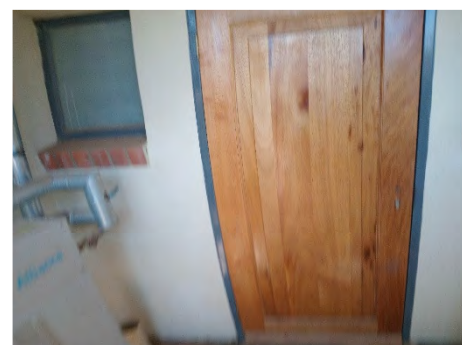
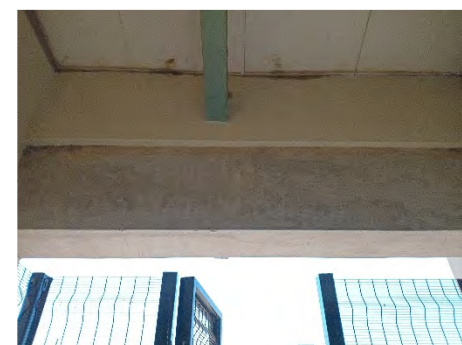
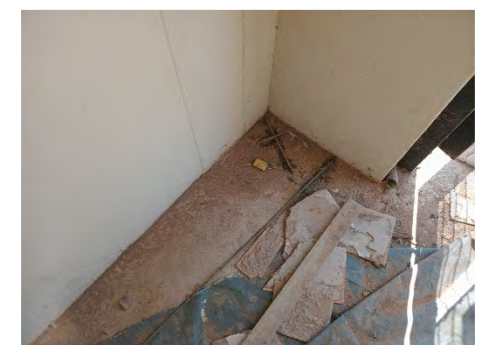
External Picture gallery

Block ID	Block E	
Area name	Central Waiting Area Elevations Front & Side Elevations	
Recorded Status Quo / Scope of Work completed / remaining External		
Area	Notes	
Roof	<p>The existing exposed wooden purlins require treatment to prevent further deterioration, and the installation of fascia is yet to be completed as per specification.</p> <p>The absence of entrance roof covers over the walkway to Pharmacy Staff area (Block J) leaves access points exposed to weather elements, potentially leading to water ingress and premature wear on underlying structures and finishes. The pest infestation, and structural compromise, necessitating immediate action. Incomplete fascia installation not only impacts the aesthetic appearance but also exposes roof edges to potential weather damage and reduces overall building envelope integrity.</p>	
Walls – Plaster & Paint	<p>The walls exhibit signs of weathering, with a specific need for repainting in areas where the existing paint is cracking and peeling, primarily due to moisture infiltration. Furthermore, the shutter concrete quality is deemed suboptimal, with visible cracks present, particularly through the concrete ring beam, indicating potential structural or material issues.</p>

Walls face brick	<p>Face brick walls require recleaning with high pressure hoses- a specification will be provided after consultations with the brick supplier.</p>	
Doors & Frame	<ul style="list-style-type: none"> All Doors require servicing, and the Shopfront Doors need checking. 	
Window & Frame	<ul style="list-style-type: none"> Windows opening gear require servicing across all opening mechanisms to ensure smooth operation. Handles are loose and stays are at time. Additionally, cleaning is needed, and dirty cills need to be addressed. Any damaged cills need to be identified and replaced to specification. Through cleaning of glazing is required – Not all glazing could be checked for completeness for chipping or cracking, and a glazing audit is required. 	
General Comments	<ul style="list-style-type: none"> Outdoor Waiting area Floor Finish to be re-looked at.

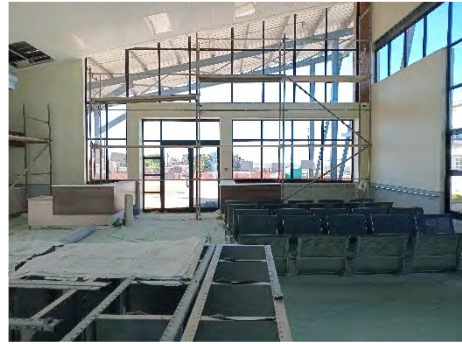
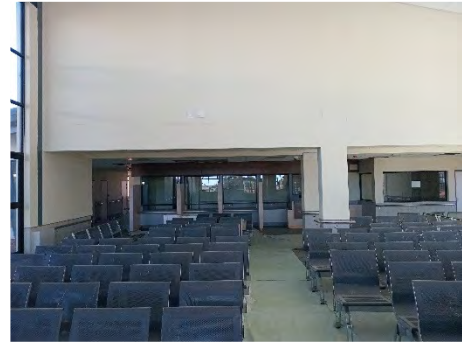
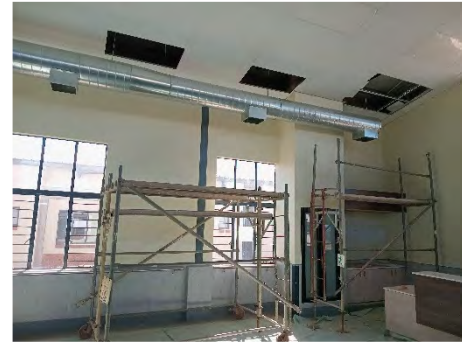
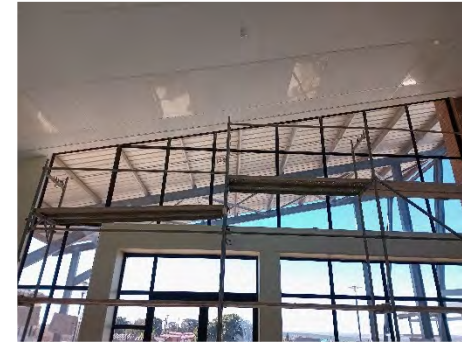
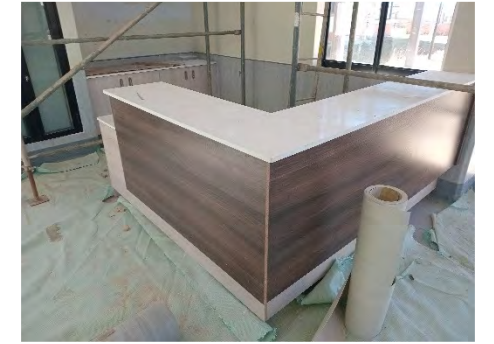
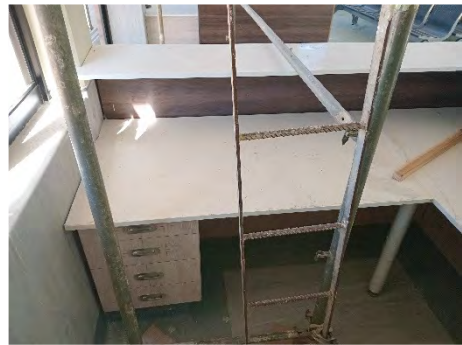
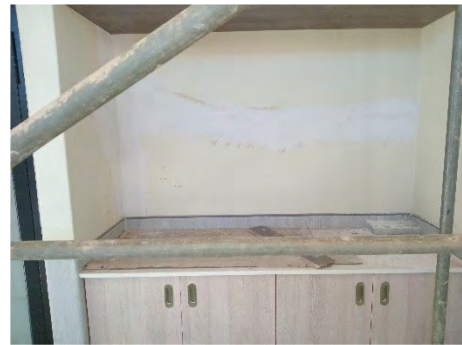
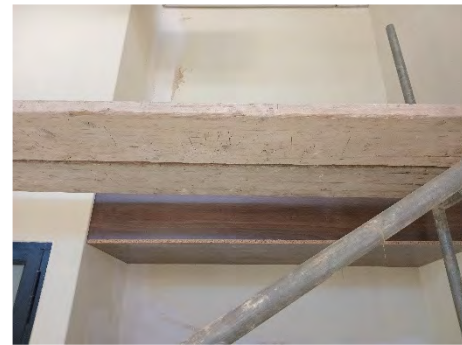
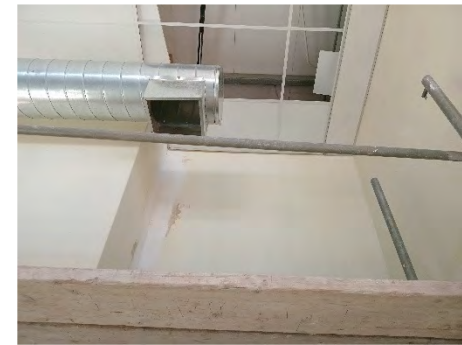
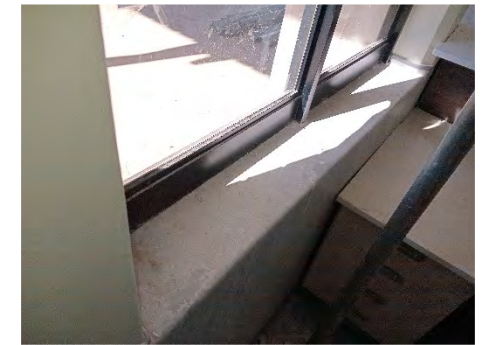
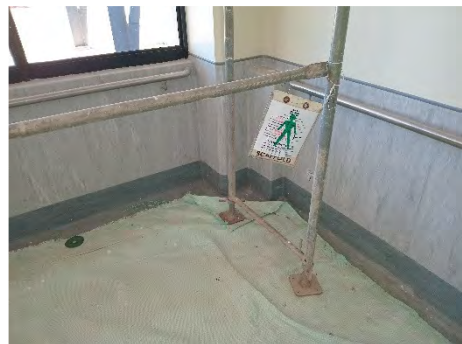
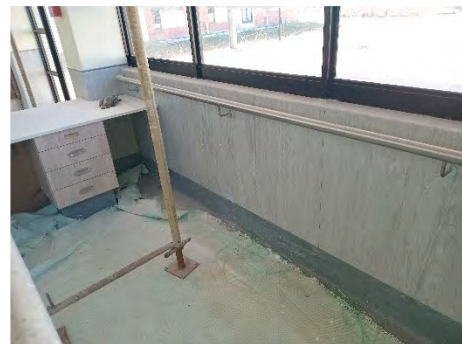
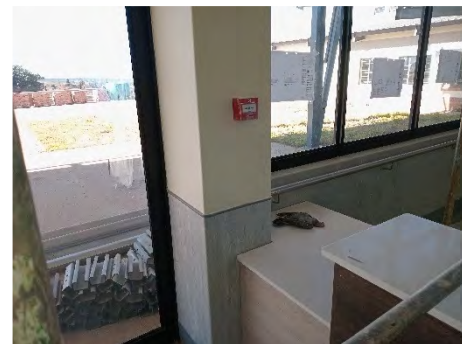
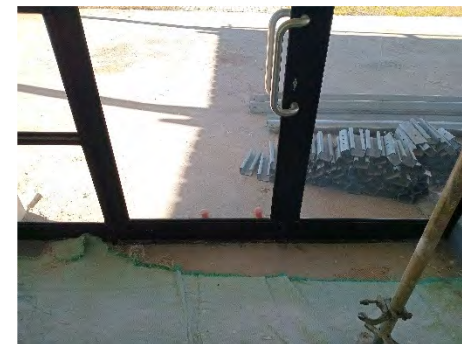
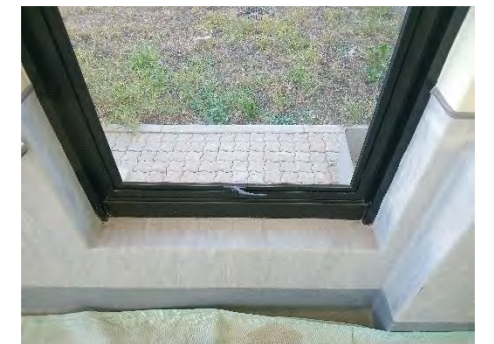
Internal Picture gallery

Block ID	E							
Block name	Central Waiting Area							
Recorded Status Quo / Scope of Work completed / remaining								
Internal								
Room name	Floors	Walls	Suspended Ceiling Grid and Tiles	Doors & Frames	Windows& Frames	Joinery and Accessories	Sanitary fittings	Other Remediation
Waiting Area RM 120	<ul style="list-style-type: none"> Vinyl covered Cleaning is needed 	<ul style="list-style-type: none"> Small finish touch ups Cleaning the vinyl clad walls also required Sill spec of vinyl vs dense board to be checked 	<ul style="list-style-type: none"> Ceiling incomplete Panels missing approx. (6) T joint strips fixing and neatness needed at all corners end points 	<ul style="list-style-type: none"> Door cleaning needed Entrance door final fixing and checking. Door furniture and ironmongery to be checked 	<ul style="list-style-type: none"> Cleaning needed All opening gear to be services 	<ul style="list-style-type: none"> Stainless steel seating to be installed as per seating layout

Help desk RM 119	<ul style="list-style-type: none"> Vinyl covered Cleaning needed 	<ul style="list-style-type: none"> Small finish touch ups Cleaning the vinyl clad wall areas also required 	<ul style="list-style-type: none"> Ceiling incomplete Panels missing approx. (6) T joint strips fixing and neatness needed at all corners end points 	<ul style="list-style-type: none"> Door cleaning needed 	<ul style="list-style-type: none"> Cleaning required Opening gear to be services 	<ul style="list-style-type: none"> Incomplete joinery Wood strips missing Cleaning of top required 		
Porter Station RM 118	<ul style="list-style-type: none"> Vinyl covered Cleaning needed 	<ul style="list-style-type: none"> Small finish touch ups Cleaning the vinyl clad wall areas also required 	<ul style="list-style-type: none"> Ceiling incomplete Panels missing approx. (6) T joint strips fixing and neatness needed at all corners end points 	<ul style="list-style-type: none"> Door cleaning needed 	<ul style="list-style-type: none"> Cleaning required Opening gear to be services 	<ul style="list-style-type: none"> Incomplete joinery of counter

Outside (Covered) Waiting area RM 117	<ul style="list-style-type: none"> Grano floor finish uneven and patchy in places. Finishing spec required to detail 	<ul style="list-style-type: none"> Face brick walls to be power washed without damaging joints 	<ul style="list-style-type: none"> Roof installed without insulation noted 	<ul style="list-style-type: none"> As per Rm 120 Waiting Area 	<ul style="list-style-type: none"> External windows Aluminium to be cleaned

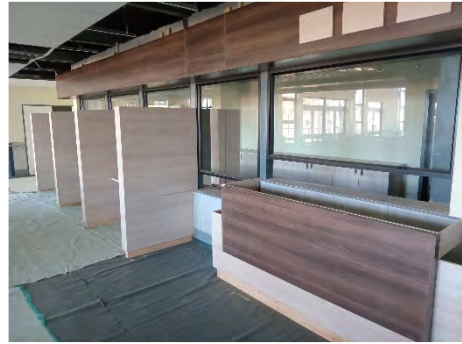
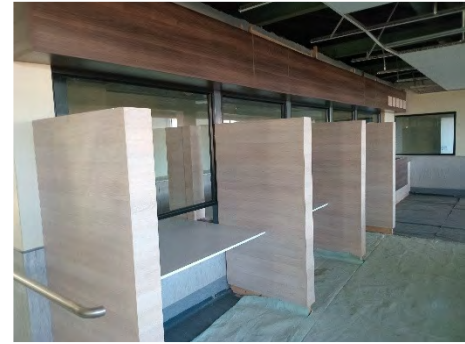
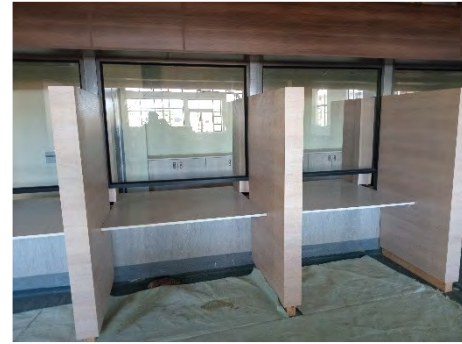
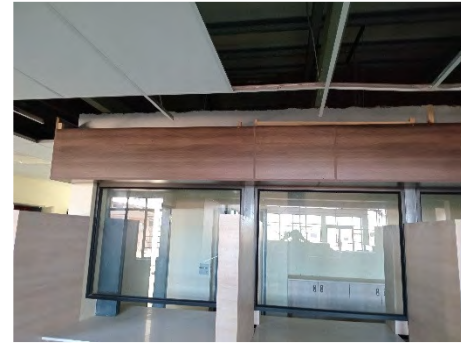
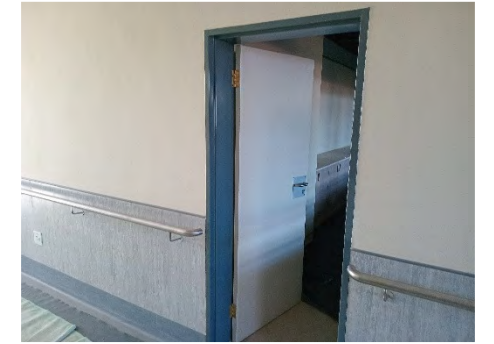
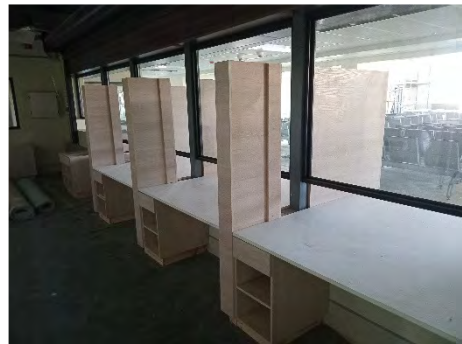
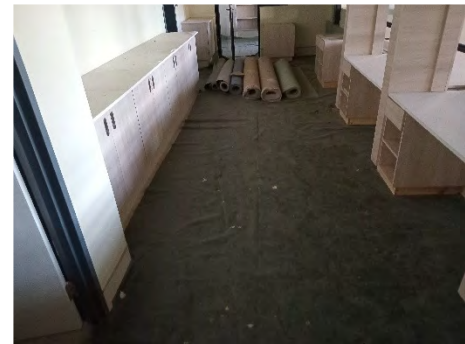
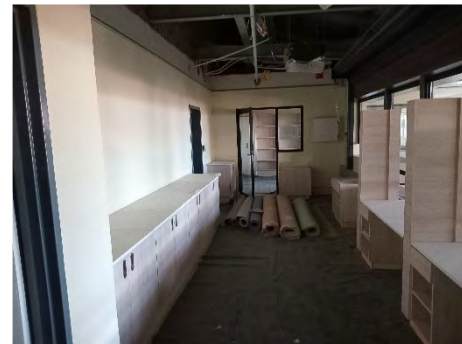
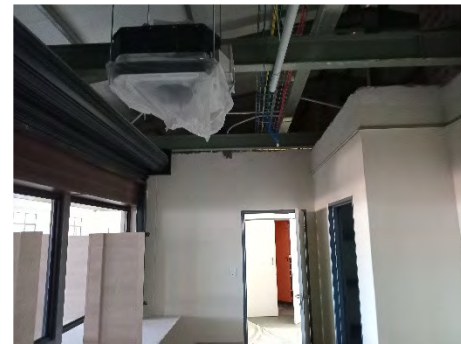
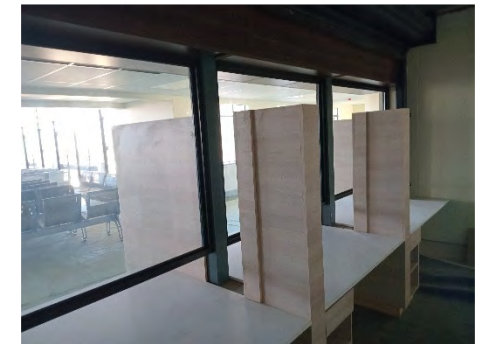
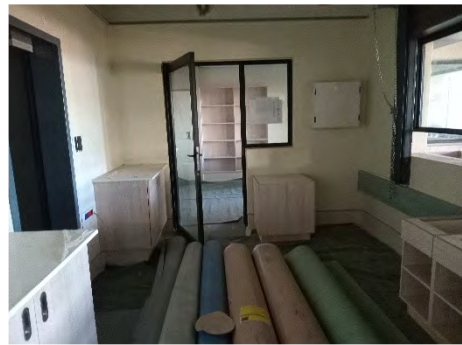
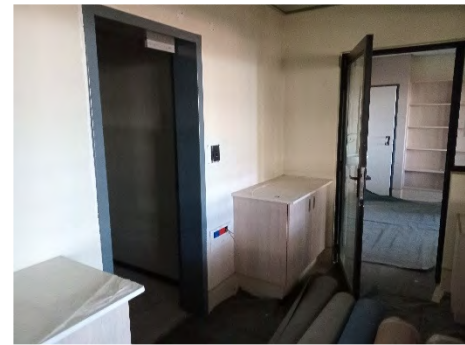
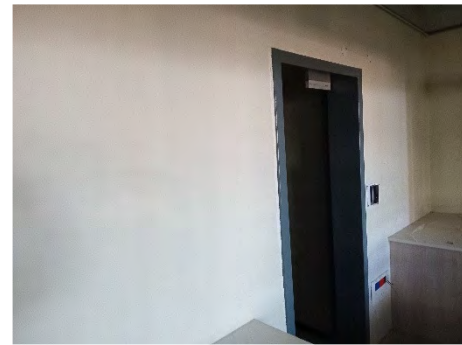
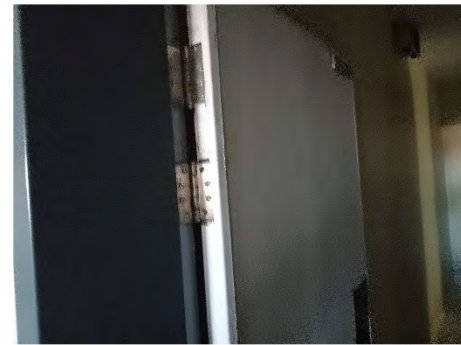
Internal Picture gallery

Office Rm 170	<ul style="list-style-type: none"> • Vinyl covered • Small area at entrance damaged 	<ul style="list-style-type: none"> • Cleaning required • Repaint may be required • 2 different paints used 	<ul style="list-style-type: none"> • Ceiling incomplete approx. • 2 panels missing 	<ul style="list-style-type: none"> • Doors to be repainted/ • Cleaning required 	<ul style="list-style-type: none"> • Cleaning required to the windows • Repaint frames where applicable 	<ul style="list-style-type: none"> • Joinery incomplete • Counter not installed yet 	<ul style="list-style-type: none"> • Sanitary ware installed • Testing required to plumbing and drainage 	
Office Rm 171 (Only accessible from outside)	<ul style="list-style-type: none"> • Floor covered • Cleaning required 	<ul style="list-style-type: none"> • Cleaning required • Repaint may be required • 2 different paints used was noted 	<ul style="list-style-type: none"> • Ceiling incomplete • 1 ceiling panel missing 	<ul style="list-style-type: none"> • Doors to be repainted/ • Cleaning required 	<ul style="list-style-type: none"> • Window to be cleaned 	<ul style="list-style-type: none"> • Joinery not done yet 	<ul style="list-style-type: none"> • Sanitary ware installed • Testing required to plumbing and drainage 	<ul style="list-style-type: none"> • Door locking keys not working • Lock to be changed - Cylinder

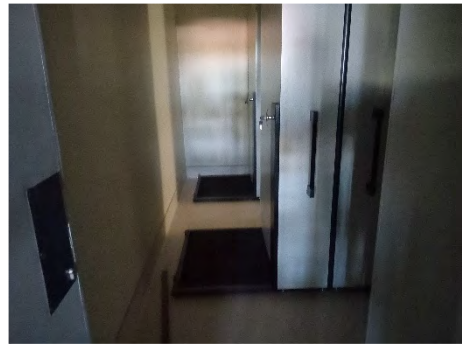
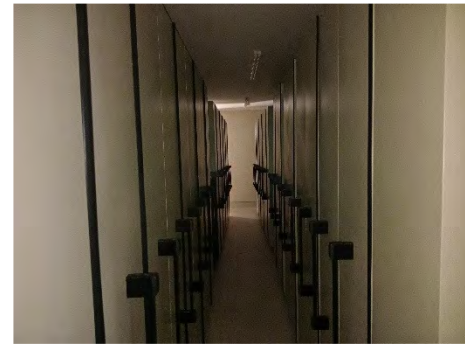
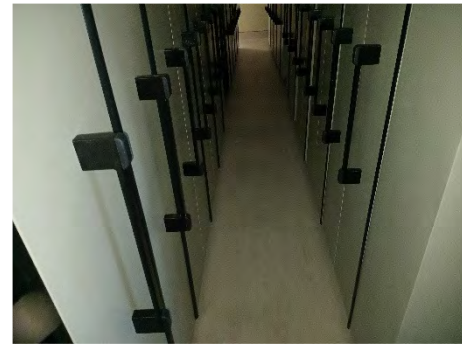
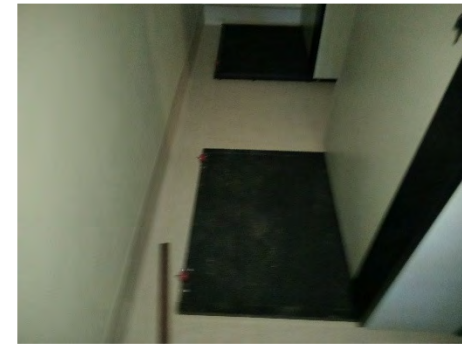
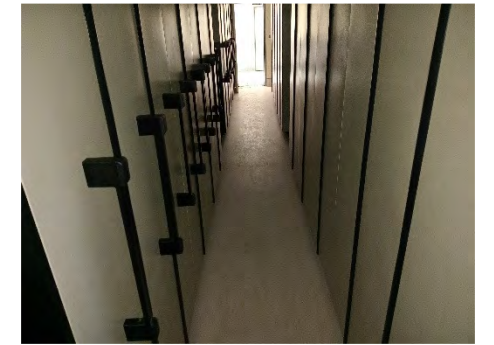
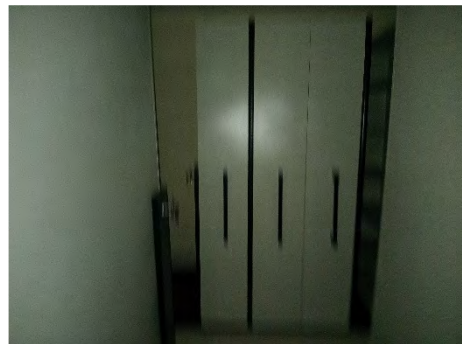
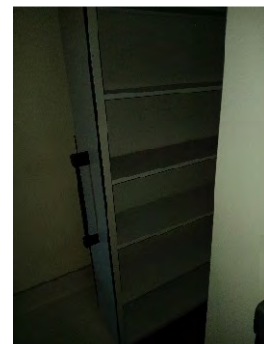
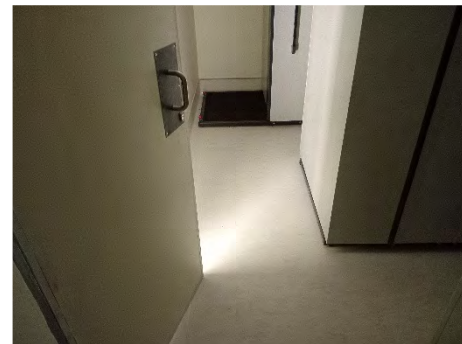
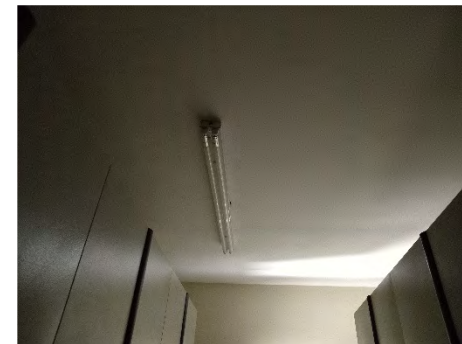
Records room

Records Rm 173	<ul style="list-style-type: none"> • Vinyl uncovered full protection required • Cleaning required • Small portion damaged 	<ul style="list-style-type: none"> • Repaint to be done – Touch ups required as shelving is installed 	<ul style="list-style-type: none"> • No ceiling done • Slab done and painted – No suspended ceiling 	<ul style="list-style-type: none"> • Repaint required to doors 		<ul style="list-style-type: none"> • Mobile shelves done • Testing to be done and certified

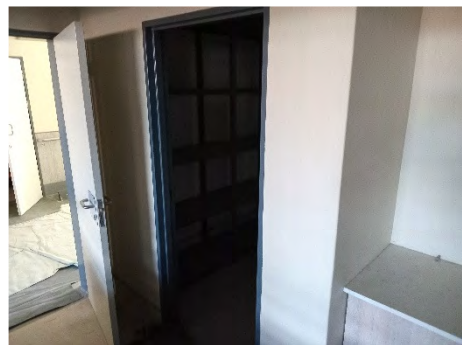
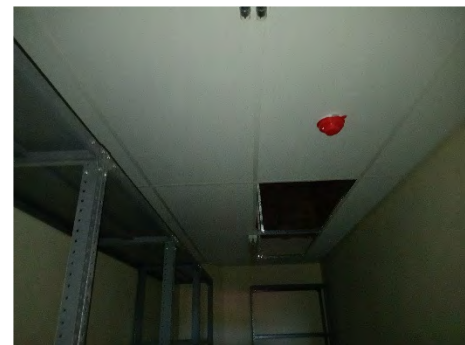
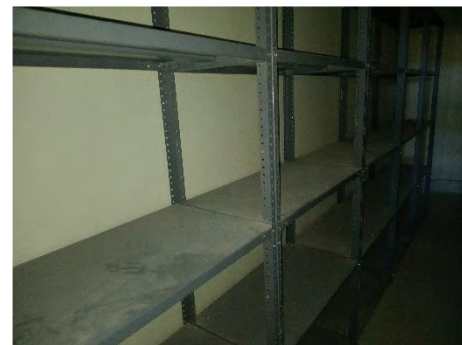
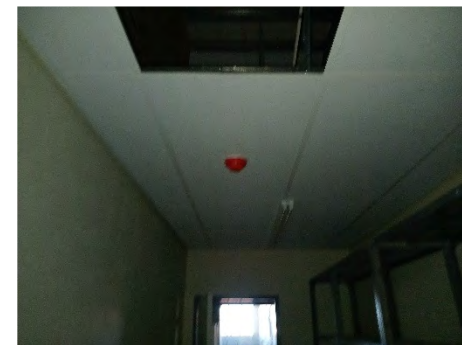
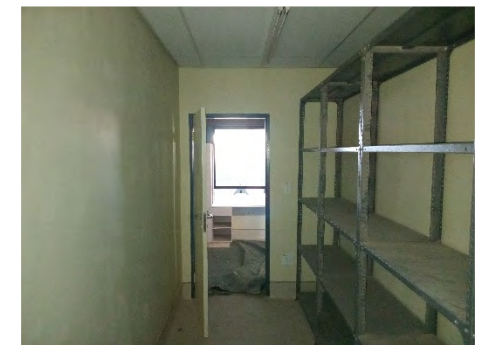
Other areas

Room name	Floors	Walls	Suspended Ceiling grid and tiles	Doors & Frames	Windows & Frames	Joinery	Sanitary fittings	Other Recommendations
Passage Block I, F.C Rm 121; Rm 174; Rm 013	<ul style="list-style-type: none"> Vinyl covered Cleaning required 	<ul style="list-style-type: none"> Repaint to be done in Block I & F ; to cover filled damaged areas 	<ul style="list-style-type: none"> Ceiling incomplete Missing ceiling panels in this block 	<ul style="list-style-type: none"> Doors to be repainted Doors and frames to be cleaned 	<ul style="list-style-type: none"> Cleaning required Repainting required to some window frames Opening gear to be serviced 			<ul style="list-style-type: none"> Sanitary fittings in public WC's is incomplete as per Block C & I
Store General Rm 172	<ul style="list-style-type: none"> Vinyl uncovered full protection required Cleaning required 	<ul style="list-style-type: none"> Cleaning and Repaint required 	<ul style="list-style-type: none"> Ceiling incomplete Missing panels approx. (4) 	<ul style="list-style-type: none"> Doors to be repainted / Doors and frames to be cleaned 		<ul style="list-style-type: none"> Shelving to be checked for final installation completeness

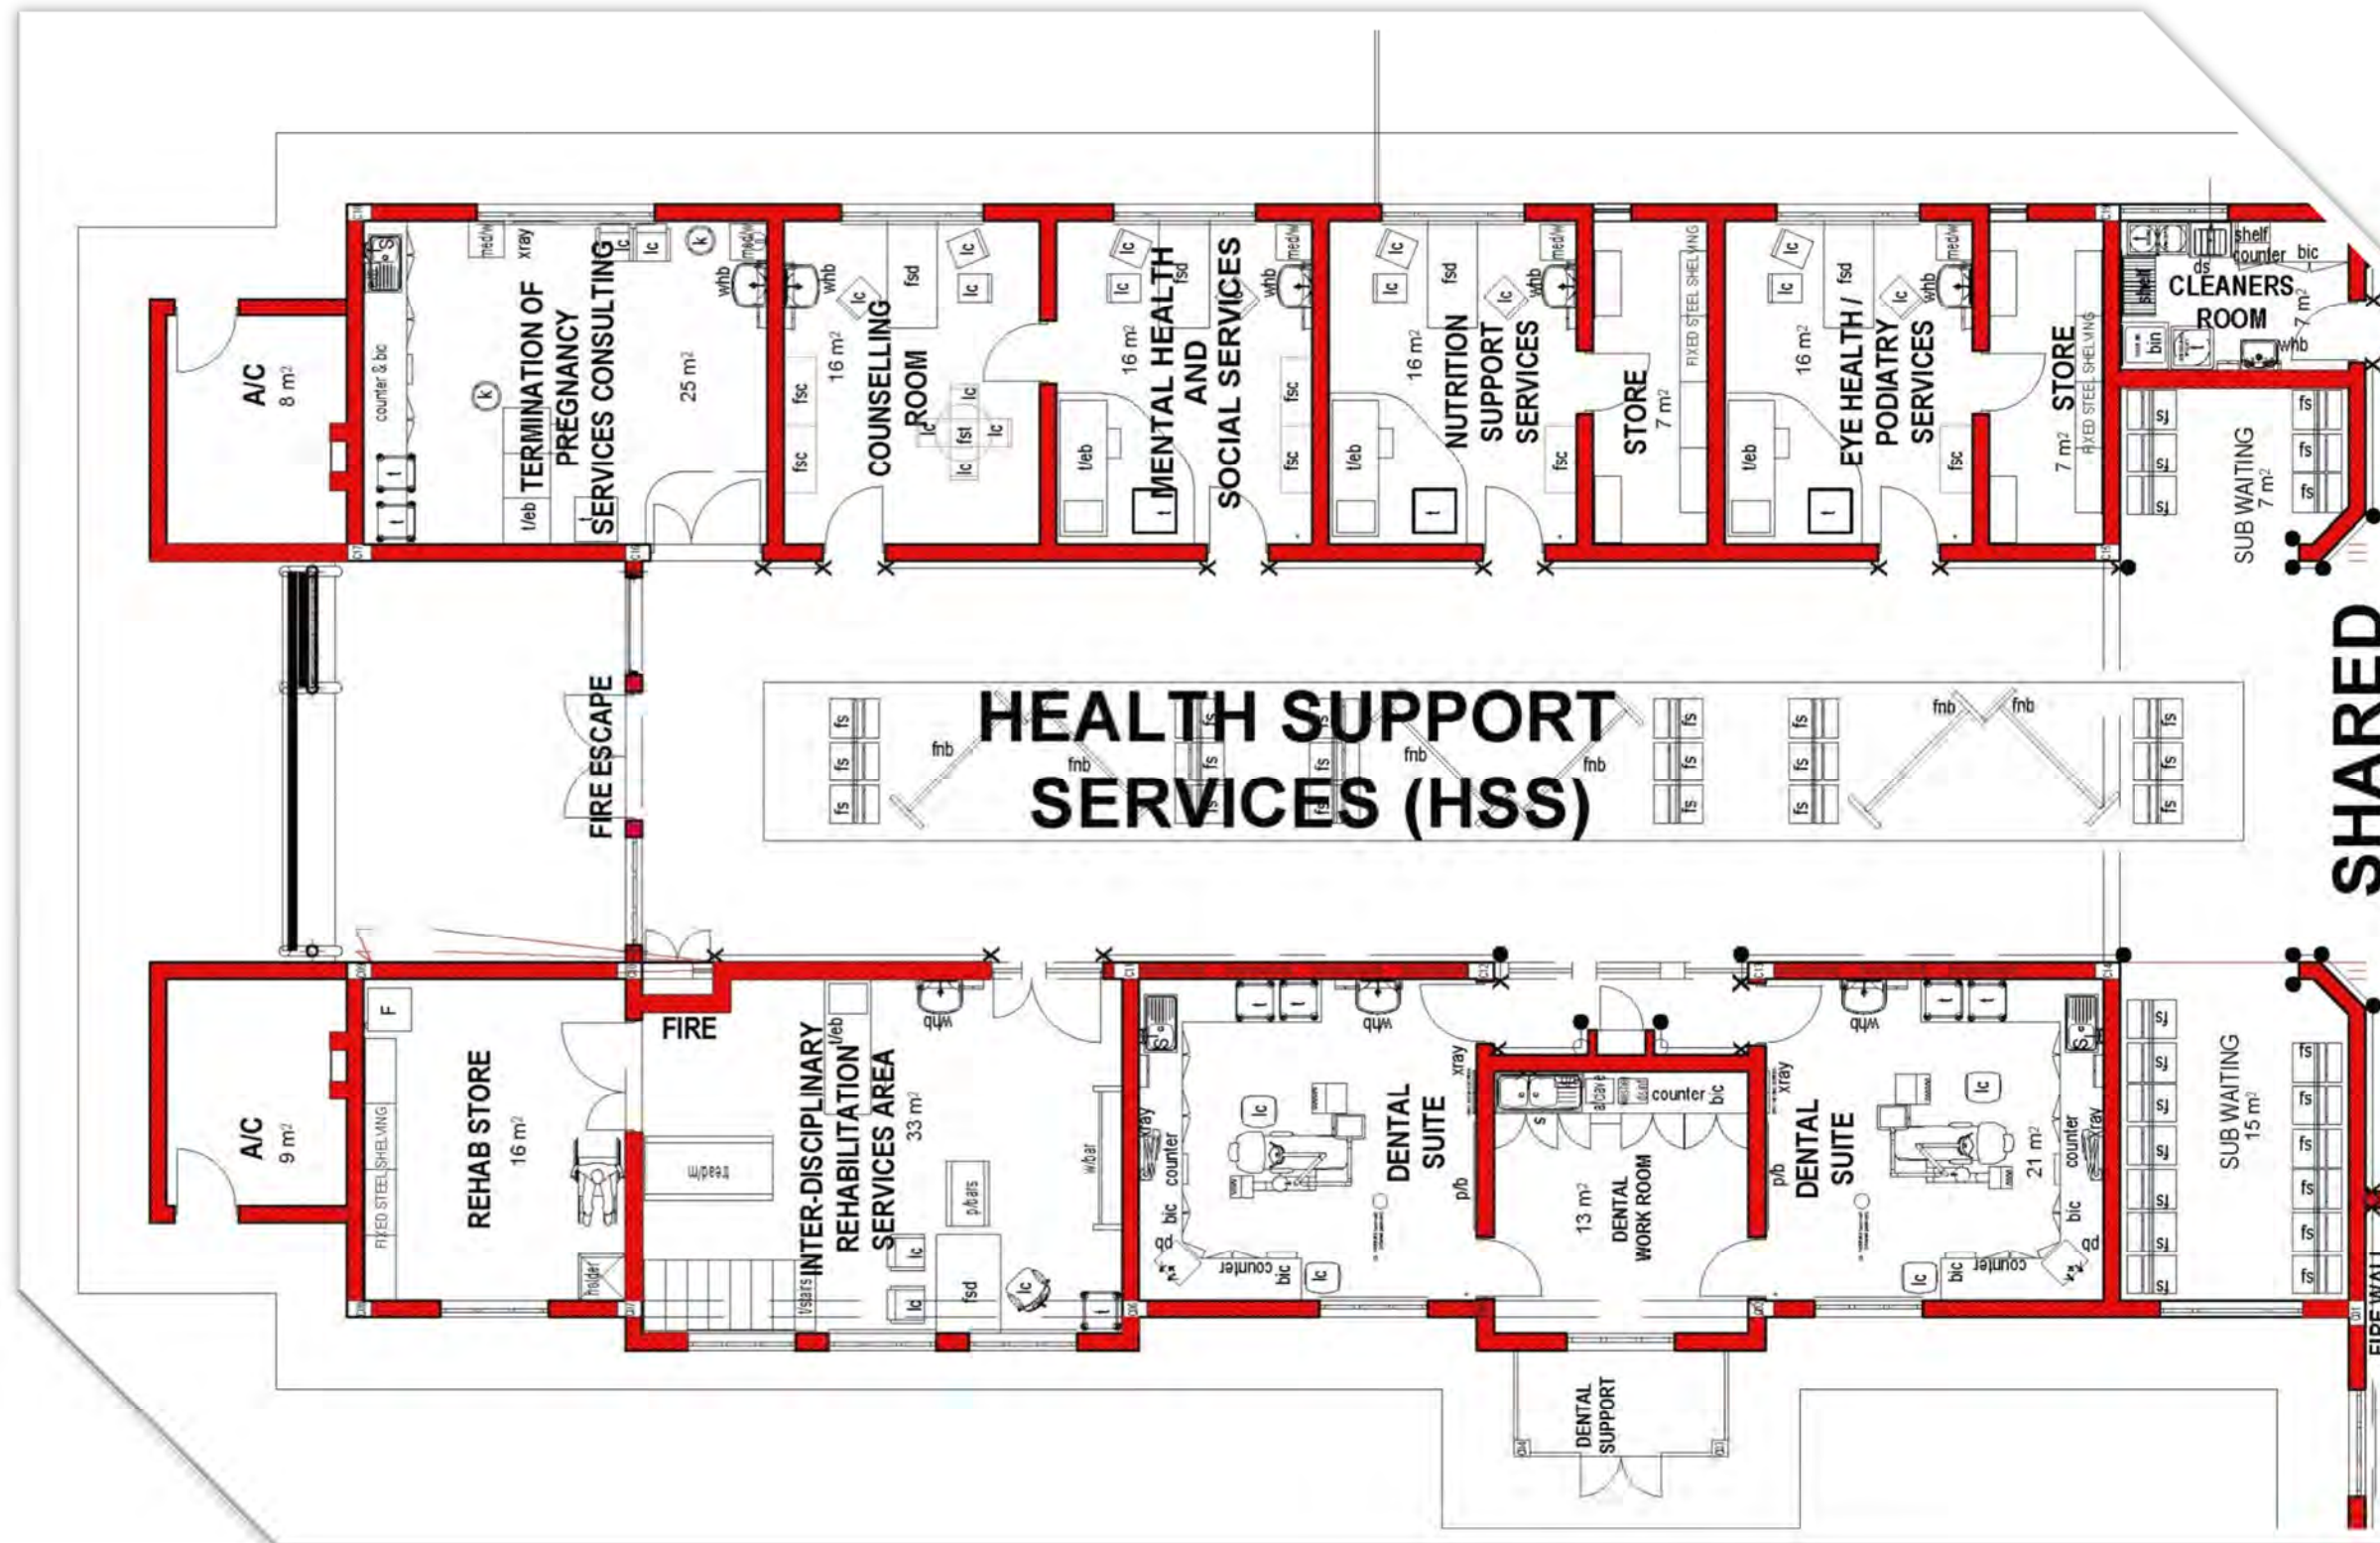
FLOOR PLAN

Block ID	G							
Block name	Health Support Services (HSS)							
Recorded Status Quo / Scope of Work completed / remaining Internal								
Room name	Floors	Walls	Suspended Ceiling grid / tiles	Doors & Frames	Windows & Frames	Joinery	Sanitary fittings & Accessories	Other Remediation
Terminal & Pregnancy Services RM 023	<ul style="list-style-type: none"> Vinyl floor covered Cleaning needed 	<ul style="list-style-type: none"> Painting done Final paint touches required 	<ul style="list-style-type: none"> Bed curtains & rails to be installed Water leak stained panels One panel area is open (TB Room only) T joint corners a joining end points to be fixed 	<ul style="list-style-type: none"> Bottom of door to be fixed (Minor defect possible from liquid) Repaint required 	<ul style="list-style-type: none"> Window cleaning Opening gear to be serviced 	<ul style="list-style-type: none"> Drawers not aligned in installed cupboard – must be corrected 	<ul style="list-style-type: none"> Adjustment to the basin mixers No sink installed Accessories to be installed Installation of ss sink to be completed. 	Water damage ceiling panels to be replaced

Counselling room RM 024	<ul style="list-style-type: none"> Vinyl floor covered Cleaning needed 	<ul style="list-style-type: none"> Painting of 2 different colour tones noted – End user to confirm 	<ul style="list-style-type: none"> T joint corners joining, end points to be fixed Water leak stained panels 	<ul style="list-style-type: none"> Kick plates needed Reclean / Repaint needed (Remove insect webs) 	<ul style="list-style-type: none"> Window cleaning Opening gear to be serviced 	<ul style="list-style-type: none"> Cleaning of door panels required 	<ul style="list-style-type: none"> Accessories to be installed 	Water damage ceiling panels approx. 7 to be replaced
Mental Health & Social Services RM 025	<ul style="list-style-type: none"> Vinyl floor covered Cleaning needed 	<ul style="list-style-type: none"> Painting of 2 different colour tones noted – End user to confirm Painting small touch around basin 	<ul style="list-style-type: none"> T joint corners joining, end points to be fixed Water leak stained panels 	<ul style="list-style-type: none"> Kick plates needed Reclean / Repaint needed (Remove insect webs) 	<ul style="list-style-type: none"> Window cleaning Opening gear to be serviced 	<ul style="list-style-type: none"> Cleaning of door panels required 	<ul style="list-style-type: none"> Accessories to be installed 	Water damage ceiling panels approx. 6 to be replaced

Nutrition Support Services RM 026	<ul style="list-style-type: none"> Vinyl floor covered Cleaning needed 	<ul style="list-style-type: none"> Painting of 2 different colour tones noted – End user to confirm Painting /Seal needed around basin 	<ul style="list-style-type: none"> T joint corners joining, end points to be fixed Water leak stained panels 	<ul style="list-style-type: none"> Kick plates needed Reclean / Repaint needed (Remove insect webs) 	<ul style="list-style-type: none"> Window cleaning Opening gear to be serviced 	<ul style="list-style-type: none"> Cleaning of door panels required 	<ul style="list-style-type: none"> Accessories to be installed 	Water damage ceiling panels approx. 6 to be replaced

Store RM 029	<ul style="list-style-type: none"> Vinyl floor covered Cleaning needed 	<ul style="list-style-type: none"> Painting needed to cover all areas 	<ul style="list-style-type: none"> T joint corners joining, end points to be fixed 	<ul style="list-style-type: none"> Kickplates needed 	<ul style="list-style-type: none"> Window cleaning Opening gear to be serviced 	<ul style="list-style-type: none"> Joinery / fixed steel sheeting not installed yet 		<ul style="list-style-type: none"> Water damage ceiling panels approx. 3 to be replaced
Sub-waiting Area (small) RM 015b	<ul style="list-style-type: none"> Vinyl floor covered Cleaning needed 	<ul style="list-style-type: none"> Wall expansion joint to be done as per Eng detail Repaint needed 	<ul style="list-style-type: none"> T joint corners joining, end points to be fixed 			<ul style="list-style-type: none"> Public Seating to be installed per layout

Sub-waiting Area RM 015a	<ul style="list-style-type: none"> Vinyl floor covered Cleaning needed 	<ul style="list-style-type: none"> Painting of 2 different colour tones noted – End user to confirm 	<ul style="list-style-type: none"> T joint corners joining, end points to be fixed 		<ul style="list-style-type: none"> Windows to be cleaned Opening gear to be serviced Window sill cracking 	<ul style="list-style-type: none"> Public to be installed per layout 		
Dental Suite RM 016	<ul style="list-style-type: none"> Vinyl exposed – Needs full protection Glue / stain residue to be removed Vinyl floor to be cleaned 	<ul style="list-style-type: none"> Splashback joint grouting not finished Wall and top seal needed 	<ul style="list-style-type: none"> T joint corners joining, end points to be fixed 2 ceiling panels missing 	<ul style="list-style-type: none"> Kickplates to be installed Cleaning of door arks 	<ul style="list-style-type: none"> Windows to be cleaned Opening gear to be serviced Windowsill cracking 	<ul style="list-style-type: none"> Cupboards top joining spots not aligned and need seal Joinery generally cupboard not completed 	<ul style="list-style-type: none"> Sanitary and sink/ basin fittings incomplete Need to complete sink mixers 	<ul style="list-style-type: none"> Dental chair equipment installed and must be kept protected from damage, theft, and unauthorised access

Room name	Floors	Walls	Suspended Ceiling grid / tiles	Doors & Frames	Windows & Frames	Joinery	Sanitary fittings & Accessories	Other Remediation
Dental Work Room RM 017	<ul style="list-style-type: none"> • Vinyl exposed – Needs full protection • Glue / stain residue to be removed • Vinyl floor to be cleaned 	<ul style="list-style-type: none"> • Splashback greeting colour not finished • Wall and top seal needed 	<ul style="list-style-type: none"> • T joint corners joining, end points to be fixed 	<ul style="list-style-type: none"> • Kickplates to be installed • Cleaning of door arks 	<ul style="list-style-type: none"> • Windows to be cleaned • Opening system to be serviced • Windowsill cracking 	<ul style="list-style-type: none"> • Cupboards top joining spots not aligned and need seal • Joinery cupboard not completed 	Sanitary and sink/ basin fittings incomplete Need to complete plumbing installation.

Dental Suite RM 018	<ul style="list-style-type: none"> • Vinyl exposed – Needs full protection • Glue / stain residue to be removed • Vinyl floor to be cleaned 	<ul style="list-style-type: none"> • Splashback joint grouting not finished • Wall and top seal needed 	<ul style="list-style-type: none"> • T joint corners joining, end points to be fixed • 2 ceiling panels missing 	<ul style="list-style-type: none"> • Kickplates to be installed • Cleaning of door arks 	<ul style="list-style-type: none"> • Windows to be cleaned • Opening gear to be serviced • Windowsill cracking 	<ul style="list-style-type: none"> • Cupboards top joining spots not aligned and need seal • Joinery generally cupboard not completed 	Sanitary and sink/ basin fittings incomplete • Need to complete plumbing installation.	Dental chair equipment installed and must be kept protected from damage, theft, and unauthorised access

Inter-diciplinary Rehab Area RM 019	<ul style="list-style-type: none"> • Vinyl floor is covered • Floor to be cleaned 	<ul style="list-style-type: none"> • 2 different colours • Clarity needed 	<ul style="list-style-type: none"> • T joint corners joining, end points to be fixed • 2 ceiling panels missing • Water marks on curtains 	<ul style="list-style-type: none"> • Kickplates to be done • Cleaning of door arks 	<ul style="list-style-type: none"> • Windows to be cleaned • Opening gear to be serviced • Windowsill cracking 		• Accessories still to be installed	
Rehab Store RM 020	<ul style="list-style-type: none"> • Vinyl floor is covered • Floor to be cleaned 	<ul style="list-style-type: none"> • Painting to be completed 	<ul style="list-style-type: none"> • T joint corners joining, end points to be fixed 	<ul style="list-style-type: none"> • Kickplates to be done • Cleaning of door arks 	<ul style="list-style-type: none"> • Windows to be cleaned • Opening gear to be serviced • Windowsill cracking 	<ul style="list-style-type: none"> • Fixed steel shelving is not installed.

HSS Internal Passage RM 015	<ul style="list-style-type: none"> • Vinyl floor is covered • Floor to be cleaned 	<ul style="list-style-type: none"> • Shopfronts to be cleaned • Door handles to be checked 	<ul style="list-style-type: none"> • Generally acceptably installed except for where minor defects have been identified. 	<ul style="list-style-type: none"> • Fire escape door handles to be checked 	<ul style="list-style-type: none"> • Windows to be cleaned • Opening gear to be serviced • Window sill cracking

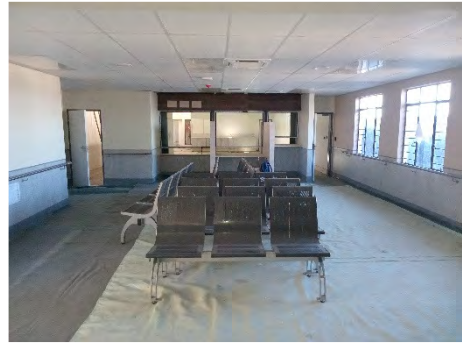
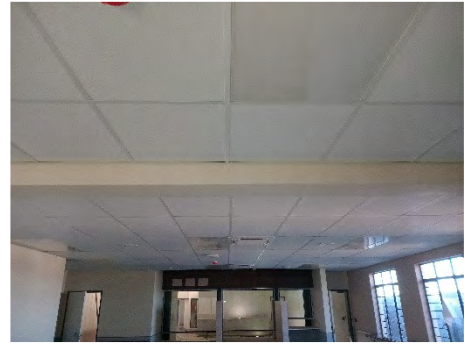
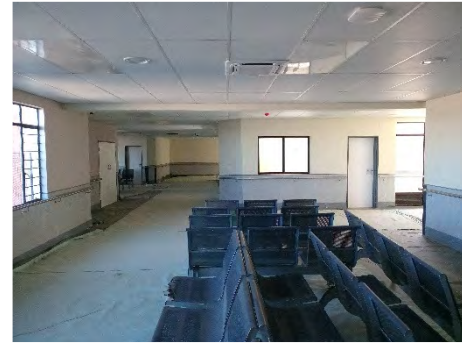
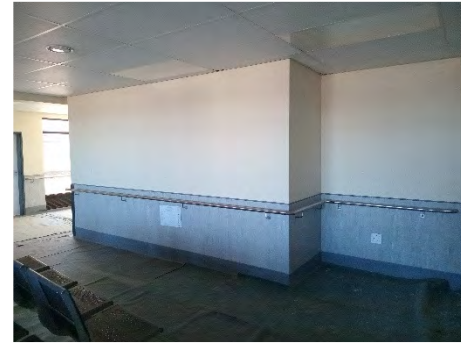
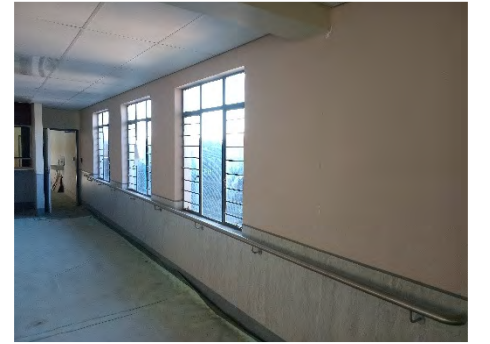
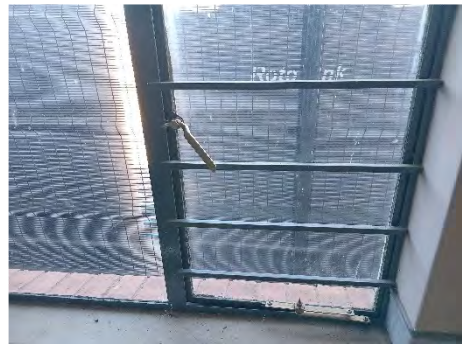
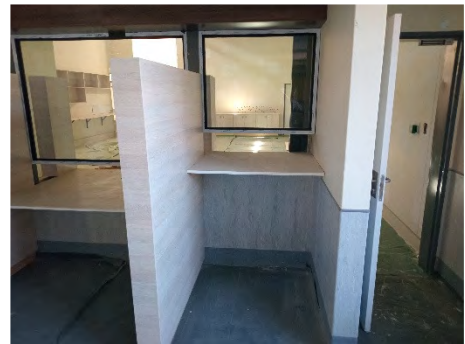
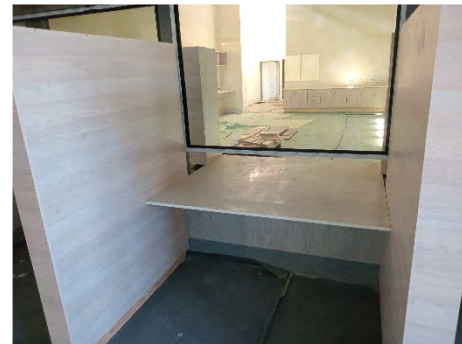
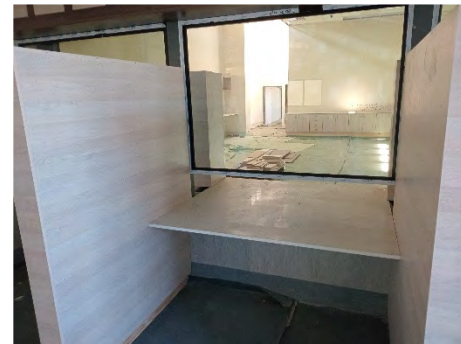
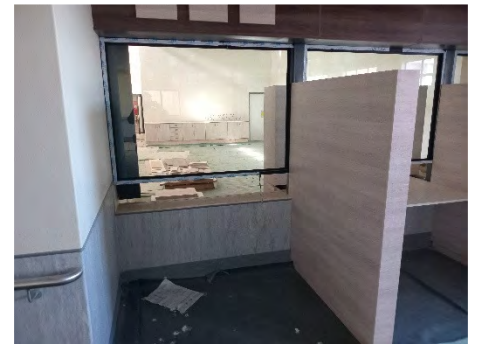
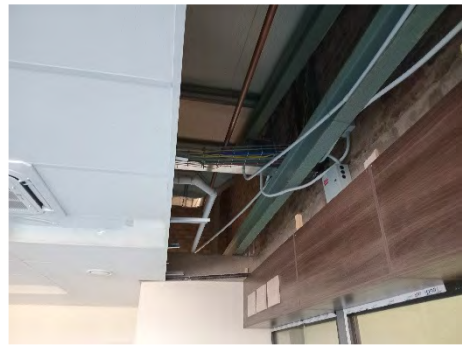
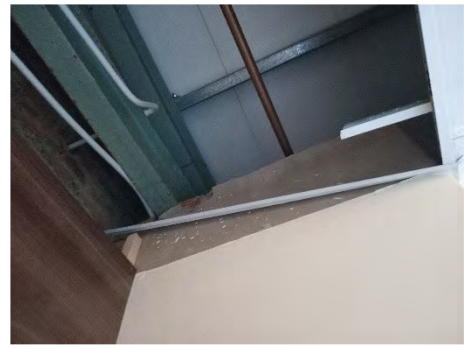
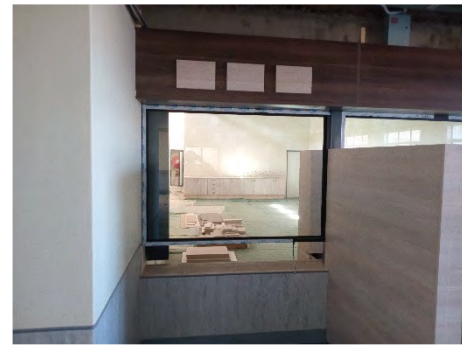
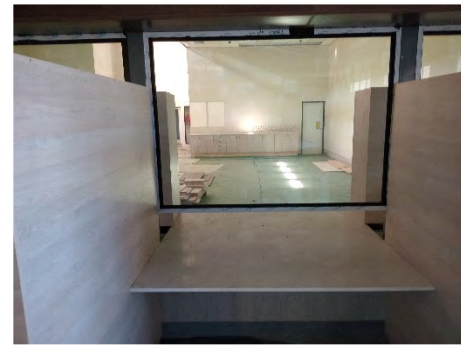
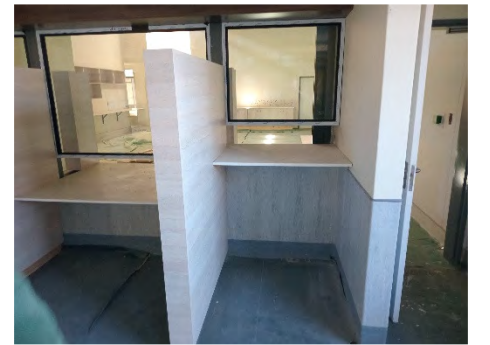
Block letter **J**
 Block name **Pharmacy, CCMDD & Staff areas**

Dispensing RM 140	<ul style="list-style-type: none"> Vinyl covered Cleaning needed 	<ul style="list-style-type: none"> Painting unfinished Cleaning required 	<ul style="list-style-type: none"> Ceiling incomplete Panels missing T joint hangers fixing and neatness needed at all corners end points 	<ul style="list-style-type: none"> Doors repaint needed Frames & wall seal required Cleaning needed 	<ul style="list-style-type: none"> Window panels to be cleaned High level clear storey windows require mobile Scaff holding 	<ul style="list-style-type: none"> Joinery at counters and bulkheads are incomplete Joinery at Wet prep area to be completed. Joinery at other prep / cupboard area to be completed. 	<ul style="list-style-type: none"> Fittings at Wet prep area to be completed Plumbing to be tested SS Sink at other prep / cupboard area to be completed 	<ul style="list-style-type: none"> Supply and installation of pharmacy shelving is pending. Complete fit-out as per layout required Linbin shelving also not installed .

CCMDD RM 133	<ul style="list-style-type: none"> • Vinyl covered • Vinyl to be cleared • Skirting seals not done 	<ul style="list-style-type: none"> • Walls to be repainted • Splashback to be cleaned 	<ul style="list-style-type: none"> • Ceiling installed is incomplete • Panel missing • T joints require correction 	<ul style="list-style-type: none"> • Doors to be cleaned / repainted 	<ul style="list-style-type: none"> • Windows to be cleaning needed • Opening gear to be services • Incomplete service window 		<ul style="list-style-type: none"> • Joinery counter not installed. • Window service ledge not installed. • Fixed steel shelving pending. 	<ul style="list-style-type: none"> • Public seating stored here to be allocated • Window Roller shutter to be completed

- All doors & window opening gear to be serviced throughout the building – Defects not included here to be notified.
- All Fire Ducts & Fire cabinets to have similar floor applied finish – Specification to be provided
- The vinyl window sill details are at times not consistent, the final detail to be confirmed and be consistent for full height vinyl clad walls.
- DB & Fire cabinets – cleaning to be done, ceiling not done, floors to be similar and consistent to every Block
