**COMPLETION OF CONSTRUCTION OF
ETHANDAKUKHANYA 24HR COMMUNITY
HEALTH CENTRE (CHC), MKHONDO
LOCAL MUNICIPALITY**

Architects Due Diligence Report:
TECHNICAL ASSESSMENT

AUGUST - 2025

Prepared for:
National Department of Health

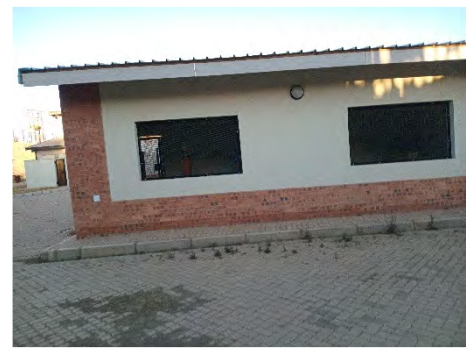
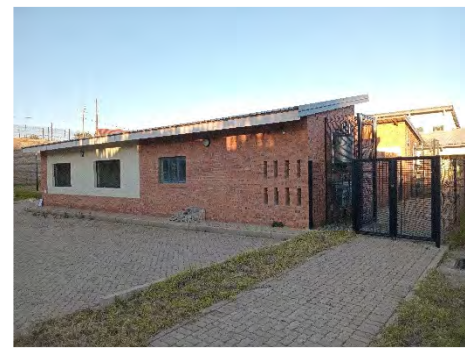
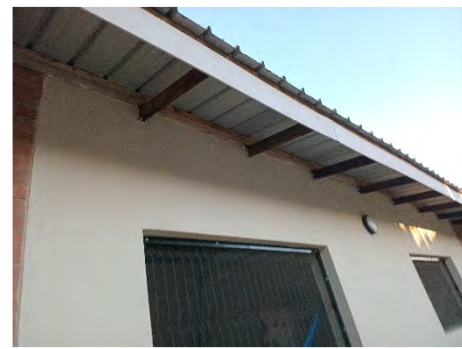
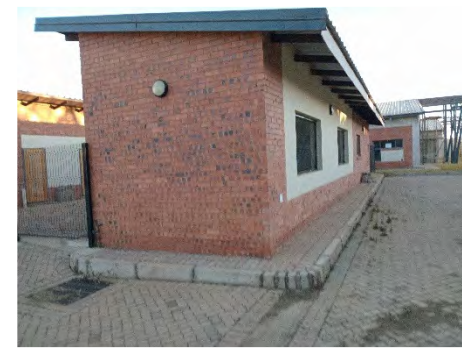
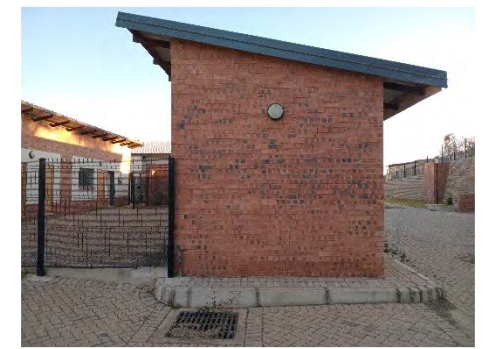
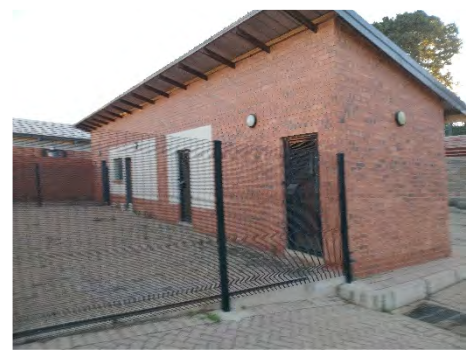
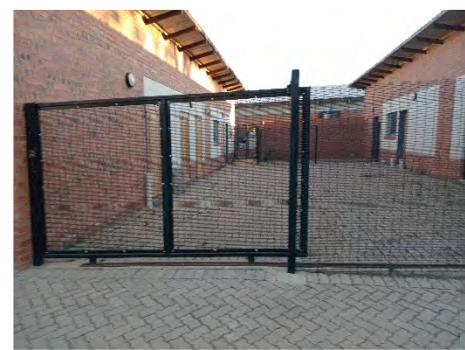
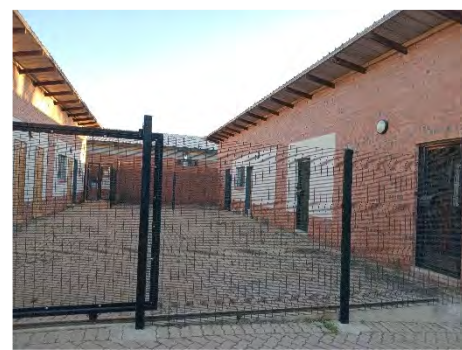
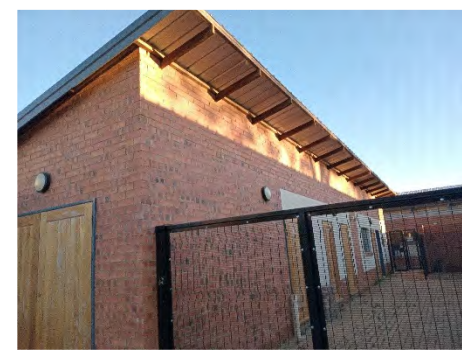
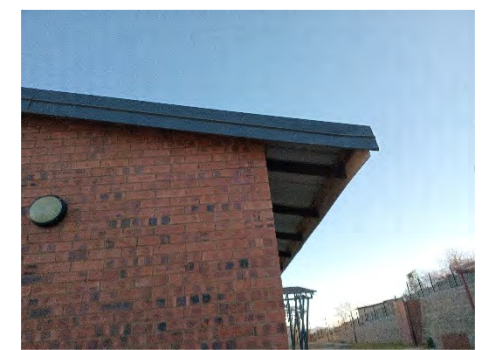
External picture gallery

Area name	Outside Support Services Front & Side Elevations
Recorded Status Quo / Scope of Work completed / remaining External	
Room name	Notes
Roof	The existing exposed wooden purlins require essential treatment to prevent deterioration, and the installation of fascia is yet to be completed as per specification. There are dented gable flashing on this building that may require replacement. The absence of entrance door awnings leaves access points exposed to weather elements, potentially leading to water ingress and premature wear on underlying structures and finishes.
Walls	The walls exhibit signs of weathering, with a specific need for repainting in areas where the existing paint is cracking and peeling,
Doors & Frame	<ul style="list-style-type: none"> All Doors require servicing need checking. The Ironmongery of the Door is to be completed.
Window & Frame	<ul style="list-style-type: none"> Windows require servicing across all opening mechanisms to ensure smooth operation. Additionally, cleaning is needed, and dirty cills need to be addressed.

Other Issues	<ul style="list-style-type: none"> Paving needs repair and clearing of invasive plants and growing vegetation, while steel cages require cleaning and painting due to rusting.
General Comments

- All External timber doors on this block have been exposed to the elements and show signs of weather beating.
- The installation of awnings and replacement of weather bars in recommended - To be confirmed.
- The Mesh panels used on storeroom areas are letting in excessive dust which will need to be a maintenance issue pointed out to the End user.

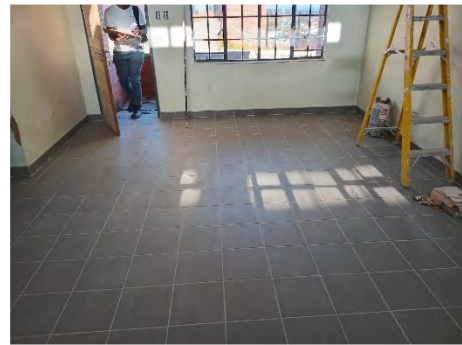
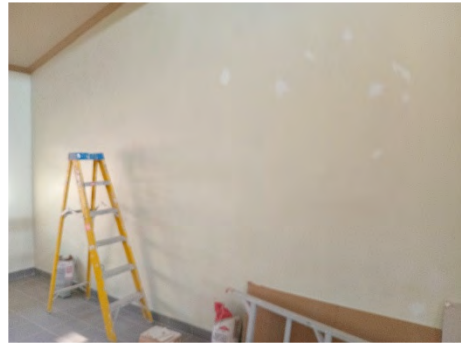
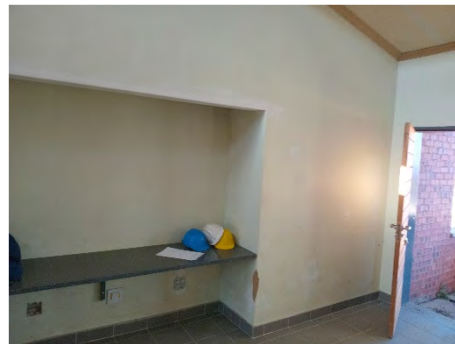
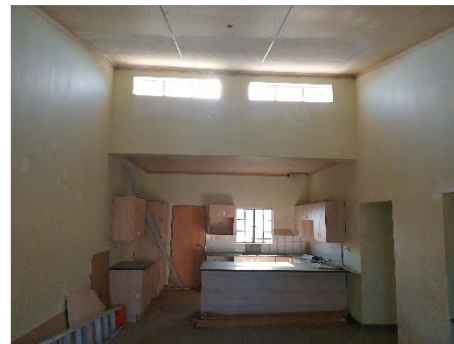
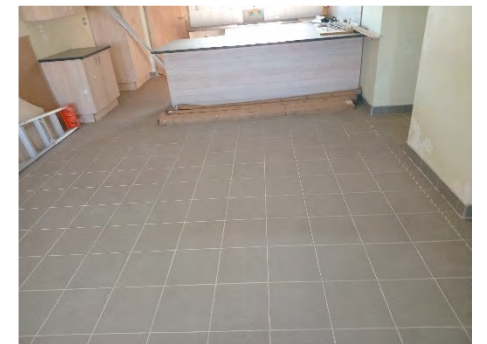
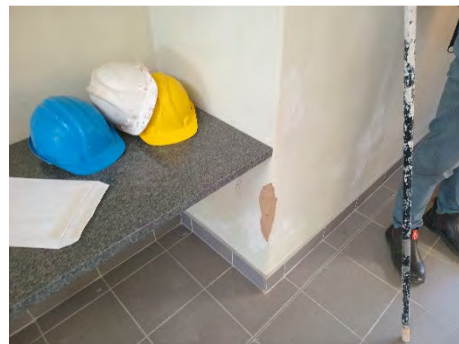
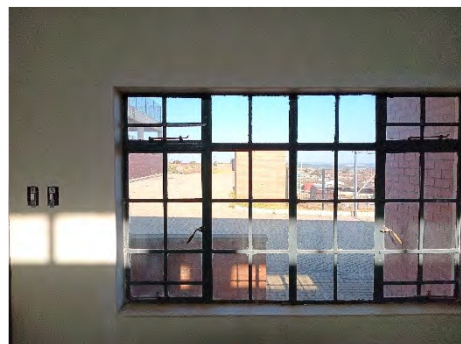
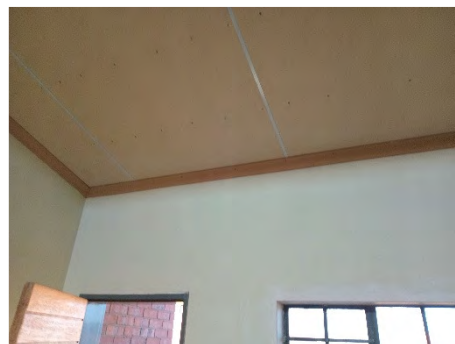
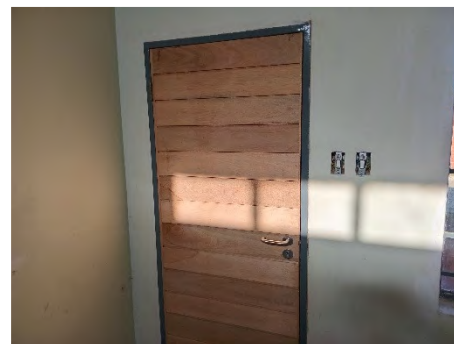
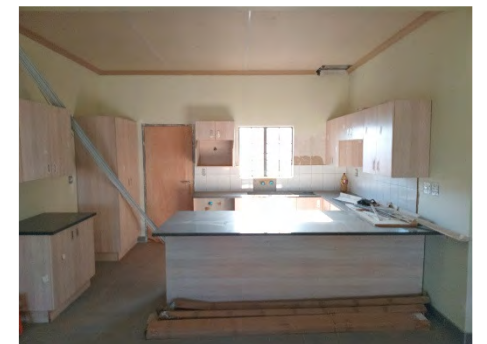
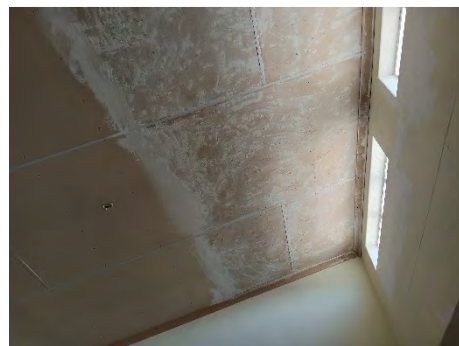
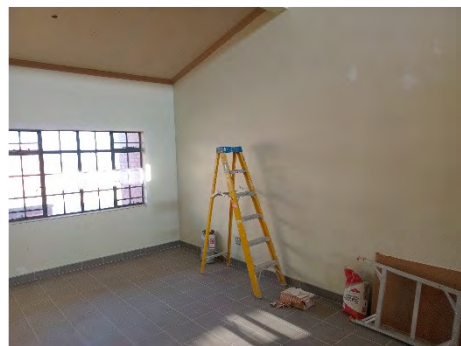
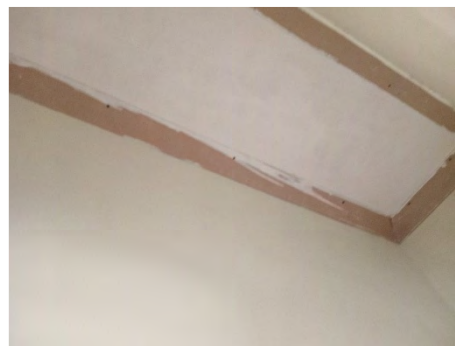
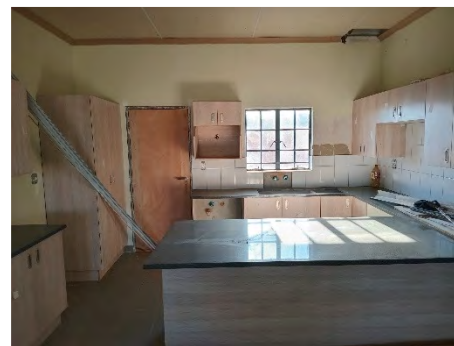
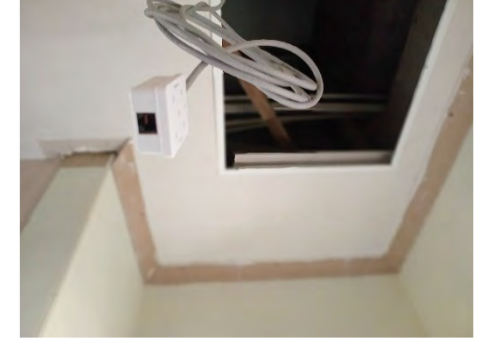
Internal Picture gallery

Block letter	M1		
Block name	Lower Staff Residence Unit 2

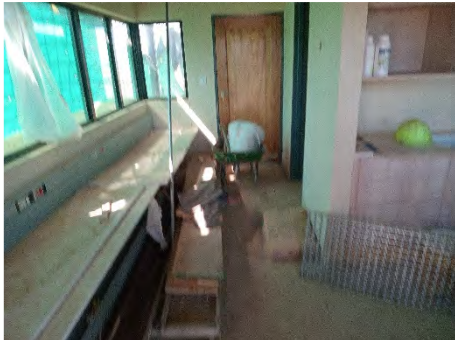
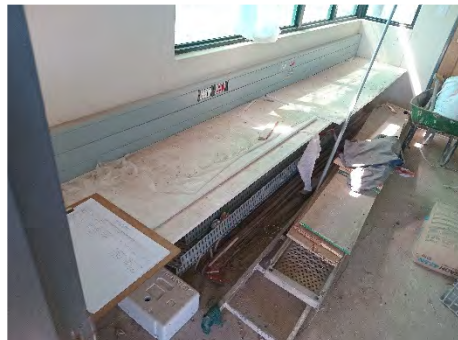
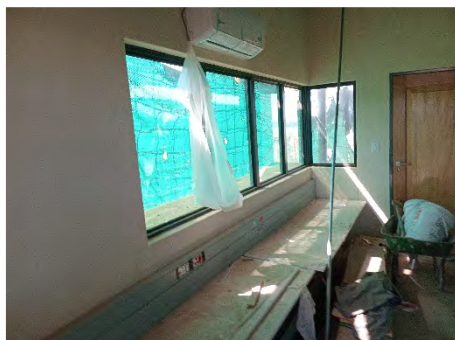
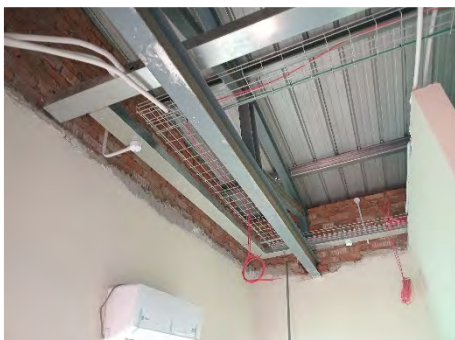
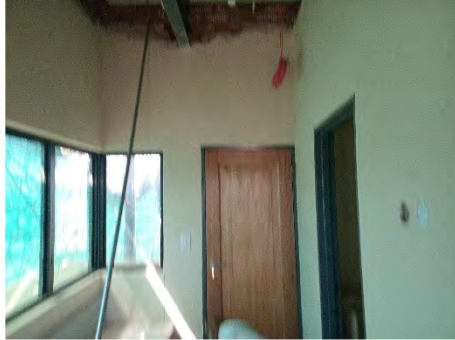
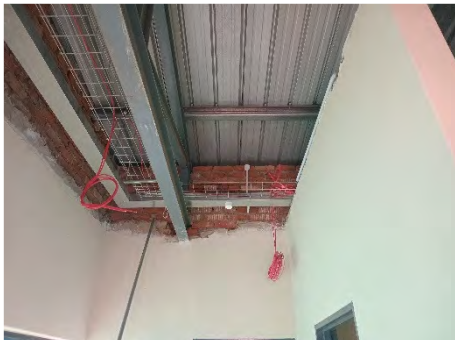
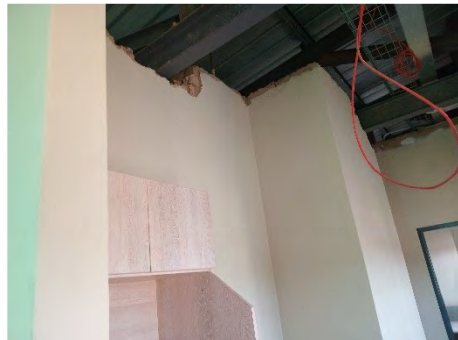
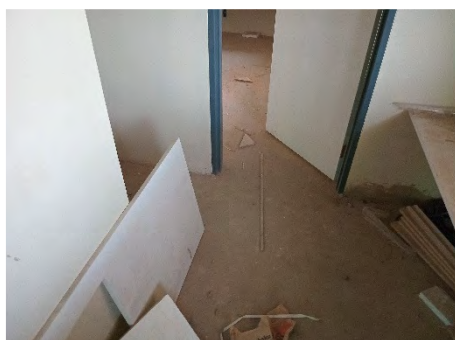
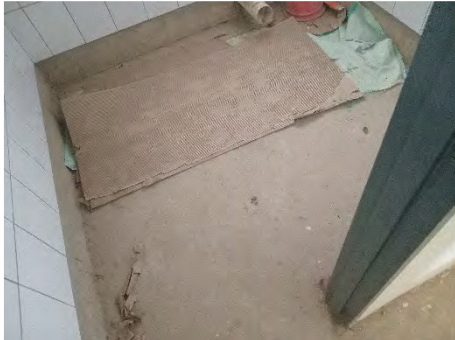
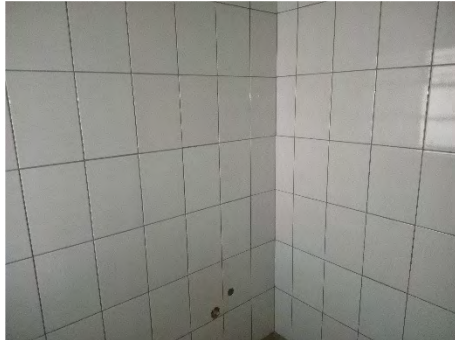
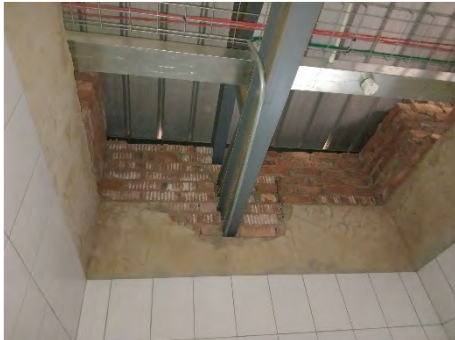
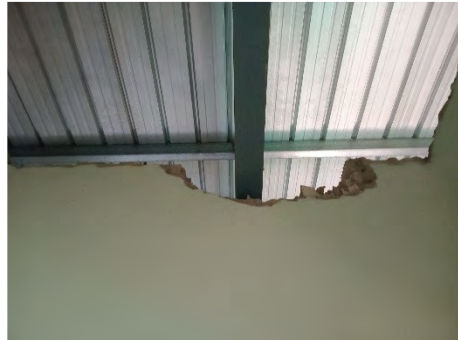
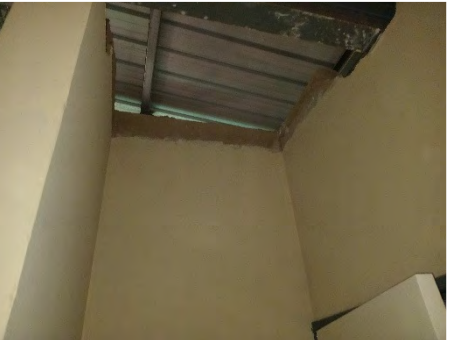
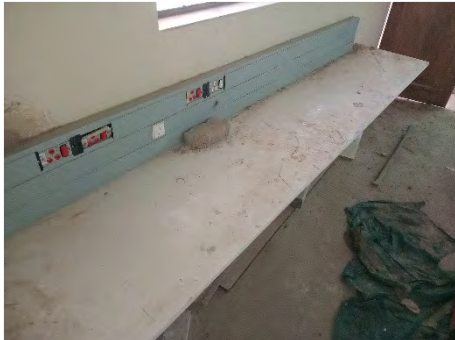
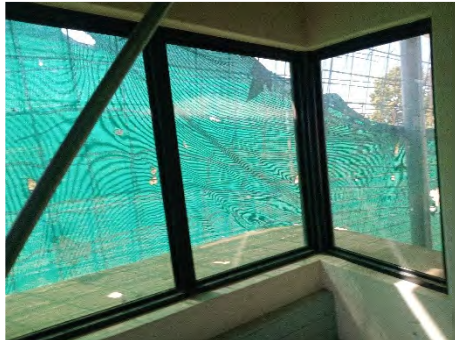
Internal Picture gallery

Doors & Frame	<ul style="list-style-type: none"> · All Doors require servicing, repaint and vanishing. · The Ironmongery system of the Entrance Door is incomplete. 	
Window & Frame	<ul style="list-style-type: none"> · Windows require servicing across all opening mechanisms to ensure smooth operation. Handles are loose and stays are at time. · Additionally, cleaning is needed, and dirty cills need to be addressed. Any damaged cills need to be identified and replaced to specification. · Through cleaning of glazing is required – Not all glazing could be checked for completeness for chipping or cracking, and a glazing audit is required. · Backyard Gates and Geyser cages are incomplete. 	
Other Issues	<ul style="list-style-type: none"> · Paving and aprons need repair and clearing of invasive plants and growing vegetation, while steel cages require cleaning and painting due to rusting. 	
General Comments	<ul style="list-style-type: none"> · Exposed Sewer Pipework to be inspected by the Wet Services engineer.

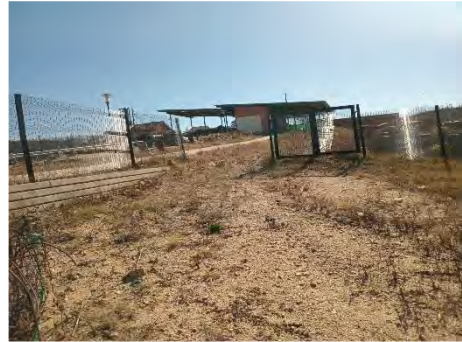
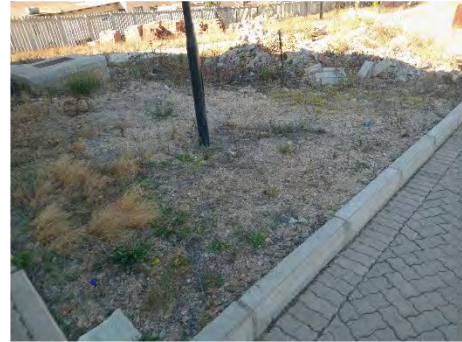
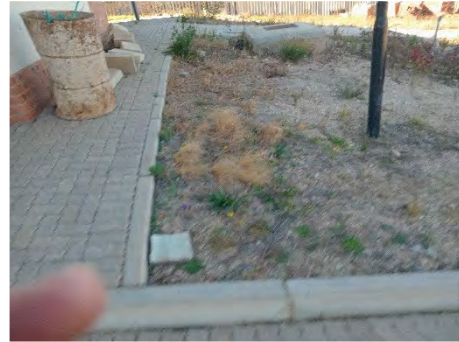
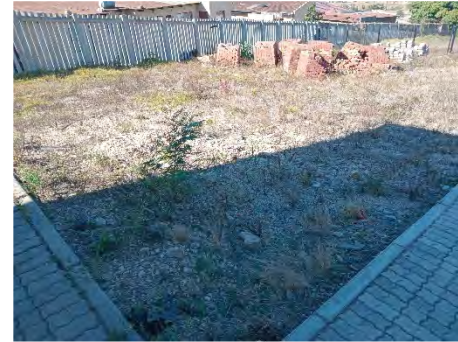
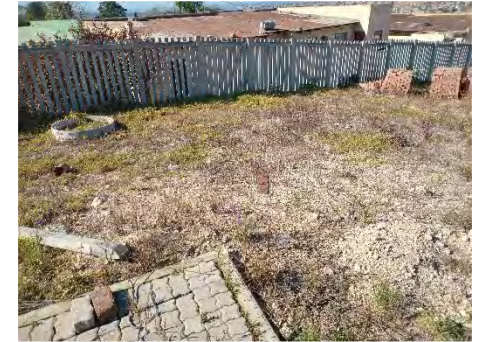
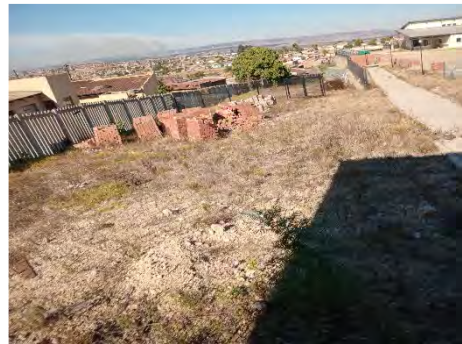
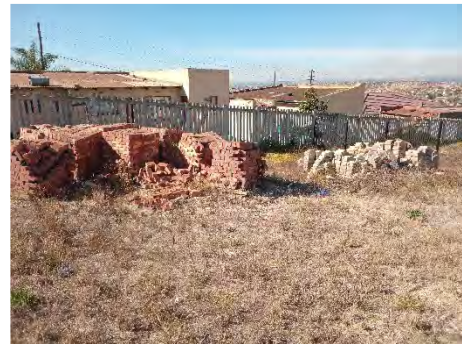
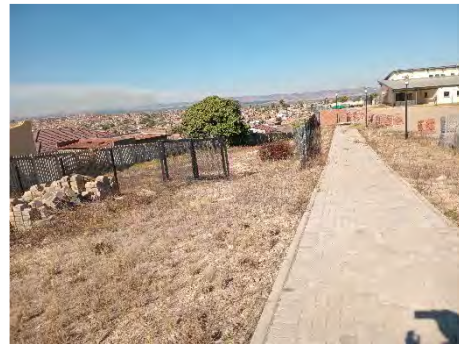
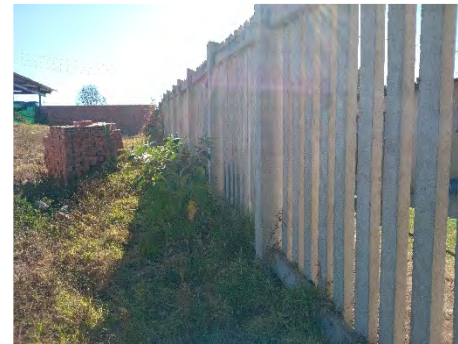
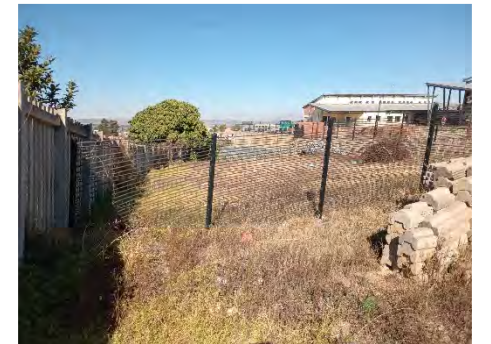
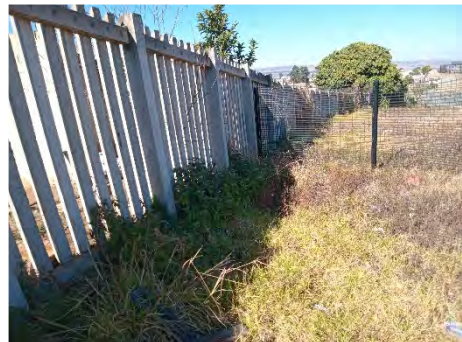
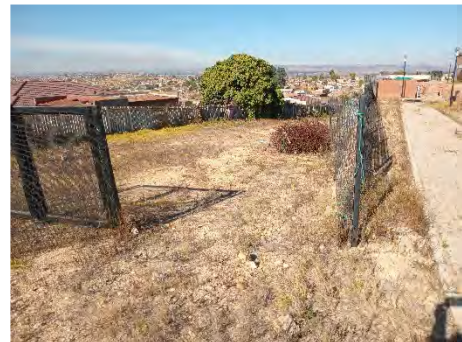
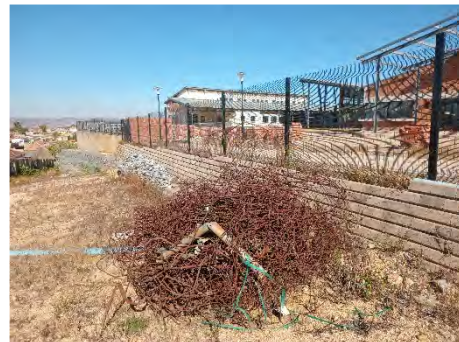
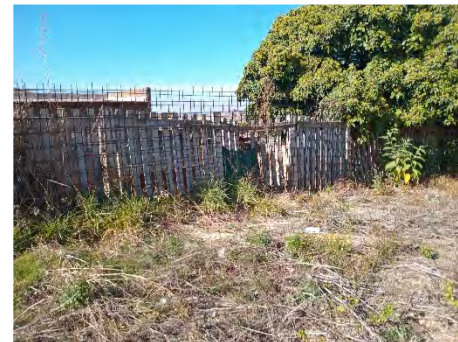
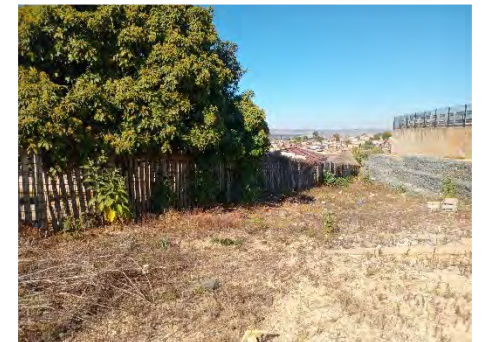
North East Surrounds – Guardhouse areas

Driveways	<ul style="list-style-type: none"> Paving in the public parking area needs to be resurfaced. Make good paving around poles Cleaning and maintenance of the culvert at the gate entrance are required. Road marking not done yet. 	
Landscaping	<ul style="list-style-type: none"> Paving – Stained Make good paving around poles Weeds 	
Carports	<ul style="list-style-type: none"> The carport's roof sheeting is not yet completed. Roof Sheetting still to be done. 	
Fencing	<ul style="list-style-type: none"> Public Parking- Palisade fence needs repairs in the section on the damaged column. Fill blocks around the clear view fence need completion between Main Gate entrance and Public Parking. The fence needs inspection and repair in areas where it is lying on the ground (specifically the Palisade fence) along the public parking area. 	
Landscape	<ul style="list-style-type: none"> The typography area behind the Guardhouse should be covered with wild grass or low-maintenance grass. Grass is not yet done behind the guard house. Reeds, rubbish dumps, and bricks (used material) need to be removed behind the Guardhouse. The landscape around the building needs to be maintained.
