# **MEYERTON WASTEWATER TREATMENT PLANT:**

## **Preliminary Structural & Visual Assessment**

30 September 2022

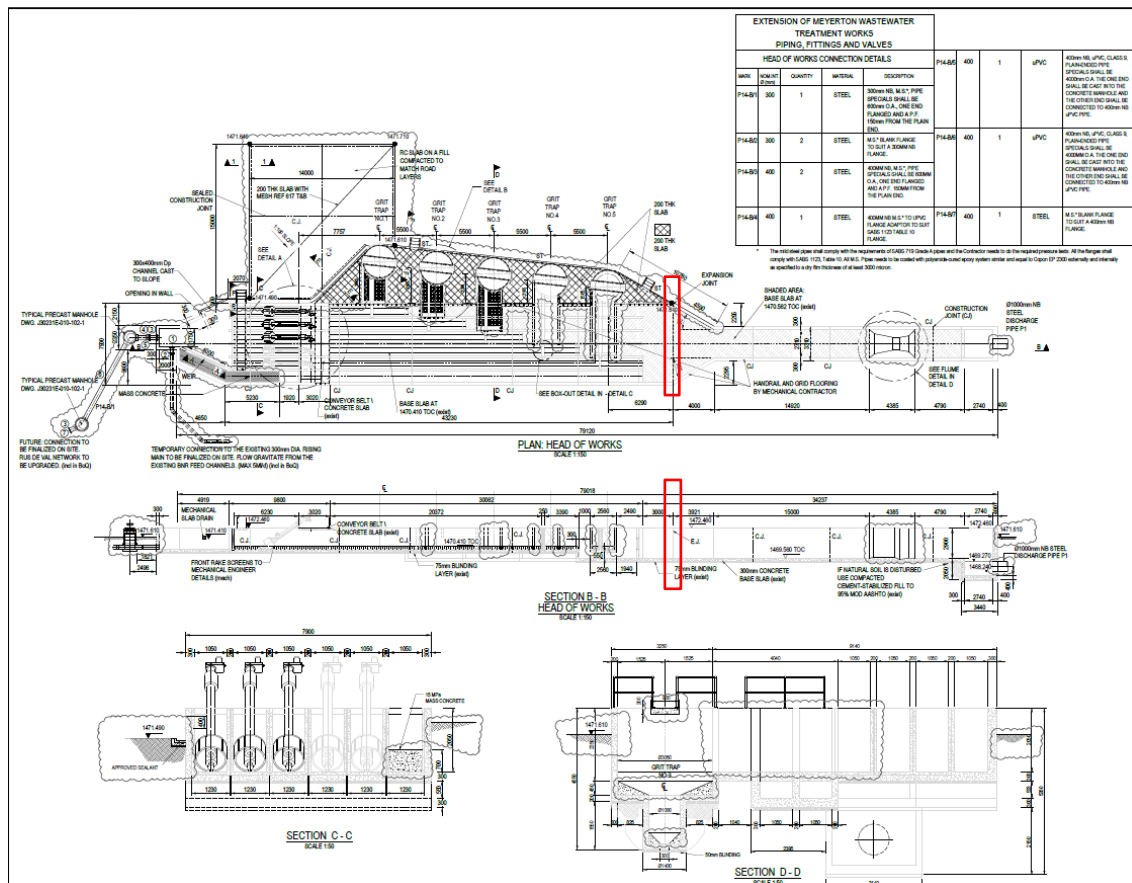
Figure 2 - Layout and Section for Header of Works

The 300mm surface bed generally displayed no major defects throughout the structure: however, a significant gap was identified in what was observed to be an expansion joint, as indicated on drawing number J40073/010-201 Rev 0 and outlined in red in Figure 2. Vegetation had in fact begun to grow through the joint, as shown in Figure 4.

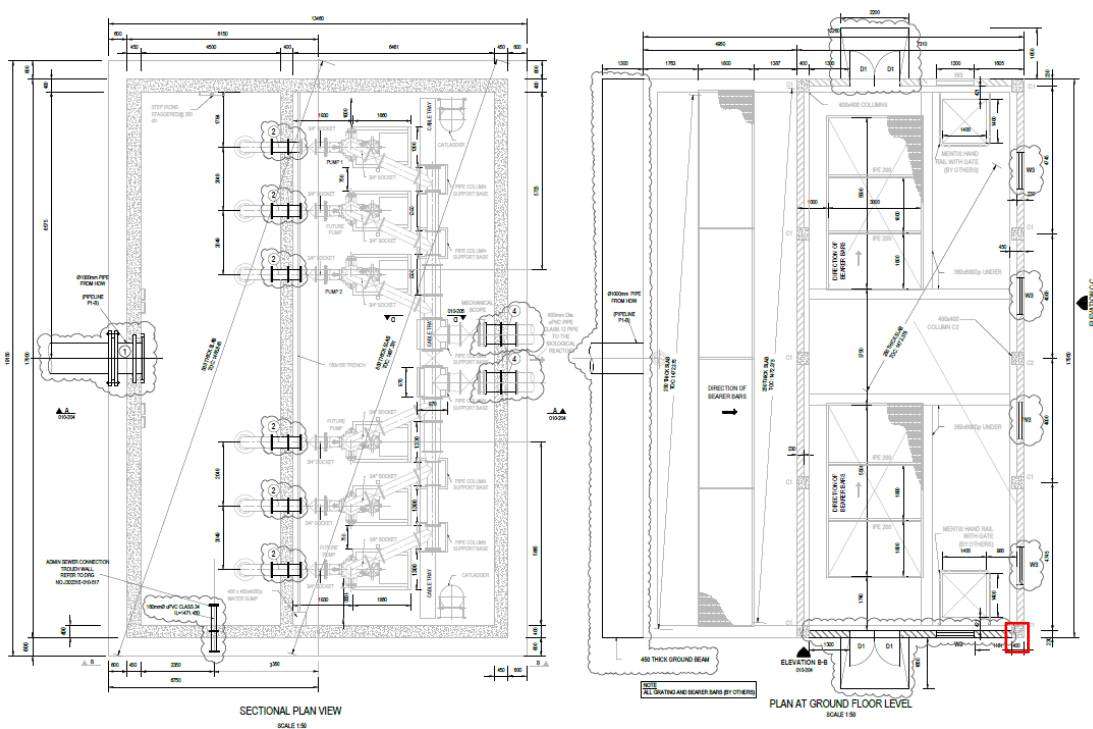
Figure 10 - Raw Water Pump Station Layout

The 400mm wide by 400mm deep ring beam has not been cast, however, some noticeable defects need to be rectified before construction can continue. Firstly, the transfer rebars from the column, outlined in red in Figure 10 above and Figure 16 below, are placed in the incorrect position, hence this will need to be rectified before the cage assembly for the beam.

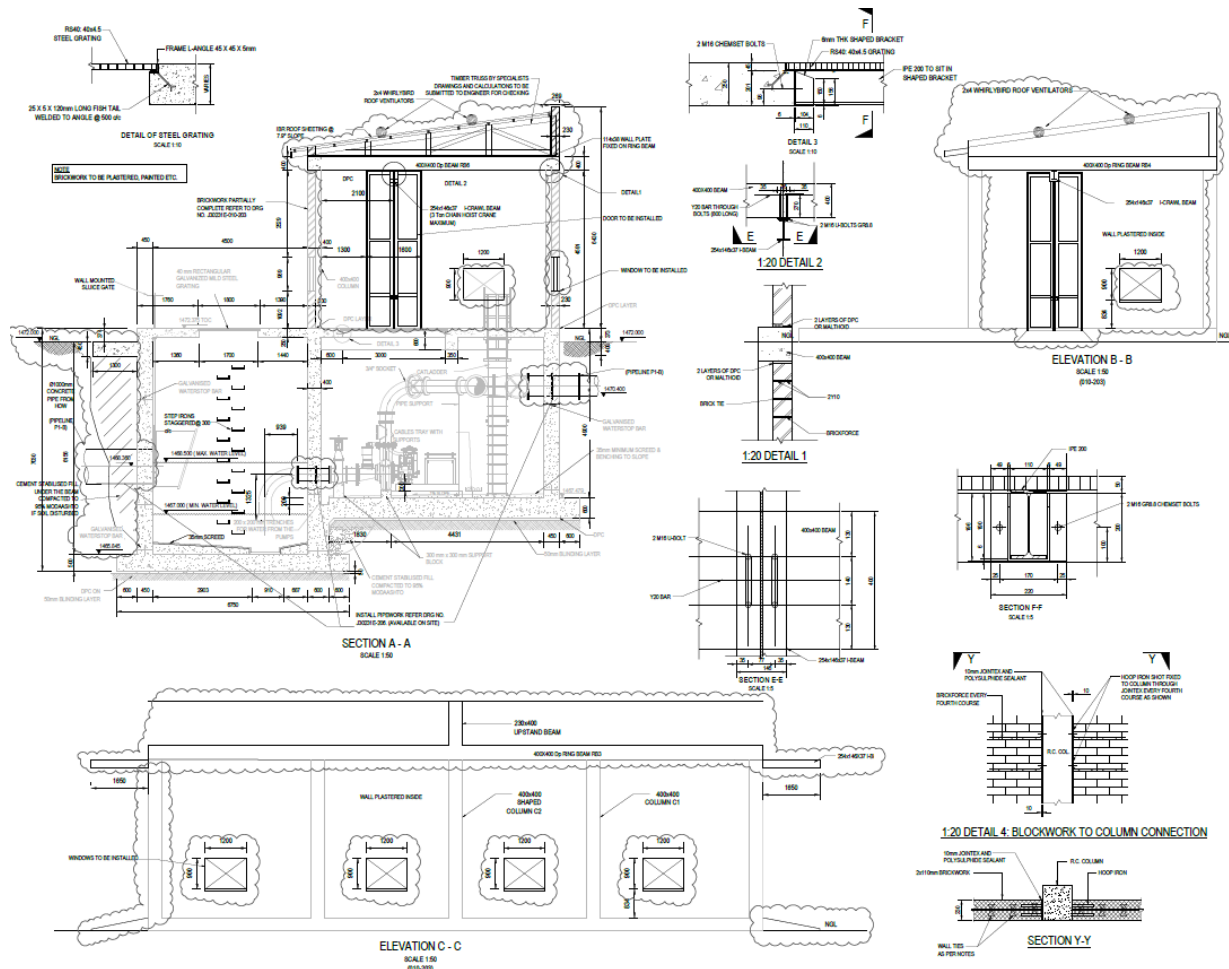
**Figure 11 - Raw Water Pump Station Section**

A special focus, in terms of likely distress due to the inadequacy of the foundation was conducted on the as-built structure, however, no settlement cracks were observed on the perimeter of the structure during the site inspection as shown in Figure 11 .

As shown in Figure 11 and Figure 12, the basement reinforced concrete walls are inaccessible due to the topography and the lack of means of access into the basement of the structure: hence, a thorough inspection could not be completed.

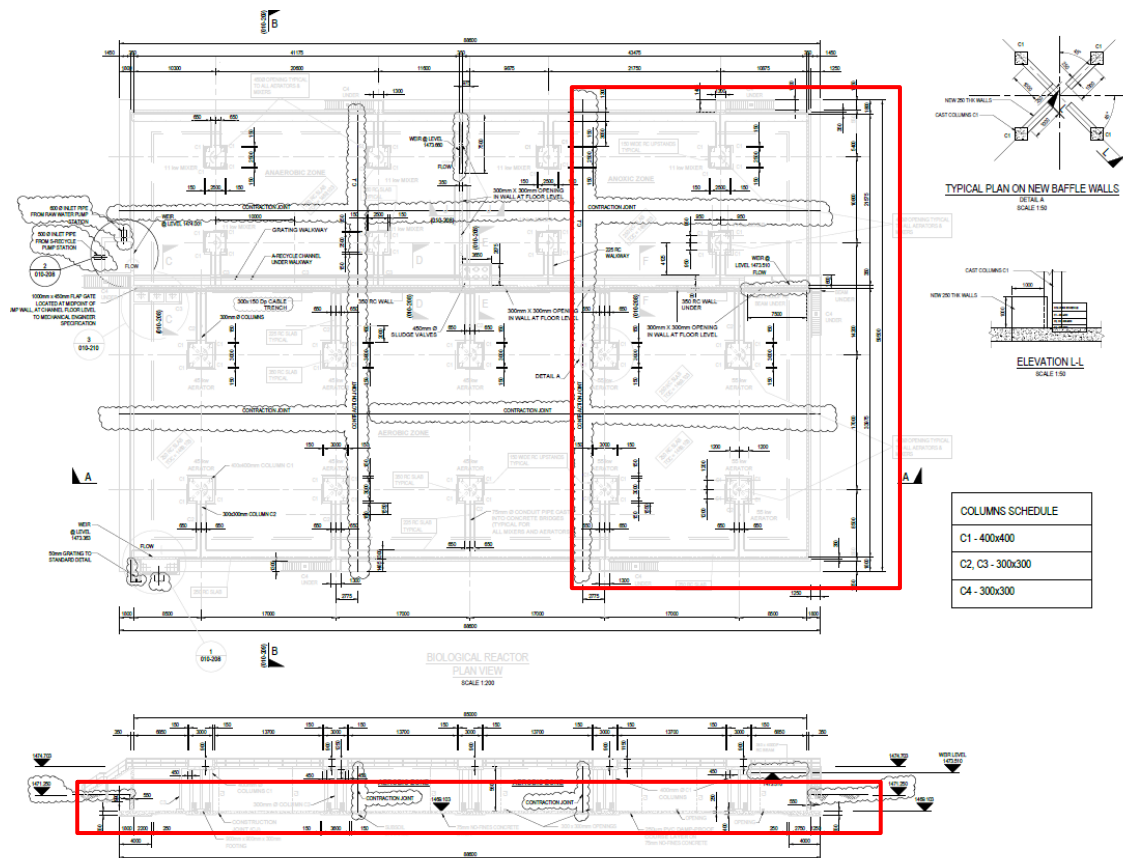
**Figure 18 - Biological Reactor Section and Layout**

The reinforced surface bed of the biological reactor displayed no major deteriorations or defects, for the section of the biological reactor, outlined in red, on the layout drawing in Figure 18, the remaining sections could not be inspected due to lack of adequate safe access into the other sections of the reactor.

The mixer platform reinforced concrete columns displayed no significant signs of defects, however, there were corrosion stains on some platform columns, as shown in Figure 23. The source must be confirmed once safe access into the structure is provided, as the visual inspection was conducted from a vantage point above the existing steel mezzanine platform adjacent to the area, outlined in red in Figure 18, on the layout.

The platform suspended slabs displayed no significant signs of defects, as shown in Figure 23, however, further investigation is required as the visual inspection was conducted from a vantage point above the existing steel mezzanine platform adjacent to the area, outlined in red in Figure 18, on the layout. Access must be first provided to ensure that there is a safe means of accessing all platform suspended slabs for further investigation.

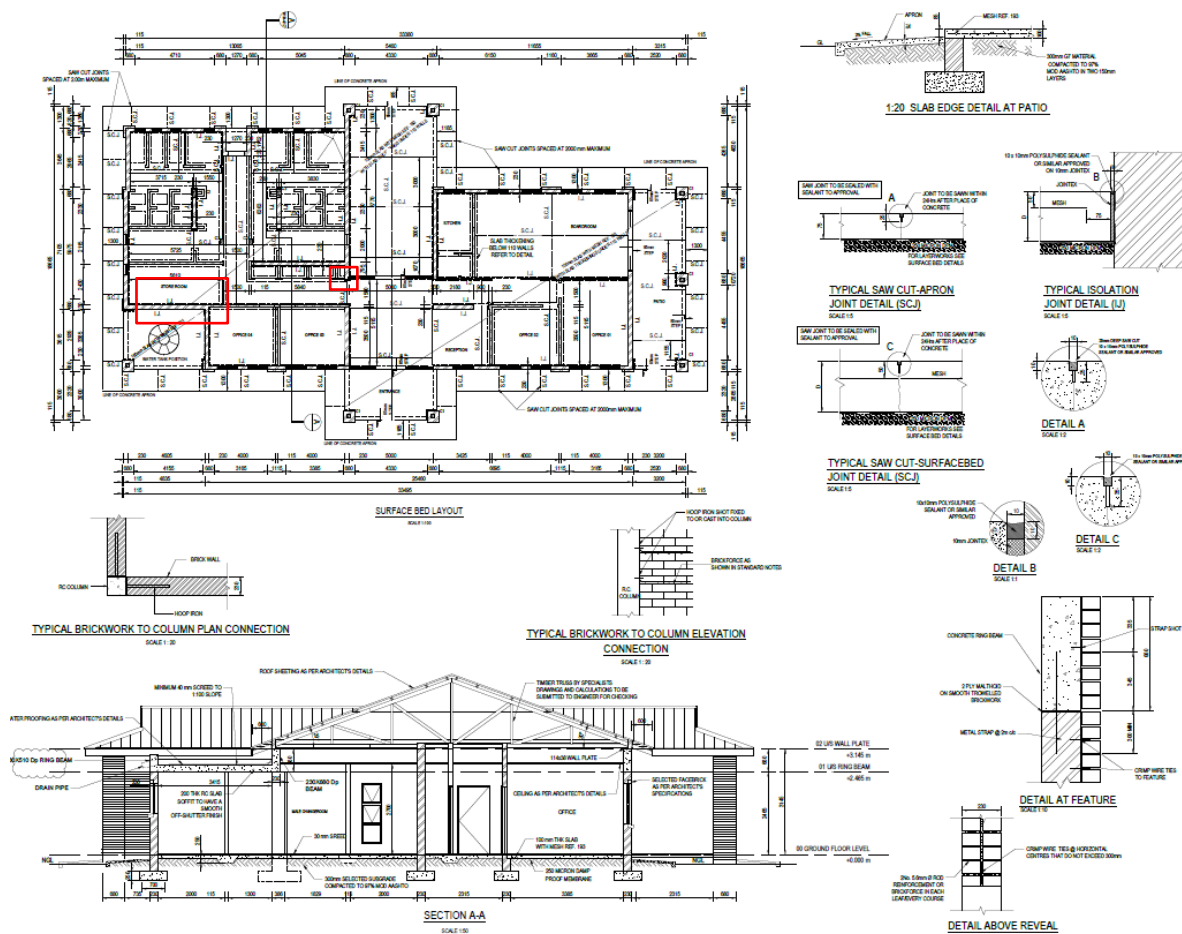
Figure 26 – The Administration Building: Layout and Sections

In Figure 33, poor and inadequate workmanship is observed for the firewall: this is located in the storeroom, and is outlined in red in Figure 26. This wall has to be demolished and redone, under strict supervision, to ensure the that the work conforms to SANS 10400: Part K.

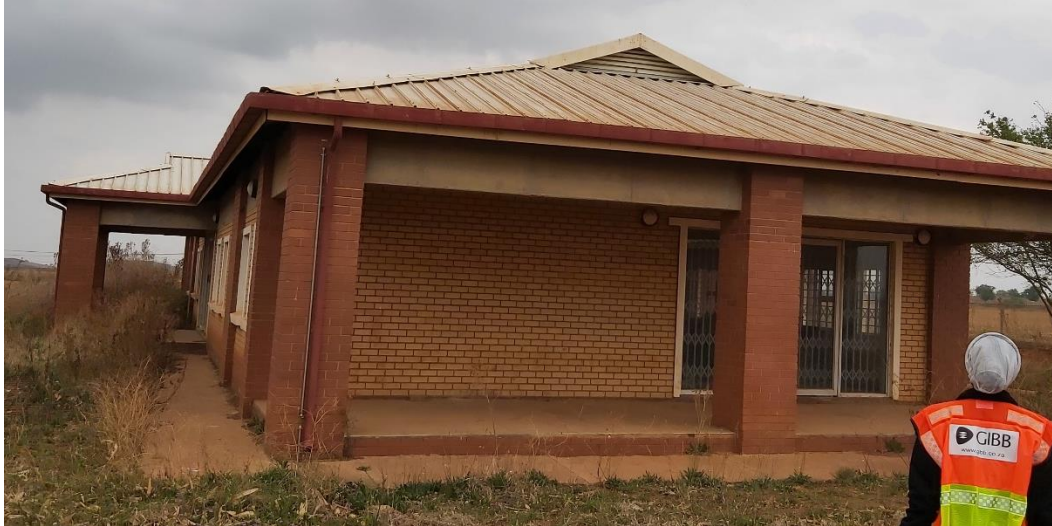
**Figure 27 - Perimeter View of the Administration Building**

No settlement cracks were observed on the perimeter of the structure during the site inspection as shown in Figure 27 below.

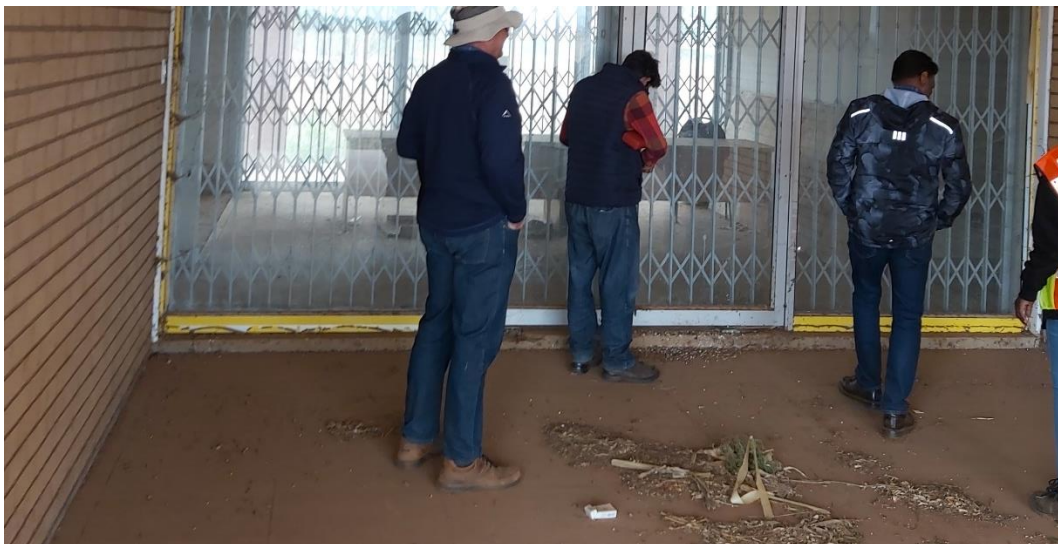
**Figure 28 - Tiled Surface Bed for the Administration Building**

The surface bed was tiled at the time of the inspection, hence the quality of the finishes could not be verified : this is shown in Figure 28 below.

There were however no defects in evidence, as would begin to point to the inadequacy of the underlying surface bed.

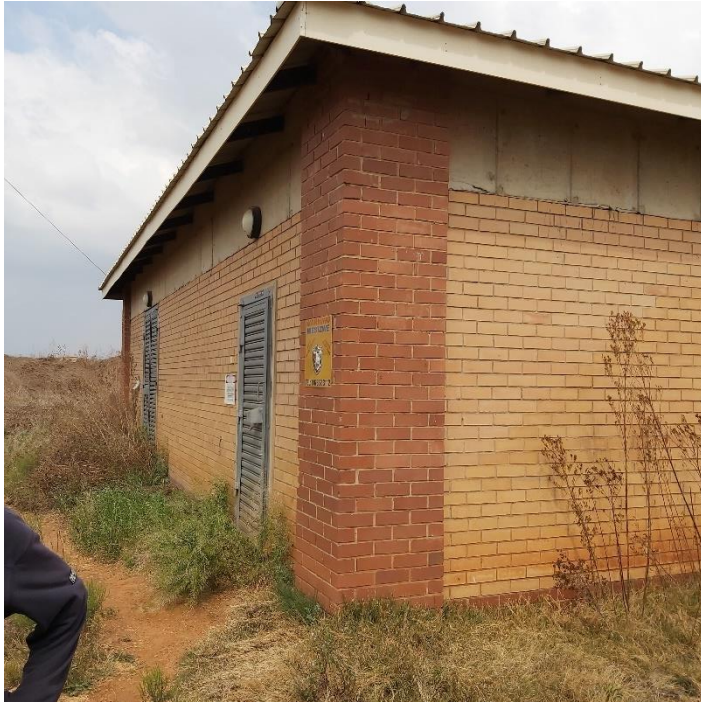
**Figure 35 - Perimeter View of the MCC Building**

No settlement cracks were observed on the perimeter of the structure during the site inspection as shown in Figure 35 below.
