# TRANSNET NATIONAL PORTS AUTHORITY

## STRUCTURAL ASSESSMENT REPORT

**SITE:** EX-ENSIMBINI SITE, MAYDON WHARF,  
DURBAN

**DATE:** 21/06/2023

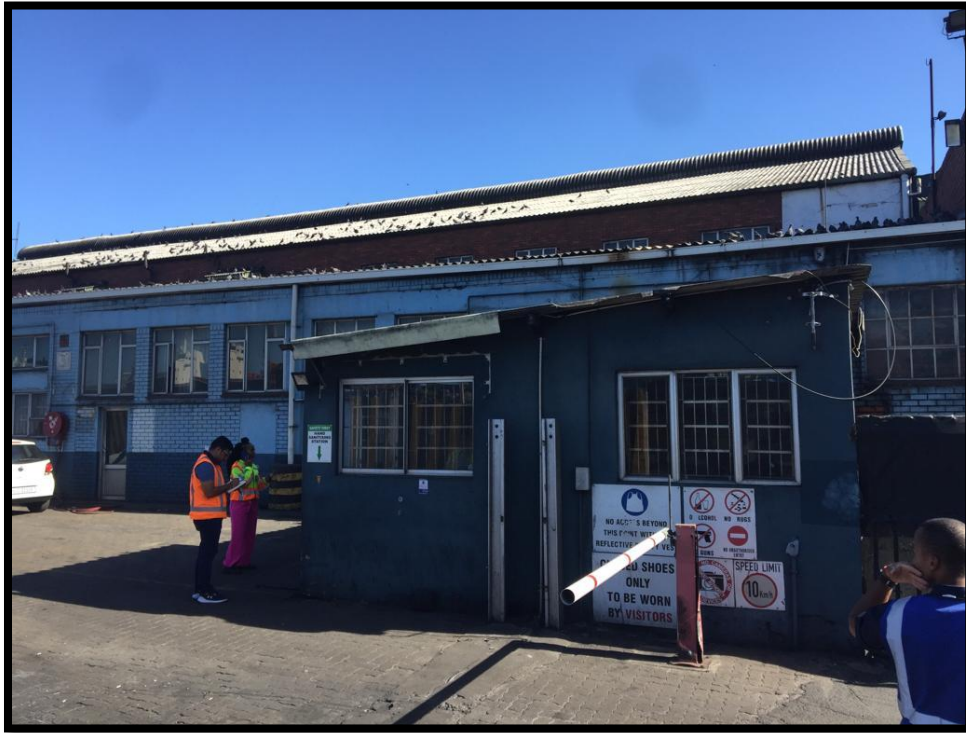
Figure 2: Guard House and Boom

Observations	Photographic records
<p><b>Structure (Exterior)</b></p> <ul style="list-style-type: none"> <li>The structure is adequate and no visible structural damage and structural cracks.</li> <li>The aesthetics of the building is in poor condition.</li> </ul>

- The asbestos roof and fascia boards are damaged.
- There is no roof drainage as the gutters have been damaged and removed.

- There are no visible structural defects and no major cracks.
- There is no ceiling installed in the guard house which presents a health risk due to the asbestos sheeting.
- There is no electrical compliance with cabling and electrical fittings installed with no discernable planning or safety consideration.

- The canopy structure bridging the guard house and office block is a structural risk. The rafters are supported by a metole pole which is not fixed to the ground. This configuration is prone to collapse and visible deflections are noted.
- There is no proper structural support for the canopy or drainage provided

therefore, there are signs of rainwater damage to the adjacent brick wall supporting the canopy structure.	
--	--

The guard house's overall is structurally sound with no major defects noted on the main structural elements. The exterior of the structure lacks proper finishes, there is an asbestos roof where certain parts show water damage leading to the damage of the adjacent brick wall. There are no major structural cracks on both the exterior and the interior of the guardhouse. The adjacent canopy structure needs to be properly supported or removed. There is no notable roof drainage present.

- Replace asbestos roof and provide proper roof drainage prevent any water ingress,
- Install proper building finishes,
- Install compliant electrical and ventilation system.

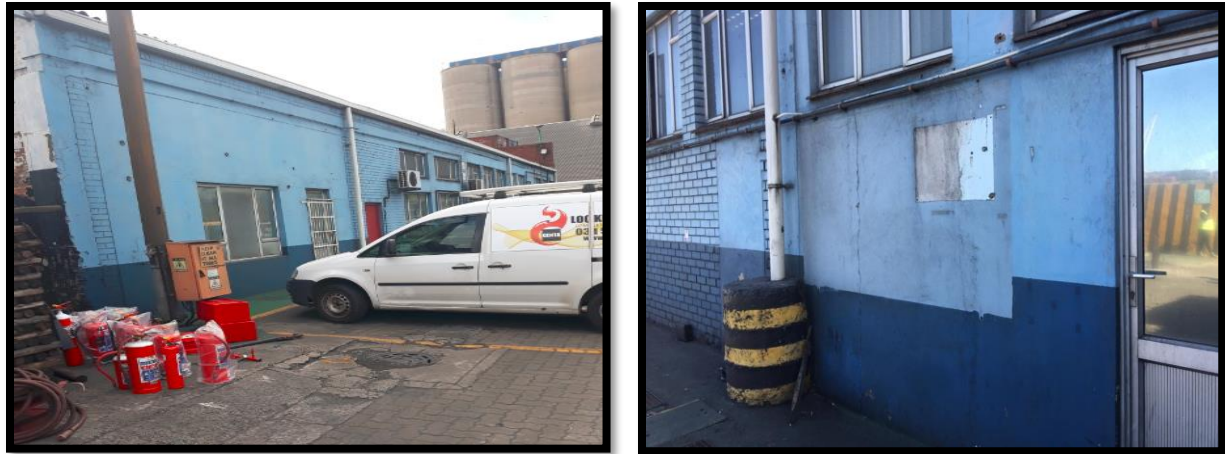
Figure 3: Office Block 1

Observations	Photographic record
<p><b>Structure (Exterior)</b></p> <p>The overall structure of the building is adequate.</p> <p>Minor cracks were noted on the exterior wall.</p> <p>The cracks are due to the enclosed previous door opening.</p>

- There are damaged sections of asbestos roof sheeting with large openings which has led to severe water ingress and animal infestation..
- The suspended ceiling has visible damage to façade and interior supports.
- The electrical wiring system has been severely vandalized.
- The interior wall structures are adequate and do not display any major defects.
- The upper-level wooden floor is not deemed safe and posed a safety hazard..
- The interior partition are not in good condition and fire rating could not be determined.

The overall structure of the building is good with no major structural defects noted in the visual assessment. The cracking noted on the exterior wall pose no structural risk and can be repaired by redoing the brickwork to engineering standards. The damage noted to the roof is severe and requires immediate attention.

- Minor cracks repairs on the exterior structure,
- Asbestos roof to be replaced,

- Interior finishes such as the ceilings, flooring and partitions require replacement,
- Electrical wiring to be repaired / replaced to ensure compliance.

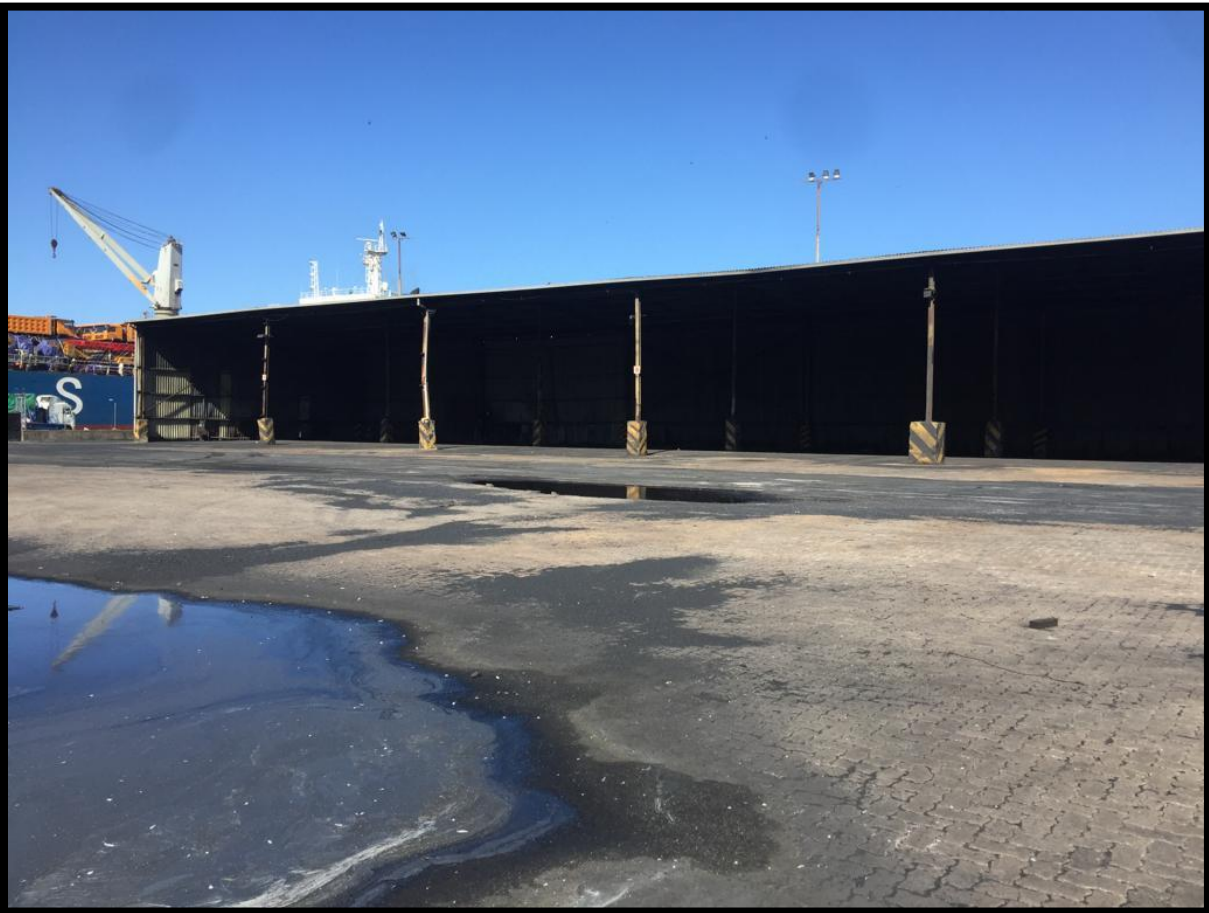
Figure 4: Shed located adjacent to the perimeter of the nearby site

The Perimeter shed is a steel portal frame structure which is covered on three sides with steel sheeting. The structure comprises of 39 steel columns connected to concrete plinths, Refer to figure 4. The structure cladding is inconsistent with ad hoc repairs to cladding noted. The base of the columns are encased in irregular sized concrete blocks to provide protections against accidental damage by machinery.

Observations	Photographic record
<p><b>Structure</b></p> <ul style="list-style-type: none"> <li>• It was noted that there are signs of corrosion on the columns, bracing, beams, and sheeting.</li> <li>• Damage and deflection of infrastructure is evident, this is noted by the bent columns and the lighting service ducts.</li> <li>• It was also evident that the eaves beams and purlins show signs of buckling.</li> <li>• There are collision damage visible to the gutter and sheeting of the shed. Various different types of sheeting were used in ad hoc repairs of the years. The different sheeting exhibits different material properties such as different thicknesses and corrosion levels.</li> <li>• The interior paving within the shed is in good condition.</li> <li>• Signs of Ponding and drainage problems at the front to the back of the shed is evident which might be caused by the fact that the floor is sloping towards the back wall of the shed and potentially causing corrosion to the</li> </ul>

<p>sheeting and exposed steel structural elements.</p> <ul style="list-style-type: none"> <li>Some interior columns are damaged due to accidental collisions. The columns have deflected significantly and may pose a structural risk if left unattended.</li> </ul>	
<p><b>Plinths</b></p> <ul style="list-style-type: none"> <li>About 50% of plinths are damaged</li> <li>The steel is exposed on plinths which makes them prone to corrosion and further degradation.</li> </ul>

All corroded steel sheeting needs to be replaced. Structural steel members that exhibit corrosion need to be treated to prevent further corrosion. All deflected columns, purlins, eaves beams and bracing are to be replaced. The Shed surface to be regraded to ensure that any water flows towards the stockpiling yard or into a stormwater drainage system. The gutter and drainage system of the roof to be repaired and directed into stormwater system.

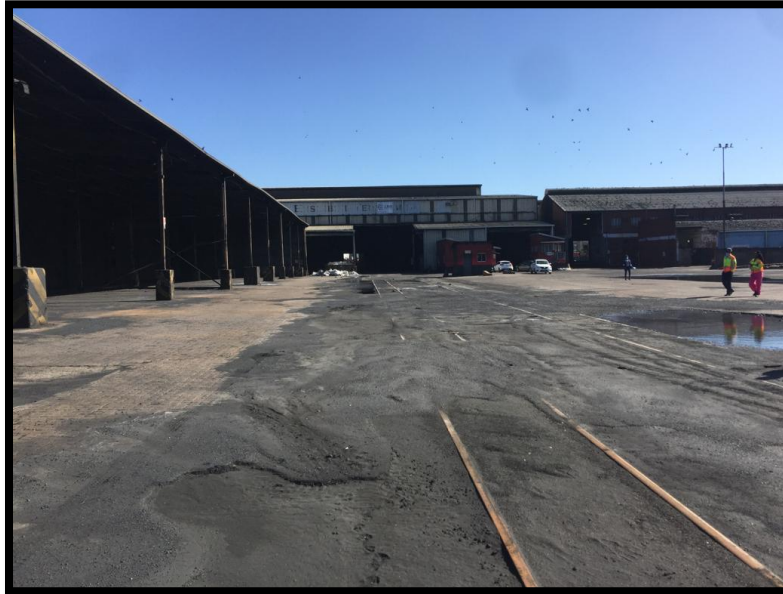
*Figure 5: Stockpile yard adjacent to the perimeter shed*

The stockpile yard adjacent to the perimeter shed is a flat area located centrally in the site. Stockpile Yard surface comprises of interlocking blocks and has a rail siding going through the site till the end of the boundary. There was no drainage system noted within the yard complex.

Observations	Photographic record
<p><b>Damaged Stockpile yard Surface</b></p> <ul style="list-style-type: none"> <li>There are visible damage and settlement noted on the yard paving blocks which has resulted in the ponding evident on site.</li> </ul>

- Unblocking of stormwater drainage system,
- Cleaning and repair of perimeter open channel drains,
- Yard resurfacing and proper sloping or profiling.

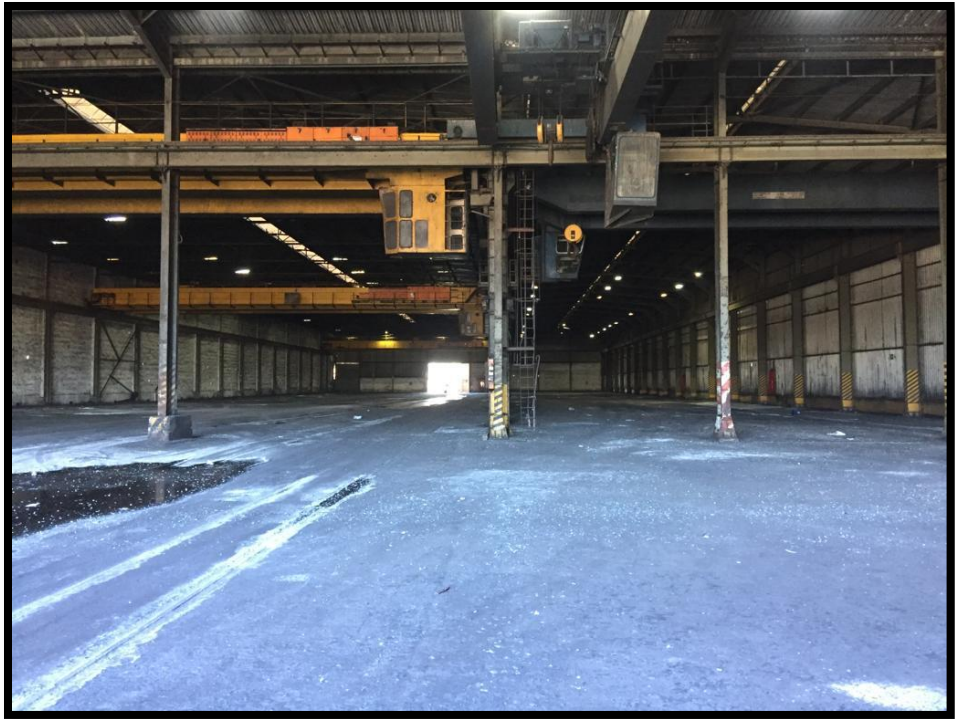
Figure 6: Warehouse 1

Observations	Photographic record
<ul style="list-style-type: none"><li>• Signs of leakage on the roof sheeting. Minor holes are evident; however roof is in a good condition.</li><li>• Signs of corrosion on the interior sheeting.</li></ul>

The condition of the concrete floors is satisfactory; however, they need to be repaved and profiles in order to prevent water ponding. Steel members need to be treated to prevent corrosion. The machinery and the sprinkler system are required to be tested to ensure compliance and utilization of the systems. Minor holes in the roof need to be repaired.

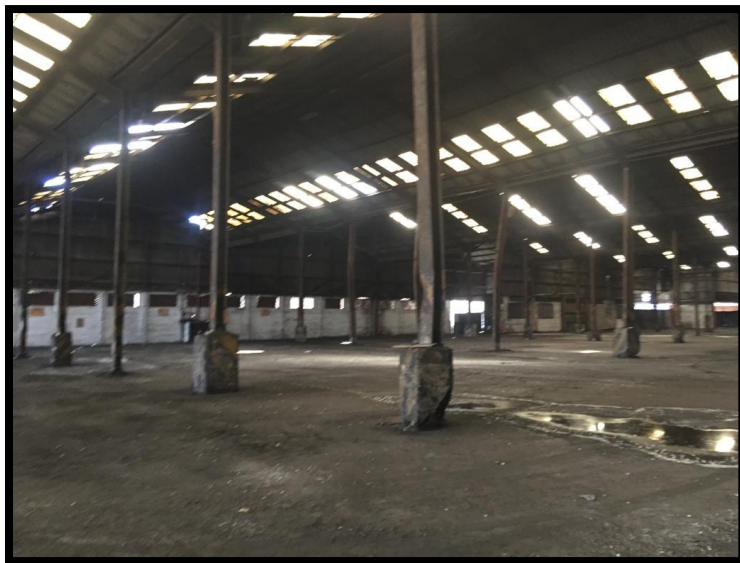
*Figure 7: Warehouse 2*

- Signs of leakage on the asbestos roof sheeting with voids present in the sheeting and water ingress within the walls.
- Signs of damage on the asbestos wall sheeting.
- Damage and deflection of columns and column bases, this is noted by the deflected columns and the completed detachment of the concrete column bases from the floor.
- Exposed reinforcement of the floor slab.

of the warehouse is a concern since most of the interior column inspected by the team were detached from the floor, it is therefore recommended that all concrete plinths and deflected columns be replaced.
