DOLOMITE STABILITY INVESTIGATION REPORT: ESKOM ESSELEN SUBSTATION,
ESSELEN, TEMBISA, GAUTENG, SOUTH AFRICA

Client: ESKOM

Report No.: 380-02-2018

Date: Feb 2018

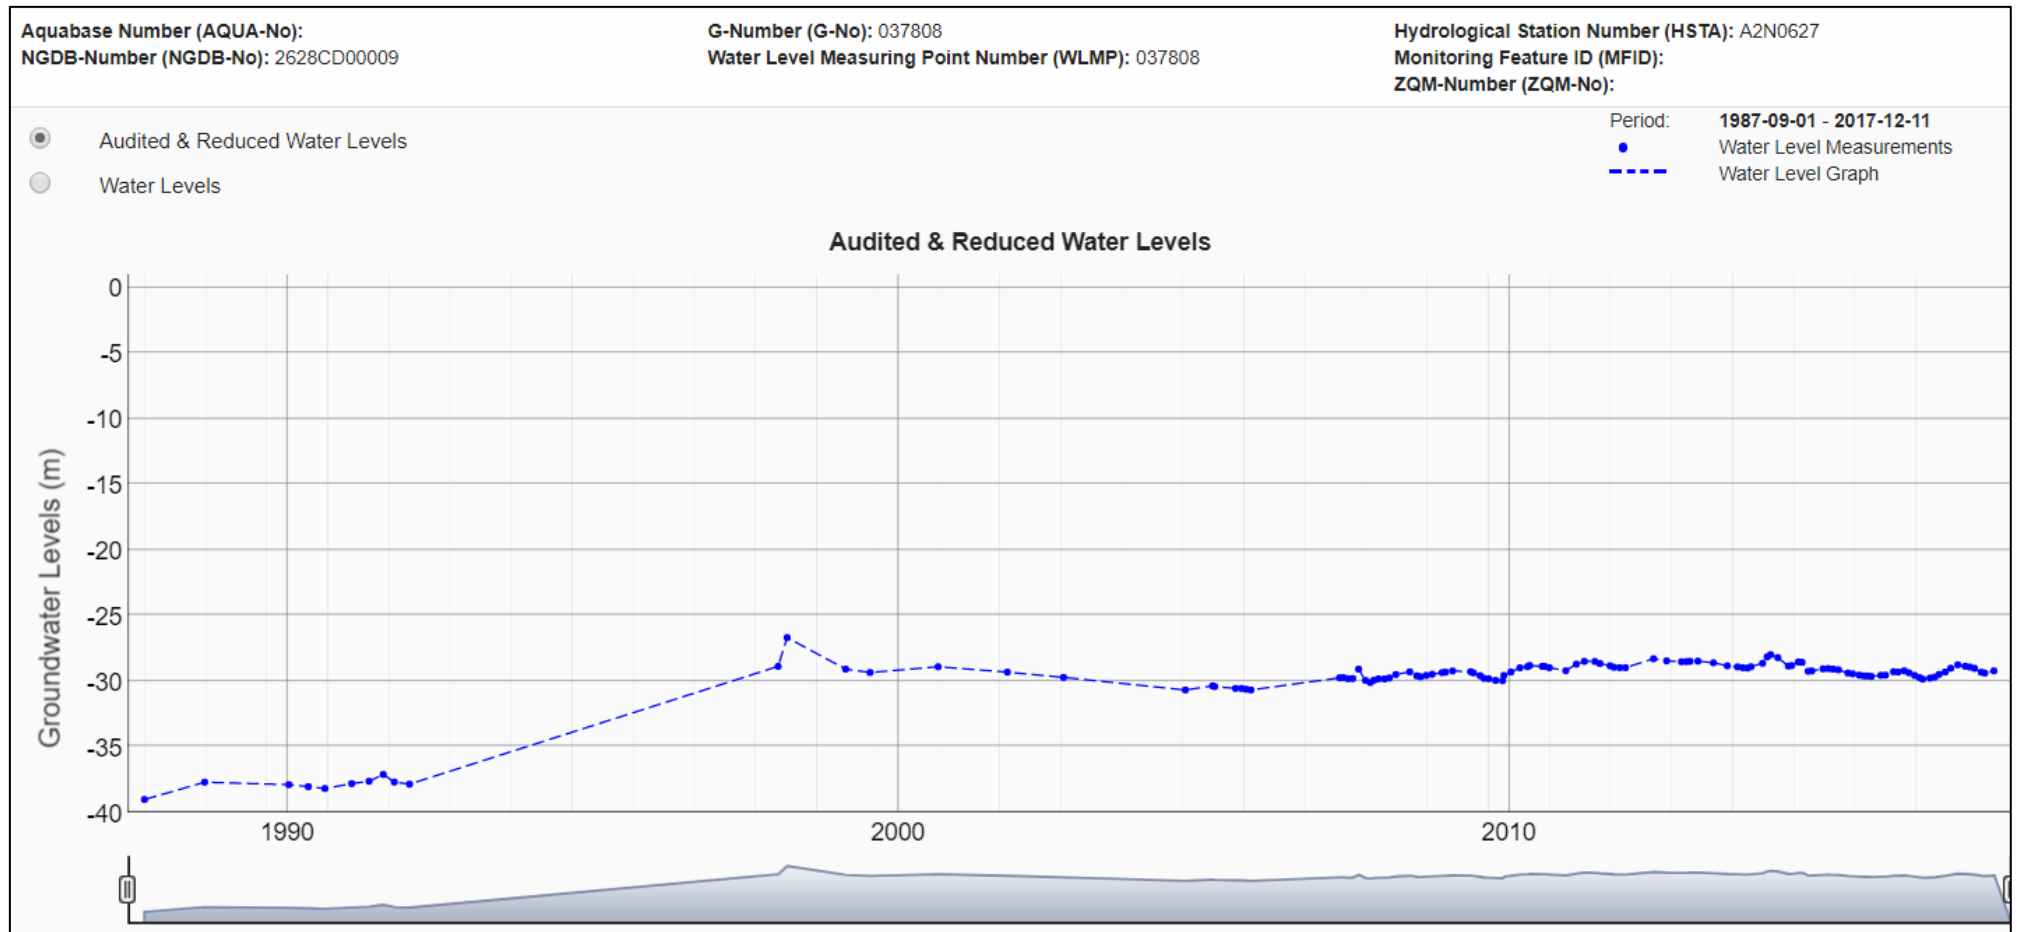
Figure 6 shows the groundwater monitoring graph for monitoring station A2N0627 from the year 1987 – 2017 (National Groundwater Achieve, 2018)

Monitoring borehole A2N0627 shown in Figure 6 indicates a steady groundwater level dating back from the year 1999 to date whereby the groundwater remains at about 30 m from surface with fractional fluctuations.

The assessment of the regional groundwater situation within the Sterkfontein Dolomite Compartment shows variable maintenance of the groundwater within the compartment whereby A2N0627 shows sustainable maintenance and A2N0631 shows variable unsteady maintenance of the groundwater level with fluctuations greater than 10 m difference in a 10 year period.

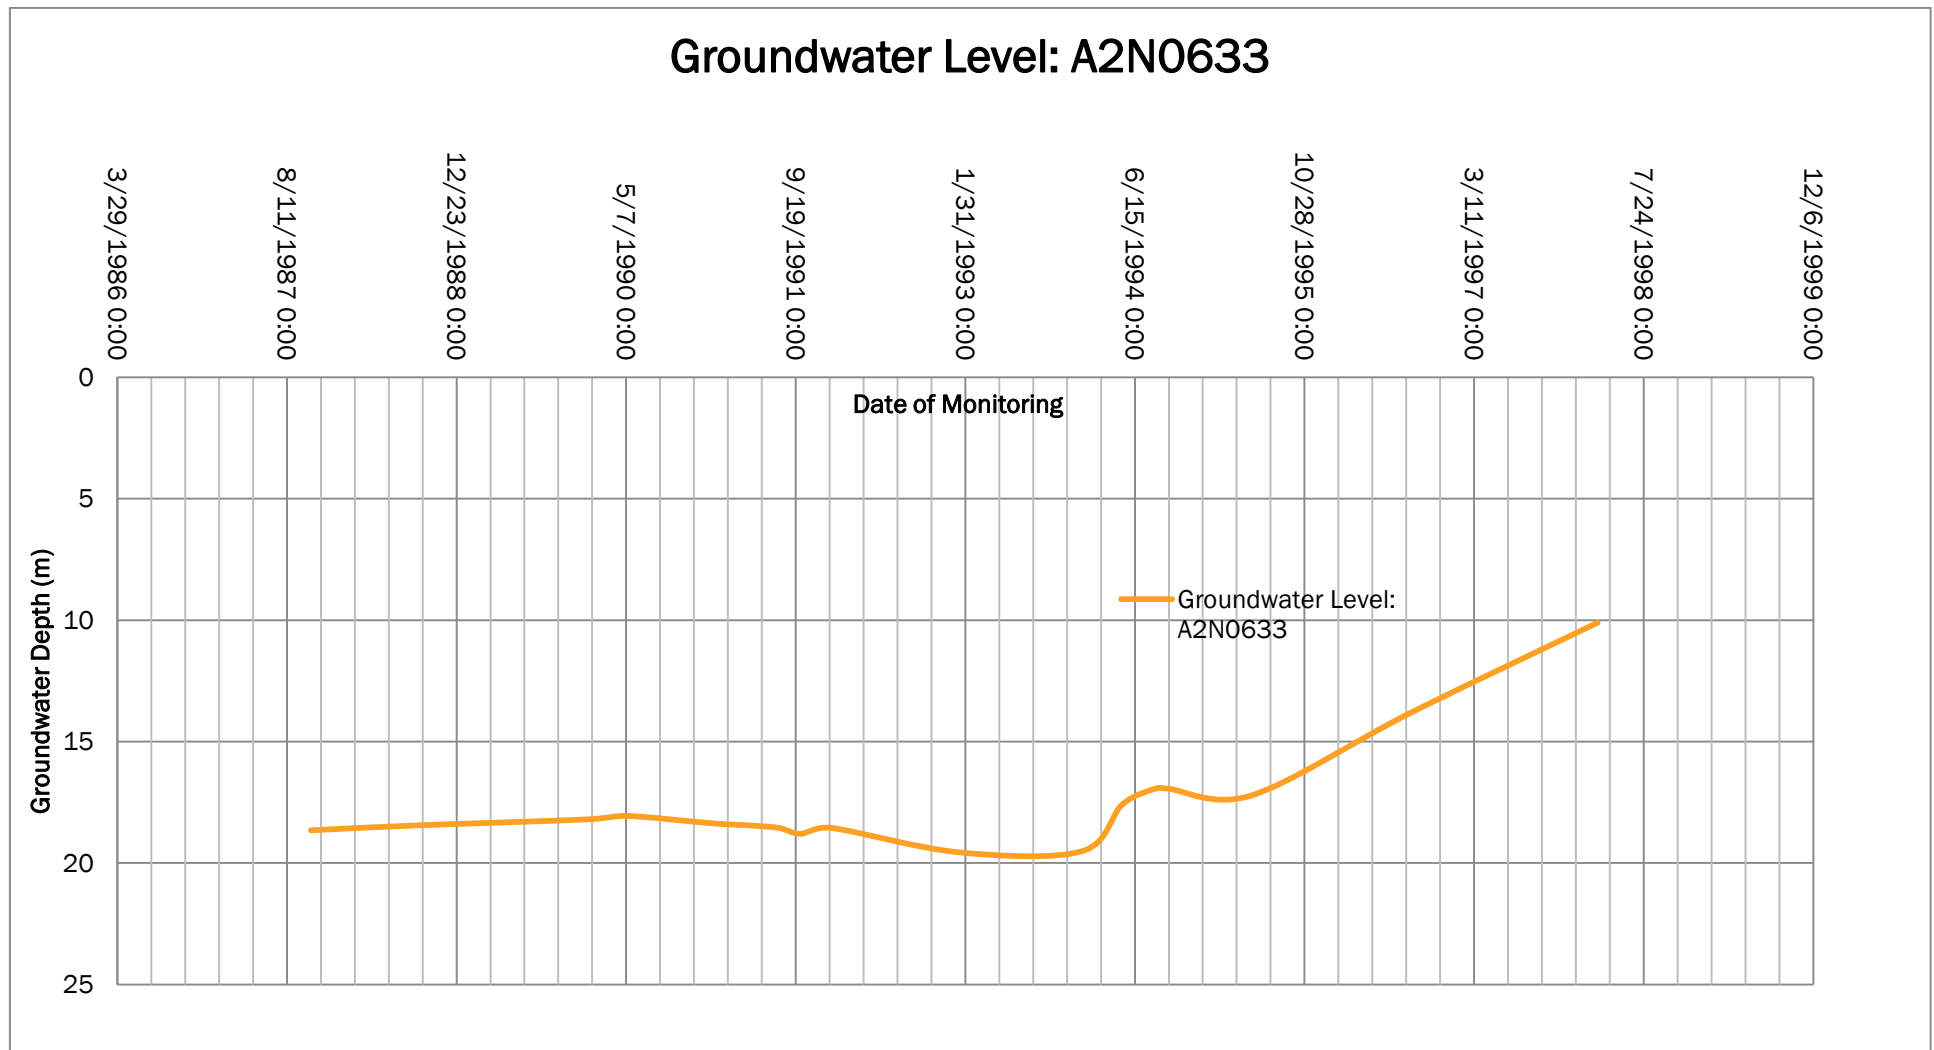
Figure 7 shows the groundwater monitoring graph for monitoring station A2N0633 from the year 1986 – 1999 (National Groundwater Achieve, 2018)

Groundwater borehole A2N0633 only has records up to the year 1998. Recent groundwater data is not available. Records of the groundwater level from 1988 to 1995 show a steady state until a sudden rise in groundwater level between 1995 and 1998 to a depth of about 10 m from surface (Figure 7).

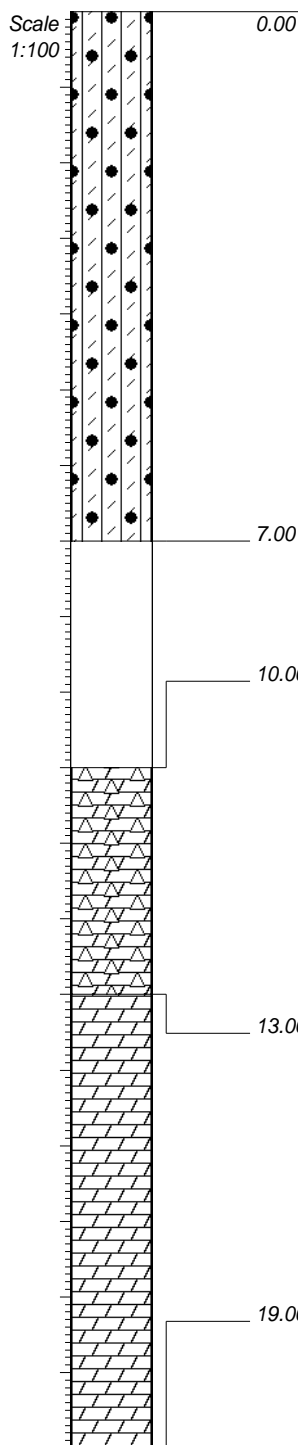
Bulk sample: Moist, maroon clayey silt. **Sieve washed:** 95% loss. Wet, silt with traces of highly weathered rounded ferruginised material. **Interpretation:** HILLWASH

NO SAMPLE, rapid penetration rates are characteristic of cavities

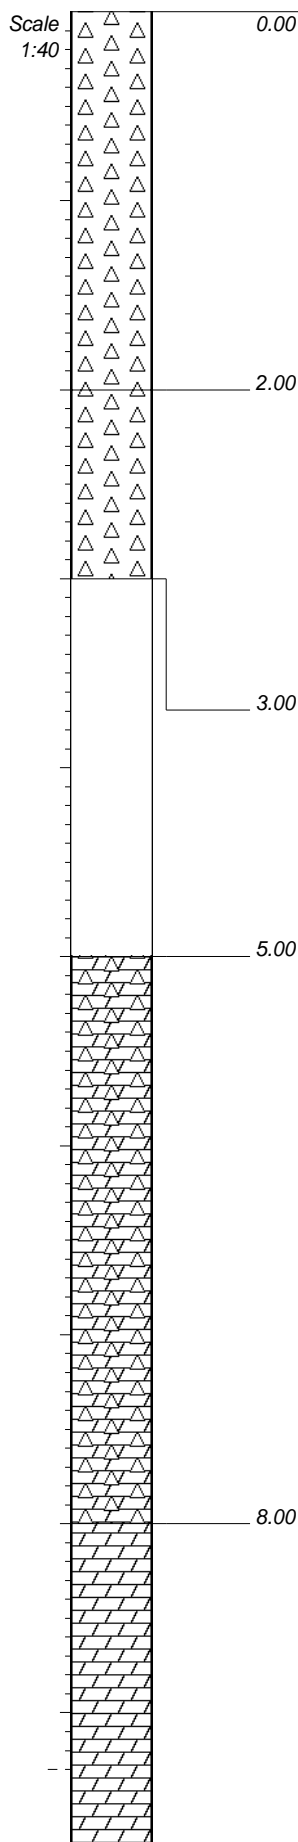
Bulk sample: Slightly moist, brown, sandy gravel. **Sieve washed:** 75% loss. Wet, fine to medium gravel chips of highly weathered rounded chips, highly weathered CHERT and traces of ferruginous material
Interpretation: Highly weathered CHERT

Bulk sample: Dry, grey gravel in a brown matrix. **Sieve washed:** 30% loss. Wet, fine to medium gravel and minor coarse gravel chips of highly weathered sub-angular CHERT.
Interpretation: Highly weathered CHERT

SAMPLE LOSS, rapid penetration rate indicates cavities.

Bulk sample: Dry, dark brown to grey, sandy gravel. **Sieve washed:** 30% loss. Wet, fine to medium gravel chips of highly to moderately weathered CHERT and traces of moderately weathered DOLOMITE. **Interpretation:** Moderately to highly weathered CHERT and Moderately weathered DOLOMITE

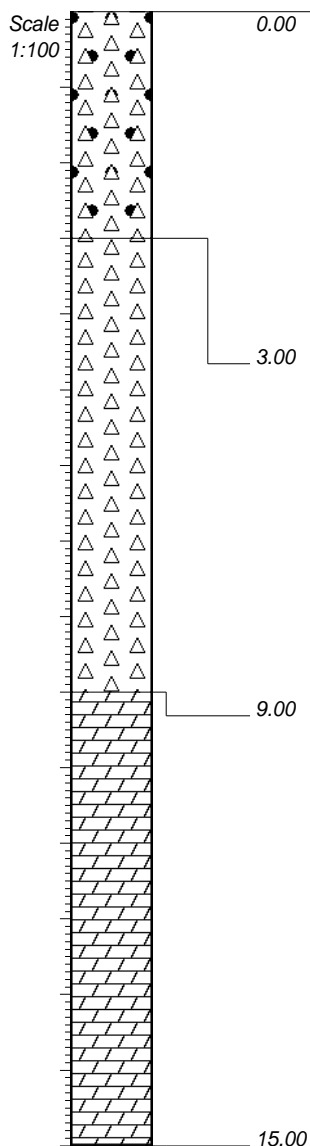
JOB NUMBER: ESN BH 13

6/7/8. Most of the high inherent hazard areas are characterised by either gravity low zones/deep bedrock or contact zones between gravity high and gravity low zones e.g. ESN BH 13. This assessment suggests platforms of shallow dolomite adjacent to troughs of weathered zones covered by soil sediment deposits (FERRUGENISED CLAYEY SILT). The platforms of shallow dolomite in most instances represent intermediate inherent hazard classified as IHC 2/3/4.

Bulk sample: Slightly moist, cream white angular gravel in a brown sand matrix. **Sieve washed:** 25% loss. Wet, fine to medium gravel chips of angular highly weathered CHERT and rounded ferricrete nodules. **Interpretation:** Highly weathered CHERT

Bulk sample: Slightly moist, dark reddish brown, sandy gravel matrix with traces of coarse gravel. **Sieve washed:** 50 - 70% loss. Wet, fine to medium gravel chips of angular grey to black highly weathered CHERT. **Interpretation:** Highly weathered CHERT

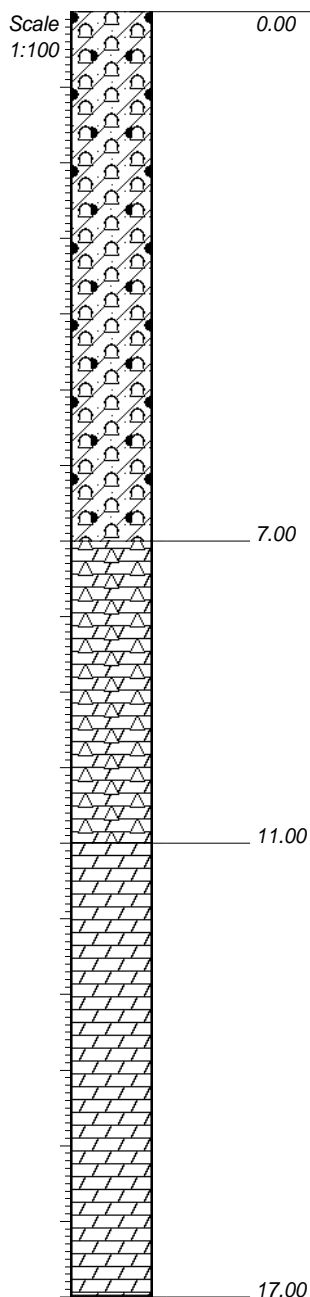
Bulk sample: Moist, dark brown to reddish maroon brown, sandy gravel with minor coarse gravel in a sandy clay matrix. **Sieve washed:** 25% loss. Wet, fine to medium gravel with minor coarse gravel chips of rounded ferricrete material and sub-angular highly weathered CHERT. **Interpretation:** Highly weathered CHERT

Bulk sample: Dry, grey, sandy gravel. **Sieve washed:** 30% loss. Wet, fine to medium angular CHERT and dark grey DOLOMITE. **Interpretation:** Slightly weathered CHERT and DOLOMITE

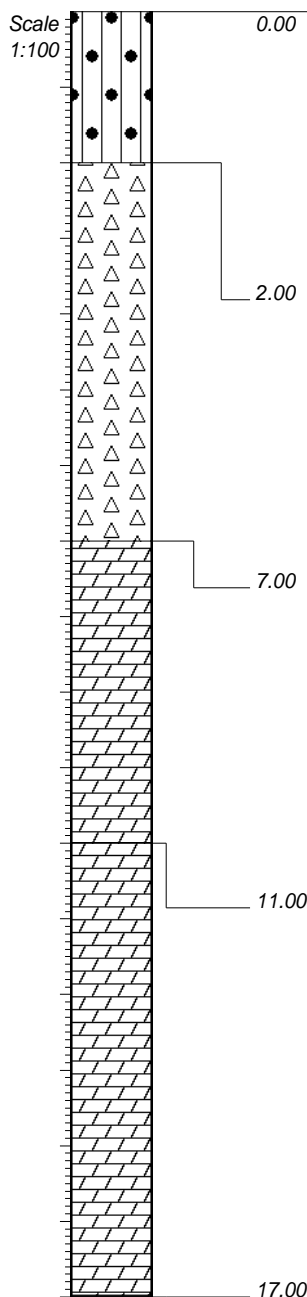
Bulk sample: Moist, dark brown, silty sand with gravel.
Sieve washed: 90% loss. Wet, SILT with traces of rounded ferricrete nodules
Interpretation: SILT with traces of ferricrete (HILLWASH)

Bulk sample: Slightly moist, dark brown, sandy gravel.
Sieve washed: 65% loss. Wet, fine to medium sub-angular translucent brown stained CHERT
Interpretation: Moderately weathered CHERT

Bulk sample: Dry, brownish grey to grey sandy gravel.
Sieve washed: 35% loss. Wet, fine to medium gravel with traces of coarse gravel chips of bluish grey and brown stained DOLOMITE
Interpretation: Moderately weathered DOLOMITE

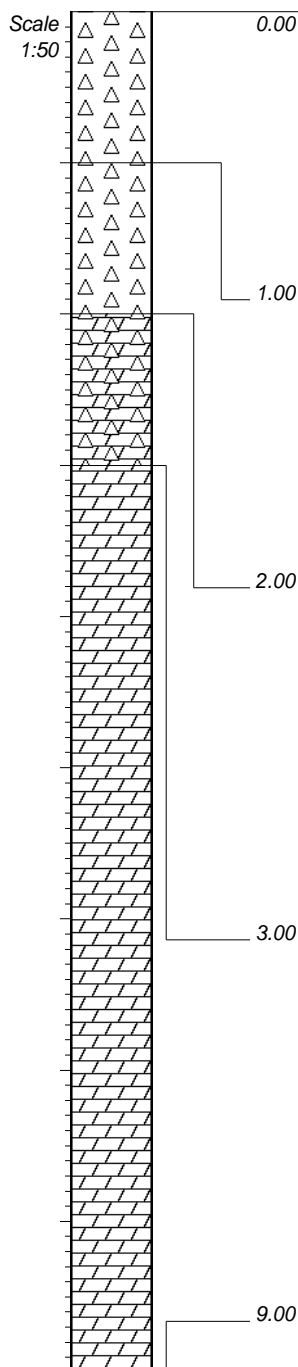
Bulk sample: Moist, brown, sandy gravel. **Sieve washed:** 30% loss. Wet, fine to medium gravel with coarse gravel chips of sub angular highly weathered white CHERT. **Interpretation:** Highly weathered CHERT

Bulk sample: Moist, brown, sandy gravel with distinct coarse gravel chips. **Sieve washed:** 10% loss. Wet, coarse gravel chips of highly weathered CHERT. **Interpretation:** Highly weathered CHERT

Bulk sample: Moist, brown, sandy gravel. **Sieve washed:** 30% loss. Wet, fine to medium gravel chips of DOLOMITE with traces of coarse gravel chips of sub-angular CHERT. **Interpretation:** Highly weathered CHERT and Moderately weathered DOLOMITE

Bulk sample: Moist, to dry, brownish grey, sandy gravel. **Sieve washed:** 40% loss. Wet, fine to medium gravel chips of angular bluish grey sometimes mottled white DOLOMITE. **Interpretation:** Solid unweathered DOLOMITE

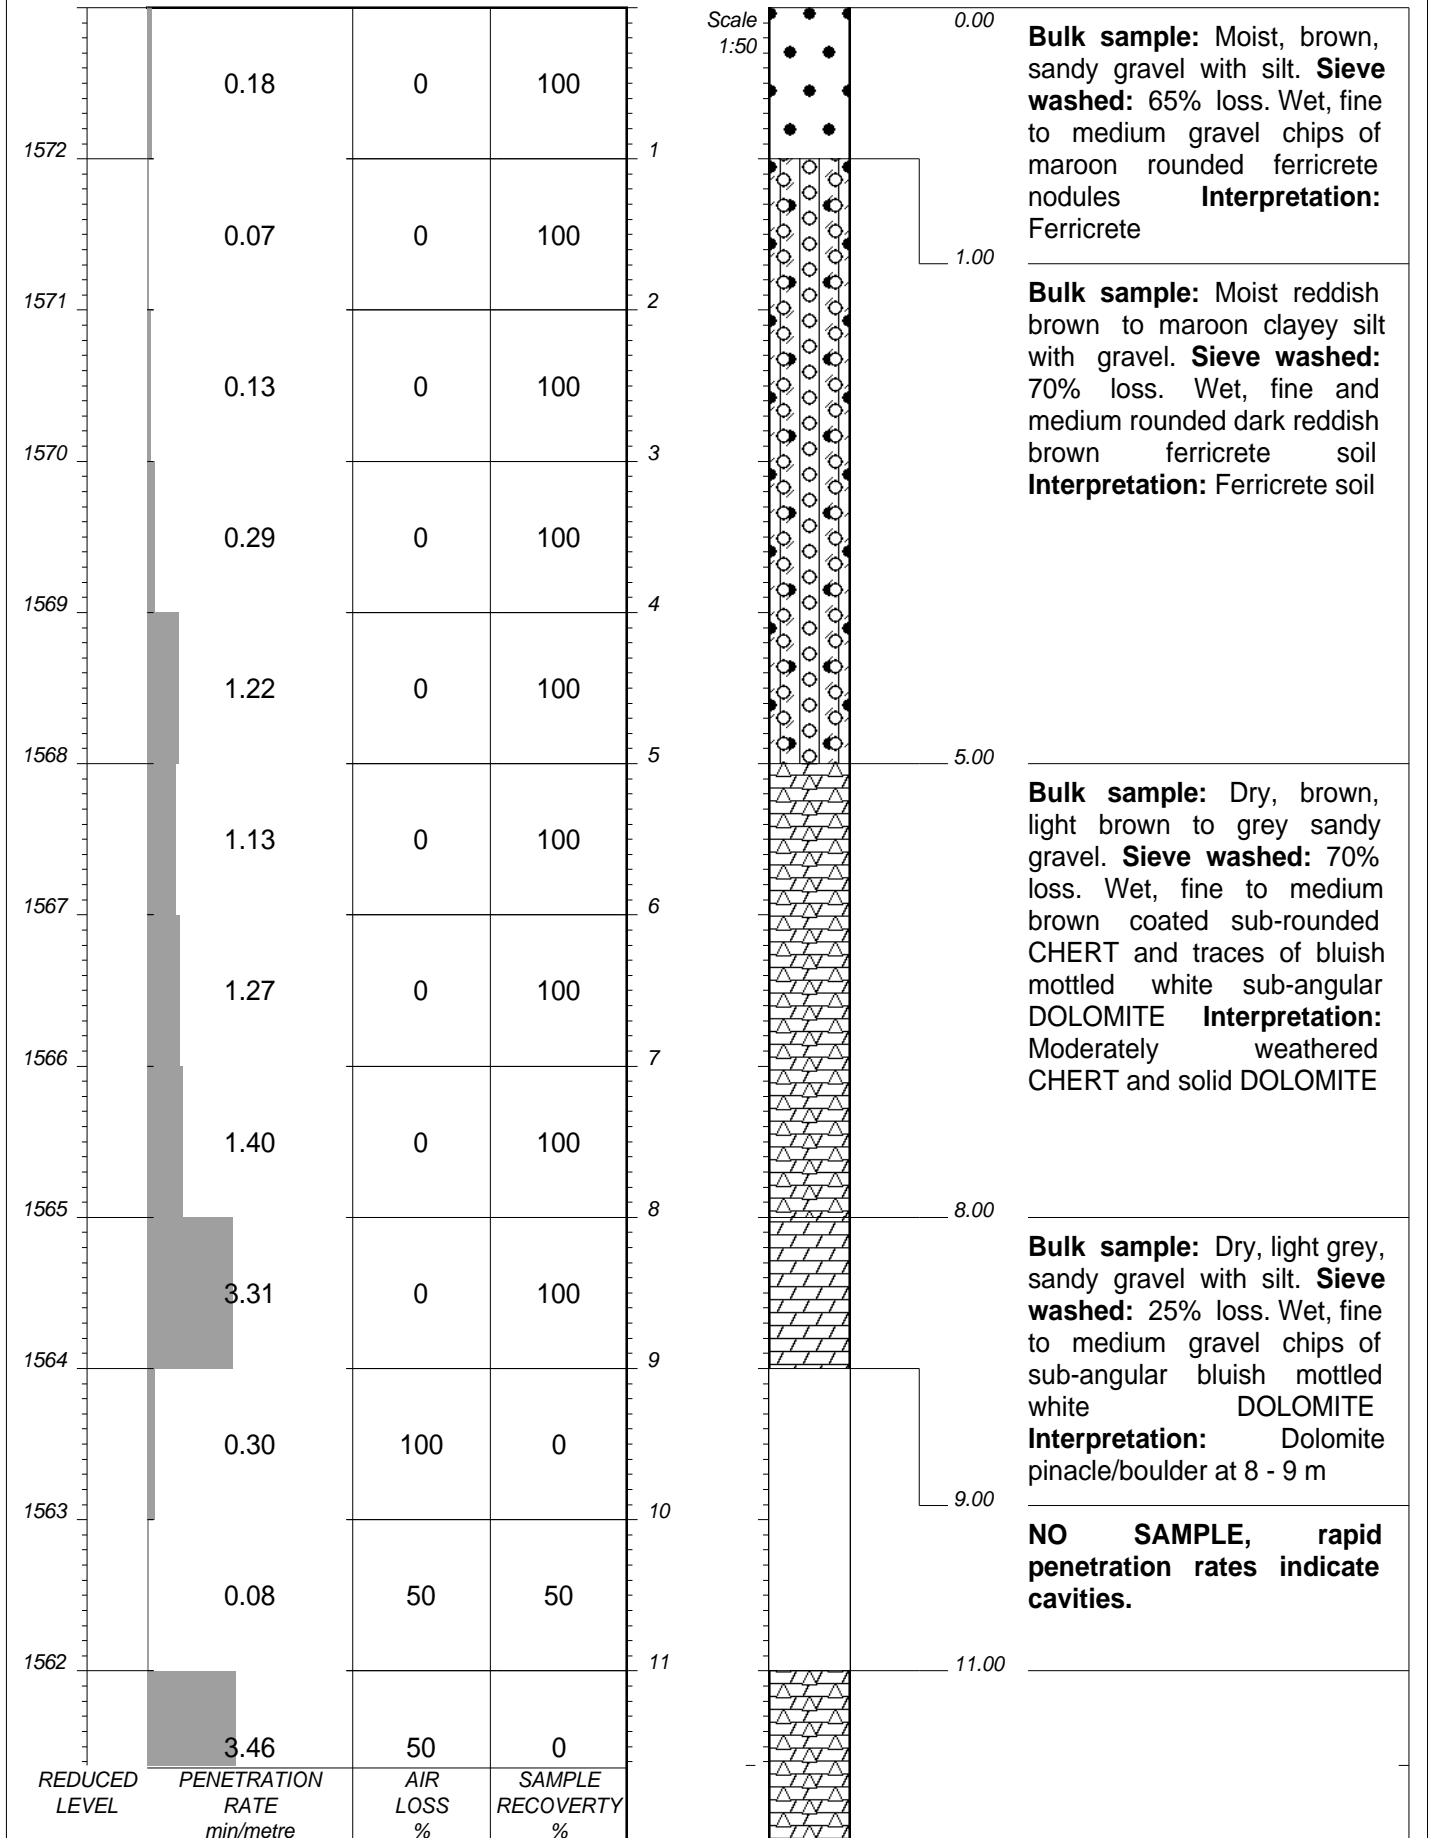
HOLE No: 21
Sheet 1 of 2

Bulk sample: Dry, brown, sandy gravel with silt. **Sieve washed:** 30% loss. Wet, fine to medium gravel chips of brown stained DOLOMITE and traces of sub-angular CHERT. **Interpretation:** Moderately weathered DOLOMITE

NO SAMPLE RETURN, rapid penetration noted during drilling

TOTAL SAMPLE LOSS, drilling indicates competent rock conditions

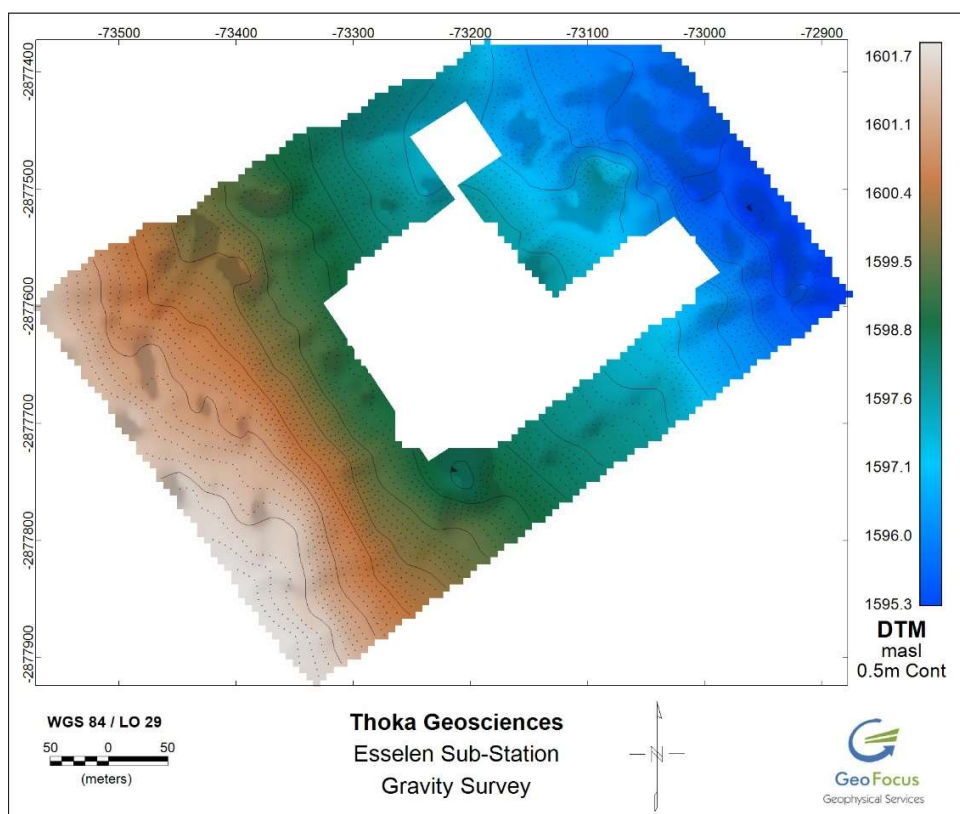
Figure 1: Elevation Map

The median elevation of the survey area is approximately 1,599 masl (relative) sloping southwest to northeast by roughly 7 m (Figure 1). A 1st-order approximation of the regional gravity field was removed from the Bouguer anomaly data (Figure 2) resulting in a residual gravity dataset with peak-to-peak distribution of approximately 0.4 mGal (Figure 3).
