### **GPR survey of the route for the new 20" Jet fuel feeder pipeline at OR Tambo International Airport**

**Report No.: PER0256**

**Client:** Megchem Pty Ltd

**PROJECT** : **GPR survey for 20" Jet Fuel pipeline**

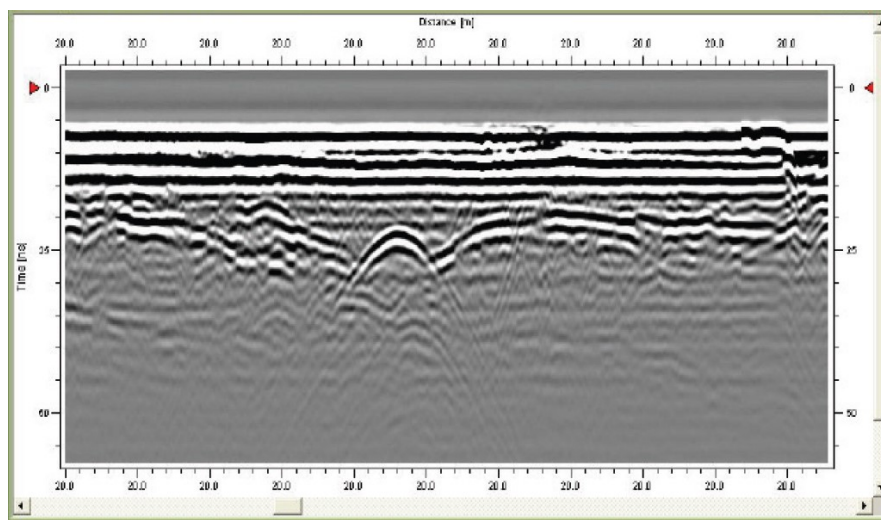
Figure 1: A typical Pipe-like reflector.

The depth of the “pipe-like” reflector can be estimated by analyzing the shape of the parabola. This **only** works correctly if the survey line is crossing the reflector at 90°. The depth estimates can vary by more than 50% if the reflector is not crossed at 90°. The depths given for the detected pipe-like structures are just an estimate, as there was no way to ensure that we crossed the anomalies at 90°.

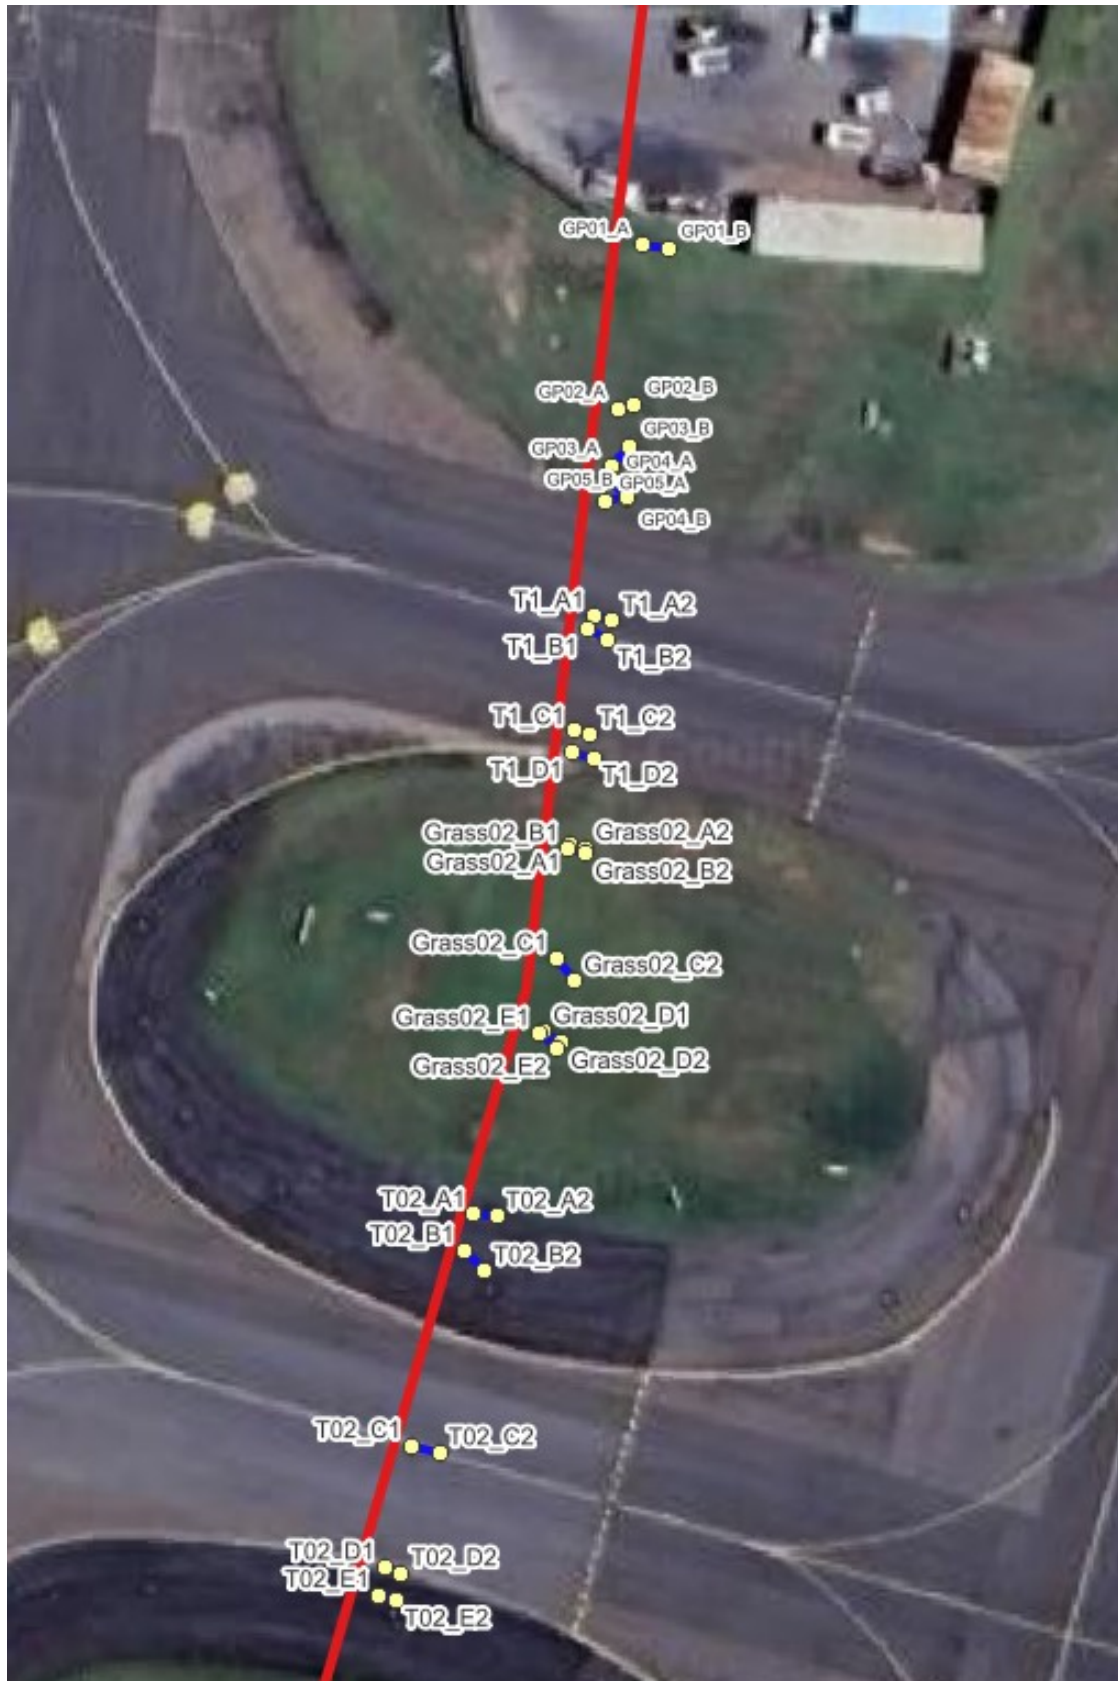
Figure 7: Overview from Bravo Apron to Taxiway 02.
