## ENGINEERING SERVICES INVESTIGATION REPORT

STATUS	INVESTIGATION REPORT
SUBJECT:	DWS: Boskop Area Offices Multidisciplinary condition assessment

<b>STATUS</b>	<b>TECHANICAL INVESTIGATION REPORT</b>
<b>SUBJECT:</b>	<b>Department of Water and Sanitation (DWS): Boskop Area Offices Electrical Infrastructure Condition Assessment</b>

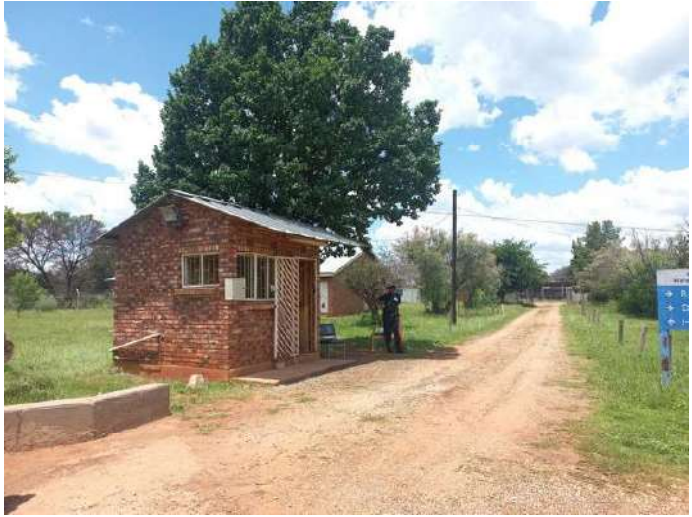
<b>Position:</b> Entrance area		<b>Category:</b> Accessibility	
<b>A1.1</b>		Internal <input type="checkbox"/> External <input checked="" type="checkbox"/>	
		<b>Description:</b> Building access as seen from the main gate. Gate house requires overhead shelter in the driveway in order to combat challenges during rainy weather.

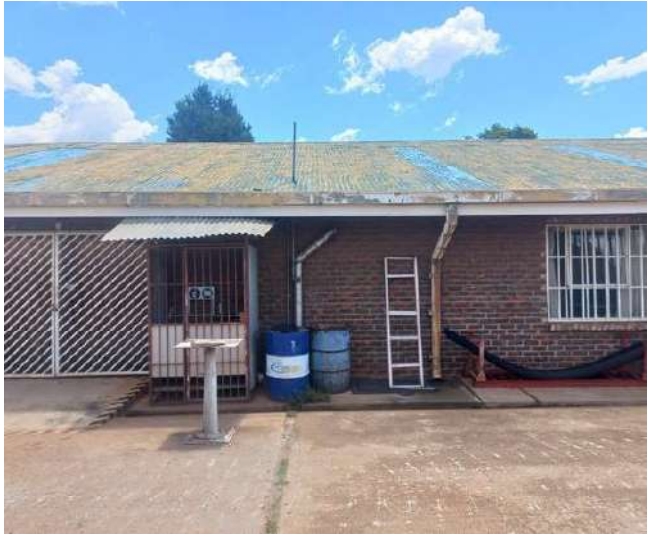
Position: Block 1 & 2		Category: General	Description:
A1.3

Internal <input type="checkbox"/> External <input checked="" type="checkbox"/>	Evidence of dilapidating roof. Facias and downpipes need replacement.

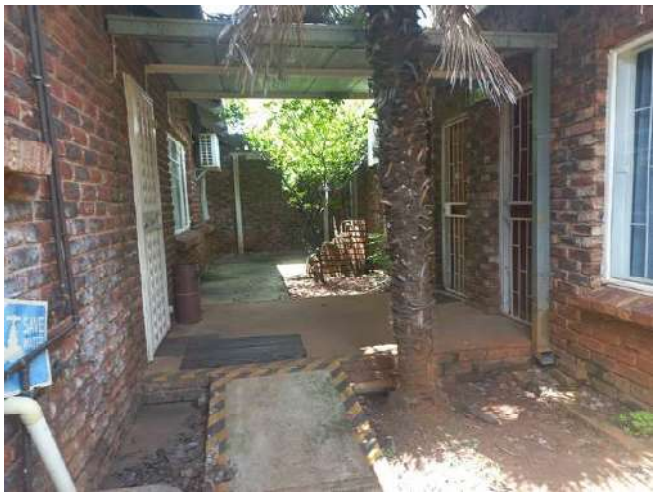
Position: Block 1 & 2		Category: General	Description:
A1.4

Internal <input type="checkbox"/> External <input checked="" type="checkbox"/>	All doors are normal. Fire escape door and panic latch to be considered. Burglar gates to be removed where fire door is installed.

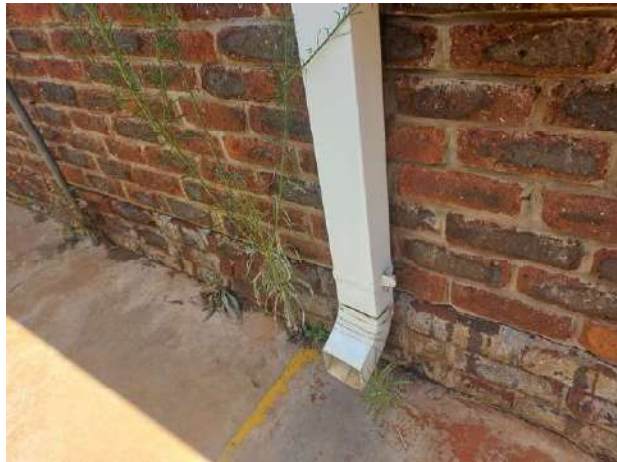
<b>Position:</b> Gate house		<b>Category:</b> General	
A1.5

Internal <input type="checkbox"/> External <input checked="" type="checkbox"/>	<b>Description:</b> Presence of weeds on apron surrounds indicate lack of building maintenance.

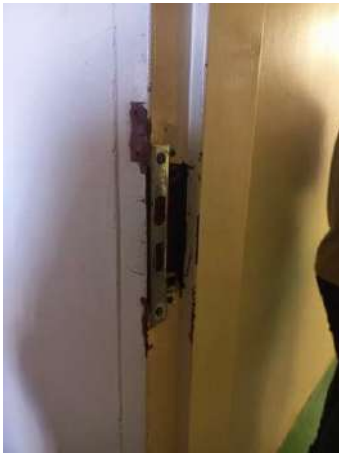
<b>A7.1</b>	<b>Block 1</b>	<b>A7.2</b>	<b>Block 3 – Storage</b>		
<b>IMAGE</b>		<b>IMAGE</b>

<b>Position: General</b>	<b>Category: Doors &amp; IM</b>	<b>Position: Escape routes</b>	<b>Category: Doors &amp; ironmongery</b>		
<b>Description:</b> Damaged locksets to be replaced.		<b>Description:</b> Fire doors to be provided. Burglar gates to be removed where applicable.			
Int <input checked="" type="checkbox"/> Ext <input type="checkbox"/>		Int <input type="checkbox"/> Ext <input checked="" type="checkbox"/>			
<b>Risk assessment</b>					
<b>Impact</b>	Insignificant	Minor	Significant	Major <input checked="" type="checkbox"/>	Severe
<b>Rating</b>	<b>Critical Risk</b>				
<b>Consequence</b>	Rare	Unlikely	Possible	Likely	Almost certain <input checked="" type="checkbox"/>
<b>Remarks</b>	Safety risk, evacuation risk

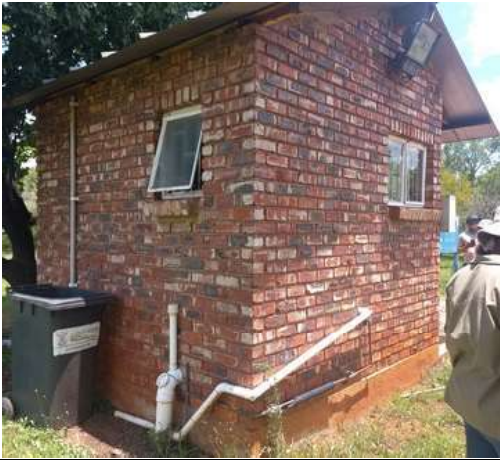
A9.1 Block 5 – Guard House		A9.2 Block 5 – Guard House	
IMAGE		IMAGE

<b>Position:</b> External	<b>Category:</b> Plumbing & drainage	<b>Position:</b> Toilet	<b>Category:</b> Plumbing & drainage
<b>Description:</b> Plumbing system to be repaired.		<b>Description:</b> Damaged sanitary fixtures to be replaced. Water supply to be repaired.	
Int <input type="checkbox"/> Ext <input checked="" type="checkbox"/>		Int <input checked="" type="checkbox"/> Ext <input type="checkbox"/>	
<b>Risk assessment</b>			
<b>Impact</b>	Insignificant	Minor	Significant <input checked="" type="checkbox"/>
<b>Rating</b>	High risk		
<b>Consequence</b>	Rare	Unlikely	Possible <input checked="" type="checkbox"/>
<b>Remarks</b>	Lack of maintenance result in system collapse.

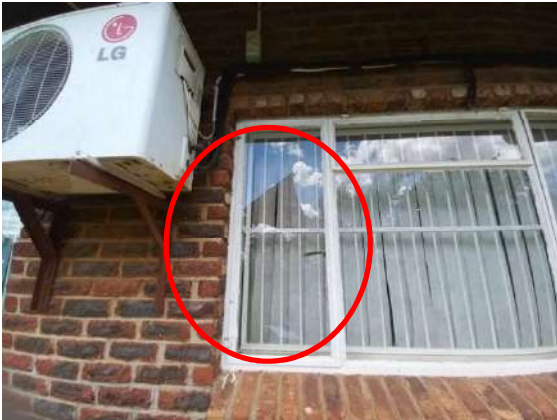
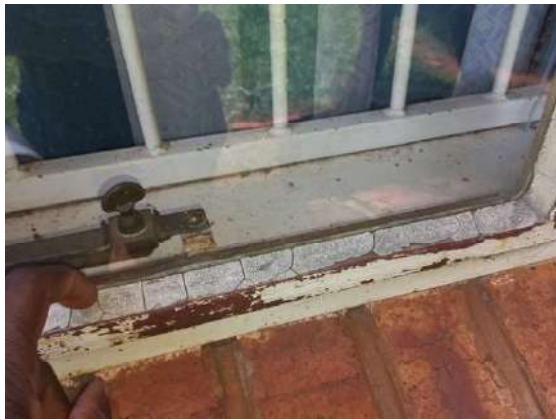
A10.1 Block 1 & 2		A10.2 Block 1 & 2	
IMAGE		IMAGE

<b>Position:</b> Windows	<b>Category:</b> Glazing/windows	<b>Position:</b> Windows	<b>Category:</b> Glazing/windows
<b>Description:</b> Replace broken glass.		<b>Description:</b> Remove damaged putty and replace with new. Painting to be done after drying of putty.	
Int <input type="checkbox"/> Ext <input checked="" type="checkbox"/>		Int <input type="checkbox"/> Ext <input checked="" type="checkbox"/>	
<b>Risk assessment</b>			
<b>Impact</b>	Insignificant	Minor	Significant
<b>Rating</b>	Critical risk		
<b>Consequence</b>	Rare	Unlikely	Possible
<b>Remarks</b>	Broken glass to be replaced with safety glass. Staff member be cut by glass during opening or closing.

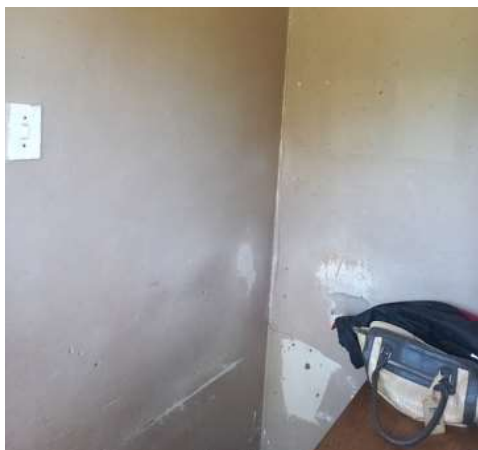
A12.1		Block 1 & 2		A12.2		Block 1 & 2	
IMAGE				IMAGE

Position: Roof		Category: Windows		Position: Entrance		Category: Windows	
<b>Description:</b> Prep wall and repaint.			Int <input checked="" type="checkbox"/> Ext <input type="checkbox"/>	<b>Description:</b> Putty to be replaced and windows re-painted.			Int <input checked="" type="checkbox"/> Ext <input type="checkbox"/>
<b>Risk assessment</b>							
Impact	Insignificant	Minor <input checked="" type="checkbox"/>	Significant	Major	Severe		
Rating	Minor Risk						
Consequence	Rare <input checked="" type="checkbox"/>	Unlikely	Possible	Likely	Almost certain		
Remarks	Paint peeling may cause discomfort and sometimes health hazard.

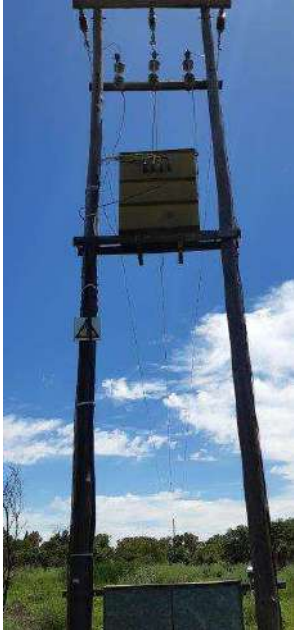
<p><i>Picture 2: Pole-mounted Transformer</i></p> <p>The Pole-mounted transformer is located outside the site boundary and supplies the facility via the generator changeover panel. It is in good condition.</p>

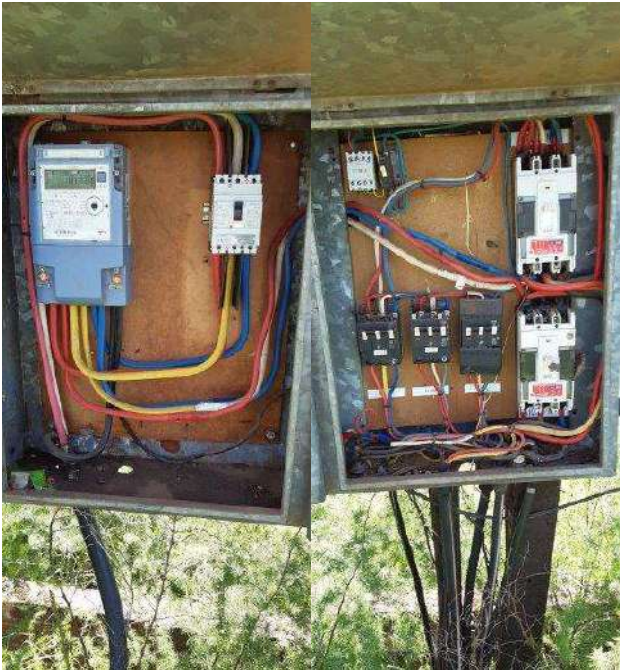
<p><i>Picture 3: Pole-mounted Main Supply Metering Kiosk</i></p> <p>The Main supply metering kiosk is located below the transformer and feeds the facility through the generator changeover panel. It is in fair condition with minor dirt ingress and rust. The Main breaker fed from the transformer and feeding the meter has a current rating of 160A, 3ph.</p>
3	X

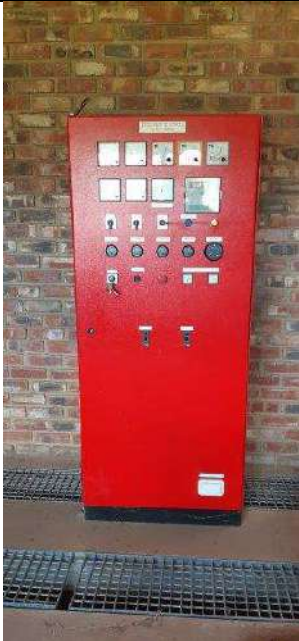
<p><i>Picture 6: Generator Changeover Panel</i></p> <p>The generator changeover panel has a power rating of 50kVA. Both the transformer and generator feed into this panel. It is properly labelled and still in good condition.</p>

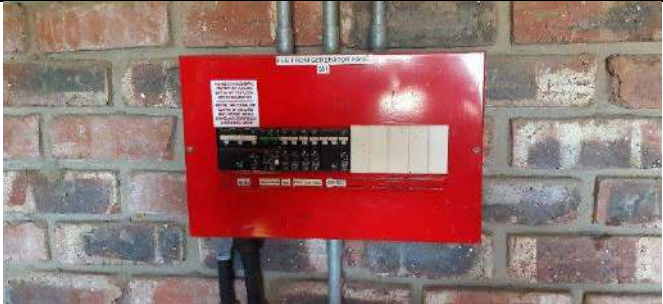
<p><i>Picture 8: D/B 1</i></p> <p>The DB is located in the generator room and has a main breaker rating of 63A, 3ph, with a fault level current of 6kA. It is in good condition as it is properly labelled, warning sign in place and spare ways properly blanked.</p>

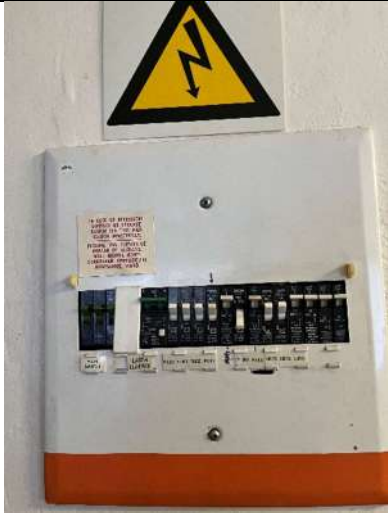
<p><i>Picture 9: DB-002</i></p> <p>The DB is located in Room 23. It has a main breaker rating of 60A, 3ph, with a fault level current of 5kA. It is non-compliant to SANS 10142 since it is not completely labelled.</p>
9		X

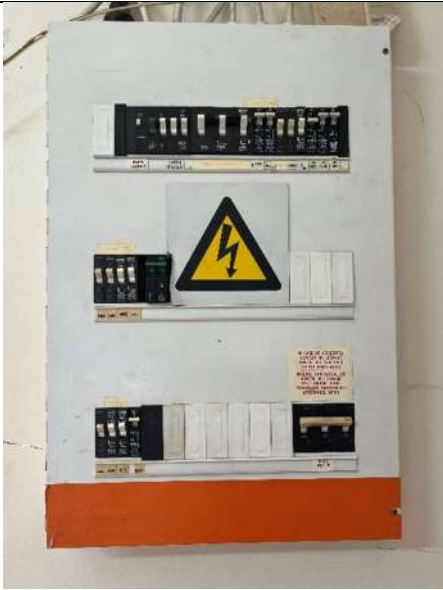
<p><i>Figure 10: DB-Sub Next to Supply Chain offices</i></p> <p>The DB Sub is located next to Supply Chain Offices. It has a main breaker rating of 80A, 3ph, with a fault level current of 5kA. It is non-compliant to SANS 10142 since it is not completely labelled.</p>

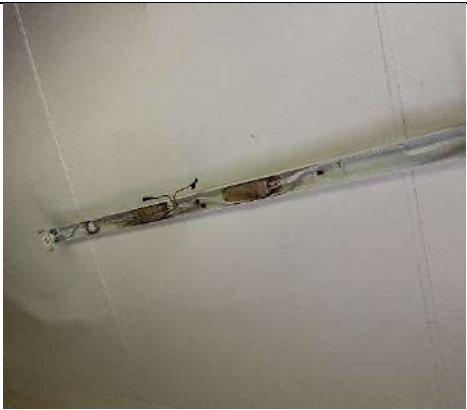
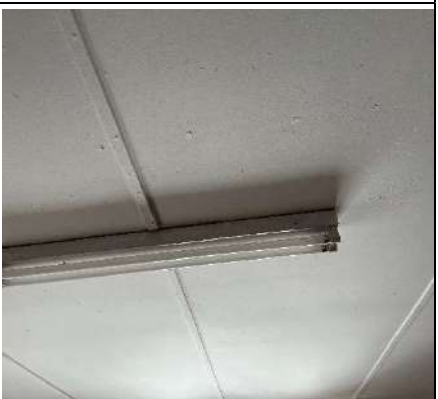
<p><i>Picture 16: Fluorescent Lights Tubes</i></p> <p>The fluorescent light tubes comprises of T8 open channel 1200mm and T8 open channel 2000m. Some of these lights are not working, missing light tubes and have damaged light fittings. Some of the light fittings appear to have reached their end of life. Majority are in poor condition.</p>
16			X

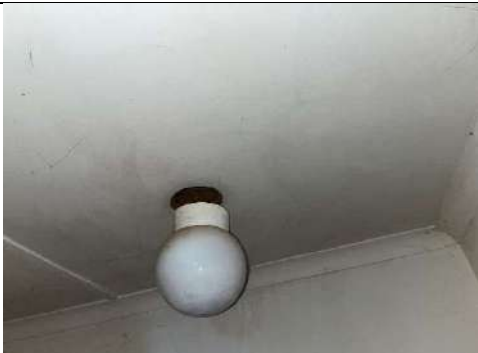
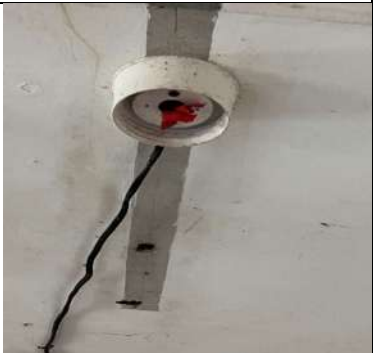
<p><i>Picture 17: CFL light fittings</i></p> <p>Some Compact Fluorescent Light fittings are not working, especially in the toilets. Some of the light fittings are worn out and appear to have reached their end of life. Majority are in poor condition.</p>
17			X	<div>

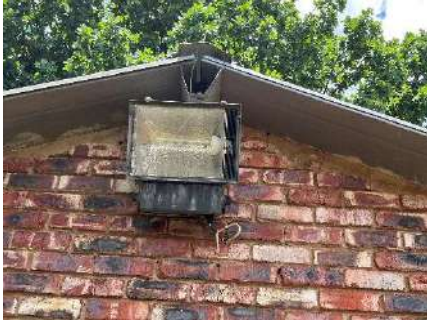
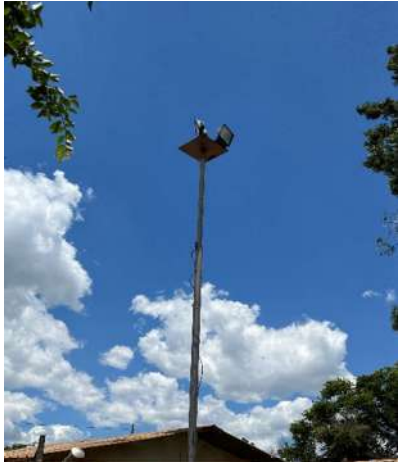
</div> <p><i>Picture 18: Floodlights for exterior</i></p> <p>Exterior floodlights for the security guard house and general lighting are not operational and worn out. They appear to have reached their end of life.</p>
18			X

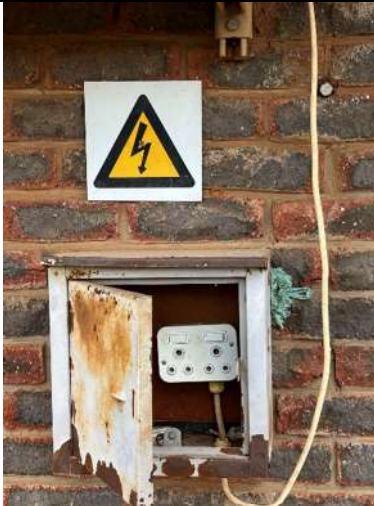
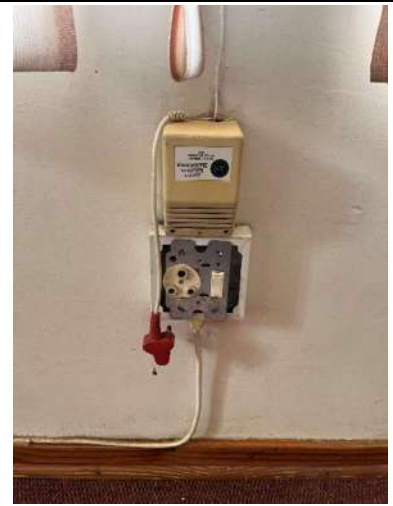
Picture 19: Power Socket

Majority of the sockets are not in good physical condition and not compliant to SANS164. Power cables are not chased into wall in some offices.

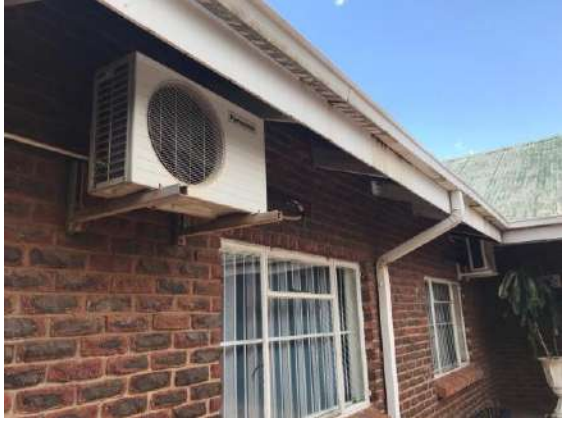
<p>Figure 4. AC condenser unit</p>

<p>Figure 5. Condenser refrigerant pipes</p> <p>The condenser units are mostly in fair condition with apparent signs of wear and tear on the refrigerant pipes. The pipes need to be re-insulated to ensure that minimal heat transfer occurs between the pipes and environment.</p>
D		X

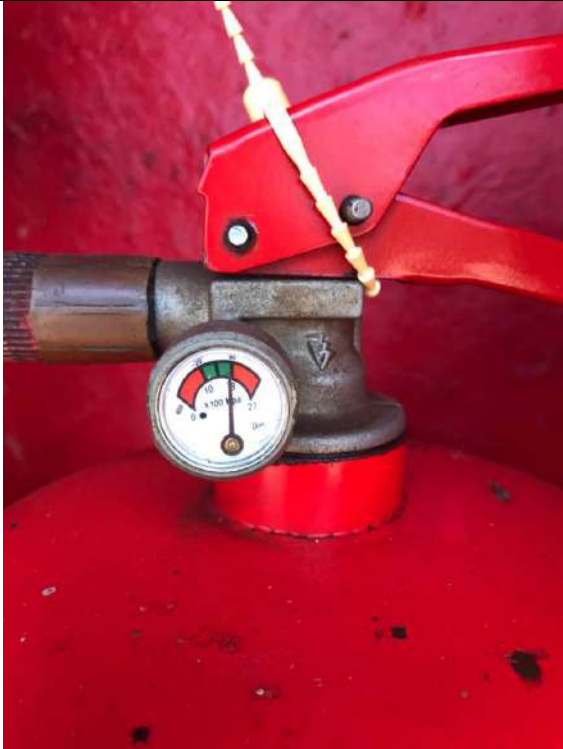
<p><i>Figure 9. Extinguisher pressure gauge</i></p> <p>The fire extinguishers have adequate pressure.</p>
C	X

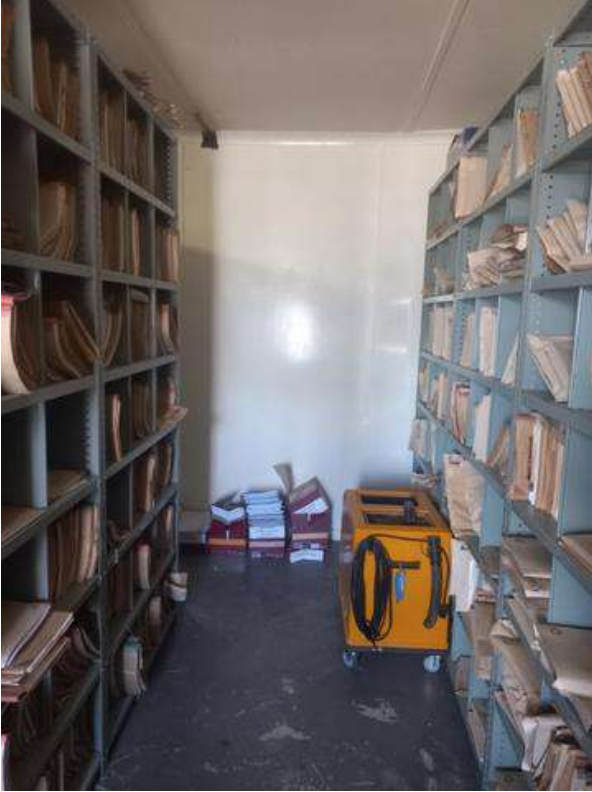
<p><i>Figure 11. No fire protection in the archive room</i></p> <p>There is no fire protection and/or detection installation in the archive room and thus records are not protected from possible eruption of fire.</p>
---	--	--	---	---

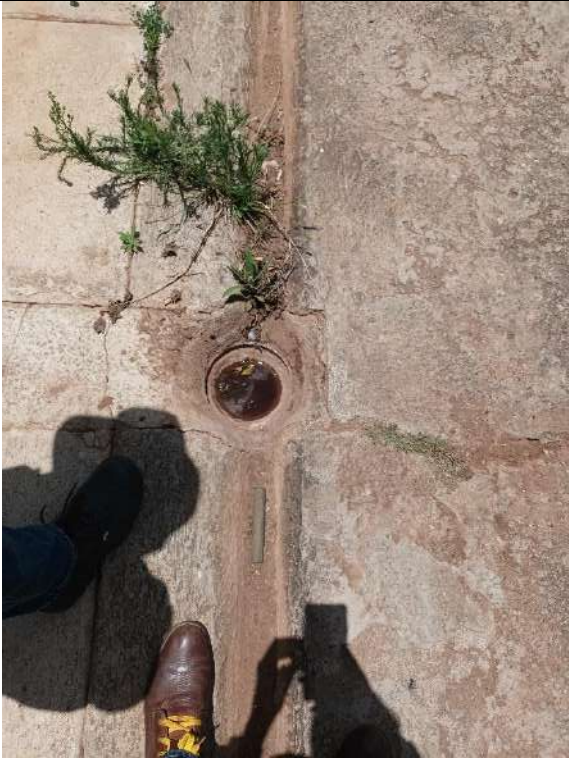
7.			x

<p><b>Drain:</b> technical stores drain is without a cover. The drain is clogged hence the visible water retention.</p>
8.			x

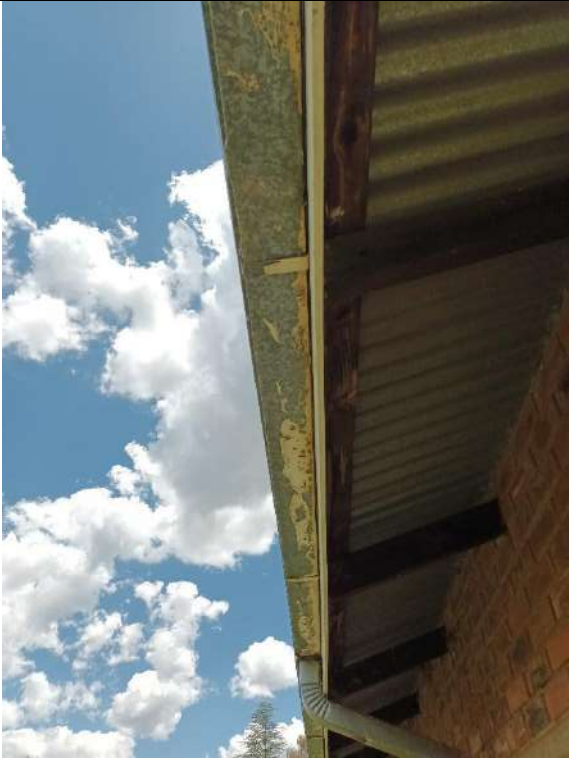
11.		x

Paint chipped off at the backup generator.
12.			x

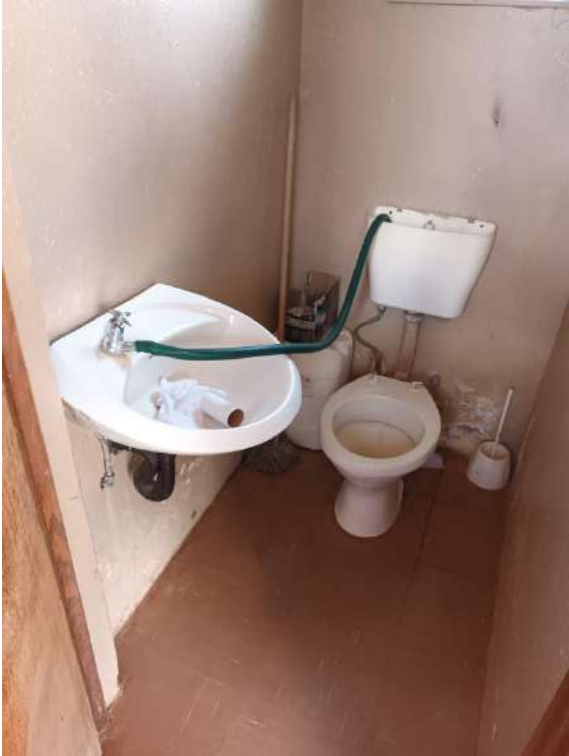
<b>Guardhouse toilet:</b> The flush master toilet (withou water supply) at the guard house connects to the basin (has water supply) for a water supply connection, to supply water into the toilet.

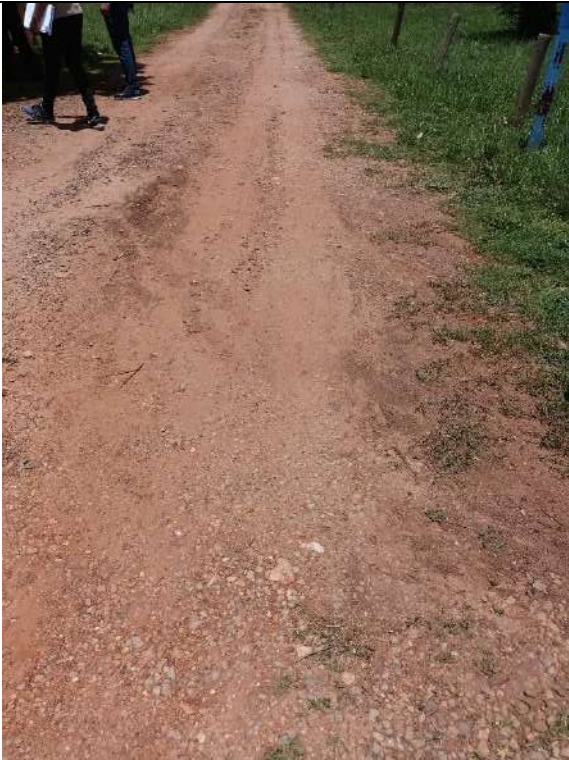
15.			x

<p><b>Entrance pathway:</b> the pathway does not have pavement and a stormwater drainage system. There is possible water ponding next to the guard house.</p>
16.		x

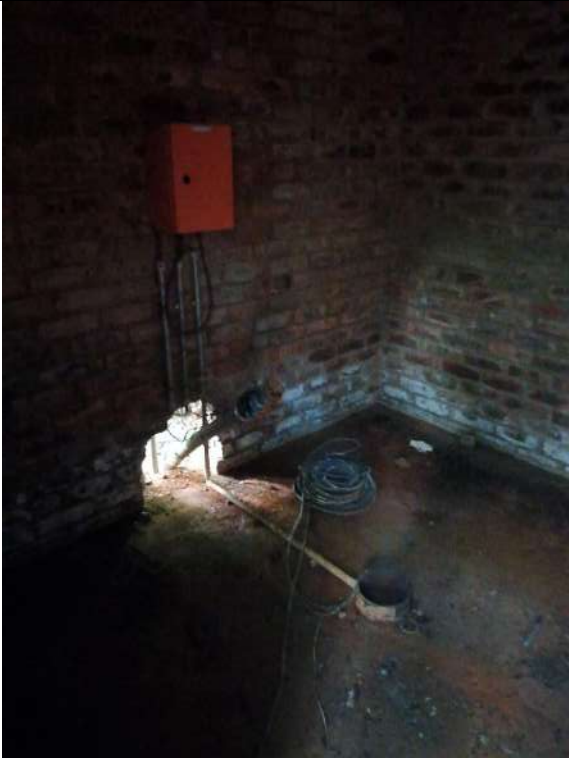
19.		x

<p><b>Borehole house:</b> The DWS officer informed the team, the boreholes system uses a submersible pump. Currently no backup power for the pump system.</p>
20.			x

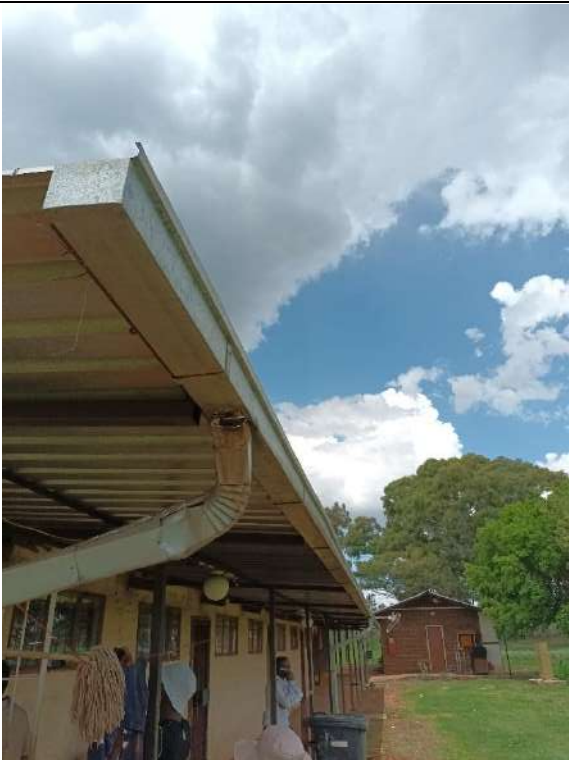
<p>Downpipe disconnecting form the gutter at the single quarters.</p>

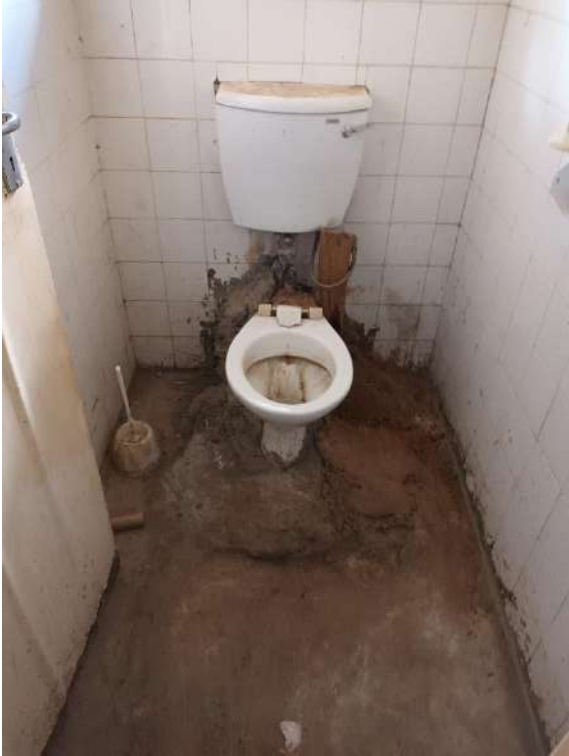
21.			x

<p><b>Single quarters bathroom:</b> the toilets, basins and showers are dilapidated at the single quarters dwelling units.</p>
22.			x

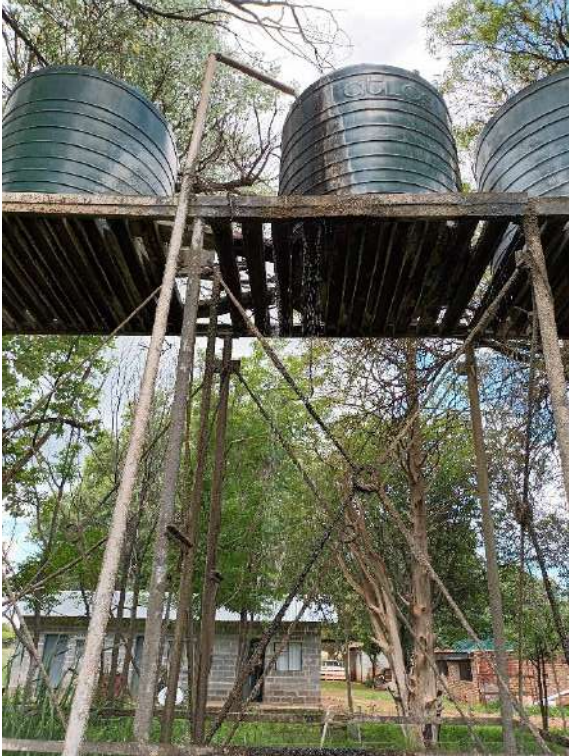
23.			x

<p><b>Storage tanks:</b> There are three storage tanks. Only one is fitted with an inlet pipe. There is a overflow of water from the tank which occurs continuously as borehole inlet pipe is not fitted with a float valve.</p>
24.			x

Design and construct the bulk water facilities (borehole, storage tanks and water treatment plant) in close proximity to each other to avoid uneconomical construction costs and frictional losses along the pipelines. Replace the storage tanks with a tank that meets the Annual Average Daily Demand (AADD) of the facility.

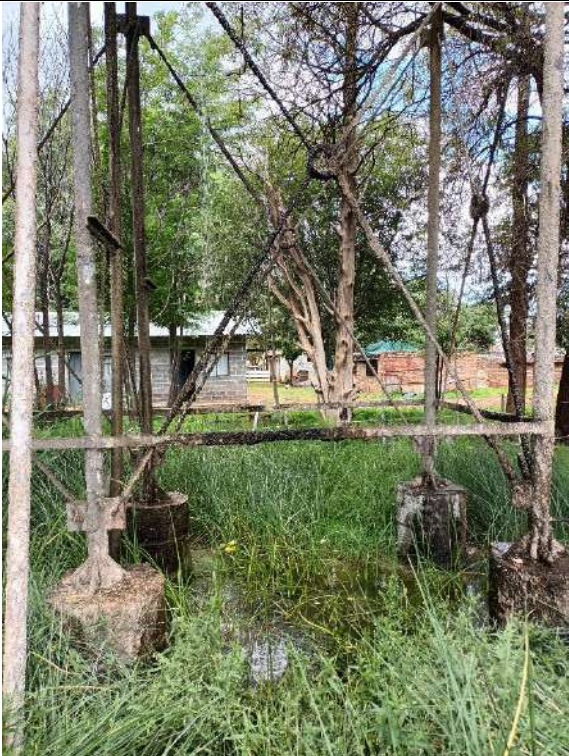
<p><b>Elevated water tank base:</b> ponding of water at the base of the elevated water storage tanks because there is no drainage point for the water.</p>

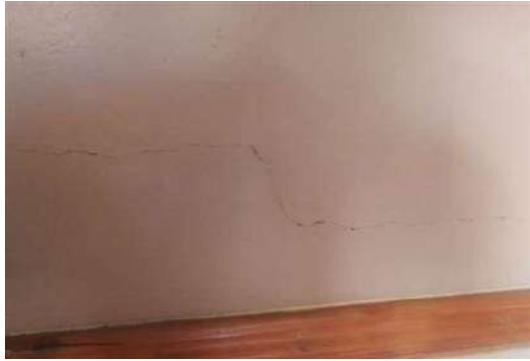
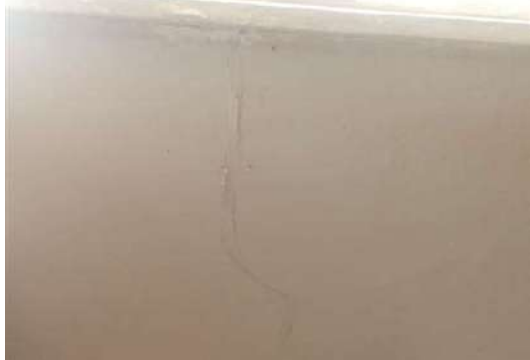
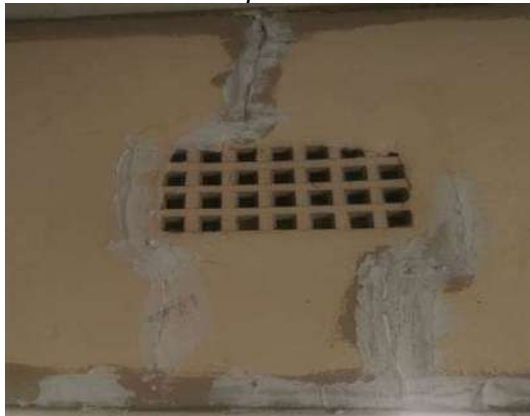
Figure 2: Horizontal crack on wall - Snoepie room				<b>Findings:</b> The following defects were observed in the Snoepie room: <ul style="list-style-type: none"> <li>• A horizontal crack on a wall. Refer to <b>Figure 2</b>.</li> <li>• A vertical crack going from the window sill to the surface bed level. Refer to <b>Figure 3</b>.</li> <li>• Vertical cracks around the air brick. Refer to <b>Figure 4</b>.</li> </ul> The cracks observed in the Snoepie room were all < 5mm in width.  <b>Impact/Risk:</b> <ul style="list-style-type: none"> <li>• The cracks leave the masonry wall vulnerable to external effects (i.e. moisture ingress) which will reduce the mechanical resistance of the masonry wall.</li> </ul> <b>Recommendation:</b> <ul style="list-style-type: none"> <li>• Conduct a geotechnical investigation to determine if underlying soil and foundation conditions are not the cause of the cracks.</li> <li>• From the results of the investigation, determine the actual cause of the crack and the most effective remedial actions</li> </ul>

Figure 3: Vertical crack under the window sill – Snoepie room

Figure 4: Vertical cracks along the vents above the doorway – Snoepie room

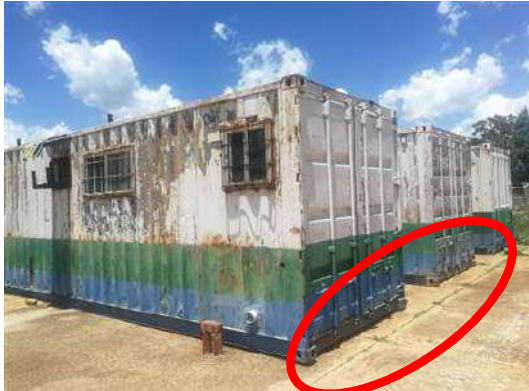
<p>Figure 6: Dilapidated shipping containers</p>		X		<p><b>Findings:</b></p> <ul style="list-style-type: none"> <li>A set of dilapidated shipping containers were observed behind office block A. Refer to <b>Figure 6</b>.</li> <li>The surface bed had grass in between its joints and worn out joint sealant. Refer to <b>Figure 6</b>.</li> </ul> <p><b>Impact/Risk:</b></p> <ul style="list-style-type: none"> <li>Worn out joint sealant will allow moisture seepage into the surface bed and underlying material.</li> </ul> <p><b>Recommendation:</b></p> <ul style="list-style-type: none"> <li>Decommission (if applicable) or Refurbish dilapidated shipping containers.</li> <li>Remove the grass on the joints and repair the joints.</li> </ul>

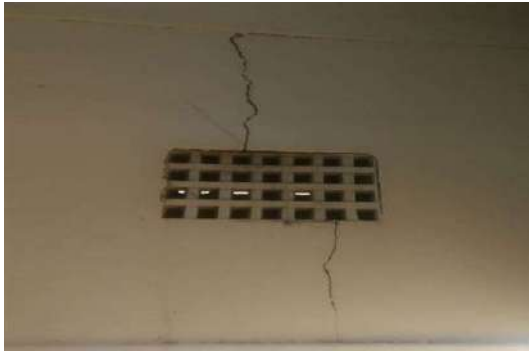
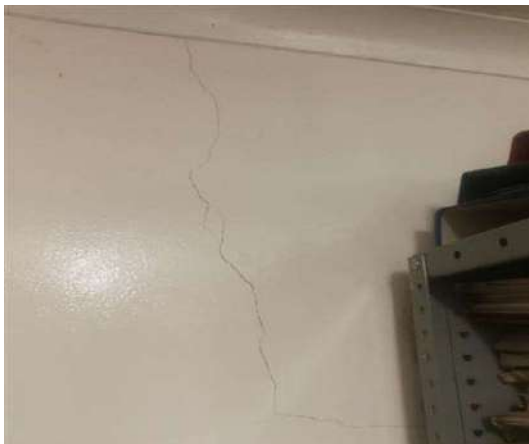
Figure 7: Vertical crack on vent - Archive			X	<p><b>Findings:</b> The following defects were observed in the Archive:</p> <ul style="list-style-type: none"> <li>• A vertical crack going through the air brick. Refer to <b>Figure 7</b>.</li> <li>• A vertical and horizontal crack on the wall. Refer to <b>Figure 8</b>.</li> </ul> <p>The cracks observed in the archive room were &lt; 5 mm in width.</p> <p><b>Impact/Risk:</b></p> <ul style="list-style-type: none"> <li>• Refer to the impact/Risk associated with <b>Figures 2, 3, and 4</b>.</li> </ul> <p><b>Recommendation:</b> Refer to the recommendation made for <b>Figures 2, 3, and 4</b>.</p>

Figure 8: Crack at the corner - Archive

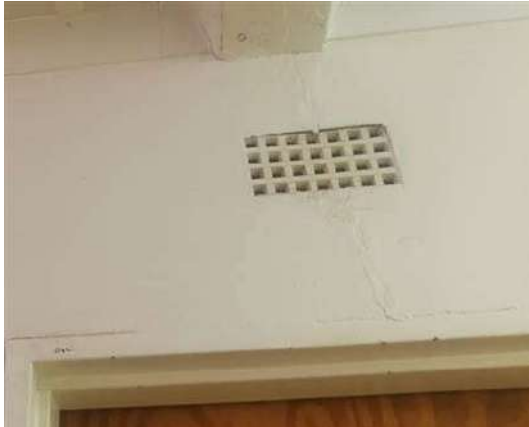
<p>Figure 12: Vertical crack through the air brick - Boardroom</p>

<p>Figure 14: Cracks on walls - Boardroom</p>		X		<p><b>Findings:</b></p> <p>The following defects were observed in the boardroom:</p> <ul style="list-style-type: none"> <li>• A vertical crack &lt; 5mm going through the air brick above the entrance. Refer to <b>Figure 12</b>.</li> <li>• A vertical crack &lt; 5mm going from the window sill to the surface bed level. Refer to <b>Figure 13</b>.</li> <li>• A horizontal and vertical crack on a section of the wall. Refer to <b>Figure 14</b>.</li> </ul> <p><b>Impact/Risk:</b></p> <ul style="list-style-type: none"> <li>• Refer to the impact/Risk associated with <b>Figures 2, 3, and 4</b>.</li> </ul> <p><b>Recommendation:</b></p> <ul style="list-style-type: none"> <li>• For the defects associated with <b>Figure 12</b>, perform detailed analyses and investigations to determine if the beam is properly supported and the most effective remedial action.</li> <li>• For <b>Figures 13 and 14</b> refer to the recommendations made for <b>Figures 2, 3, and 4</b>.</li> </ul>

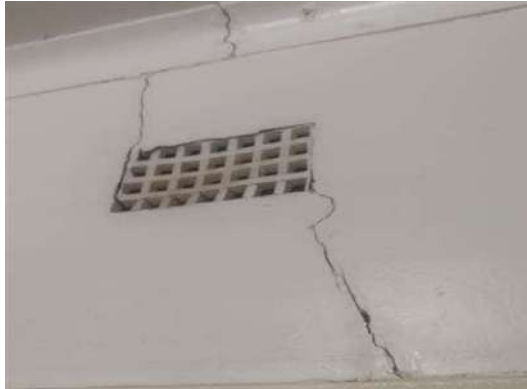
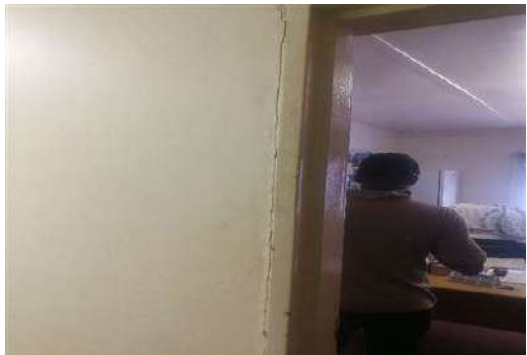
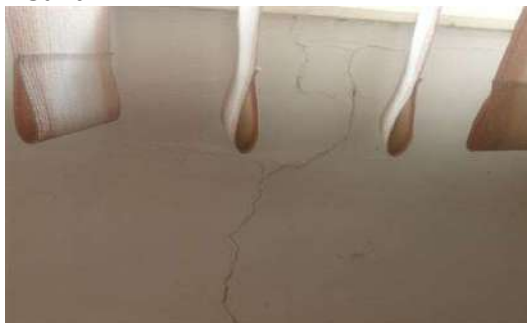
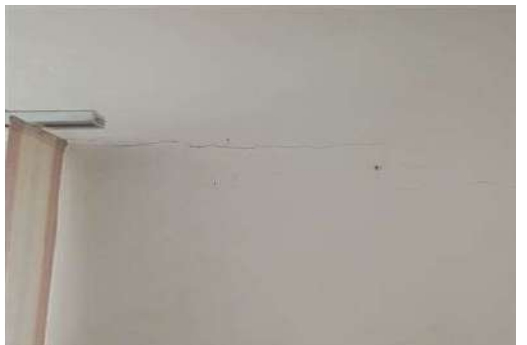
Figure 15: Vertical crack through the air brick - Stinah

Figure 16: Vertical along the door frame - Stinah

Figure 17: Vertical crack below the window sill - Stinah

Figure 18: Horizontal crack at window edges - Stinah

- A vertical and diagonal crack < 5mm going through the air brick above the entrance. The crack was visible on both sides of the wall. Refer to **Figure 15**.
- A vertical crack along the doorframe. Refer to **Figure 16**.
- A vertical crack < 5mm going from the window sill to the surface bed level. Refer to **Figure 17**.
- A horizontal crack originating from the edge of the window opening. Refer to **Figure 18**.

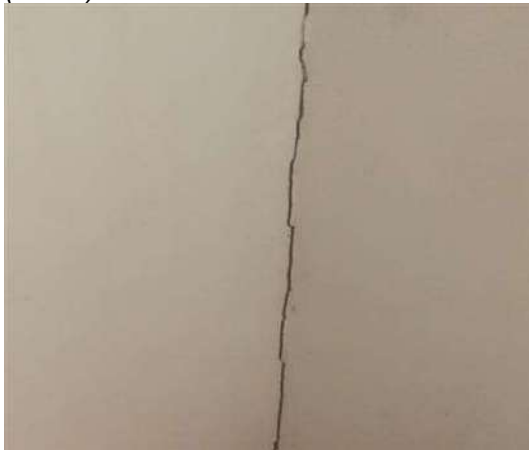
<p>Figure 20: Vertical crack at corner (2 of 2) - Toilet</p>		X		<p><b>Findings:</b></p> <p>The following defects were observed in the toilet:</p> <ul style="list-style-type: none"> <li>• Pieces of plaster were breaking off towards the ceiling level. Refer to <b>Figure 19</b>.</li> <li>• A vertical crack &lt; 5mm going from the roof level to the surface bed level. Refer to <b>Figure 20</b>.</li> </ul> <p><b>Impact/Risk:</b></p> <ul style="list-style-type: none"> <li>• Refer to the impact/Risk associated with <b>Figures 2, 3, and 4</b>.</li> </ul> <p><b>Recommendation:</b></p> <p>Refer to the second recommendation made for <b>Figures 2, 3, and 4</b>.</p>

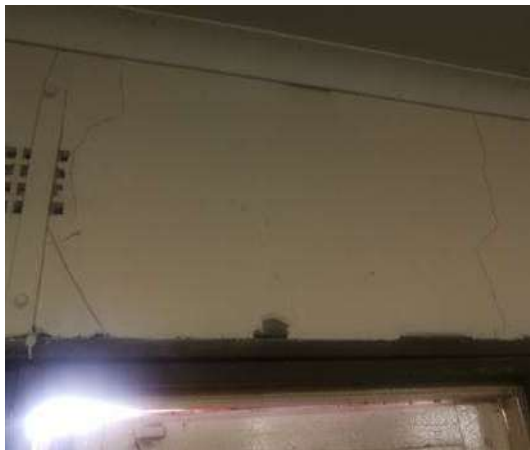
<p>Figure 22: Vertical cracks at storeroom 039 – Store 1</p>				<p><b>Findings:</b> The following defects were observed in Store 1:</p> <ul style="list-style-type: none"> <li>• A vertical crack &lt; 5mm spanning from the roof level to the surface bed level with pieces of the plaster falling off. Refer to <b>Figure 21</b>.</li> <li>• Vertical hairline cracks above the entrance. Refer to <b>Figure 22</b>.</li> </ul> <p><b>Impact/Risk:</b></p> <ul style="list-style-type: none"> <li>• Refer to the impact/Risk associated with <b>Figures 2, 3, and 4</b>.</li> </ul> <p><b>Recommendation:</b></p> <ul style="list-style-type: none"> <li>• Refer to the recommendations made for <b>Figures 2, 3 and 4</b>.</li> </ul>

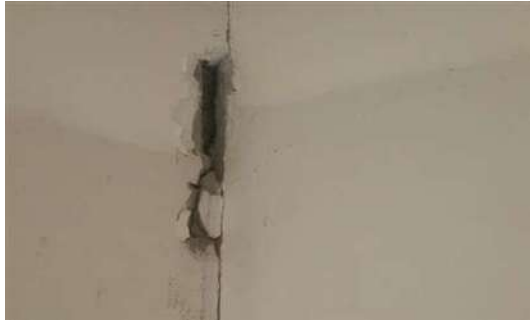
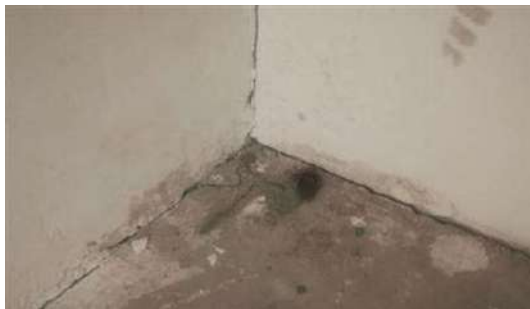
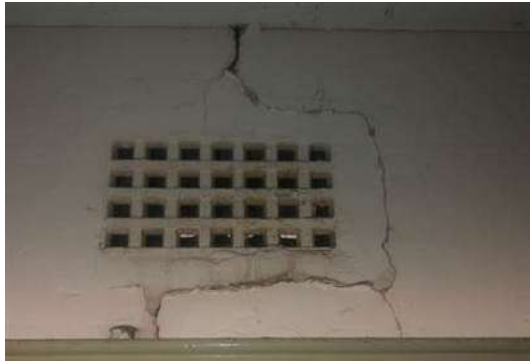
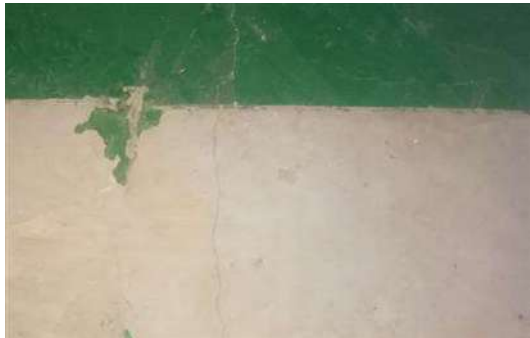
<p>Figure 23: Vertical crack at old store corner – Store 2</p>

<p>Figure 24: Separations at old store corner – Store 2</p>

<p>Figure 25: Vertical cracks at the air brick above the entrance – Store 2</p>

<p>Figure 26: Transverse crack on old store slab – Store 2</p>				<p><b>Findings:</b></p> <p>The following defects were observed in Store 2:</p> <ul style="list-style-type: none"> <li>• A vertical crack &lt; 5mm at one of the corners with a void formed by missing plaster. Refer to <b>Figure 23</b>.</li> <li>• A slab that was detached from two of the walls connected to it. Refer to <b>Figure 24</b>.</li> <li>• A vertical crack going around the air brick above the entrance. Refer to <b>Figure 25</b>.</li> <li>• Hairline cracks on the surface bed slab. Refer to <b>Figure 26</b>.</li> </ul> <p><b>Impact/Risk:</b></p> <ul style="list-style-type: none"> <li>• Refer to the impact/Risk associated with <b>Figures 2, 3, and 4</b>.</li> </ul> <p><b>Recommendation:</b></p> <ul style="list-style-type: none"> <li>• For the crack repairs, refer to the recommendation made for <b>Figures 2, 3, and 4</b>.</li> <li>• Conduct geotechnical investigation on the material under the surface bed to determine the cause of the detachment in <b>Figure 24</b>. After the cause has been determined, the appointed Structural Engineer will determine the most effective repair method.</li> </ul>

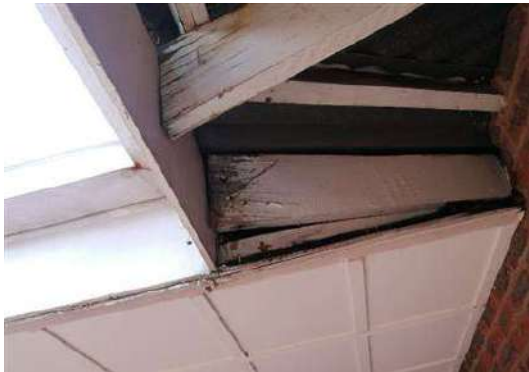
<p>Figure 28: Damaged timber truss – Office block B</p>			X	<p><b>Findings:</b></p> <ul style="list-style-type: none"> <li>The paint of the timber trusses exposed at the entrance is worn-out and is peeling off. Refer to <b>Figure 28</b>.</li> <li>Some of the nails on the timber truss members had loosened. Refer to <b>Figure 28</b>.</li> </ul> <p><b>Impact/Risk:</b></p> <ul style="list-style-type: none"> <li>Worn-out truss coating exposes the truss elements to external elements such as moisture and mites.</li> </ul>

Photograph	Condition			Comment
	Good	Fair	Poor	
				<ul style="list-style-type: none"> <li>Loosened nails may fall off completely leading to unrestrained truss members.</li> </ul> <p><b>Recommendation:</b></p> <ul style="list-style-type: none"> <li>Replace the damaged trusses and roof sheeting.</li> </ul>

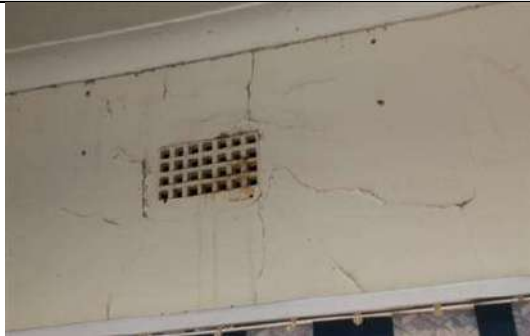
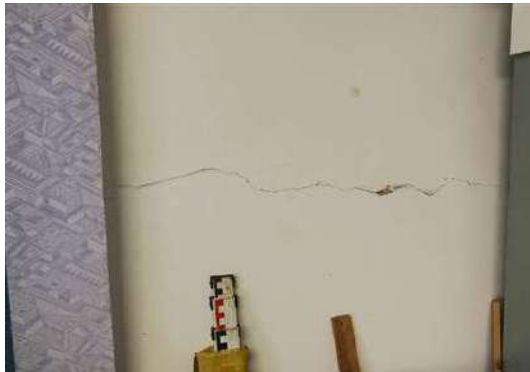
Figure 31: Map cracks around the air brick - Deon				<ul style="list-style-type: none"> <li>A horizontal crack &lt; 5mm going from the edge of the window opening to the corner of the room. Refer to <b>Figure 32</b>.</li> </ul> <p><b>Impact/Risk:</b></p> <ul style="list-style-type: none"> <li>Refer to the impact/Risk associated with <b>Figures 2, 3, and 4</b>.</li> </ul> <p><b>Recommendation:</b></p> <ul style="list-style-type: none"> <li>Refer to the recommendation made for <b>Figures 2, 3, and 4</b>.</li> </ul>

Figure 32: Horizontal crack next to window - Deon

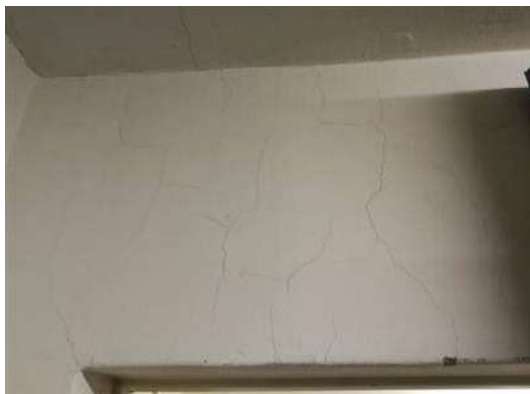
Figure 33: Plaster cracks at entrance - Safe		X		<p><b>Findings:</b></p> <ul style="list-style-type: none"> <li>The Safe had numerous plaster cracks above its entrance. Refer to <b>Figure 33</b>.</li> </ul> <p><b>Impact/Risk:</b></p> <ul style="list-style-type: none"> <li>Refer to the impact/Risk associated with <b>Figures 2, 3, and 4</b>.</li> </ul> <p><b>Recommendation:</b></p> <p>Refer to the recommendation made for <b>Figures 2, 3, and 4</b>.</p>

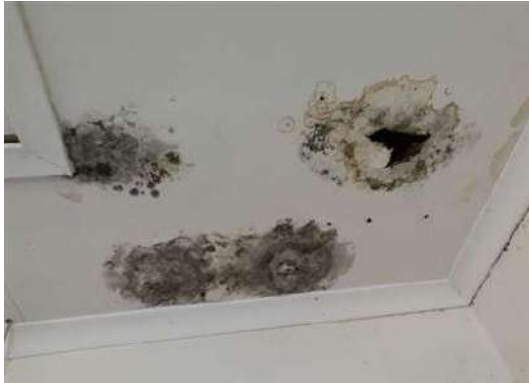
<p><i>Figure 34: Discoloured ceiling – Fax and copy room</i></p>		X		<p><b>Findings:</b></p> <ul style="list-style-type: none"> <li>The fax and copy room had a patch of discoloured ceiling indicating a leaking roof. Refer to <b>Figure 34</b>.</li> </ul> <p><b>Impact/Risk:</b></p> <ul style="list-style-type: none"> <li>Continuous contact with water will damage the timber truss supporting the roof.</li> </ul> <p><b>Recommendation:</b></p> <p>Refer to the recommendation made for <b>Figure 11</b>.</p>

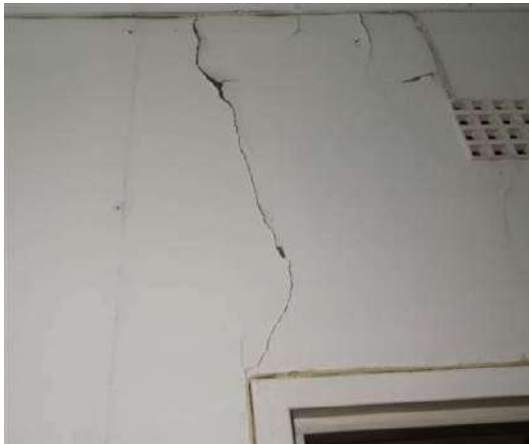
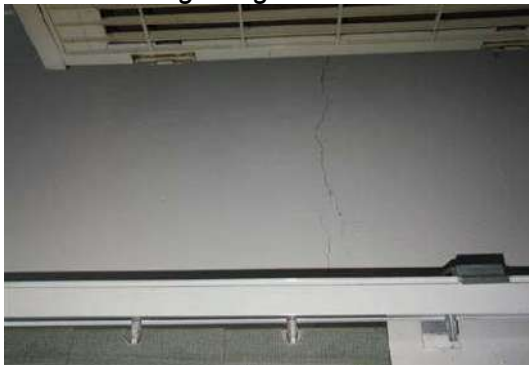
<p><i>Figure 35: Vertical crack above entrance – Digitizing room</i></p>

<p><i>Figure 36: Vertical crack under AC unit – Digitizing room</i></p>			X	<p><b>Findings:</b></p> <ul style="list-style-type: none"> <li>The entrances to the digitizing room and the safe had vertical cracks above them. Refer to <b>Figure 35</b>.</li> <li>A vertical hairline crack was observed under the AC unit in the digitizing room. Refer to <b>Figure 36</b>.</li> </ul> <p><b>Impact/Risk:</b></p> <ul style="list-style-type: none"> <li>Refer to the impact/Risk associated with <b>Figures 2, 3, and 4</b>.</li> </ul> <p><b>Recommendation:</b></p> <p>Refer to the recommendation made for <b>Figures 2, 3, and 4</b>.</p>

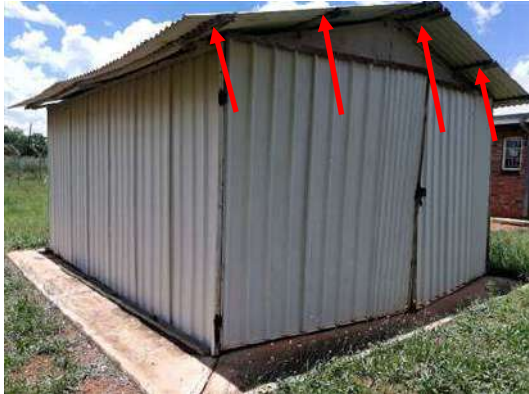
<p>Figure 39: Decaying timber purlins – Fire storage</p>		X		<p><b>Findings:</b></p> <ul style="list-style-type: none"> <li>The fire storage was observed to be constructed from corrugated iron sheeting. Refer to <b>Figure 39</b>.</li> <li>The timber purlins supporting the roof sheeting on the fire storage had signs of decay. Refer to <b>Figure 39</b>.</li> </ul> <p><b>Impact/Risk:</b></p> <ul style="list-style-type: none"> <li>Further decay of the timber purlins will weaken the roof.</li> </ul> <p><b>Recommendation:</b></p> <ul style="list-style-type: none"> <li>Decommission (if applicable) and reconstruct fire storage building.</li> </ul>

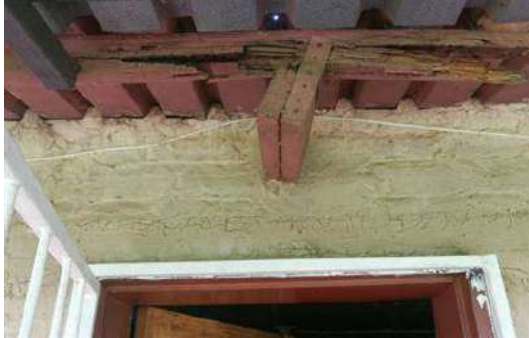
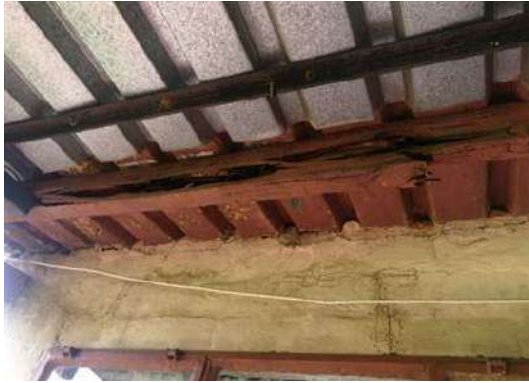
<p>Figure 40: Rotting roof truss members (1 of 2) – Single living quarters</p>				<p><b>Findings:</b></p> <ul style="list-style-type: none"> <li>The exposed roof truss elements at the single quarters were damaged and rotting. Refer to <b>Figures 40 and 41</b>.</li> <li>The front walls of the single quarters were covered in map cracks. Refer to <b>Figures 40 and 41</b>.</li> </ul> <p><b>Impact/Risk:</b></p> <ul style="list-style-type: none"> <li>Rotting of the timber truss members weakens the roof truss.</li> </ul> <p><b>Recommendations:</b></p> <ul style="list-style-type: none"> <li>Replace damaged timber members and roof sheeting.</li> <li>For the cracks, refer to the recommendation made for <b>Figures 2, 3, and 4</b>.</li> </ul>

<p>Figure 41: Rotting roof truss members (2 of 2) – Single living quarters</p>			X

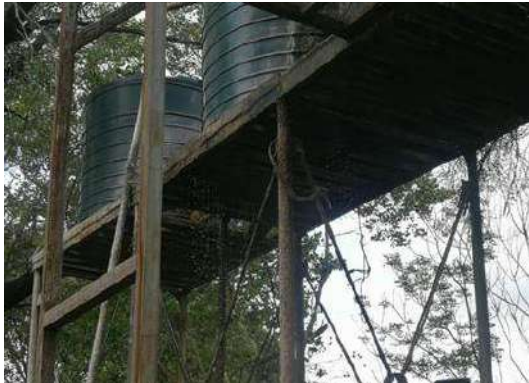
Figure 42: Corroded steel support structure - Water tanks				<p><b>Findings:</b></p> <ul style="list-style-type: none"> <li>Members of the steel structure supporting the water tanks were corroded. Refer to <b>Figures 42, 43 and 44.</b></li> <li>The concrete footings supporting the steel frame were observed to be damp mouldy and dilapidated. Refer to <b>Figure 43.</b></li> </ul> <p><b>Impact/Risk:</b></p> <ul style="list-style-type: none"> <li>The continued corrosion on the steel elements will weaken the steel structure supporting the water tanks.</li> <li>Excess mould leaves the concrete susceptible to chemical attacks.</li> </ul> <p><b>Recommendations:</b></p> <ul style="list-style-type: none"> <li>Replace the steel structure supporting the water tanks.</li> <li>Replace concrete footings supporting the steel structure.</li> </ul>

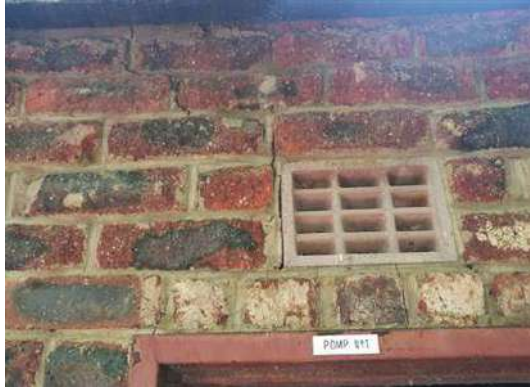
<p><i>Figure 45: Diagonal crack above entrance – Pump house</i></p>		X		<p><b>Findings:</b></p> <ul style="list-style-type: none"> <li>The pump house housing pump no.1 had a diagonal crack &lt; 5mm going from the air brick to the roof level. Refer to <b>Figure 45</b>.</li> </ul> <p><b>Impact/Risk:</b></p> <ul style="list-style-type: none"> <li>Refer to the impact/Risk associated with <b>Figures 2, 3, and 4</b>.</li> </ul> <p><b>Recommendation:</b></p> <p>Refer to the recommendation made for <b>Figures 2, 3, and 4</b>.</p>

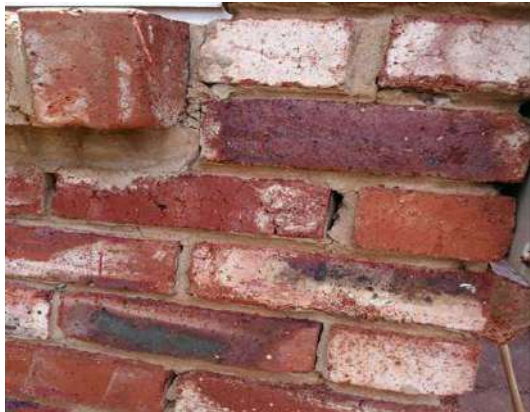
<p>Figure 46: Voids in mortar on masonry brick wall - Guardhouse</p>		X		<p><b>Findings:</b></p> <ul style="list-style-type: none"> <li>The mortar of the masonry brick wall of the guardhouse had voids. Refer to <b>Figure 46</b>.</li> <li>The wall around the air bricks was uneven as seen in <b>Figure 47</b>.</li> </ul> <p><b>Impact/Risk:</b></p> <ul style="list-style-type: none"> <li>The openings make the wall vulnerable to external effects like moisture, dust and air.</li> </ul> <p><b>Recommendation:</b></p> <ul style="list-style-type: none"> <li>Fill voids in mortar with cementitious grout.</li> <li>Conduct geotechnical investigation to determine if ground conditions are the cause of the bulging around the air bricks and to assist determining the most effective remedial actions.</li> </ul>
