## ENGINEERING SERVICES INVESTIGATION REPORT

STATUS	INVESTIGATION REPORT
SUBJECT:	DWS: Boskop Area Offices Multidisciplinary condition assessment

<b>STATUS</b>	<b>TECHANICAL INVESTIGATION REPORT</b>
<b>SUBJECT:</b>	<b>Department of Water and Sanitation (DWS): Boskop Area Offices Electrical Infrastructure Condition Assessment</b>

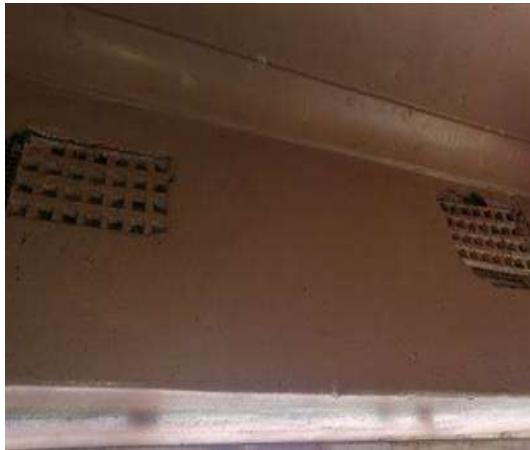
<p>Figure 46: Voids in mortar on masonry brick wall - Guardhouse</p>		X		<p><b>Findings:</b></p> <ul style="list-style-type: none"> <li>The mortar of the masonry brick wall of the guardhouse had voids. Refer to <b>Figure 46</b>.</li> <li>The wall around the air bricks was uneven as seen in <b>Figure 47</b>.</li> </ul> <p><b>Impact/Risk:</b></p> <ul style="list-style-type: none"> <li>The openings make the wall vulnerable to external effects like moisture, dust and air.</li> </ul> <p><b>Recommendation:</b></p> <ul style="list-style-type: none"> <li>Fill voids in mortar with cementitious grout.</li> <li>Conduct geotechnical investigation to determine if ground conditions are the cause of the bulging around the air bricks and to assist determining the most effective remedial actions.</li> </ul>

<p>Figure 47: Bulging around the air bricks – Guardhouse</p>
