Duvha Power Station	Unit	2
	Genix ID	17610
	Date	2020/03/08

Outage type	MGO	Outage start date	2022/01/07
Department	Turbine Engineering	System	Main turbine Condenser
Scope review date	N/A

1. DETAILED SCOPE OF WORK: MAIN TURBINE CONDENSER

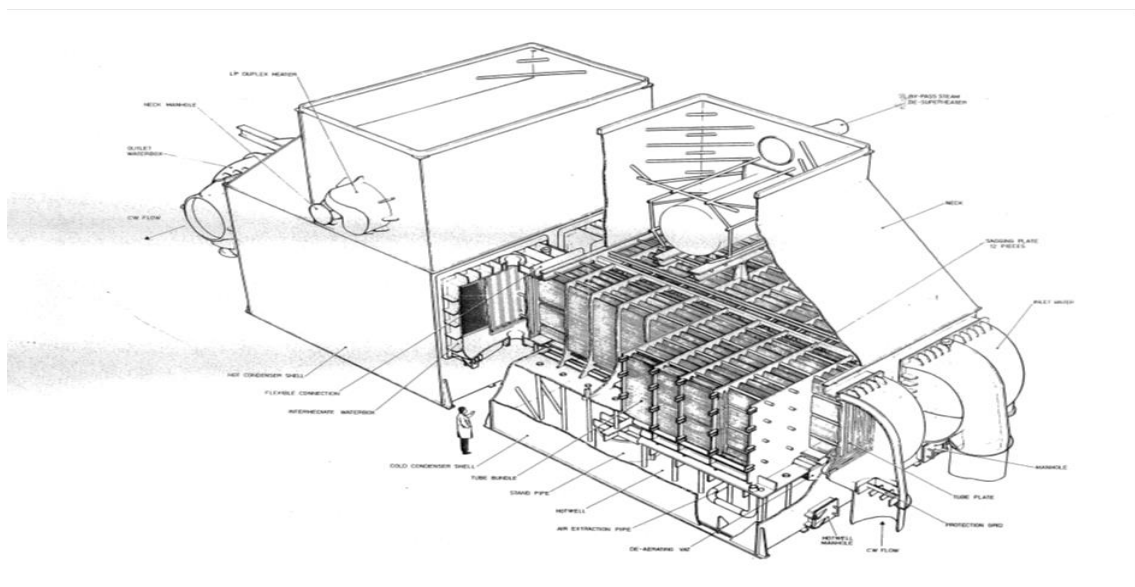
Figure 1: Layout of inlet and outlet ducts

During an inspection in the main turbine condenser waterboxes during the current MGO it became apparent that there are severe damage to the “B” pass inlet tubesheets. Both the cold condenser and hot conder inlet tubesheets are damaged and need urgent repairs.
