CONDITION ASSESSEMENT OF THE OVERVAAL TUNNEL

10 November 2023

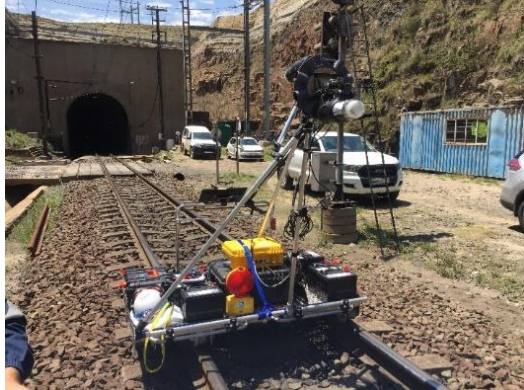
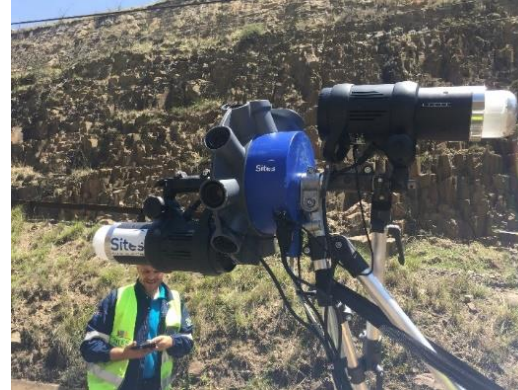
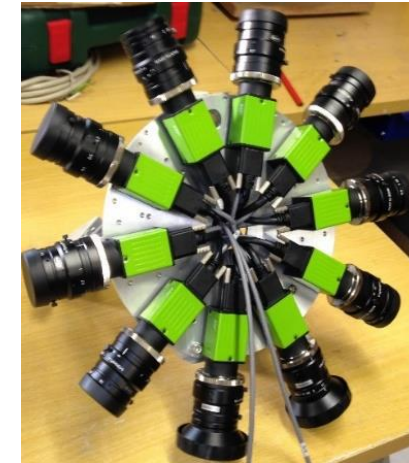
Digital Condition Assessment

- Semi-automatic 360° UHD imaging system was used to capture the tunnel lining's condition.
- The assembled HD orthophotography was used to perform the remote inspection of the tunnel lining
- The first 300m of the track slab was visually inspected and used as a reference and scale.

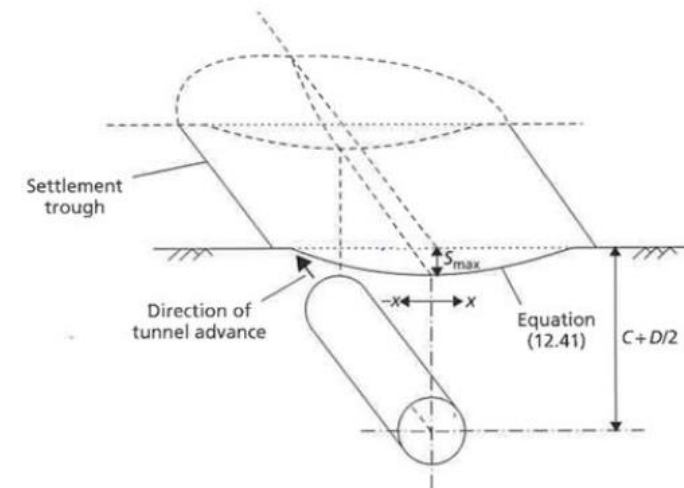
1. Deformation/Settlement hazard

$$i = 0.35 \left(110 + \frac{12,044}{2} \right)$$

$$i = 40,608\text{m}$$

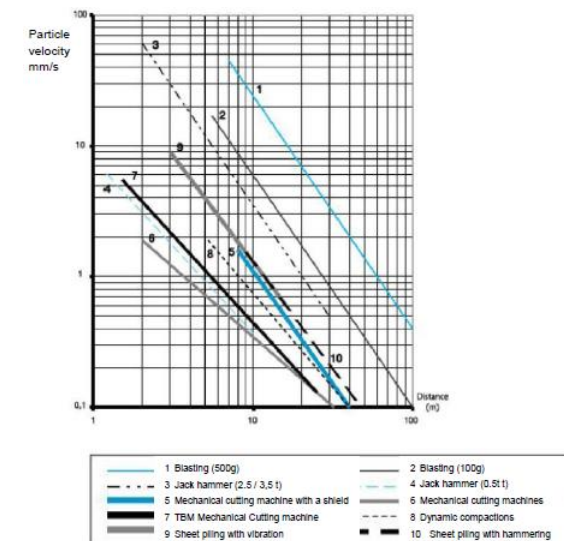
2. Vibration hazard

- Influence zone: Drill and blast = 100m from center of new tunnel
TBM = 50m
- Only the existing tunnel will be affected by vibrations

Structure	Distance from new tunnel (m)	Level of signal expected PV (mm/s)		Hazard (Y/N)
		Drill & Blast	TBM	
Overvaal Tunnel	25	4	0.13	Y
