NELSON MANDELA PRISON HOUSE

**DESCRIPTION OF THE WORKS AND TECHNICAL SPECIFICATIONS  
FOR REPAIRS AND MAINTENANCE**

**PREPARED BY:** OSMOND LANGE ARCHITECTS

**ISSUE DATE:** AUGUST 2025

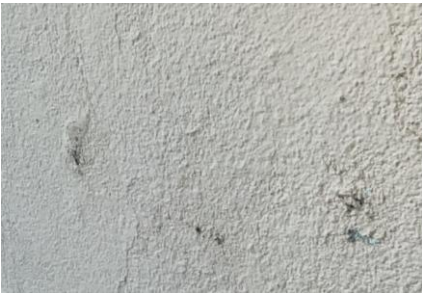
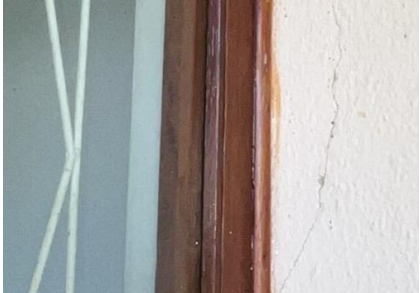
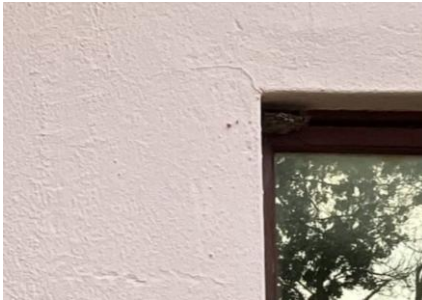
Walls were originally white during Nelson Mandela's incarceration, but in recent years they have been painted a cream colour. Localised areas of minor cracking in paint/plaster and weathering are evident. Wall cracks are to be repaired. Heritage Architect recommends that a paint specialist investigate the paint layers to establish the historic paint used. All external walls of the main house are to be repainted in accordance with the specialist's report and recommendations.

</div>	<div><div>1.</div><div>2.</div><div>2.1.</div><div>2.2.</div><div>3.</div><div>3.1</div><div>3.2.</div><div>4.</div><div>4.1.</div><div>4.2.</div><div>4.3.</div></div>	<div><p><b>Inspection:</b> Visually inspect all exterior wall plaster surfaces of the Nelson Mandela Prison House and identify areas that require repair i.e. Plaster cracks, hollow plaster, damaged cement areas.</p><p><b>Preparation:</b></p><p>2.1. Clean surfaces with a Sugar soap/water solution, or a similar product, to remove all surface contaminants and chalky residue. Rinse thoroughly with clean water and allow to dry.</p><p>2.2. Prepare surfaces by removing all paint coatings, friable deposits, grease, dirt, etc. Sand thoroughly to break the surface to provide a uniform finish. Brush down and wash to remove dust and surface contamination and wipe clean. (Use of water jet NOT allowed)</p><p><b>Fine Crack Repair</b></p><p>3.1 Spread Professional Bridging Compound, or similar, to be thinned 5-10 % with water over the entire fine cracked area to a wet film thickness of 400 µm (a medium pile or short pile roller may be used with thinned material to avoid texturing the coating. Stipples should be smoothed out while still wet using a water wet brush).</p><p>3.2. Crazed cracking: A second diluted coat will be required after a drying time of two hours to fill and bridge these cracks.</p><p><b>More Severe Crack Repair</b></p><p>4.1. Open damaged area sufficiently to allow repair material to be adequately filled to achieve a mechanical bond.</p><p>4.2. Clean away dust, grease and grime from surface.</p><p>4.3. Fill areas with the appropriate Masonry Patching Plaster using a putty knife or trowel. Smooth off whilst still wet. Allow to dry for 24hours. Patch prime using newly repaired areas with the appropriate primer, and allow 16 hours drying at 23°C. NB: Texture on repaired areas must be finished off to match the existing profile.</p></div>

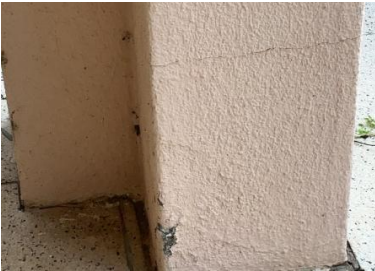
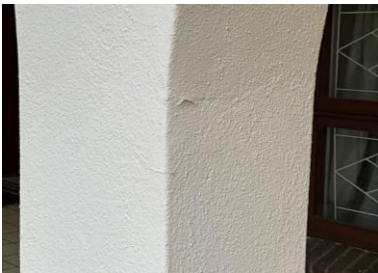
Stoep/ arcade walls have minor cracking in paint/plaster, and signs of weathering is evident. Heritage Architect recommends that a paint specialist investigate the paint layers to establish the historic paint used. All stoep/ arcade walls are to be repainted according to the specialist's report and recommendations.

</div>	<div><div>1.</div><div>2.</div><div>2.1.</div><div>2.2.</div><div>3.</div></div>	<div><p><b>Inspection:</b> Visually inspect all wall plaster surfaces of stoep / arcade walls and identify areas that require repair i.e. Plaster cracks, hollow plaster, damaged cement areas.</p><p><b>Preparation:</b></p><p>2.1. Clean surfaces with a Sugar soap/water solution, or a similar product, to remove all surface contaminants and chalky residue. Rinse thoroughly with clean water and allow to dry.</p><p>2.2. Prepare surfaces by removing all paint coatings, friable deposits, grease, dirt, etc. Sand thoroughly to break the surface to provide a uniform finish. Brush down and wash to remove dust and surface contamination and wipe clean. (Use of water jet NOT allowed)</p><p><b>Small Crack Repair</b></p><p>Professional Bridging Compound, or similar, to be thinned 5-10 % with water over the entire fine cracked area to a wet film thickness of 400 µm (a medium pile or short pile roller maybe used with thinned material to avoid texturing the coating. Stipples should be smoothed out while still wet using a water wet brush).</p></div>

TYPE OF REPAIR	IMAGE	NR	REPAIR INSTRUCTION
REPAIR STOEP/ ARCADE WALLS CONTINUED		<div>4.</div> <div>4.1.</div> <div>4.2.</div> <div>4.3.</div>	<p><b>More Severe Crack Repair:</b></p> <p>Open damaged area sufficiently to allow repair material to be adequately filled to achieve a mechanical bond.</p> <p>Clean away dust, grease and grime from surface.</p> <p>Fill areas with the appropriate Masonry Patching Plaster using a putty knife or trowel. Smooth off whilst still wet. Allow to dry for 24hours. Patch prime using newly repaired areas with the appropriate primer, and allow 16 hours drying at 23°C. NB: Texture on repaired areas must be finished off to match the existing profile.</p>
REPAIR GARDEN WALL	<div>

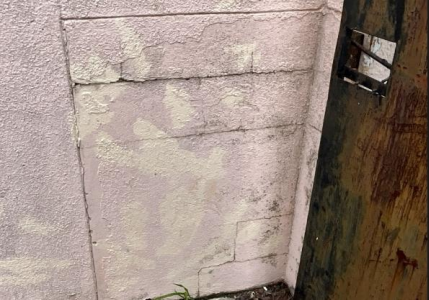
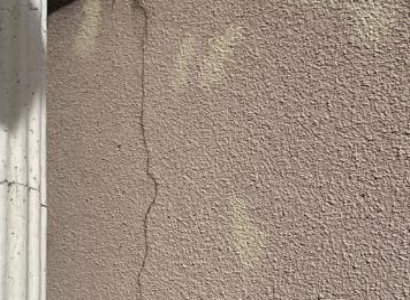
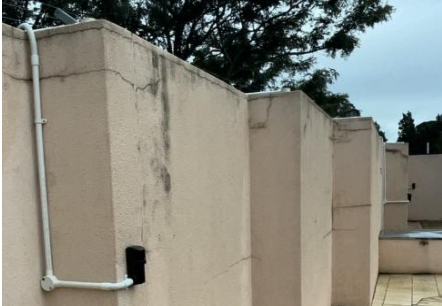
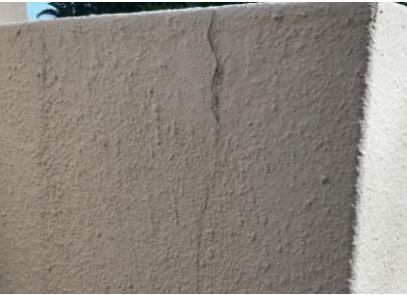
The garden walls have more localised areas of cracking in paint/plaster, and signs of more severe weathering is evident that is to be repaired before repainting. A portion of the garden wall remains in the original paint colour. Heritage architect recommends a paint specialist investigation. The garden walls are to be repainted according to the specialist's report and recommendations.

</div>	<div>1.</div> <div>2.</div> <div>2.1.</div> <div>2.2.</div> <div>3.</div> <div>3.1</div> <div>3.2.</div> <div>4.</div> <div>4.1.</div> <div>4.2.</div> <div>4.3.</div>	<p><b>Inspection:</b></p> <p>Visually inspect all wall plaster surfaces of the garden wall, on both sides, and identify areas that require repair i.e. Plaster cracks, hollow plaster, damaged cement areas.</p> <p><b>Preparation:</b></p> <p>Clean surfaces with a Sugar soap/water solution, or a similar product, to remove all surface contaminants and chalky residue. Rinse thoroughly with clean water and allow to dry.</p> <p>Prepare surfaces by removing all paint coatings, friable deposits, grease, dirt, etc. Sand thoroughly to break the surface to provide a uniform finish. Brush down and wash to remove dust and surface contamination and wipe clean. (Use of water jet NOT allowed)</p> <p><b>Fine Crack Repair:</b></p> <p>Professional Bridging Compound, or similar, to be thinned 5-10 % with water over the entire fine cracked area to a wet film thickness of 400 µm (a medium pile or short pile roller maybe used with thinned material to avoid texturing the coating. Stipples should be smoothed out while still wet using a water wet brush).</p> <p>Crazed cracking: A second diluted coat will be required after a drying time of two hours to fill and bridge these cracks.</p> <p><b>More Severe Crack Repair:</b></p> <p>Open the damaged area sufficiently to allow repair material to be adequately filled in to achieve a mechanical bond.</p> <p>Clean away dust, grease and grime from surface.</p> <p>Fill areas with the appropriate patching plaster using a putty knife or trowel. Smooth off whilst still wet. Allow to dry for 24hours. Patch prime using newly repaired areas with the appropriate primer, and allow 16 hours drying at 23°C. NB: Texture on repaired areas must be finished off to match the existing profile.</p>

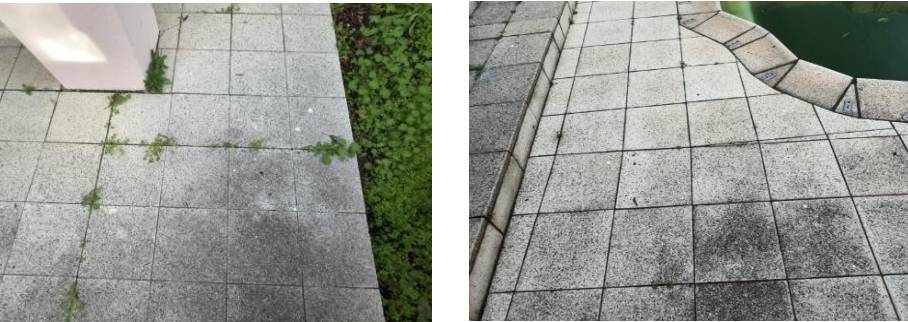
The pavement areas that are finished with terrazzo tiles are in acceptable condition considering their age, but they are severely weathered. There are localised areas where a tile has cracked or is coming loose from the surface it was mounted to. There is also evidence of poor past repair.

<div>1.</div> <div>2.</div> <div>2.1</div> <div>2.2.</div> <div>2.3.</div> <div>2.4.</div>	<p><b>Preparation:</b></p> <p>Clean the surface by removing loose debris, sand and leaves using a broom</p> <p><b>Clean tile:</b></p> <p>Clean tile using a mild dish soap mixed with warm water. Note: Harsh chemical cleaners are not to be used.</p> <p>Apply cleaning mixture to the tiles using a sponge or a mop and allow to sit for 10 minutes.</p> <p>Gently scrub the tiles with a soft-bristle brush to remove the grime.</p> <p>Rinse tiled surface thoroughly with clean water and allow to dry.</p>
REPLACE TERRAZZO TILE

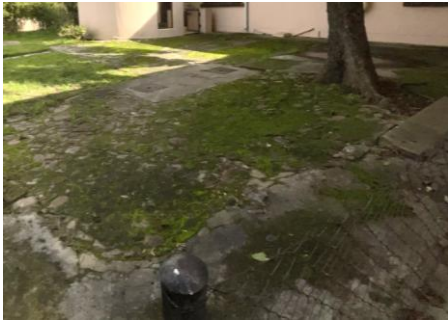
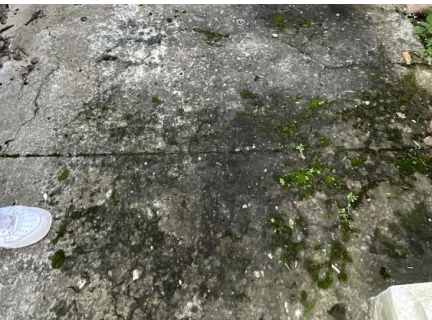
Concrete paved area type 1: This type refers to small paved concrete areas. The paving shows signs of severe weathering, mild to moderate cracks forming in the concrete, and minor vegetation growth affecting the pavement. The cracks are to be repaired, vegetation is to be removed, and concrete paving is to be power-washed.

</div>	<div>1.</div>	<p><b>Pressure Wash:</b></p> <p>Pressure wash the concrete pavement of grime, moss and other forms of weathering. Care must be taken not to damage the pavement or its surroundings.</p>

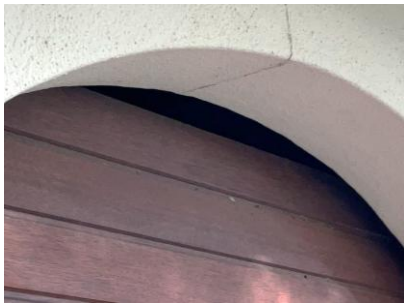
External timber doors are in good condition. The sliding door, leading to the swimming pool, has the frame pulling loose from the glass pane and appears to be detached from the sliding track. The sliding door needs to be repaired and placed back on its rail. There are two single timber garage doors with tongue and groove horizontal boarding that have been varnished. One of the garage doors is missing its topmost horizontal board.

<div>1.</div>	<p><b>Install new timber slat:</b> A new horizontal timber slat is to be installed to replace the missing one of the single garage door. New timber slat is to match the existing as far as reasonably possible.</p>

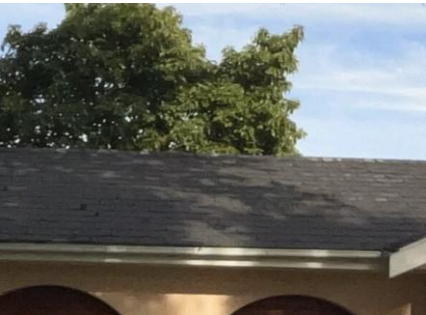
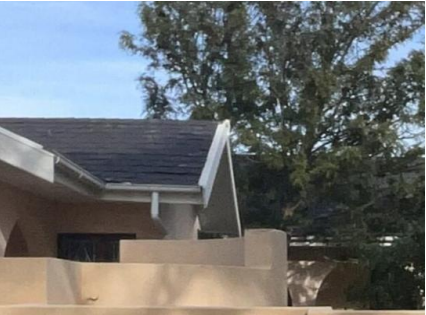
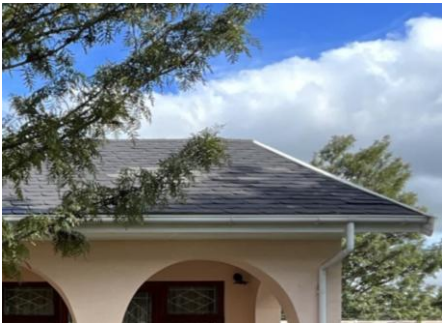
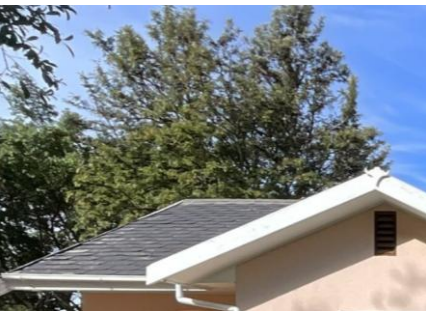
The roof appears to be in acceptable condition with indications of weathering. There was a leak that had been repaired in passage 2 (G09). In bedroom 4 (G17), there is evidence of a water leak that is to be found & repaired. The roof appears to be sound for the most part, but the architect suspects the tiles are asbestos and recommends a sample be sent for testing. Roof tiles are to be repainted.

</div>	<div>1.</div> <div>1.1.</div> <div>1.2.</div> <div>2.</div> <div>3</div> <div>3.1.</div> <div>3.2.</div> <div>3.3.</div> <div>3.4.</div>	<p><b>Investigate:</b></p> <p>A roof tile is to be removed as a sample and submitted for asbestos testing in accordance with the Asbestos Abatement Regulation of 2020, published under Government Notice R1196 in GG 43893 of 10 November 2020.</p> <p>If the results indicate Asbestos (fibrous silicates) are present, the roof tiles are all to be removed by a type 3 registered asbestos contractor with the chief inspector.</p> <p>Note: The contractor must allow Iziko the "asbestos client", 7 days to notify the Provincial Director before the commencement of work.</p> <p><b>Preparation:</b></p> <p>Remove all roof tiles.</p> <p><b>New installation:</b></p> <p>Once roof tiles are removed, install new 80 mm IsoBoard insulation or similar insulation board under battens, between the rafters. New insulation to be installed as per the manufacturer's specifications. Allow for total new installation.</p> <p>Install new Sisalation FR430 fire retardant or similar is to be installed as per the manufacturer's specifications. Allow for total new installation.</p> <p>Tiles are to be replaced with new fibre cement Nutec roof tiles, or similar shingle tiles to match the existing roof tile profile. Allow for total replacement of the surface. Tiles to be re-laid to match the existing pattern. COLOUR: Charcoal Slate (Mitred) to match existing. Note: Roof tile is to be installed manufacturer's specifications.</p> <p>Replace existing roof ridge flashings with new galvanised ridge flashings before re-laying ridge tiles with new fibre cement Nutec roof tiles, or similar shingle tile.</p>

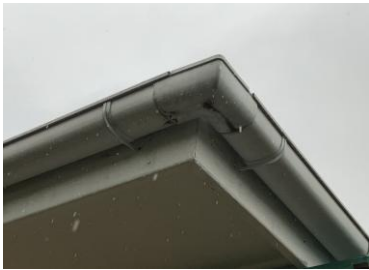
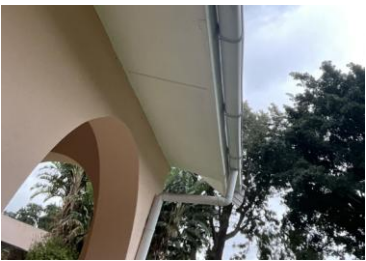
Rainwater goods have recently been replaced with PVC. They appear to be in acceptable condition with localised issues. Gutters and downpipes to be inspected and cleaned.

<div>1.</div> <div>1.1.</div> <div>1.2.</div>	<div><b>Servicing Rainwater Goods:</b></div> <div>Inspect gutters and downpipes to see if they are functioning properly.</div> <div>Clear gutters and downpipes of blockages.</div>
INSPECT & PAINT FASCIA BOARD

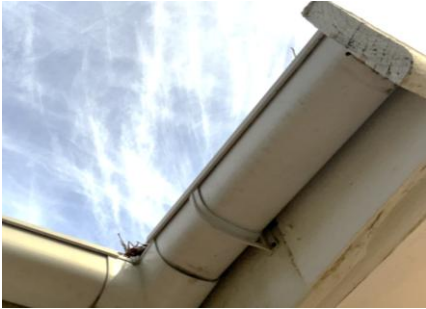
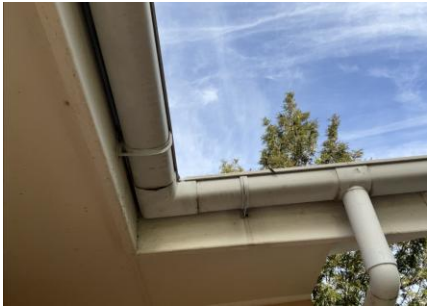
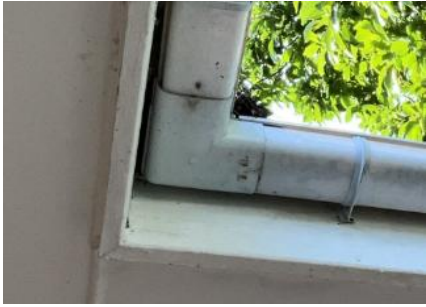
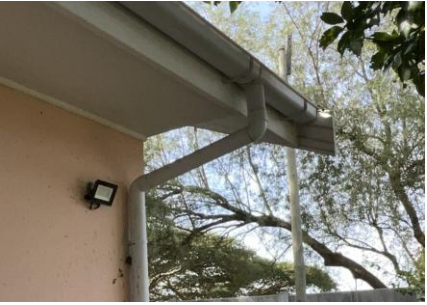
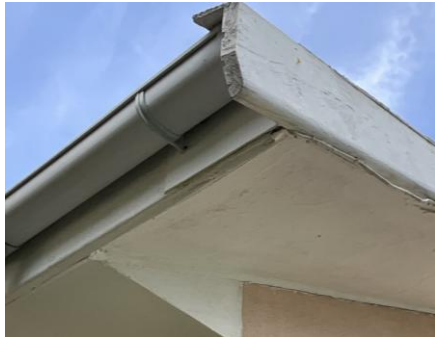
All fascia boards show signs of weathering, and in some areas, there is evidence of poor past repairs. Damaged and dilapidated fascia board sections are to be replaced to match the existing and repainted.

<div>1.</div> <div>2.</div> <div>2.1.</div> <div>2.2.</div> <div>2.3.</div> <div>2.4.</div> <div>3.</div> <div>3.1.</div> <div>3.2.</div> <div>3.3.</div> <div>3.4.</div> <div>4.</div> <div>4.1.</div> <div>4.2.</div> <div>5.</div> <div>6.</div>	<div><b>Inspection:</b></div> <div>A roofing specialist is to inspect the fascia boards to assess if it is possible to partially replace damaged portions of the fascia boards.</div> <div><b>Partical Replacement:</b></div> <div>If roofing specialist deems a partial replacement of fascia board is possible, the gutter attached to the damaged portion is to be carfully removed and stored for reinstallation.</div> <div>Carefully cut out the damaged fascia board back to the first unaffected rafter. Care must be taken while detaching it from the rafters as not to damage them.</div> <div>New timber fascia to match the height and thickness of the existing timber fascia. It is to be cut to size to fit the section that was removed.</div> <div>Fix new timber fascia portion to rafters. The seam where the new timber fascia meets the existing one is to be sealed with an appropriate caulking and painted to match the rest of the fascia board.</div> <div><b>Total Replacement</b></div> <div>If the roofing specialist deems partial replacement is not possible, a total replacement of the timber fascia board will need to be done.</div> <div>For the portions where whole sections of fascia boards are to be totally replaced, the gutter sections attached to them are to be carefully removed and stored for reinstallation.</div> <div>New timber fascia to match the height and thickness of the existing timber fascia. It is to be cut to size to fit the section that was removed.</div> <div>Fix new timber fascia portion to rafters. The seam where the new timber fascia meets the existing one is to be sealed with an appropriate caulking and painted to match the rest of the fascia board.</div> <div><b>Preparation</b></div> <div>Wipe down timber fascia boards to remove grime, dust and flaking paint. Sand wood with 120 grit paper and finish off with 220 grit paper in the direction of the grain. Dust off.</div> <div>Fill holes and defects using an appropriate wood filler following the manufacturer's instructions. Note: the wood filler must be paint compatible. Once holes and defects have been filled, ensure to remove excess wood filler while it is wet. Allow 8 hours to dry. Sand to a smooth finish.</div> <div><b>Primer:</b></div> <div>Apply one coat of an appropriate timber primer to achieve a continuous film. Primer is to be applied following the manufacturer's specifications.</div> <div><b>Fishing coat:</b></div> <div>Apply an appropriate exterior paint following the manufacturer's instructions.</div> <div>Paint colour: WHITE</div>

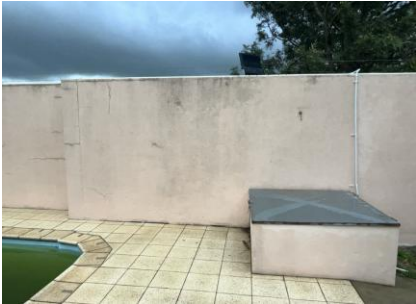
The swimming pool is in bad condition. The pool pump is broken and needs to be repaired. The swimming pool needs a deep clean. The existing swimming pool net was found in the garage, but its condition is unknown. The swimming pool net is to be reinstated or replaced with a new one.

<div>1.</div> <div>2.</div>	<p><b>NOTE: All repair work related to the swimming pool is to be completed by a swimming pool specialist.</b></p> <p><b>Investigate:</b></p> <p>The pool pump is to be inspected to identify the scope and extent of pump damage. Pool pump specialist to report findings to the architect.</p> <p><b>Repair</b></p> <p>The pool pump is to be repaired by a pool pump specialist.</p>

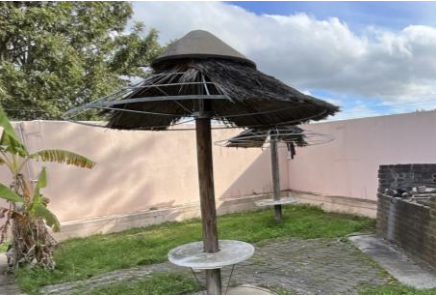
The thatch umbrellas adjacent to the swimming pool are in a dilapidated condition and require rethatching.

1.  2.  3.  4.	<p><b>NOTE: All repair work related to the thatch umbrellas is to be completed by a thatching specialist.</b></p> <p><b>1. Remove old thatch &amp; ridge cap:</b> Carefully remove all old thatch, taking care not to damage the metal frame. The thatching expert should take note of the existing fasteners/wires used to secure the thatch to the frame, as the same method of fastening is to be used. The existing ridge cap is to be removed and safely stored for reuse.</p> <p><b>2. Preparation:</b> Inspect and prepare the metal frame to ensure it is clean and sound before applying new thatch. Any structural damage is to be repaired by the specialist.</p> <p><b>3. New thatch:</b> Apply new thatch in layers, securing it to the frame with the same method used on the existing structure. The thatch is to be applied in strict accordance with the manufacturer's instructions.</p> <p><b>4. Umbrella Ridge:</b> Special care must be taken to ensure the ridge is finished properly and that the existing ridge cap is reinstalled or replicated to match existing if damgaed.</p>

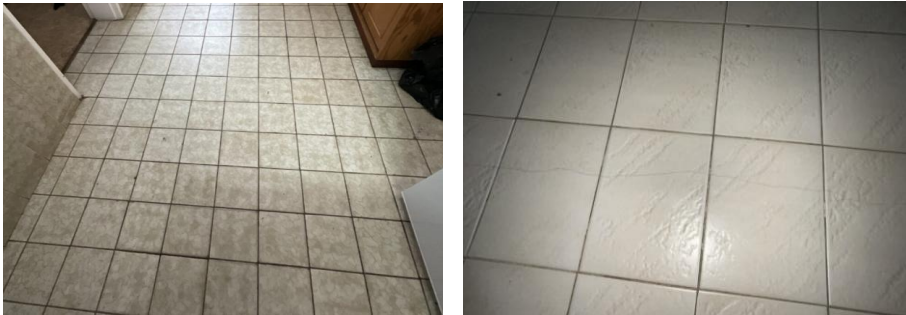
TYPE OF REPAIR	IMAGE	NR	REPAIR INSTRUCTION
CLEAN CERAMIC FLOOR TILE

1. Floor:  
The house has a variety of floor finishes in varying conditions.
- 1.1. Kitchen tile:  
The kitchen floor tile is in an acceptable condition with localised areas of damage.

1.	<b>Application:</b> Using soft brushes, mild detergents, and deionized water to remove dirt and grime without damaging the tiles. For more stubborn stains, carefully selected chemical agents can be used. It's essential to test these agents on a small, inconspicuous area first to ensure they do not cause harm.
REPLACE CREAM CARPET

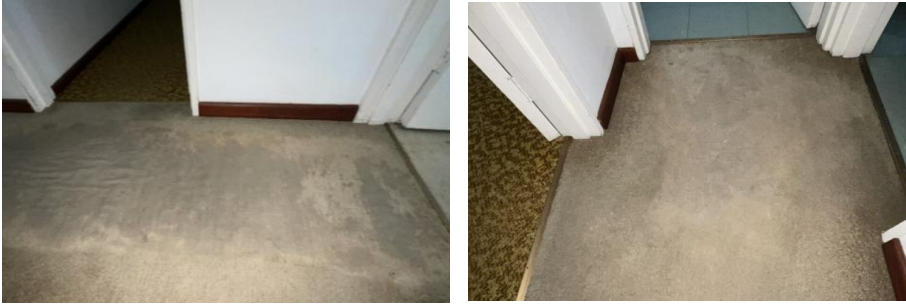
1.2. Cream-coloured carpet:  
The cream coloured carpet that runs from the master bedroom through to the passage shows signs of wear and tear, with a patch of severe water damage in a localised area where the roof used to leak, which has been repaired. Architects recommend a like-for-like replacement of this area. The carpet in the dining room (G03) and the sitting room (G02) is in a slightly better condition.

1.  2.  3.  4.	<b>Preparation:</b> Clear the rooms and passageways of furniture. The Furniture that is to be removed is to be handled with care and must be safely stored while new carpet is installed.  <b>Investigation:</b> A carpet specialist is to investigate the existing cream coloured carpet and recommend a like-for-like replacement.  <b>Remove existing cream coloured carpet:</b> Investigate if the carpet is glued down or stretch fitted (alternative name: broadloom stretch fitted) and use the appropriate method to remove the carpet. Note: extreme care must be taken not to damage the existing skirting board.  <b>New cream carpet:</b> New carpet to be installed according to the carpet specialist's specifications and detail. Colour and type of carpet to strictly adhere to the recommendations of the carpet specialist.

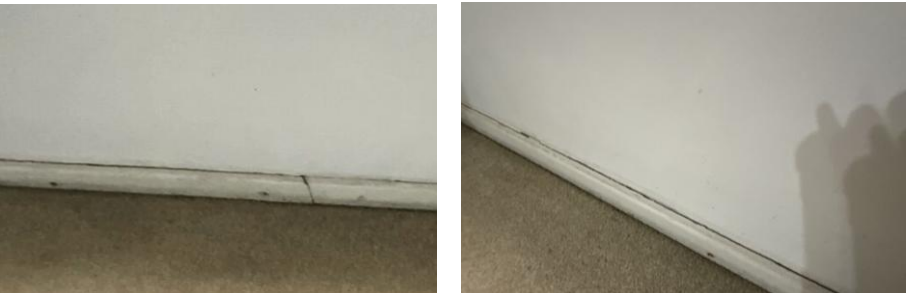
REFIX PAINTED SKIRTING

2.2. Painted timber skirting:  
The main bedroom has white painted timber skirting. The skirting is in an acceptable condition, with localised areas where it is starting to pull away from the wall.

<div>1.</div> <div>1.1</div> <div>1.2</div> <div>2.</div> <div>3.</div> <div>4.</div>	<p><b>Inspection:</b> 1.1 Visually inspect all painted skirting and identify areas that require to be refixed to wall. 1.2 Inspect nails of affected areas to identify if they are loose.</p> <p><b>Refixing skirting:</b> Loose nails are to be carefully hammered back into place with a hammer. Care must be taken not to damage the skirting board.</p> <p><b>Preparation - Recaulking:</b> Ensure timber painted skirting surfaces are clean of dirt, dust, loose paint and old caulking material or wood filler.</p> <p><b>Small Gaps:</b> For small gaps, apply a bead of an appropriate caulking material or wood filler along the opening. Ensure the caulking is finished off smoothly. The caulking material is to be applied following the manufacturer's specifications. Colour: WHITE</p>
REPAIR VINYL SKIRTING

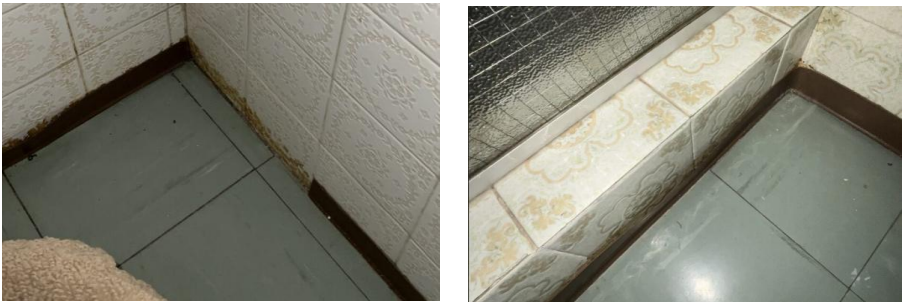
2.3. Vinyl skirting:  
The vinyl skirting can be found in the bathroom areas. They are in good condition with localised areas where they are pulling loose from the wall.
3. Walls:  
Interior walls appear to be in good condition.
- 3.1. Plaster and painted:  
All interior walls that are plastered have been painted white. There are areas of localised minor cracking in the plaster/ paint.

<div>1.</div> <div>1.1.</div> <div>1.2.</div> <div>1.3.</div> <div>2.</div>	<p><b>Refix Loose Vinyl Skirting:</b> 1.1. Visually inspect all vinyl skirting and identify areas that require to be refixed to the wall surface. 1.2. Remove old adhesive from vinyl skirting. Care must be taken not to damage skirting. 1.3. Using an appropriate adhesive, refix loose vinyl skirting to the wall surface. The adhesive must not cause damage to the historic wall tile or vinyl skirting. The adhesive must be applied in accordance with the manufactures specifications.</p> <p><b>New Vinyl Skirting to match existing:</b> Quantity surveyor to allow for total replacement. Total replacement to be confirmed at a later stage.</p>

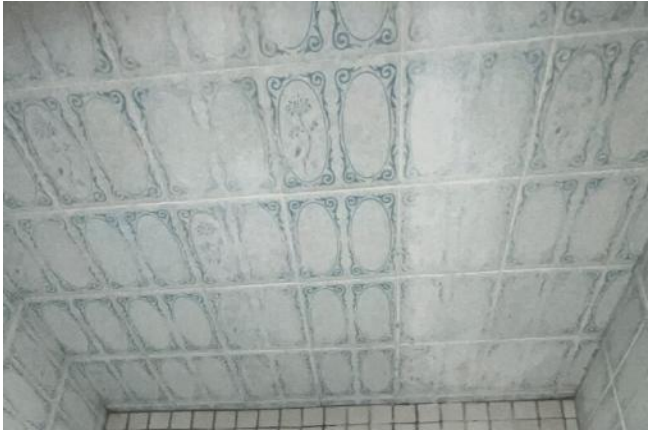
CLEAN WALL TILE

3.2. Wall tiles:  
A variety of historic wall tiles are present. All of the tiles are in excellent condition considering their age, with minor localised issues.  
The kitchen (G05) & scullery (G06) have beige veined wall tiles. Ensuite 1 (G11) has a blue tile with a floral pattern. There is evidence of past repairs in the bathroom, where original tiles were replaced with a simple white tile. Ensuite 2 (G13) has a beige tile with a leaf pattern present on some tiles. Toilet (G15) has a white tile with cream floral wreath patterns. Bathroom (G16) has a cream kaleidoscopic tile pattern. There is evidence of past repairs in the bathroom, where original tiles were replaced with a simple white tile.

<p><b>1.</b></p>	<p><b>Application:</b></p> <p>Using soft brushes, mild detergents, and deionized water to remove dirt and grime without damaging the tiles. For more stubborn stains, carefully selected chemical agents can be used. It's essential to test these agents on a small, inconspicuous area first to ensure they do not cause harm.</p>
REPAIR CEILING CRACKS

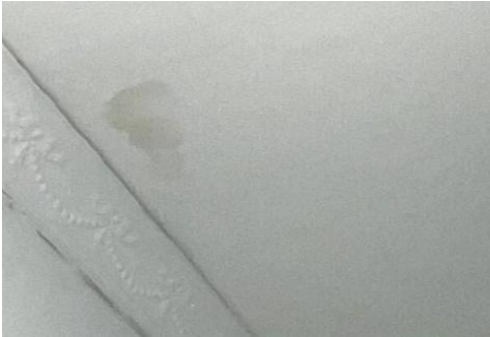
TYPE OF REPAIR	IMAGE	NR	REPAIR INSTRUCTION
CLEAN STAINED CEILING

4. Ceilings:  
The house has gypsum plasterboard ceilings that are painted white. Passage 1 (G08), passage 2 (G09), main bedroom (G10), study /clinic (G18), entrance lobby (G01), sitting room (G02) and dining room (G03) have a ceiling medallion. Pantry (G07), bathroom (G16) & bedroom 4 (G17) have half-round ceiling strip joints. All other rooms have a plain standard ceiling. The ceilings are in excellent condition with localised cracks and minor water damage evident.

1.	<b>Clean Water Damaged Area</b> Clean ceiling with an appropriate mould remover or bleach. Care must be take not to spill the mould remover or bleach onto any other surface.
REPAINT CEILING		1.	<b>New Paint:</b> Repaired damaged ceiling areas and repaired water-damaged areas are to be primed with an appropriate primer, applied according to manufacturer's instructions  Repaired damaged ceiling areas and water-damaged areas are to be repainted with an appropriate PVA Paint. Paint to be applied following the manufacturer's instructions. Colour: WHITE
REPAIR 75MM STANDARD GYPSUM COVED CORNICE

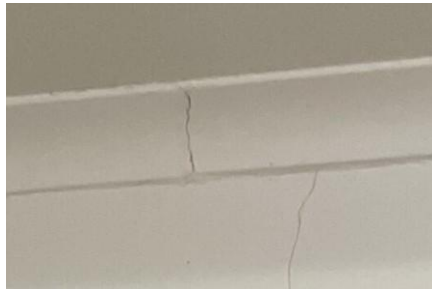
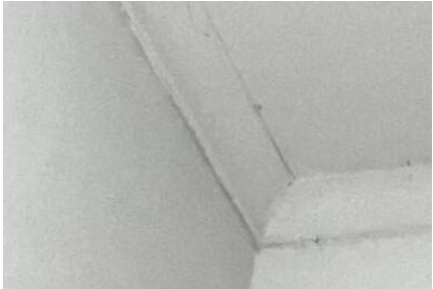
5. Cornice:  
Three different cornices were used inside the house. In the kitchen (G05), bathrooms (G11, G13, G15 &G16 ), scullery (G06), pantry (G07), bedroom 3 (G14). Secondary bedrooms (G12, G14, G17) have a 75mm standard gypsum coved cornice, painted white. In the main bedroom (G10), passageways (G08 & G09), study/clinic (G18), entrance lobby (G01), and dining room (G03), have a 135 mm standard gypsum garland cornice, painted white. The sitting room (G02) has an unidentifiable triple band cornice that is unique to this room. The cornices are in an acceptable condition with localised issues.

1.  2.  3. 3.1. 3.2. 4. 4.1. 4.2.	<b>Investigation:</b> Visually inspect all standard cornices to identify small cracks and areas where it is pulling loose from the ceiling or wall.  <b>Preparation</b> Ensure the affected cornice area is clean of dirt, flaking paint, and debris.  <b>Small Cracks</b> 3.1. Apply an appropriate crack filler to the affected area following manufacturer instructions. 3.2. Sand down and prime the repaired area with an appropriate primer.  <b>Cornice Pulling Loose</b> 4.1. Apply an appropriate acrylic sealant to the areas where cornice is pulling loose. 4.2. Touch up repaired areas with a PVA paint. Colour: WHITE

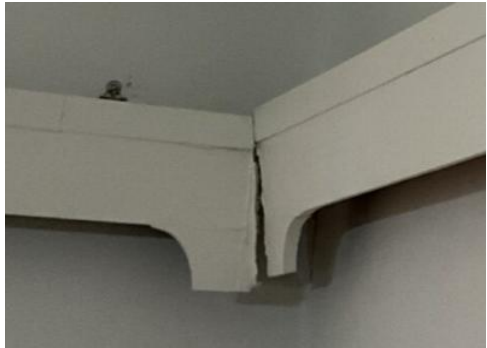
7. Pelmets:  
Most curtain pelmets are in acceptable condition with localised damage. Pelmets are made from timber boards that have been painted white, except for the study/clinic (G18), which has a varnished timber pelmet.

<div>1.</div> <div>2.</div> <div>3.</div> <div>3.1.</div> <div>3.2.</div> <div>3.3.</div> <div>3.4.</div>	<p><b>Inspection:</b> Contractor to inspect the pelmet fixings to ensure any loose screws etc. are tightened and that the pelmet is properly fixed to wall.</p> <p><b>Preparation:</b> Remove dirt, old glue or damaged timber from the pelmet joint using a scraper or chisel as needed.</p> <p><b>Repair Pelmet:</b> 3.1. Glue the two parts of the pelmet together with an appropriate wood glue. 3.2. Fix the two parts of the pelmet together by installing a 40 mm x 40 mm stainless steel bracket behind the joint where the two pelmets meet, where it will not be visible. 3.3. The stainless steel bracket is to be attached to the pelmet with screws. Note screw must not stick out the front of the pelmet. 3.4. Once the two are joined, seal the front of the pelmet joint with an appropriate caulking material that is paint friendly. Ensure the joint is neat.</p>

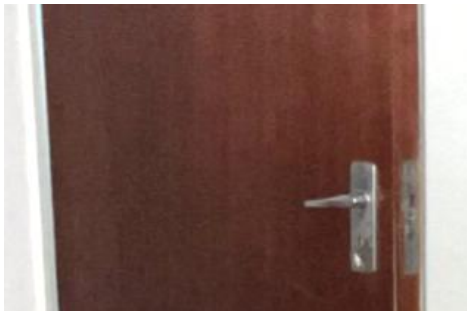
INSTALL NEW BRASS DOORKNOB BEDROOM 2 (G12)

9. Ironmongery:  
The house features a variety of ironmongery that appears to be in acceptable condition with localised issues. The Scullery (G06) window has a side-opening leaf that is missing its bottom hinge. In the main bedroom (G10), most of the internal cupboard closers are broken. In bedroom 2 (G12), a new, historically incorrect door handle has been installed where a round brass doorknob used to be.

<div>1.</div> <div>2.</div>	<p><b>Preparation</b> Remove the existing lever door handle. Care must be taken not to damage the door.</p> <p><b>New door knob</b> Install new Union Weaver Knob Furniture Euro Escut PL, or similar round brass knob with round brass rose, following the manufacturer's instructions. Finish: BRASS <i>Note: The Union Weaver Knob Furniture Euro Escut PL is the closest locally available knobset to match the knob furniture that was present in 2013 when the CMP was compiled.</i></p>
REPAIR TAP LEAK IN ENSUITE 1 ( G11)
