**A PHASE ONE GEOTECHNICAL REPORT ON THE REMAINDER OF THE  
FARM PALMIETFONTEIN 3750 IN DANNHAUSER FOR A PROPOSED NEW  
INDUSTRIAL TOWNSHIP ESTABLISHMENT**

Report Number: 2019/J018/KVD

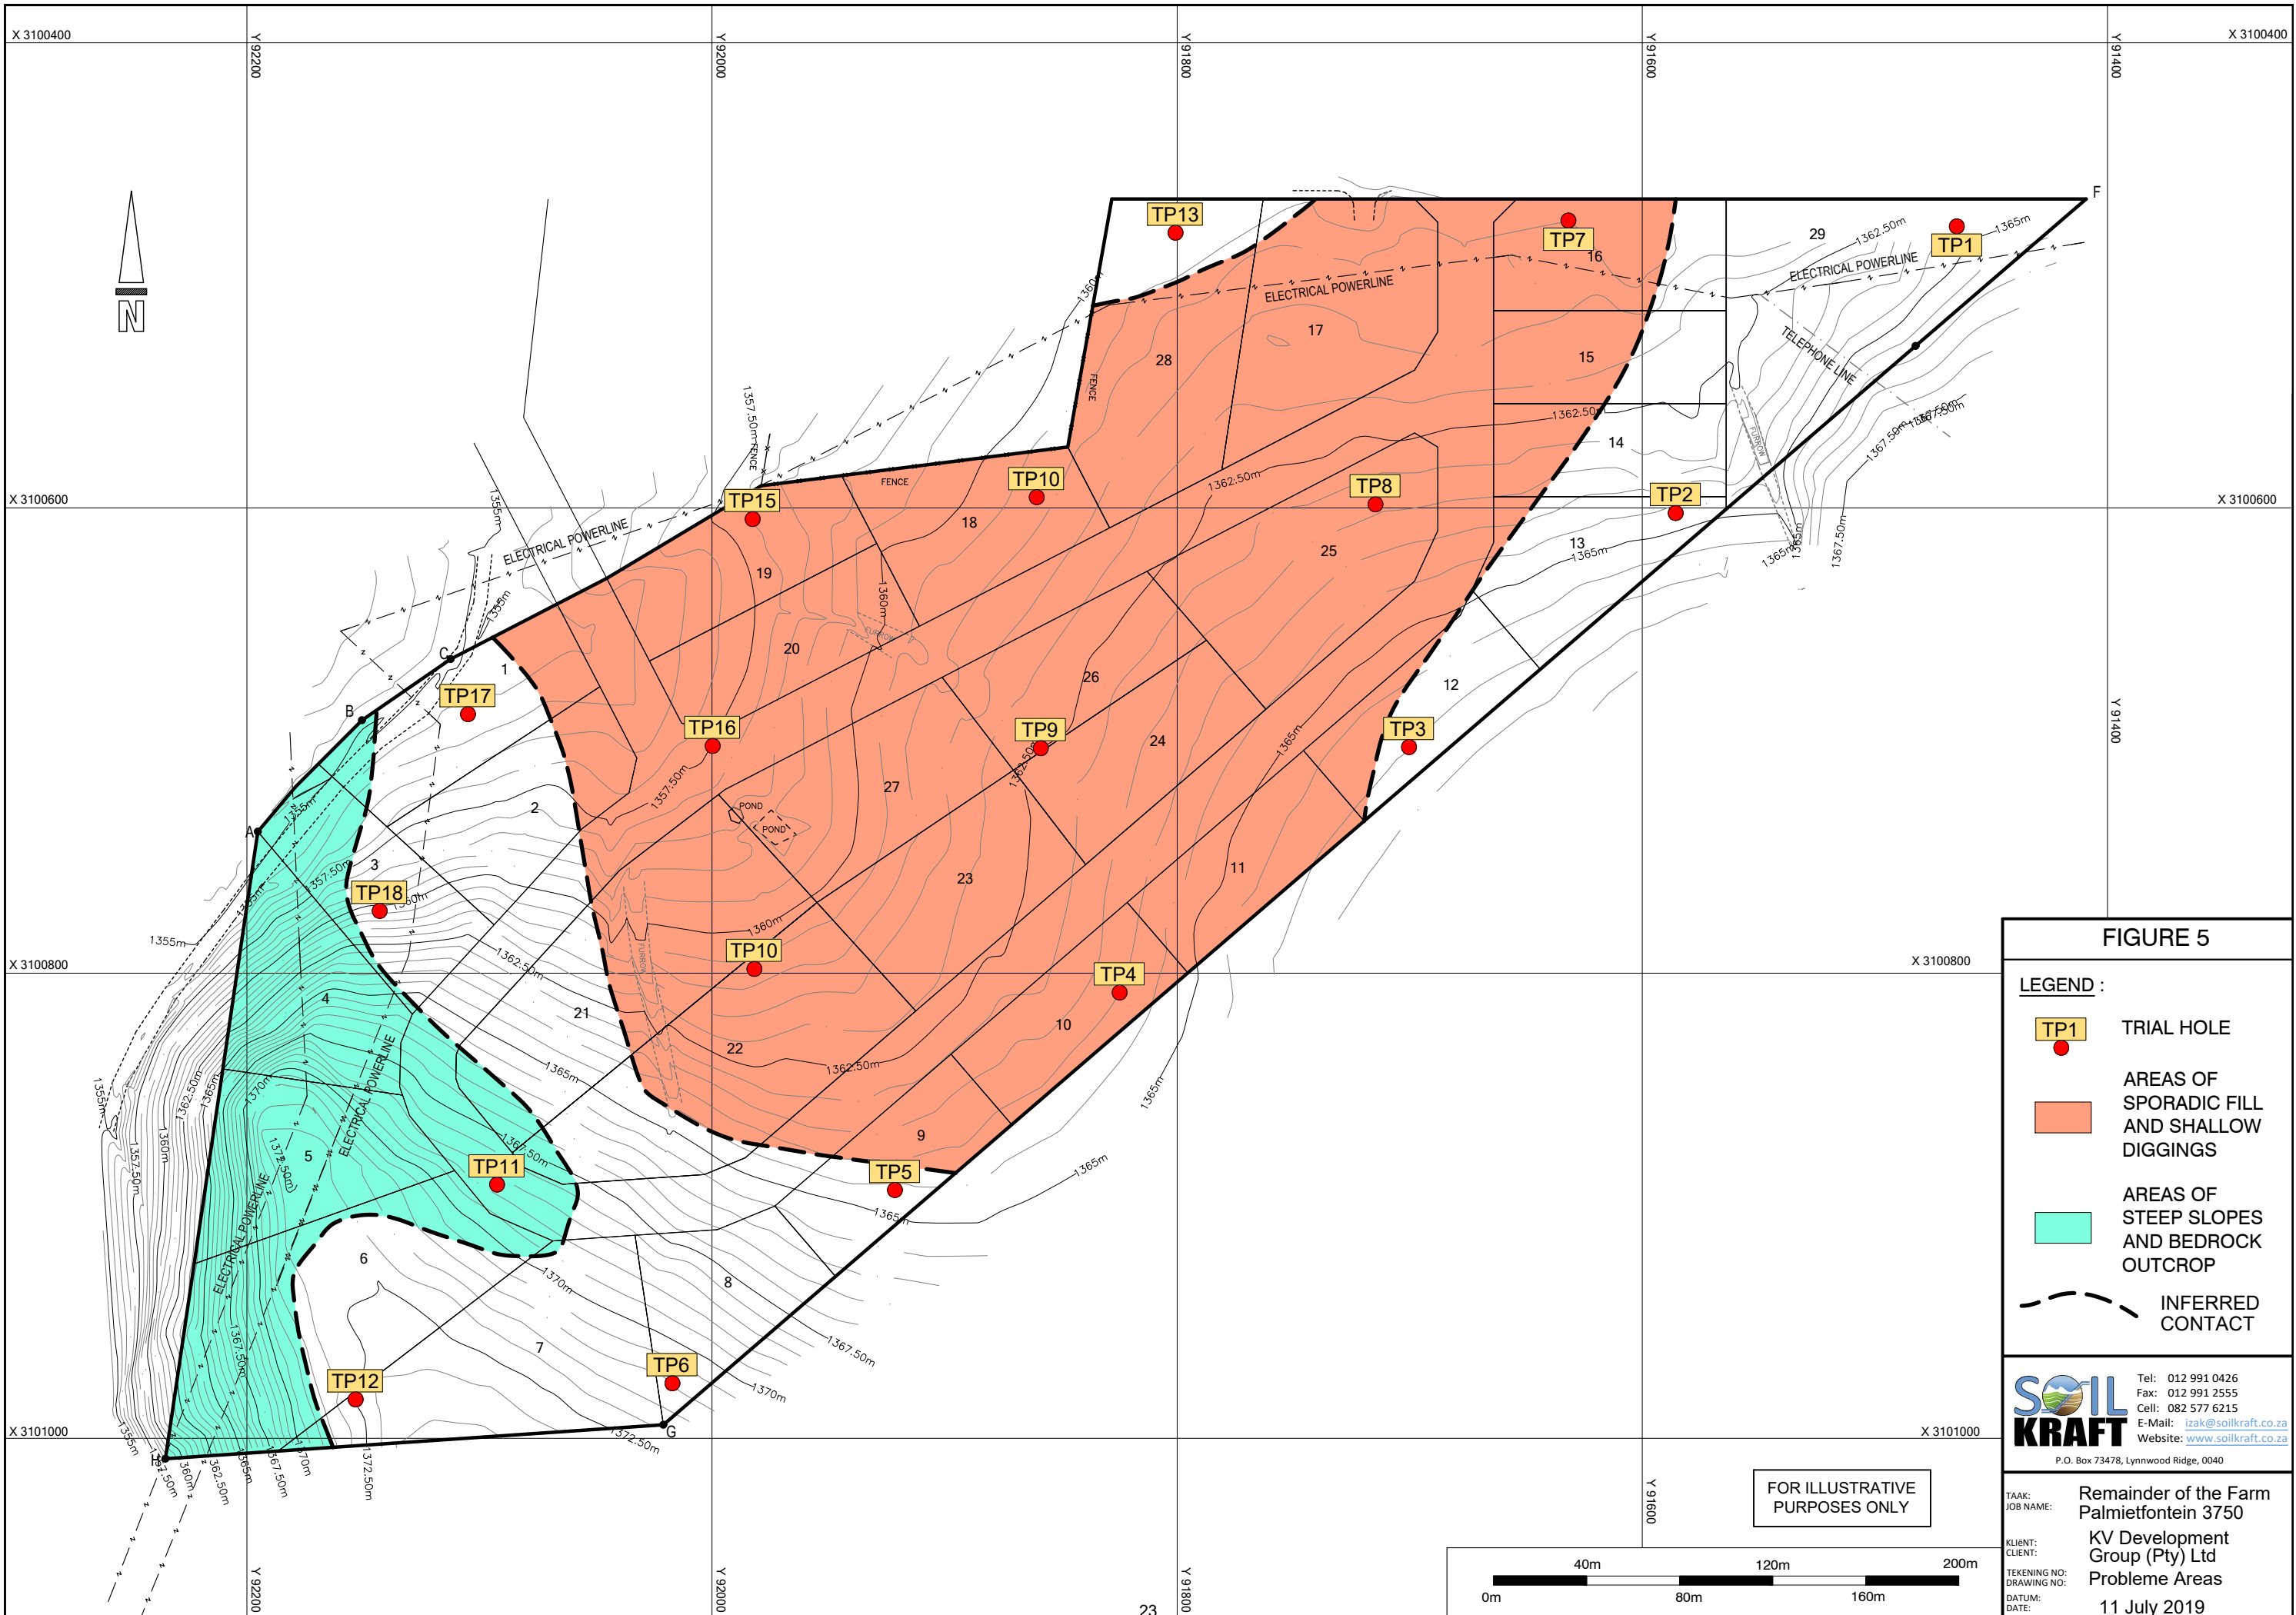
FIGURE 5

In addition to the geotechnical zoning, certain problematic aspects need to be highlighted that may further affect the proposed development. Though already discussed to some extent above, Figure 5 shows areas which require particular attention, as follows:

- *Areas of Steep Slopes and Rock Outcrop:* Large parts of the western side of the study area are characterised by bedrock outcrop and associated steep slopes, as illustrated in Photo 5 and Photo 6. To complicate matters, the contact between geotechnical zones 2 and 3 is not clear, as zone 2 is associated with abundant dolerite boulders and cobbles, while zone 3 is associated with bedrock outcrop. It is therefore difficult to discern (on surface) which rock materials constitute bedrock and which constitute loose lying boulders protruding the surface.

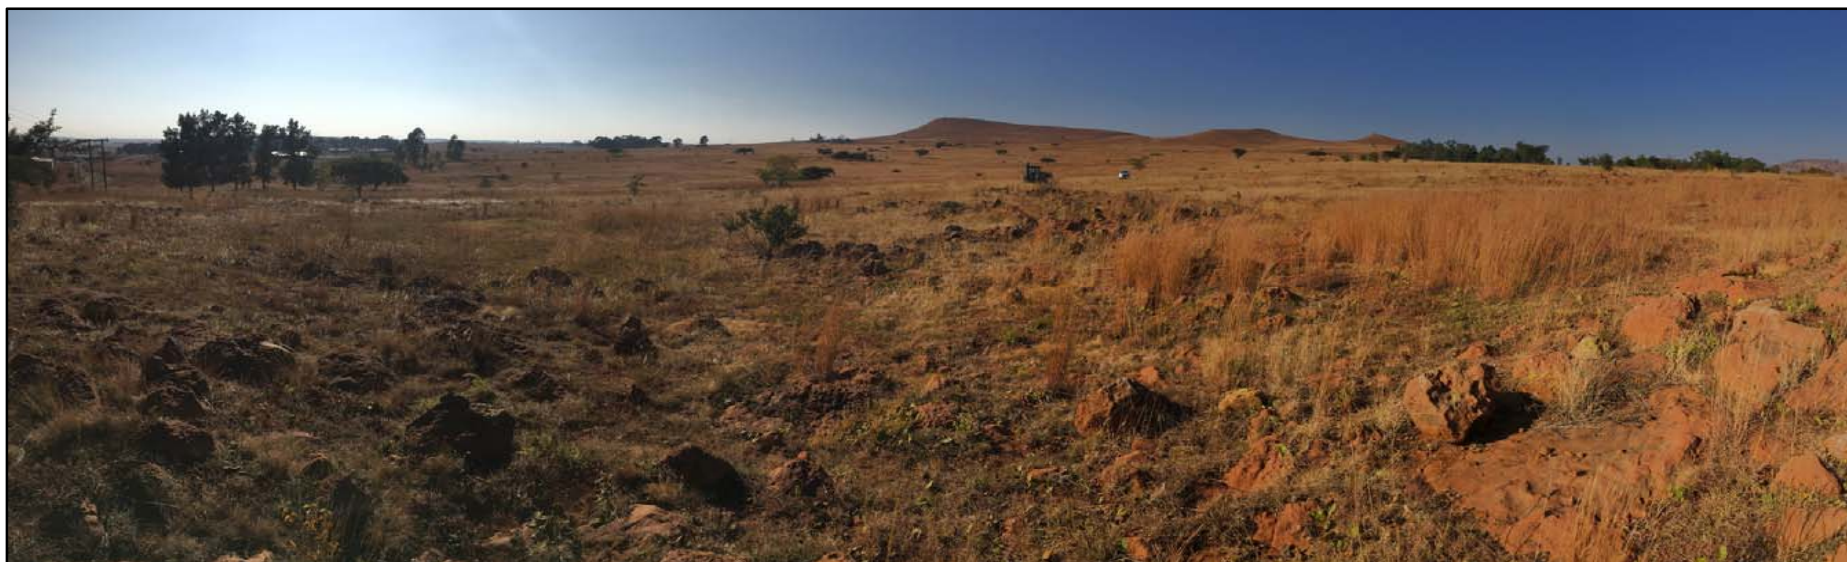
**PHOTO 5**

**AREAS OF BEDROCK OUTCROP AND SURFACE BOULDERS**

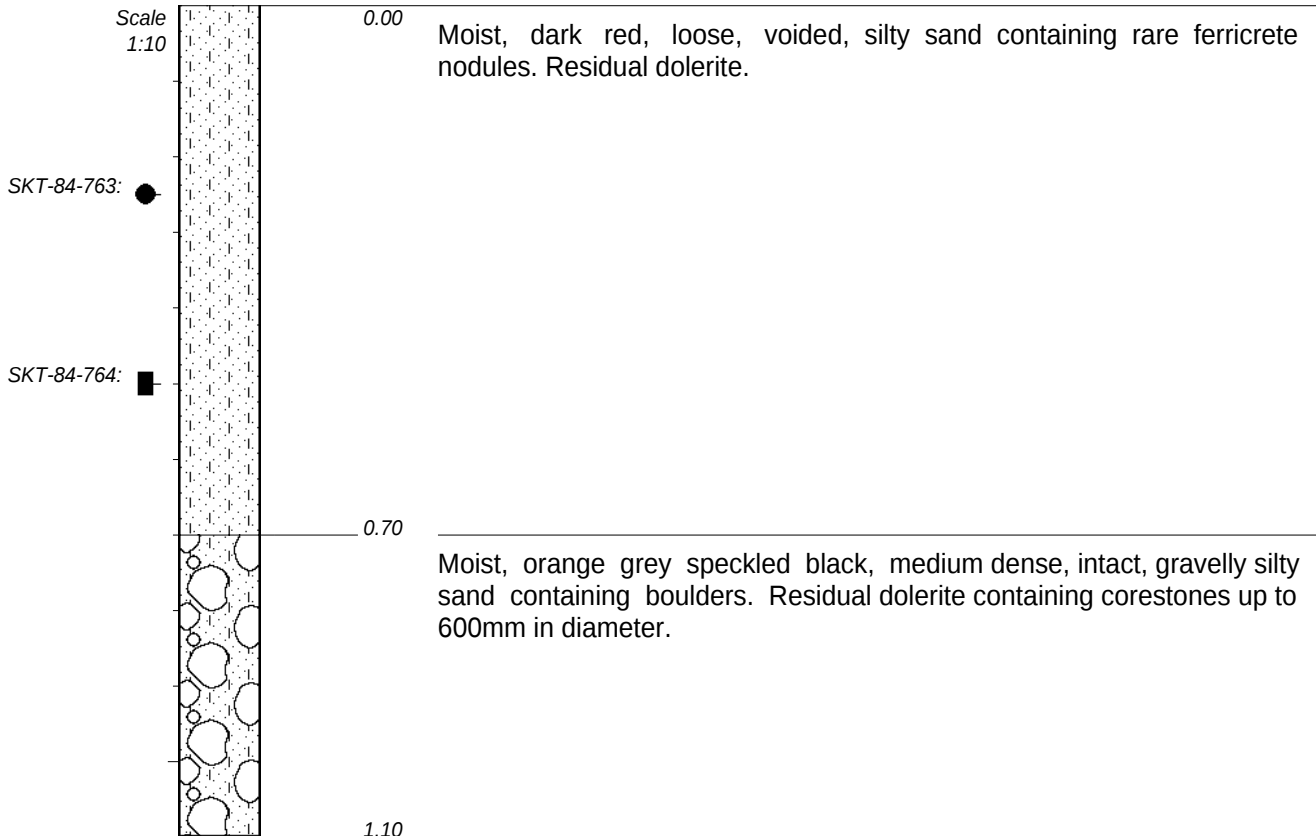
**HOLE No: 5**  
**Geotechnical Investigation**

- 1) Refusal of excavation on corestones.
- 2) No seepage.
- 3) Disturbed Sample SKT-84-763: 0.25m.
- 4) Undisturbed Sample SKT-84-764: 0.50m.

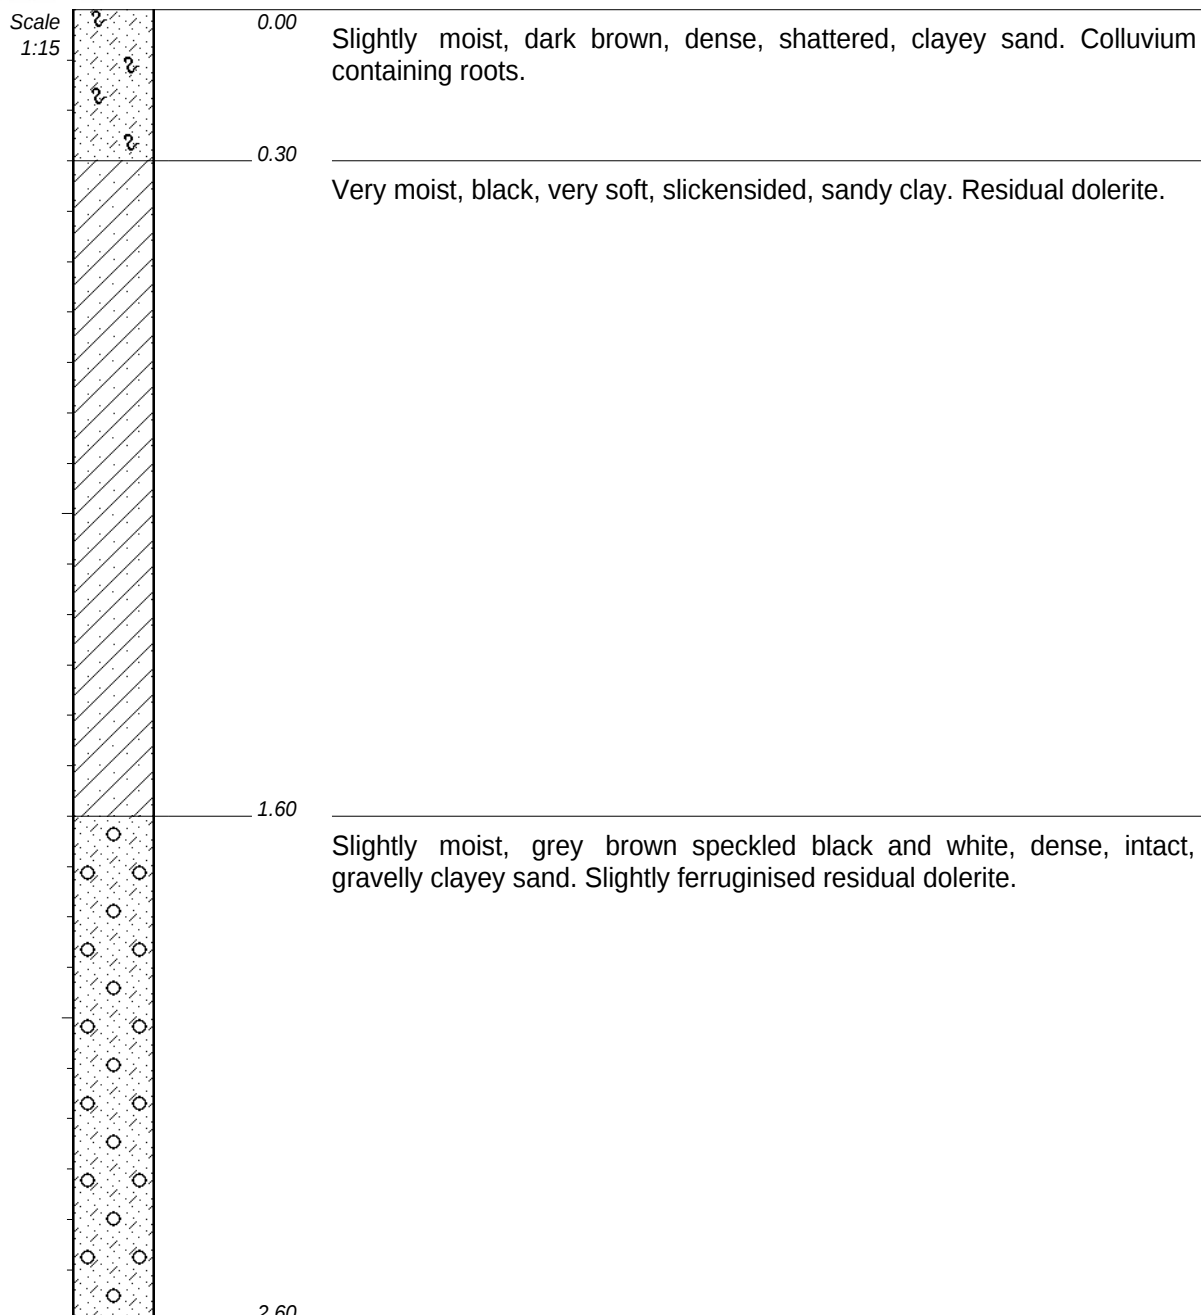
**HOLE No: 6**  
**Geotechnical Investigation**

- 1) No refusal of excavation.
- 2) No seepage.

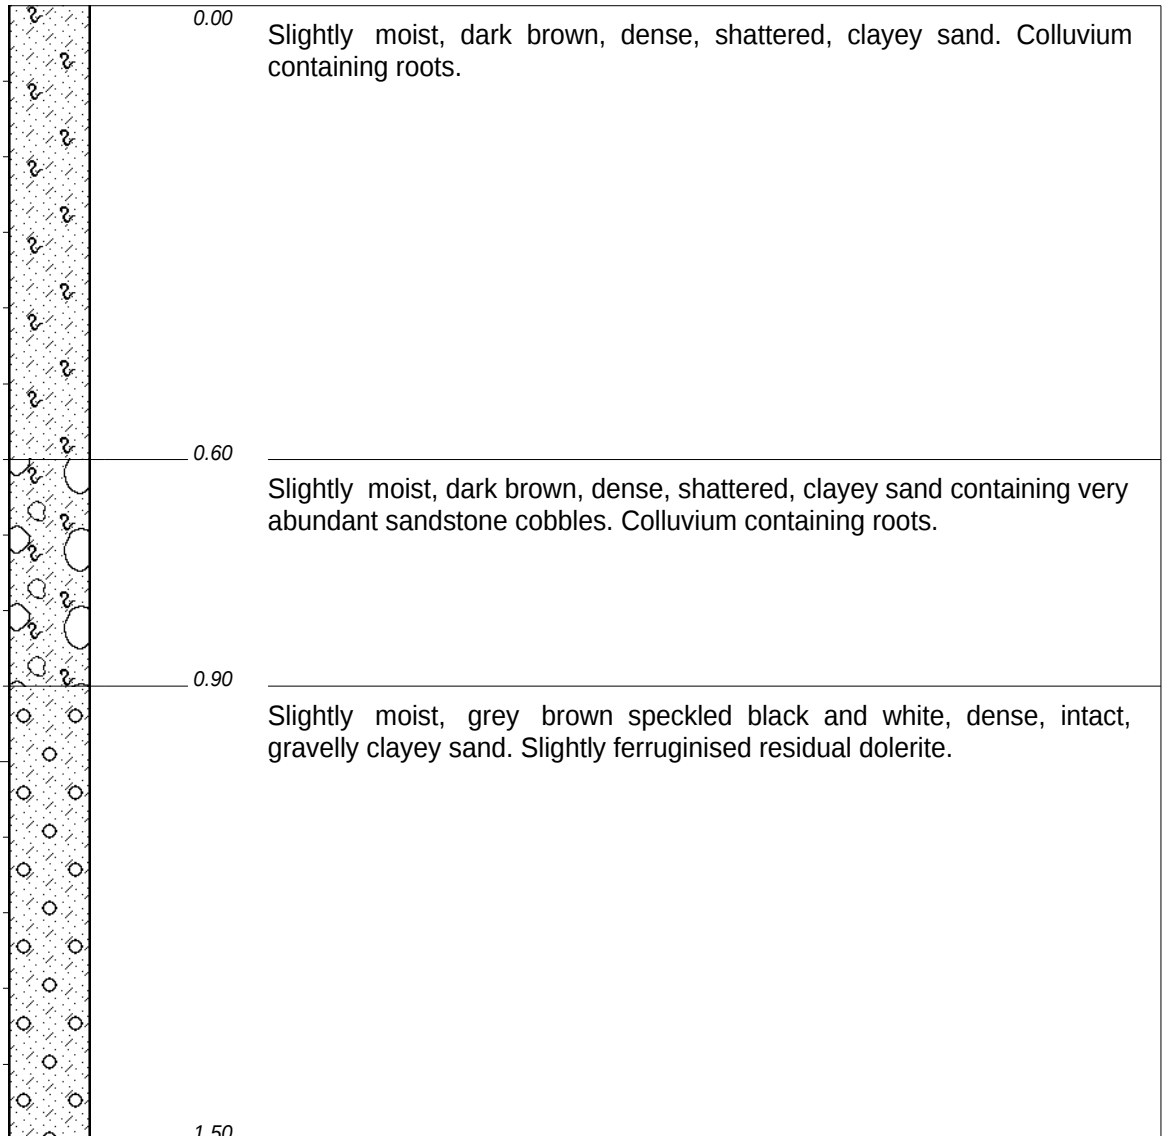
**HOLE No: 7**  
**Geotechnical Investigation**

- 1) Instant refusal of excavation, presumably on dolerite bedrock.
- 2) No seepage.
