Strategy	Medupi Power Station Project
---	-----------------	-------------------------------------

Title **Rehabilitation Strategy and Implementation Plan for Medupi Power Station (RSIP)**

Document Identifier: **348-77837**

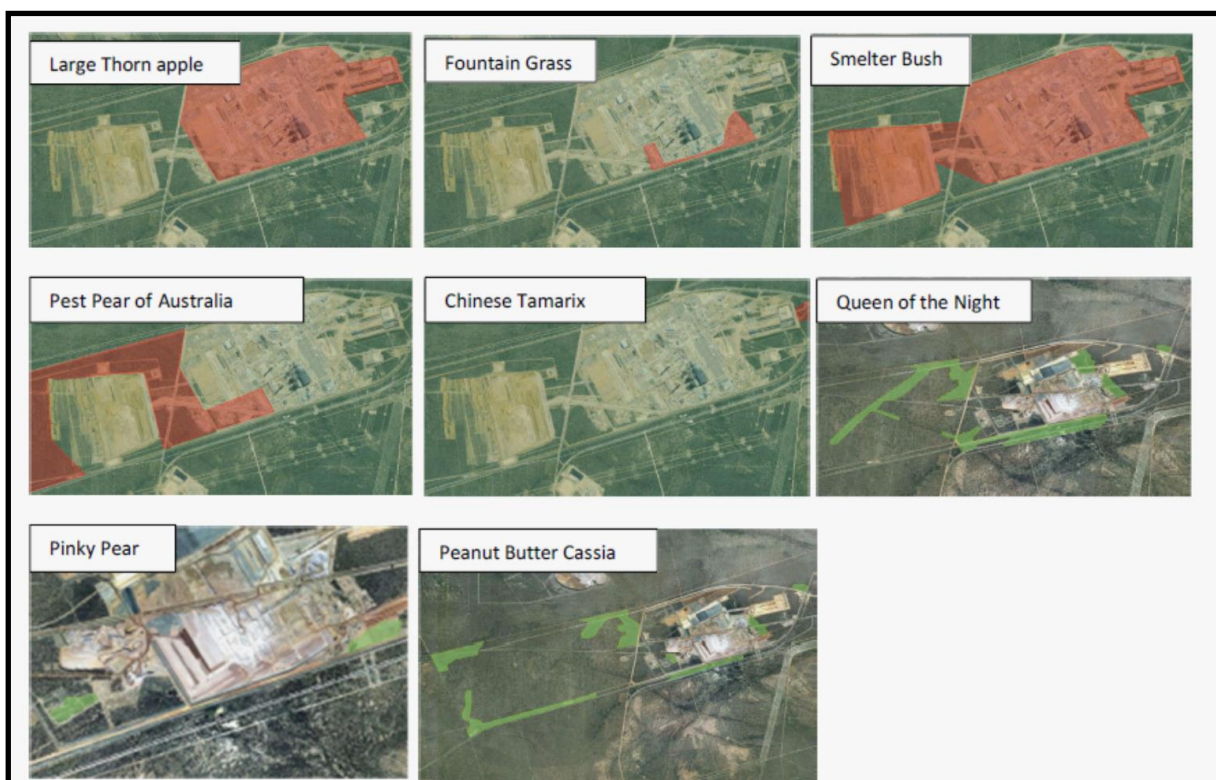
Figure 2 Location of identified alien and invasive species within Medupi Power Station Footprint

Several Alien and Invasive species were recorded during Alien and Invasive species survey that was conducted by the Specialist/ Botanist. The majority of alien and invasive species were recorded at locations that have been disturbed during construction activities (See table 6; Table 7 and Figure 2). Few were recorded from topsoil stockpile and within intact vegetation types.
