FLEET PLANNING
WORK INSTRUCTION

SAMPLE TESTING PROCEDURE FOR XB-5, 8, 9,10, 11, 12, 13, & 14 TANK
WAGONS :2024/2025

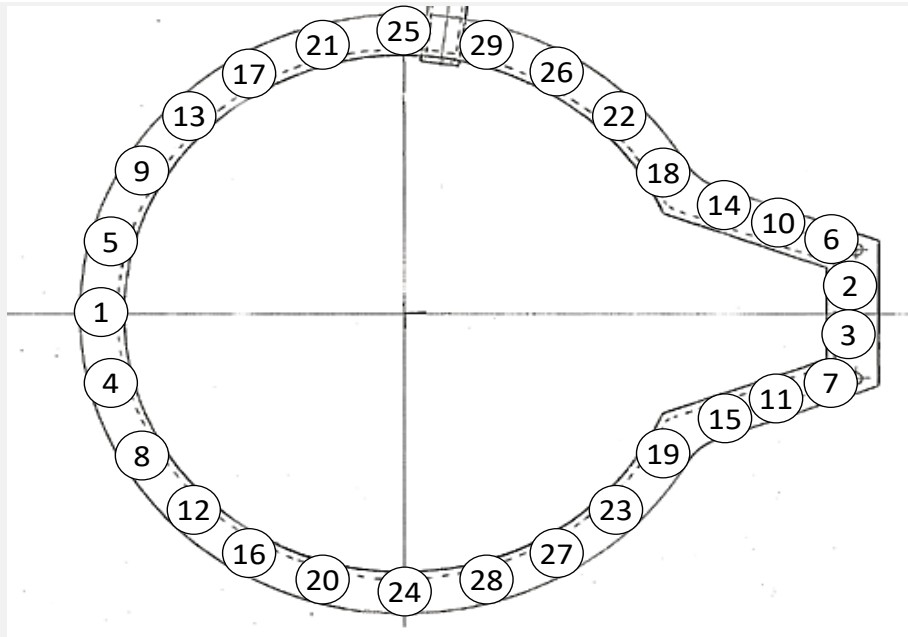
Figure 1: Illustration of 'Spiral Pattern' for tightening sequence of bolts/nuts

5.3.	Torque bolts/nuts in a clockwise "SPIRAL" pattern to the required torque value of 210 Nm as shown in Figure 1. Start at Position 1 and move sequentially up to Position 29. Repeat this sequence three (3) times as follows:

5.3.1.	Using a torque wrench, tighten to a maximum of 30% of the required torque value (approximately 60 Nm). Check that flange is compressed uniformly.

5.3.2.	Using a torque wrench, tighten to a maximum of 60% (approximately 120 Nm). Check that flange is compressed uniformly.
5.3.3.	Using a torque wrench, tighten to 100% of the required torque value, 210 Nm.
