A DIVISION OF TRANSNET SOC LIMITED

FLEET PLANNING WORKS INSTRUCTION

**SAMPLE TESTING PROCEDURE FOR XB-5, 8, 9,10, 11, 12, 13, & 14 TANK
WAGONS: 2025/2026**

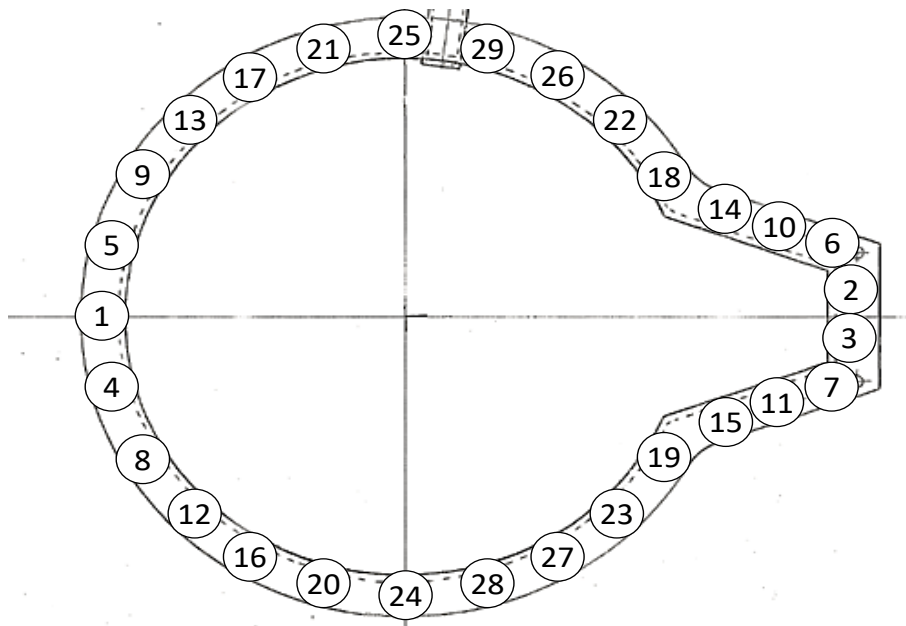
Figure 1. Illustration of 'Spiral Pattern' for tightening sequence of bolts/nuts

- 4.3. Torque bolts/nuts in a clockwise "SPIRAL" pattern to the required torque value of 210 Nm as shown in Figure 1. Start at Position 1 and move sequentially up to Position 29. Repeat this sequence three (3) times as follows:

- 4.3.1. Using a torque wrench, tighten to a maximum of 30% of the required torque value (approximately 60 Nm). Check that flange is compressed uniformly.

- 4.3.2. Using a torque wrench, tighten to a maximum of 60% (approximately 120 Nm). Check that flange is compressed uniformly.
 - 4.3.3. Using a torque wrench, tighten to 100% of the required torque value, 210 Nm.
