OUTAGE SCOPE OF WORK FORM/TEMPLATE	Template Identifier	240-98982530 (Rev 2)
		Doc Identifier	14593
		Doc Revision	1
		Effective Date	16 February 2021
		Eskom	Page 1 of 31

Matla Power Station Outage Scope of Work	Reference No.	MEB-054694
	Revision:	1
	Unit No.	Generic GO
	Genix ID.	Generic GO
	Date:	NA

Outage Type:	GO	Outage Start Date:	Generic
Department:	Boiler Engineering	Plant Area:	PF Piping
Scope Review Date:	NA	Discipline:	Mechanical

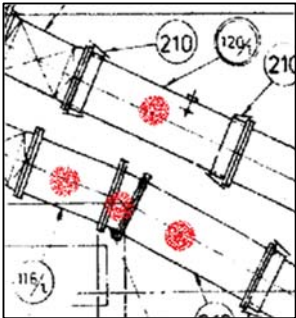
SCOPE:		REPLACEMENT AND REFURBISHMENT		
SUBSYSTEM:		9.4.1 Milling Plant		
COMPONENT ACTIVITIES			GOVERNING DOCUMENTS	
No	DETAILED ACTIVITY DESCRIPTION	WORK SPEC & CHECK SHEET NO.	HOLD, WITNESS, REPORTS	RESPONSIBLE PARTY
5.	<p>Pipes (946 horizontal) 116, R28, 212, 120 directly after the two PF isolating dampers needs to be fully tiled (staggered) with 12mm weld-on tiles.</p>

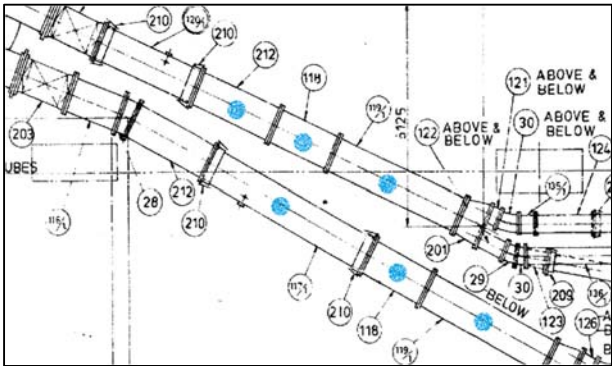
6.	<p>Pipes (946 horizontal) 117,118,119 and 212 to be tiled on the bottom to a height of 570mm. Tiles need to be staggered. Edges of all tiling sections need to be in a straight line achieved by means of smaller fill-in tiles. All discontinuities and steps to be smoothed with wear resistant beaded epoxy and the tiling sections edged/framed with 6mm finger tiles.</p>

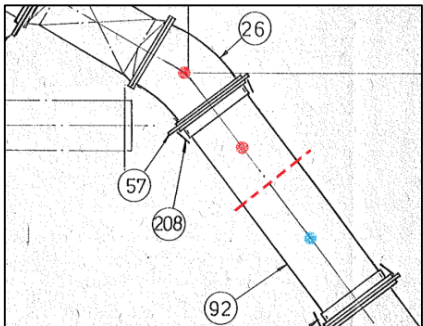
15.	<p>Pipe (1335 horizontal) 26 directly after the two PF isolating dampers needs to be fully tiled with 12mm weld-on tiles and pipe 92 needs to be fully tiled 2.5m from pipe 26. The rest of pipe 92 can be tiled halfway to a height of 800mm. Tiles need to be staggered. Edges of all tiling sections need to be in a straight line. All discontinuities and steps to be smoothed with wear resistant beaded epoxy and the tiling sections All discontinuities and steps to be smoothed with wear resistant beaded epoxy and the tiling sections edged/framed with 6mm finger tiles.</p>

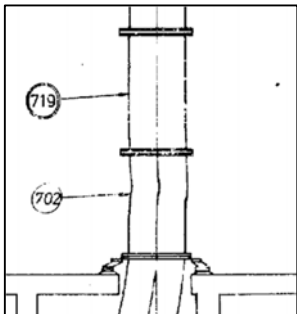
19.	<p>The vertical 1335mm pipes (702 and 719) needs to be wear protected with 12mm weld-on alumina tiles (100% of circumference).</p>

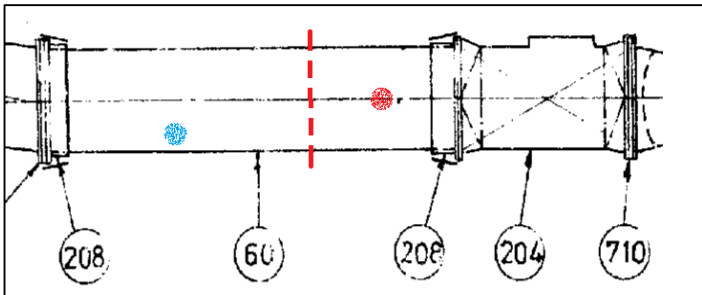
27.	<p>Pipe (1335 horizontal) 60 directly after the two PF isolating dampers needs to be fully tiled with 12mm weld-on tiles 2.5m from the PF isolating damper. The rest of pipe 60 can be tiled halfway to a height of 800mm. Tiles need to be staggered and the edges of all tiling sections need to be in a straight line. All discontinuities and steps to be smoothed with wear resistant beaded epoxy and the tiling sections edged/framed with 6mm finger tiles.</p>

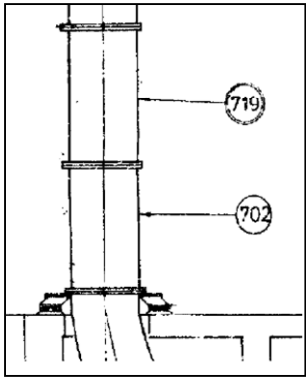
30.	Horizontal pipes joints need to be dressed as per Appendix B.	Appendix B	Witness	Tile-Contractor
31.	<p>The vertical 1335mm pipes (702 and 719) needs to be wear protected with 12mm weld-on alumina tiles (100% of circumference) staggered.</p>

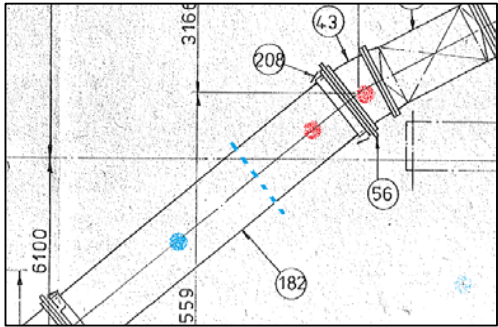
39.	<p>Pipe (1335 horizontal) 43 directly after the two PF isolating dampers needs to be fully tiled with 12mm weld-on tiles and pipe 182 needs to be fully tiled 2.5m from pipe 43. The rest of pipe 182 can be tiled halfway to a height of 800mm. Tiles need to be staggered and the edges of all tiling sections need to be in a straight line. All discontinuities and steps to be smoothed with wear resistant beaded epoxy and the tiling sections edged/framed with 6mm finger tiles.</p>

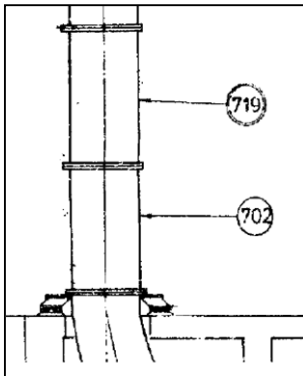
43.	<p>The vertical 1335mm pipes (702 and 719) needs to be wear protected with 12mm weld-on alumina tiles (100% of circumference) staggered.</p>

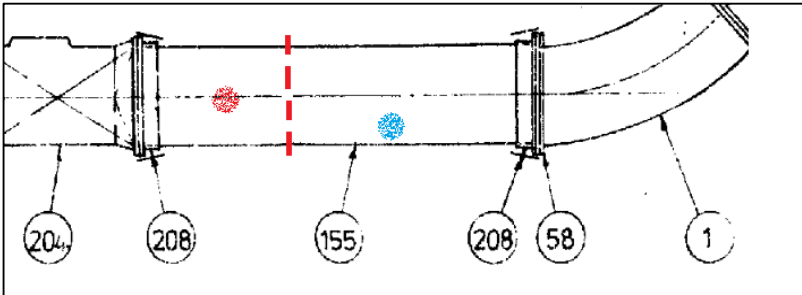
51.	<p>Pipe (1335 horizontal) 155 directly after the two PF isolating dampers needs to be fully tiled with 12mm weld-on tiles 2.5m from the PF isolating damper. The rest of pipe 155 can be tiled halfway to a height of 800mm. Tiles need to be staggered and the edges of all tiling sections need to be in a straight line. All discontinuities and steps to be smoothed with wear resistant beaded epoxy and the tiling sections edged/framed with 6mm finger tiles.</p>

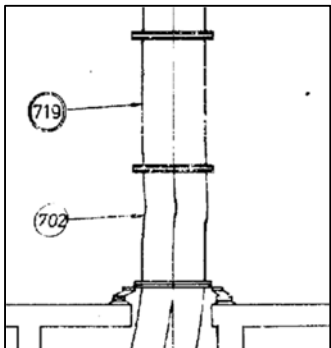
54.	Horizontal pipes joints need to be dressed as per Appendix B.	Appendix B	Witness	Tile-Contractor
55.	<p>The vertical 1335mm pipes (702 and 719) needs to be wear protected with 12mm weld-on alumina tiles (100% of leading circumference) staggered.</p>

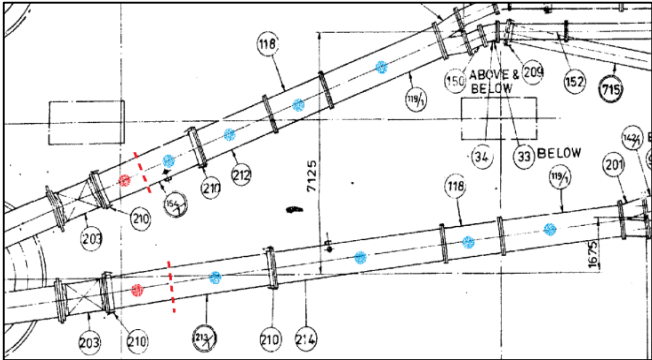
63.	<p>Pipes (946 horizontal) 154 & 213 directly after the two PF isolating dampers need to be fully tiled with 12mm weld-on tiles to 2.5m from the PF isolating damper. The rest of 154 & 213 pipes can be tiled halfway to a height of 570mm. Tiles need to be staggered and the edges of all tiling sections need to be in a straight line. All discontinuities and steps to be smoothed with wear resistant beaded epoxy and the tiling sections edged/framed with 6mm finger tiles.</p>

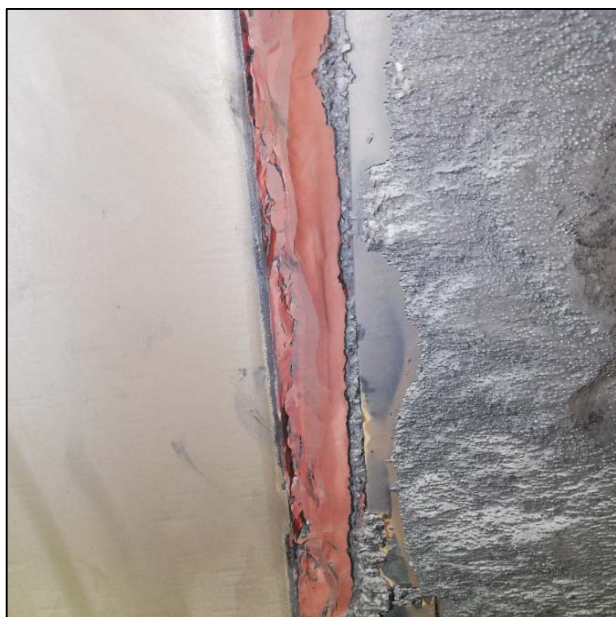
A.)

APPENDIX B – PIPE JOINTS

All joints need to be dressed with epoxy that overlaps the pipe joint to the adjacent pipe's tiles, taking care not to create unnecessary steps.

8.	Horizontal pipes joints need to be dressed as per Appendix B.	Appendix B	Witness	Tile-Contractor
9.	Remove all spool pieces, bends and straights (121, 122, 126, 127, 29, 30, 31, 135, 123, 124, 128, 136) for internal inspection, repair, tiling and/or replacement.	0.47-21747	Report	Tile-Contractor

65.	Horizontal pipes joints need to be dressed as per Appendix B.	Appendix B	Witness	Tile-Contractor
66.	Remove all spool pieces, bends and straights (140, 139, 142, 147, 94, 150, 152, 34, 33, 209) from both the 4-way splitter boxes for internal inspection, repair, tiling and/or replacement	0.47-21749	Report	Tile-Contractor

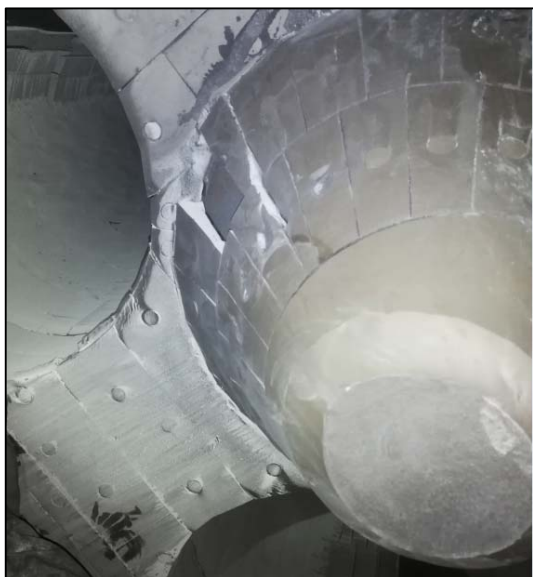
A.)

APPENDIX C – SPLITTERBOX NOSE CONES

Note worn out nose cones (A.) needs to be build up with wear resistant alumina beaded epoxy and M6 bolts or threaded studs and (B.) nose cones with worn out tiling cement needs to be rebuild by plastering wear resistant alumina beaded epoxy over the first 250mm of the cone.

13.	Build-up the nose cone with a layer of epoxy taking care to fill worn-out tile grout between the tiles. If the splitter box ceramic nose cone is worn down to the inner cement layer, the remaining nose cone tiles removed and a new section of nose cone welded in and tiled and caped with a new ceramic nose cone.	0.47-46937 Ceramic beaded epoxy - 160224	Witness	Tile-Contractor

25.	Build-up the nose cone with a layer of epoxy taking care to fill worn-out tile grout between the tiles. If the splitter box ceramic nose cone is worn down to the inner cement layer, the remaining nose cone tiles removed and a new section of nose cone welded in and tiled and capped with a new ceramic nose cone.	0.47-46938 Ceramic beaded epoxy - 160224	Witness	Tile-Contractor
