Title	<b>Kriel Power Station: Raw Water Reservoir Assessment and Remediation of Liner</b>	Unique Identifier	<b>EAP0543</b>
		Alternative Reference Number	<b>N/A</b>
		Area of Applicability	<b>Engineering</b>
		Documentation Type	<b>Specification</b>
		Revision	<b>1.0</b>
		Total Pages	<b>17</b>
		Next Review Date	<b>N/A</b>
		Disclosure Classification	<b>CONTROLLED DISCLOSURE</b>

The scope of work is to clean, conduct detail assessments and execution of remedial works to bring Kriel Power Station Raw Water Dam compartments' (East & West) back to original design.

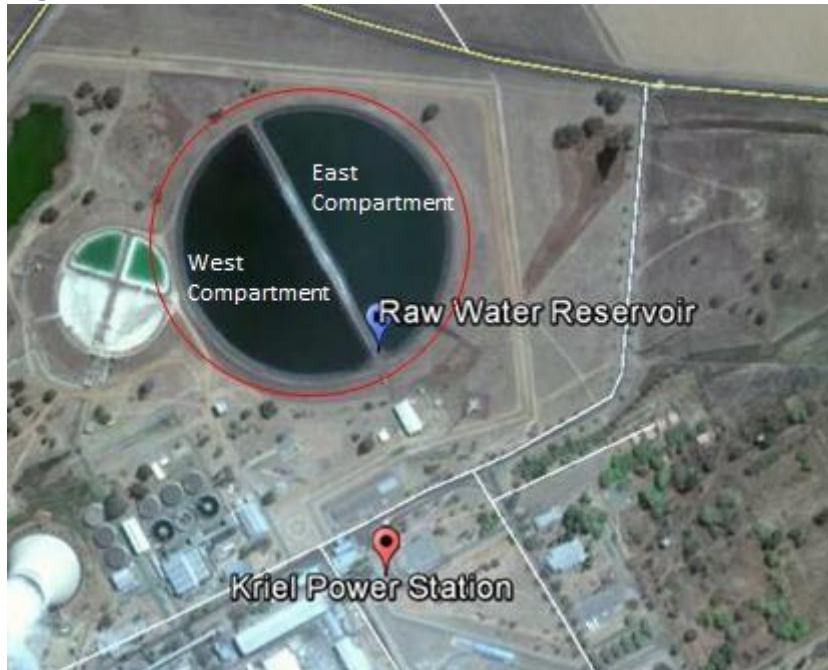
**Figure 1 Raw Water Reservoir Location**

The raw water reservoir is circular in shape and consists of two compartments (east and west) of total storage capacity of 680ML (figure 1). The circular raw water reservoir is position 350 m north of the main power station building. Raw water is pumped from the Jericho Dam and stored in the raw water reservoir for supply to the power station. The floor of the dam basin is located 5 m below the natural ground level. The dam was designed to have water depth full supply level of 14 m and a maximum wall height of 9 m. The east compartment is lined with 2.0 mm HDPE geo-membrane. The western compartment is lined with 1.5 mm thick polyethylene membrane as referenced in Dam safety inspection report of the raw water dams at kriel power station March 1991 (section 2.2.1 item [20]).
