## C5.1-1: *SPECON PIPELINE REPLACEMENT PHASE 3*

## C5.1-2: REHABILITATION OF MEGORING AND THAKGALANG RIVER CROSSINGS

DOCUMENT NO.  
M-21-146D  
10/05/2022

**CENTERLINE AND MATERIALS INVESTIGATION  
OLIFANTSPOORT WATER SUPPLY SCHEME  
OLIFANTSPOORT WTW TO SPECON RESERVOIR  
LIMPOPO PROVINCE- SOUTH AFRICA**

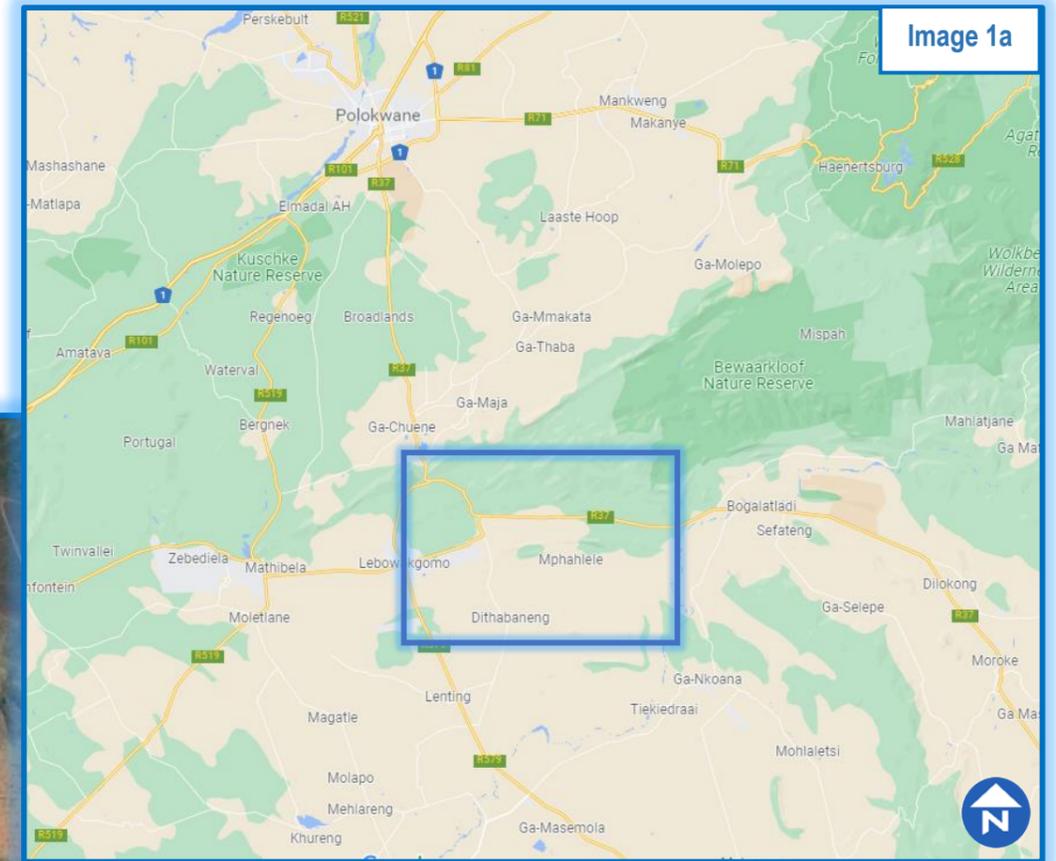
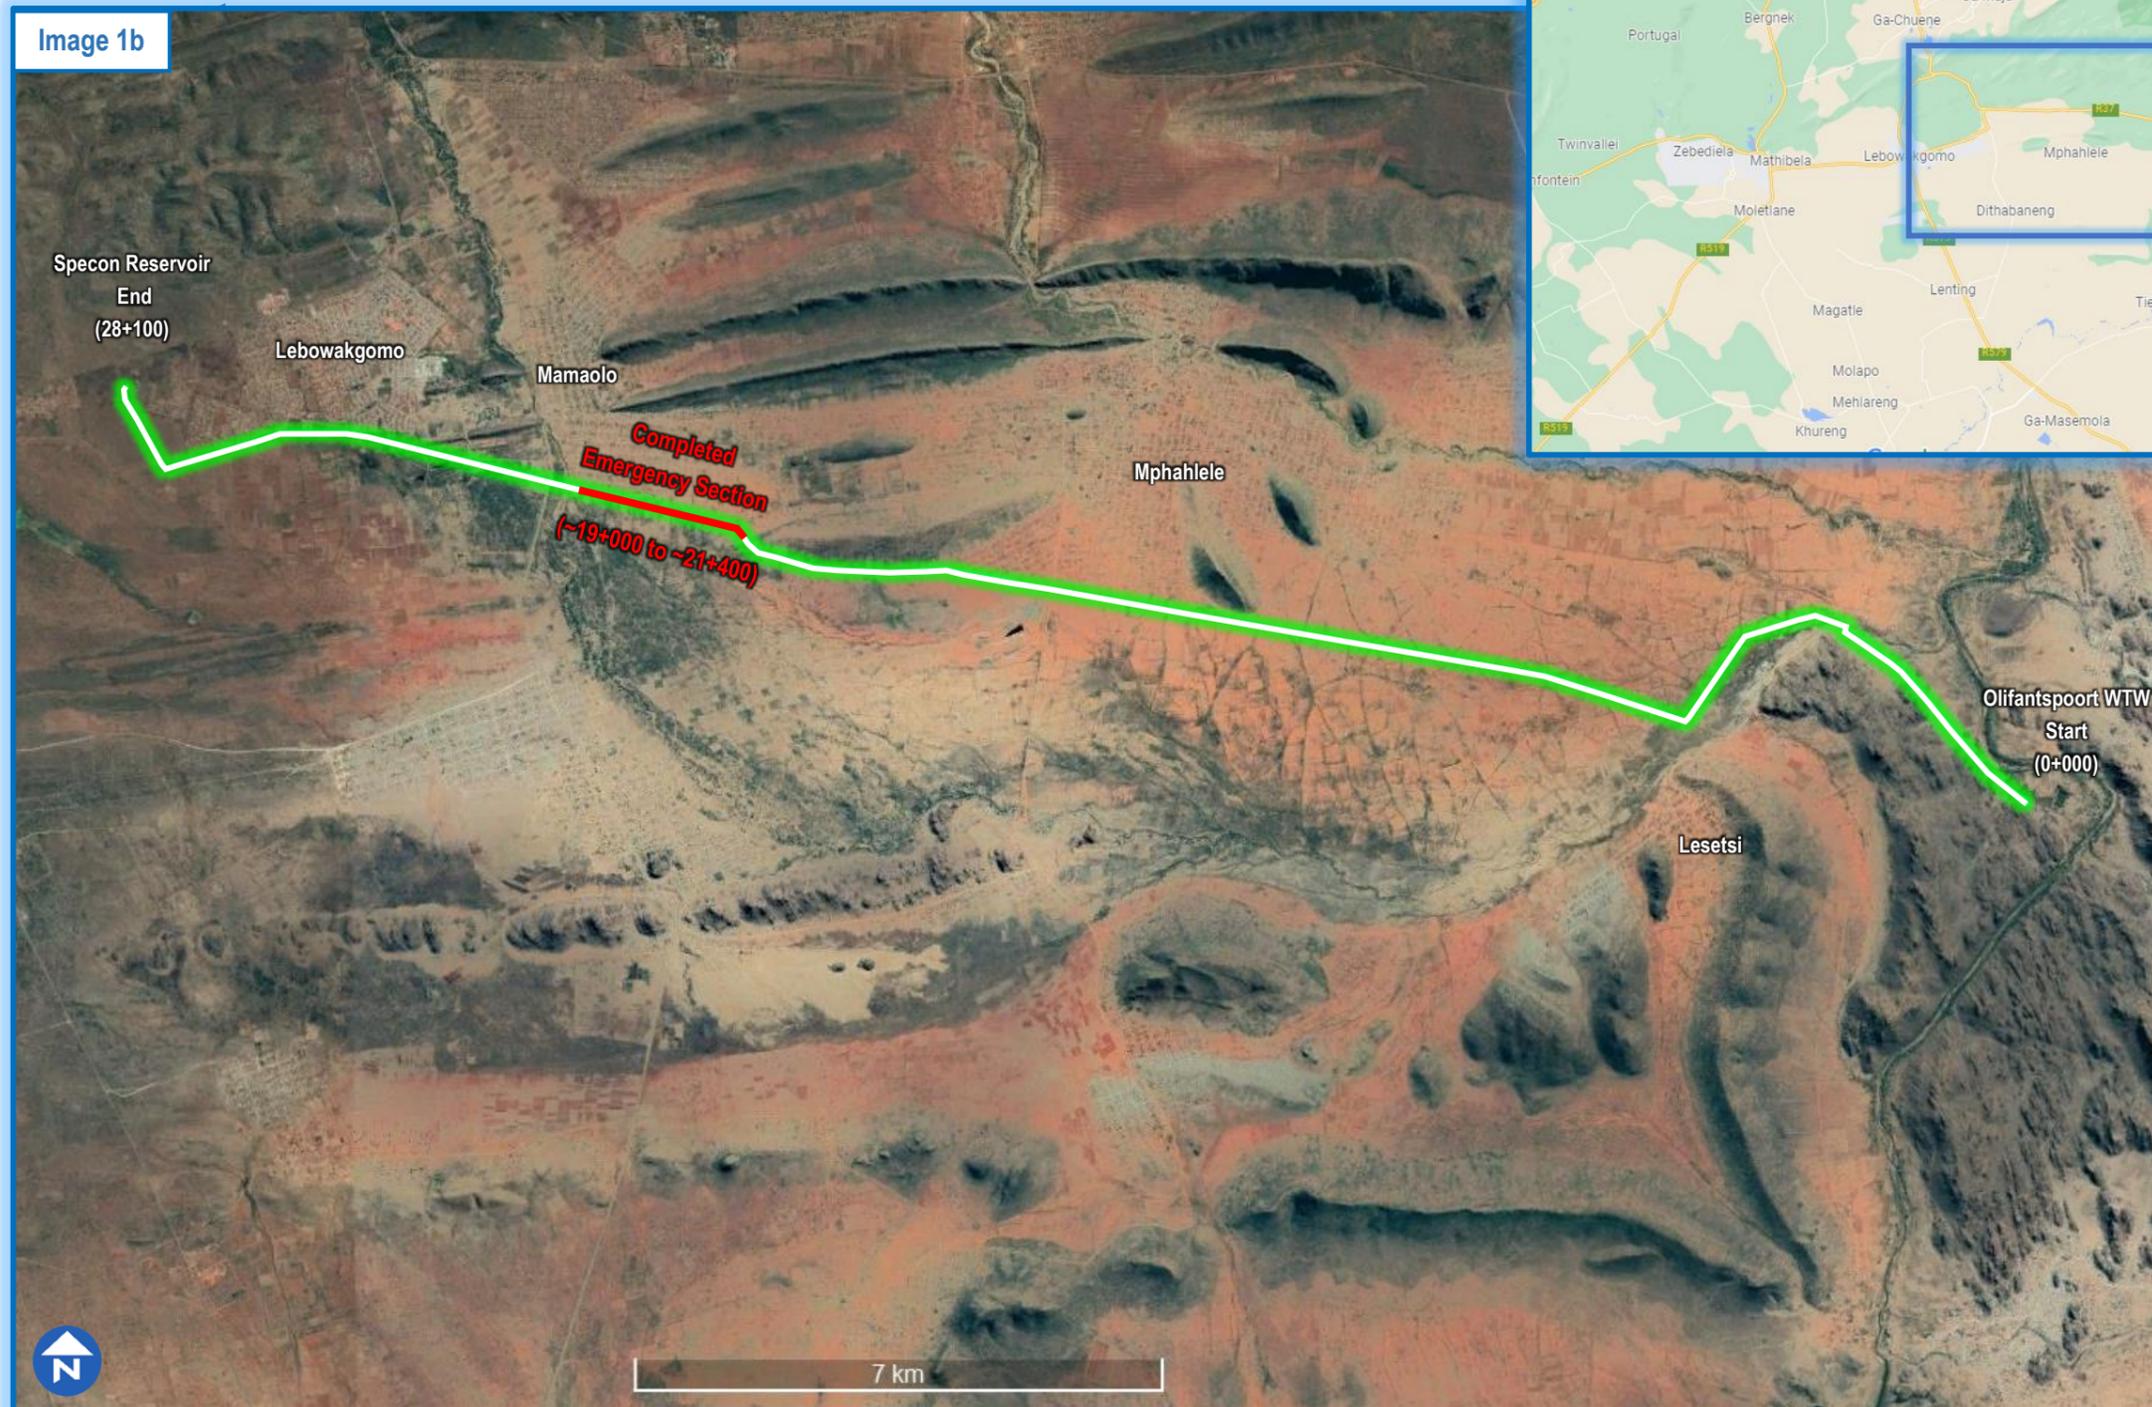
Image 1: Geographical Location and Breakdown of the Study Area (1a & 1b)

Refer to Image 1 overleaf graphically delineating the extent of the development:

The **study area** for this investigation falls within the central portions of the Limpopo Province of South Africa; approximately 50 km south-east of the City of Polokwane. On a more localised scale, the study area is located between the Lesetsi Rural Settlement and the town of Lebowakgomo (Figure 1).

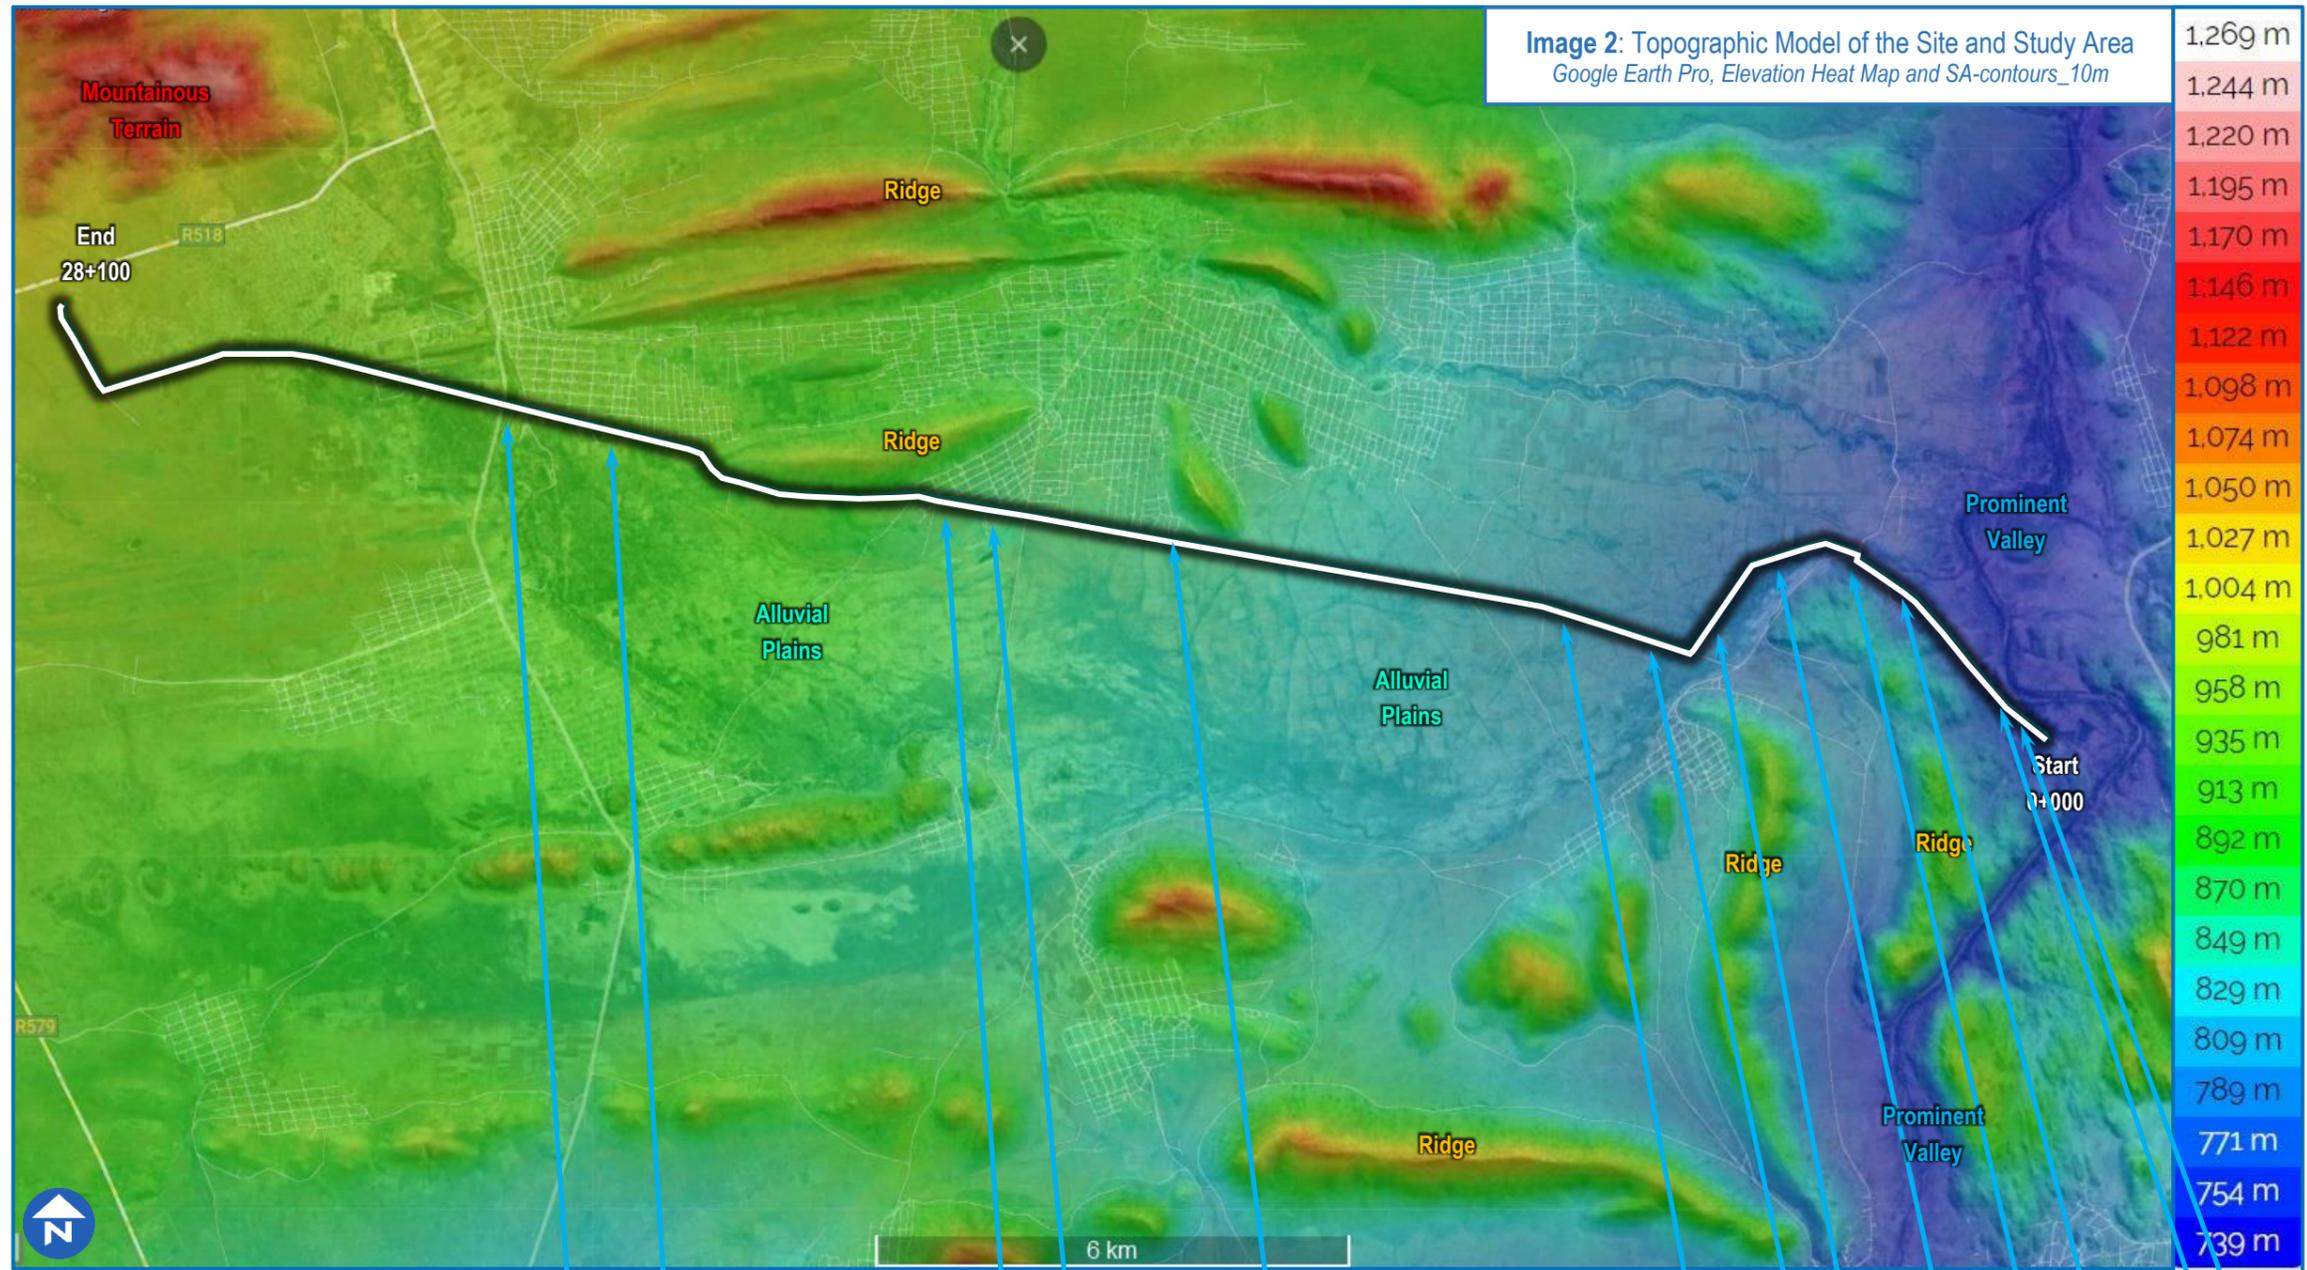
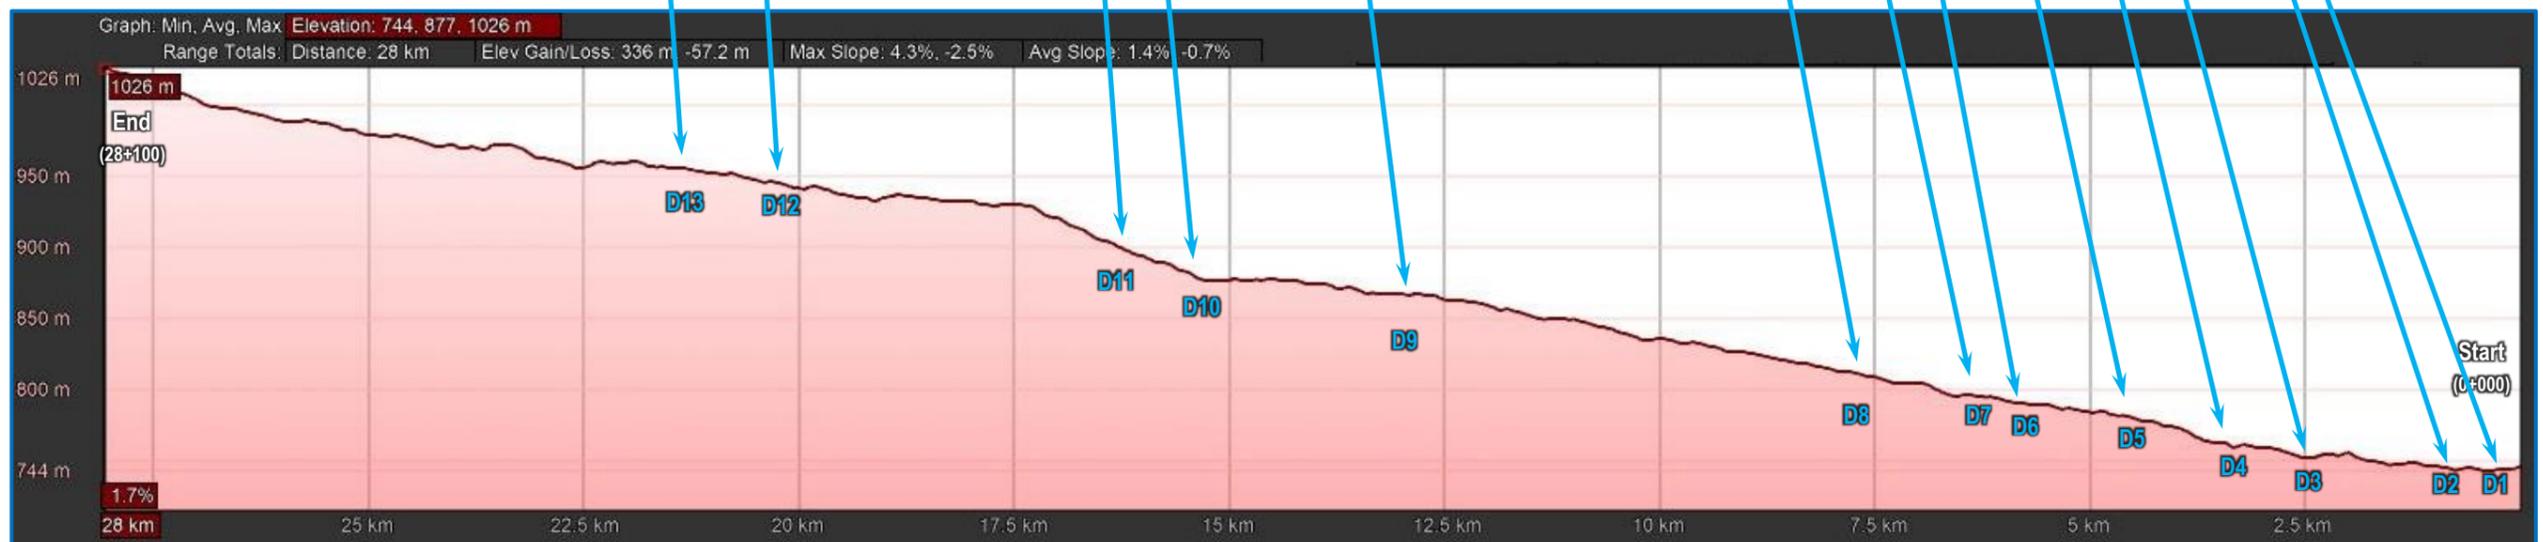
The start of the route marks the lowest point, with an elevation of ~750 meters above mean sea level (mamsl); whereafter the road ascends along its length towards the end point of the site, at an elevation of ~1025 mamsl.

See Graphic 1 below depicting the change in elevation along the route of the pipeline.

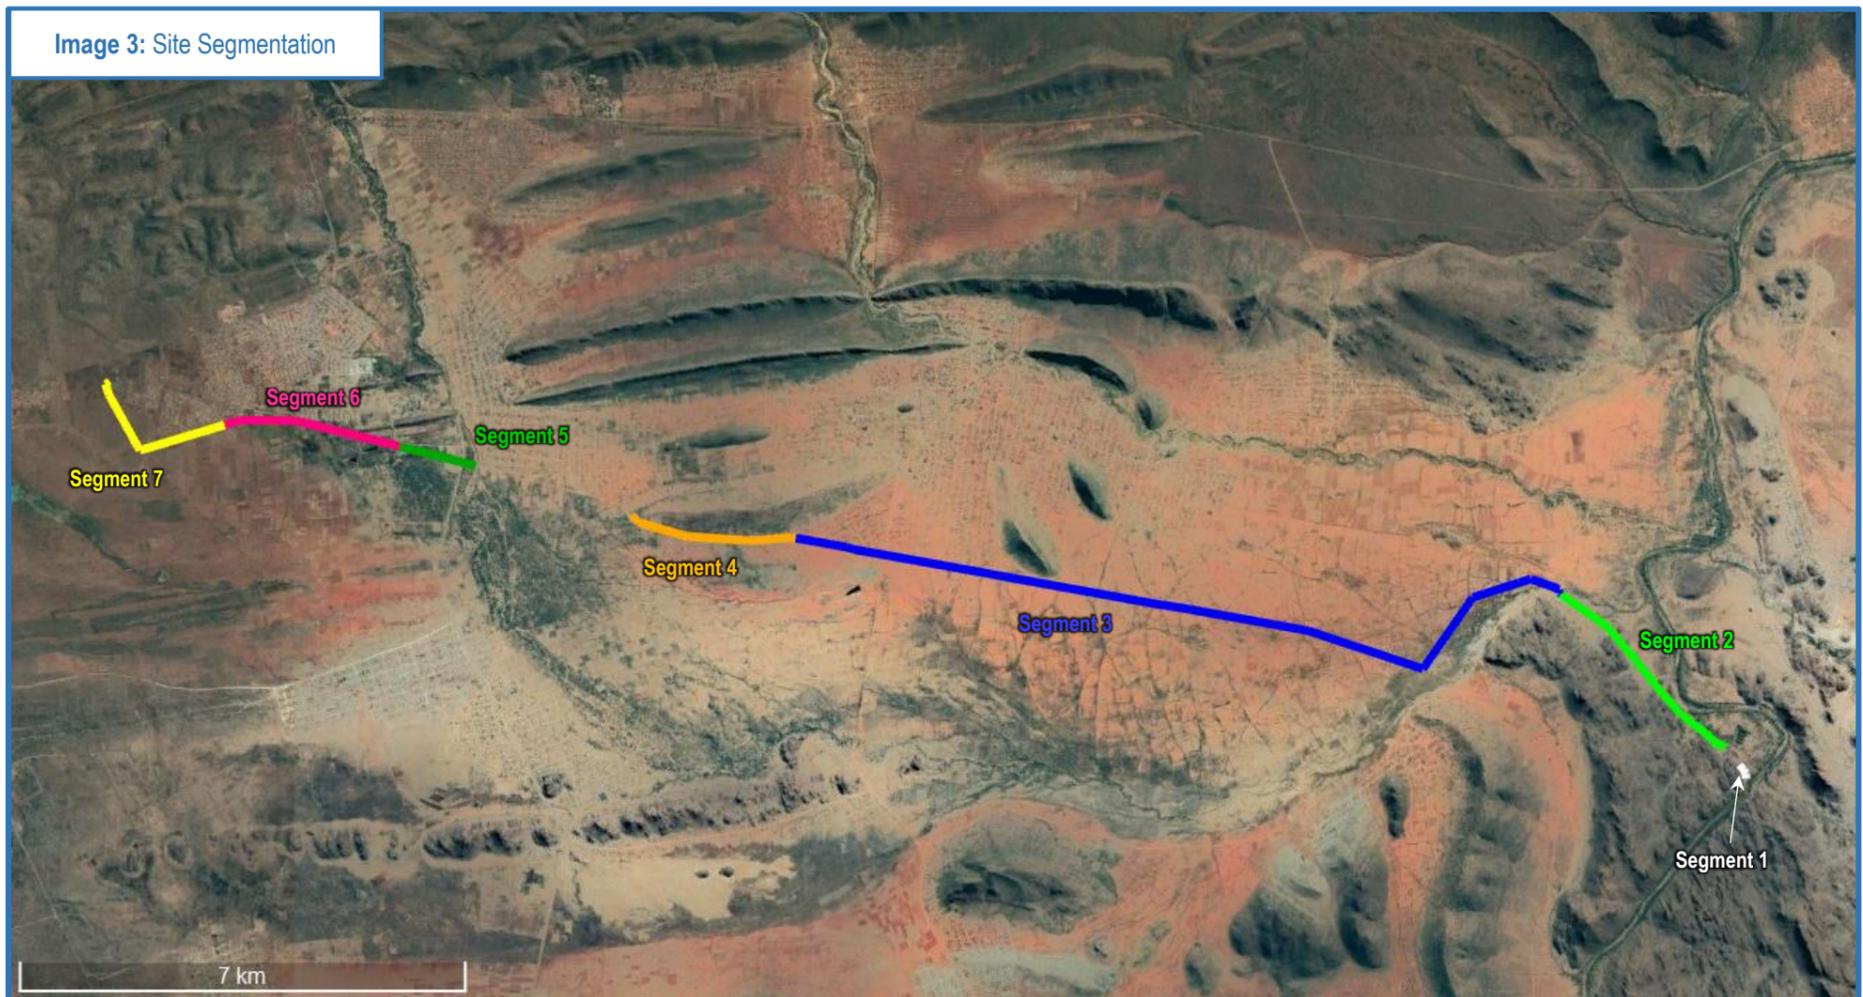
Table 1: Site Segmentation Breakdown

Segment	Chainage	Test Pits	General Geotechnical Character
1	0+000 to 0+500 (WTW to abstraction Works)	TP1 & TP2	<ul style="list-style-type: none"> <li>• <u>Generalised Material Succession:</u> <ul style="list-style-type: none"> <li>- Initial Section: thick alluvial deposit with thin layer of backfill material</li> <li>- Final section: backfill → alluvium → Gabbro bedrock</li> </ul> </li> <li>• <u>Excavatability:</u> <ul style="list-style-type: none"> <li>- <b>Initial</b> Section: <b>good</b> excavatability to 2.5 m</li> <li>- <b>Final</b> section: <b>poor</b> excavatability to 2.5 m (shallow bedrock)</li> </ul> </li> <li>• Groundwater predicted to perch on bedrock along final section</li> <li>• Very gentle sloping surface</li> <li>• Easy accessibility to plant and vehicles</li> </ul>
2	0+000 to 3+550	TP3 to TP16	<ul style="list-style-type: none"> <li>• <u>Generalised Material Succession:</u> <ul style="list-style-type: none"> <li>- Initial Section: alluvium <u>or</u> hillwash → Gabbro bedrock</li> <li>- Middle Section: alluvium (calcified at depth) <u>or</u> Hillwash → residual Gabbro <u>or</u> Calcified Residual Gabbro</li> <li>- Final section: hillwash → Gabbro bedrock</li> </ul> </li> <li>• <b>Overall Poor Excavatability</b> to 2.5 m, due to <b>very dense</b> residual soils and <b>bedrock</b></li> <li>• <b>Localised</b> occurrence of <b>groundwater</b> seepage (TP4) from a depth of <b>~0.90 m</b> below EGL</li> <li>• Perching of infiltrating groundwater on bedrock</li> <li>• Very gentle sloping surface</li> <li>• Easy accessibility to plant and vehicles, with the exception of localised farm boundaries.</li> </ul>

3	3+550 to 16+420	TP17 to TP67	<ul style="list-style-type: none"> <li>• <u>Generalised Material Succession:</u> <ul style="list-style-type: none"> <li>- Thick alluvial deposits</li> <li>- Calcified alluvium, present as nodular and/or concretionary Calcrete</li> <li>- Ferruginised alluvium along final sections</li> <li>- Localised calcified residual Gabbro</li> <li>- Localised occurrence of hardpan Calcrete</li> </ul> </li> <li>• <u>Excavatability:</u> <ul style="list-style-type: none"> <li>- <b>Initial</b> section: <b>moderate</b> to <b>good</b> excavatability to 2.5 m</li> <li>- <b>Middle</b> section: <b>poor</b> to <b>moderate</b> excavatability to 2.5 m- due to very dense soils and/or hardpan Calcrete</li> <li>- <b>Final</b> section: overall <b>good</b> excavatability to 2.5 m</li> </ul> </li> <li>• Groundwater predicted to perch on hardpan Calcrete</li> <li>• Very gentle sloping surface</li> <li>• <b>Slight accessibility issues</b> along initial section- undeveloped land &amp; farm boundaries</li> </ul>

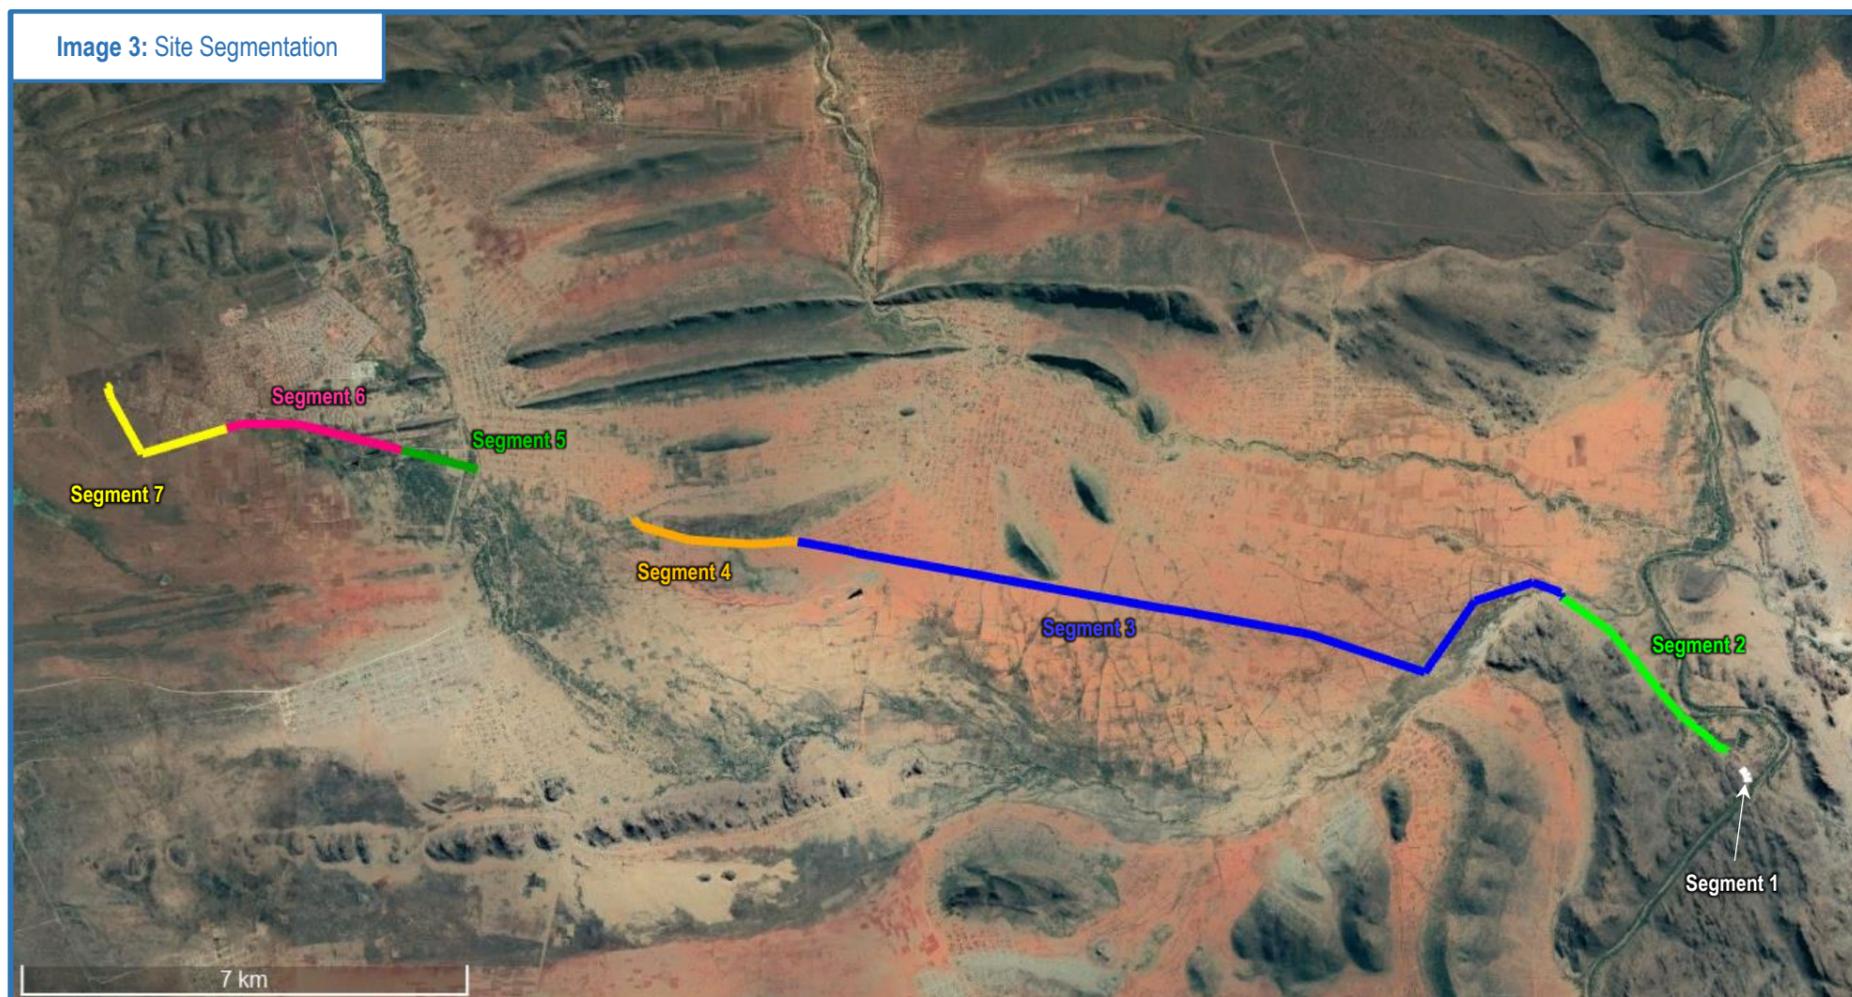
**Table 2: Site Segmentation Breakdown Cont.**

Segment	Chainage	Test Pits	General Geotechnical Character
4	16+420 to 19+065	TP68 to TP78	<ul style="list-style-type: none"> <li>• <u>Generalised Material Succession:</u> <ul style="list-style-type: none"> <li>- Alluvium (initial section) or hillwash (remaining sections)</li> <li>- Residual Quartzite</li> <li>- Calcified and/or ferruginised residual Quartzite</li> </ul> </li> <li>• Localised bedrock (TP70 &amp; TP78) and hardpan Calcrete (TP75)</li> <li>• <b>Poor excavatability</b> to 2.5 m- as a result of very dense soils, bedrock and/or hardpan Calcrete</li> <li>• Groundwater predicted to perch on bedrock and hardpan Calcrete</li> <li>• Very gentle sloping surface</li> <li>• Easy accessibility to plant and vehicles</li> </ul>
5	21+660 to 22+880	TP79 to TP83	<ul style="list-style-type: none"> <li>• <u>Generalised Material Succession:</u> <ul style="list-style-type: none"> <li>- Thick sequence of alluvial deposits</li> <li>- Localised deposits were altered (calcified) at depth</li> </ul> </li> <li>• Localised sidewall instabilities were encountered (TP79)</li> <li>• <b>Good excavatability</b> to 2.5 m</li> <li>• Very gentle sloping surface</li> <li>• Easy accessibility to plant and vehicles</li> </ul>

6	22+880 to 25+675	TP84 to TP94	<ul style="list-style-type: none"> <li>• <u>Two Generalised Material Successions were encountered:</u> <ul style="list-style-type: none"> <li>- Alluvium and/or calcified/ferruginised alluvium, followed by abrupt refusal on hardpan Calcrete/Ferricrete</li> <li>- Hillwash underlain by residual Quartzite (ferruginised within isolated locations)</li> <li>- Isolated occurrence (TP86) of residual Hornfels</li> </ul> </li> <li>• <b>Overall poor excavatability</b> to 2.5 m, due to hardpan Calcrete/Ferricrete and very dense residual soils</li> <li>• Localised <b>groundwater seepage</b> from between <b>0.60 and 2.20 m</b> below EGL</li> <li>• Perching of infiltrating groundwater on hardpan Calcrete/Ferricrete</li> <li>• Very gentle sloping surface</li> <li>• <b>Slight accessibility issues</b>- undeveloped land, marshy areas &amp; farm boundaries</li> </ul>
7	25+675 to 28+100	TP95 to TP105	<ul style="list-style-type: none"> <li>• <u>Generalised Material Succession:</u> <ul style="list-style-type: none"> <li>- Thick scree deposits</li> <li>- Isolated occurrence (TP100) of residual Quartzite underlying the scree deposits</li> </ul> </li> <li>• <b>Localised</b> occurrence of <b>bedrock</b> at depth (TP95 &amp; TP105)</li> <li>• Groundwater predicted to perch on the bedrock</li> <li>• <b>Moderate to good</b> excavatability to 2.5 m</li> <li>• Very gentle sloping surface</li> <li>• <b>Slight accessibility issues</b>- farm and residential boundaries</li> </ul>

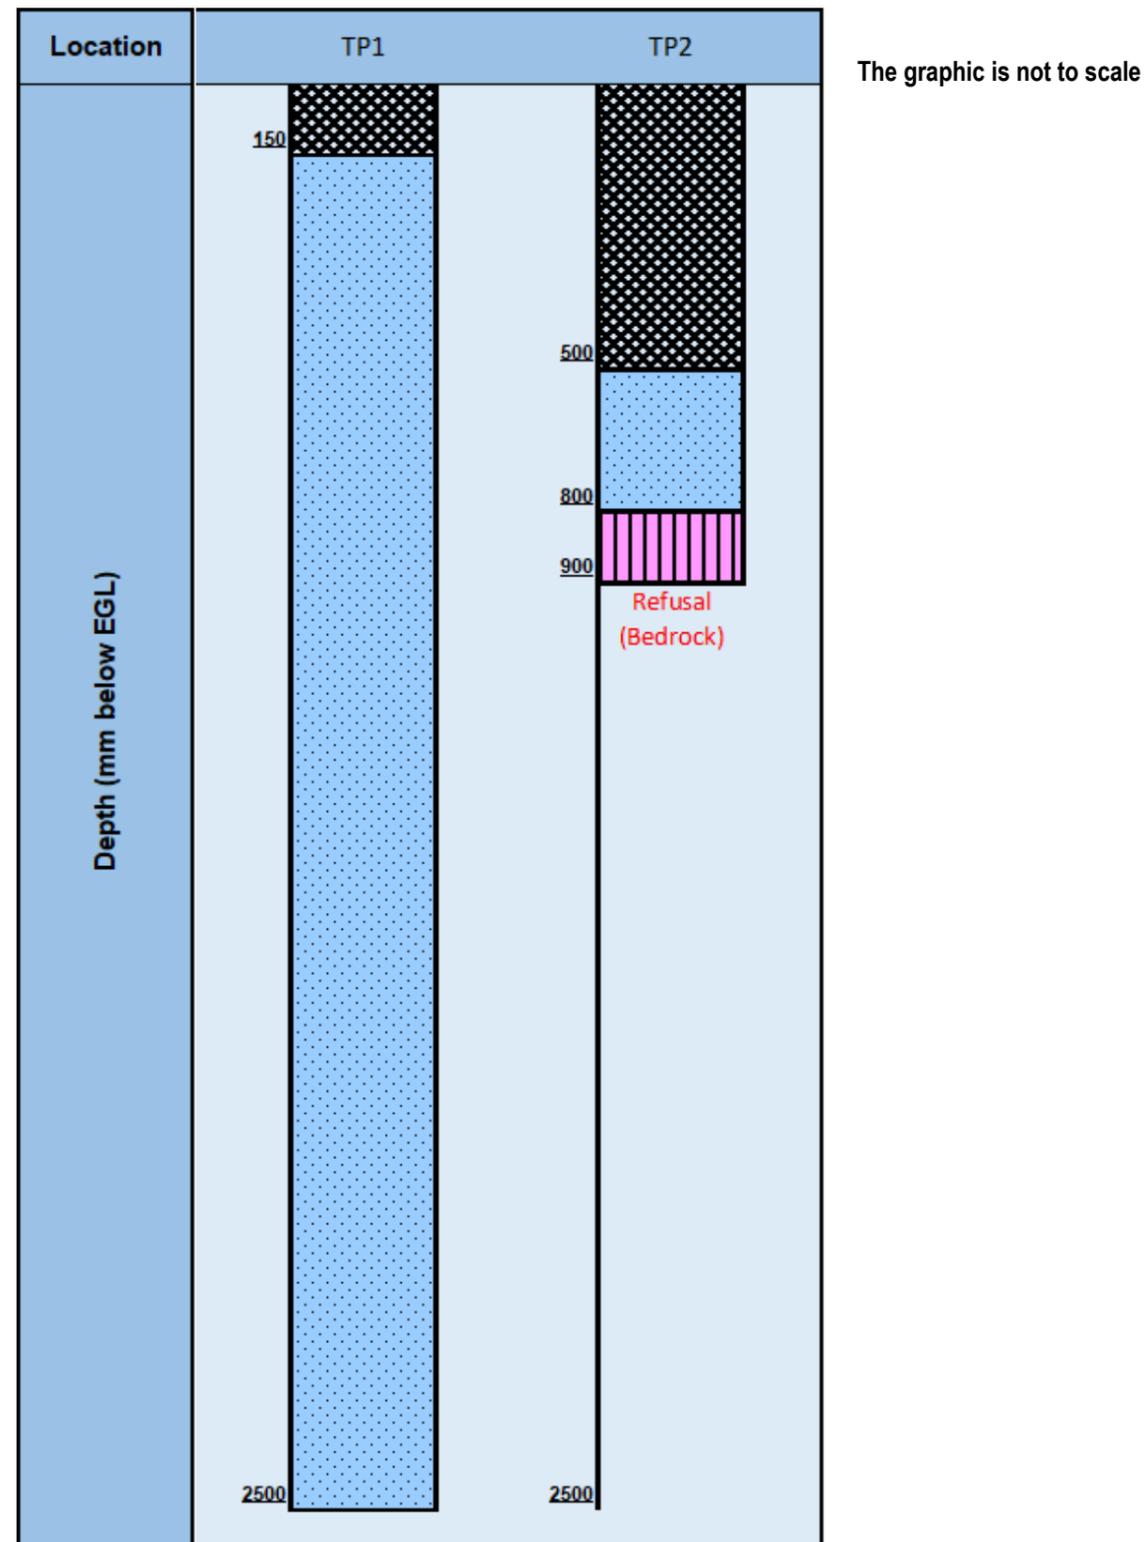
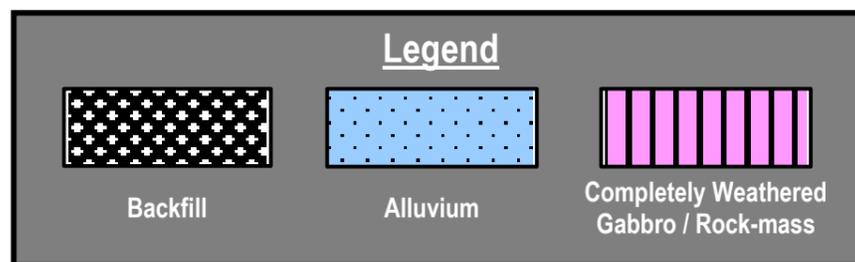
**Graphic 1: Summarised Material Succession- Segment 1 (TP1 & TP2)**

The graphics to follow serve as a visual summary of the occurrence as well as the vertical and lateral extent of the various materials (as per the previous section) encountered across the site in question.

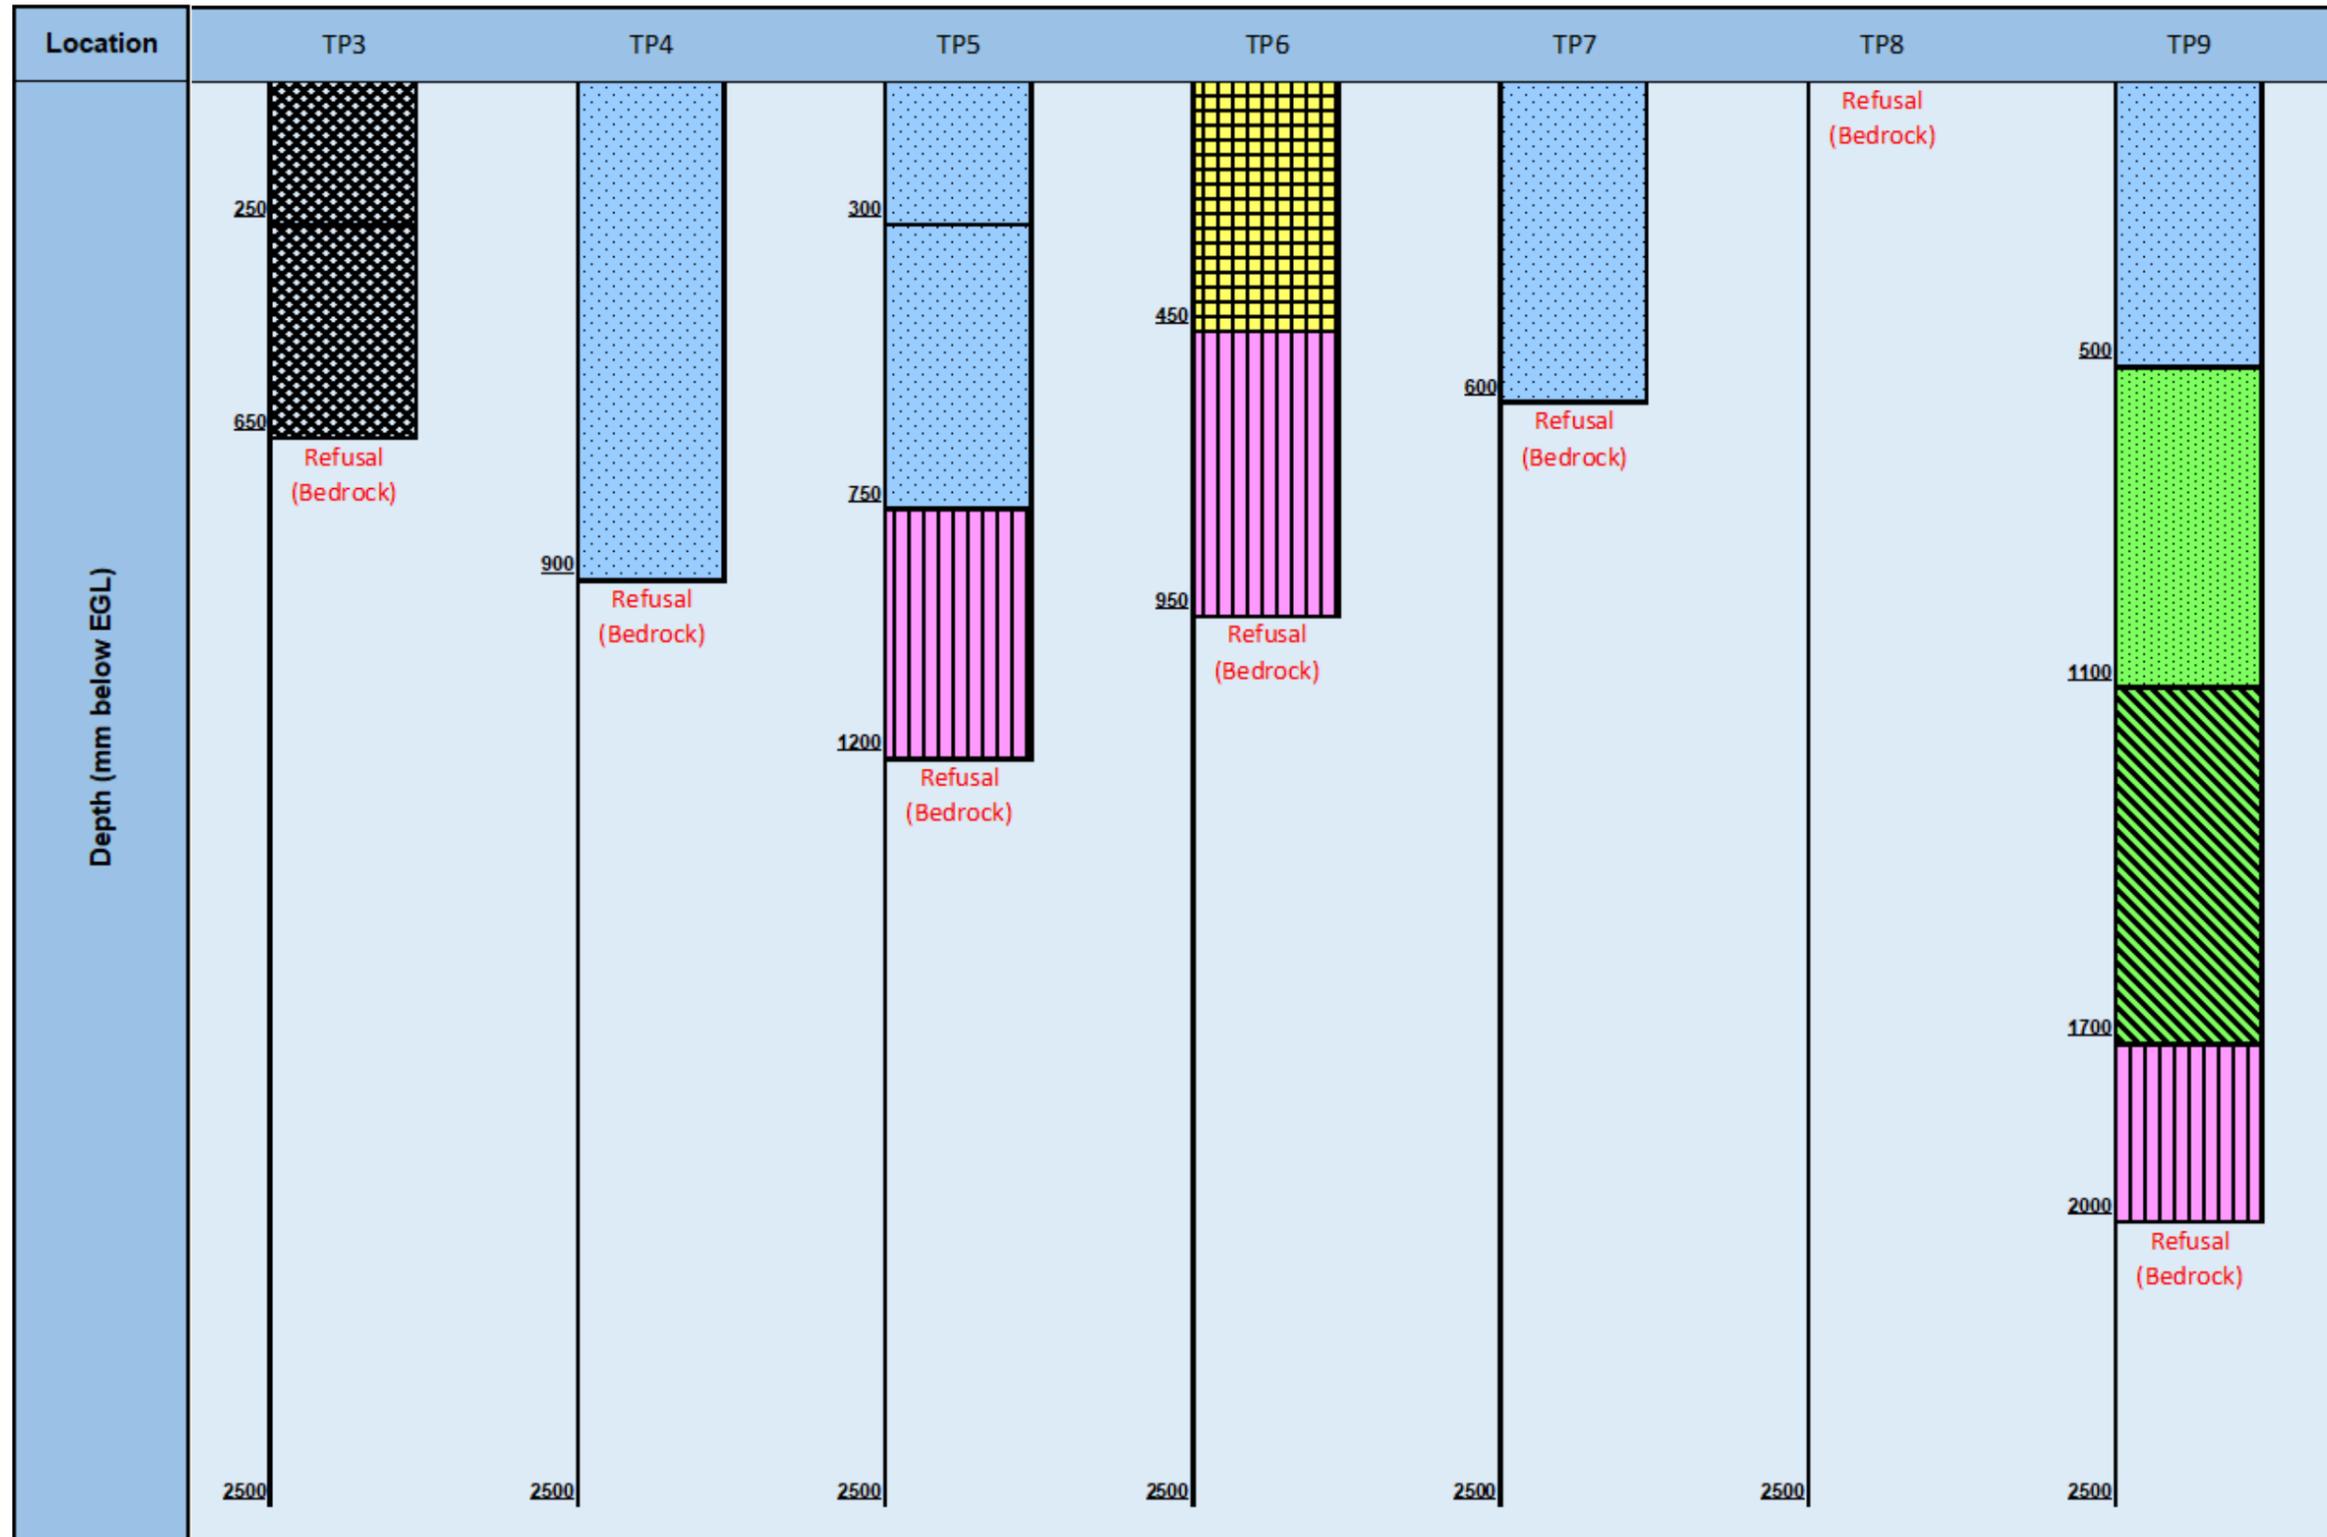
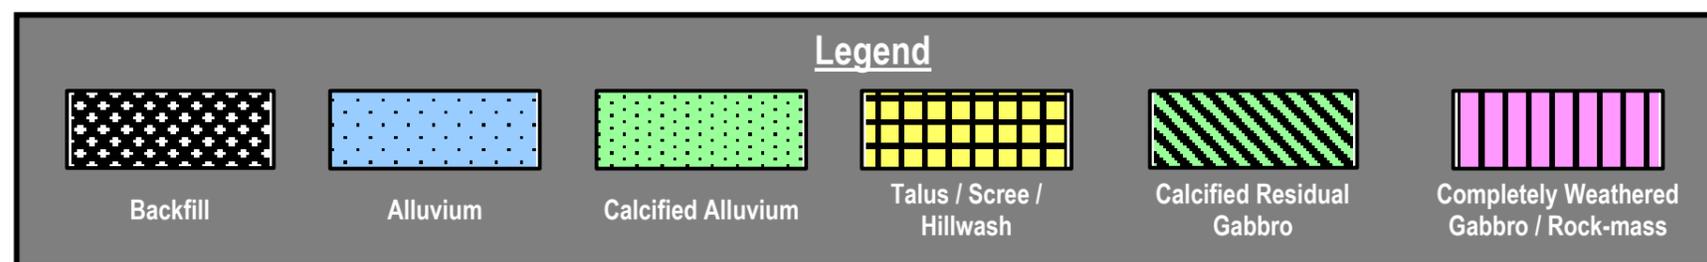
Graphic 2: Summarised Material Succession- Segment 2 (TP3-TP9)

The graphic is not to scale
