## C5.1-1: *SPECON PIPELINE REPLACEMENT PHASE 3*

## C5.1-2: REHABILITATION OF MEGORING AND THAKGALANG RIVER CROSSINGS

DOCUMENT NO.  
M-21-146D  
10/05/2022

**CENTERLINE AND MATERIALS INVESTIGATION  
OLIFANTSPOORT WATER SUPPLY SCHEME  
OLIFANTSPOORT WTW TO SPECON RESERVOIR  
LIMPOPO PROVINCE- SOUTH AFRICA**

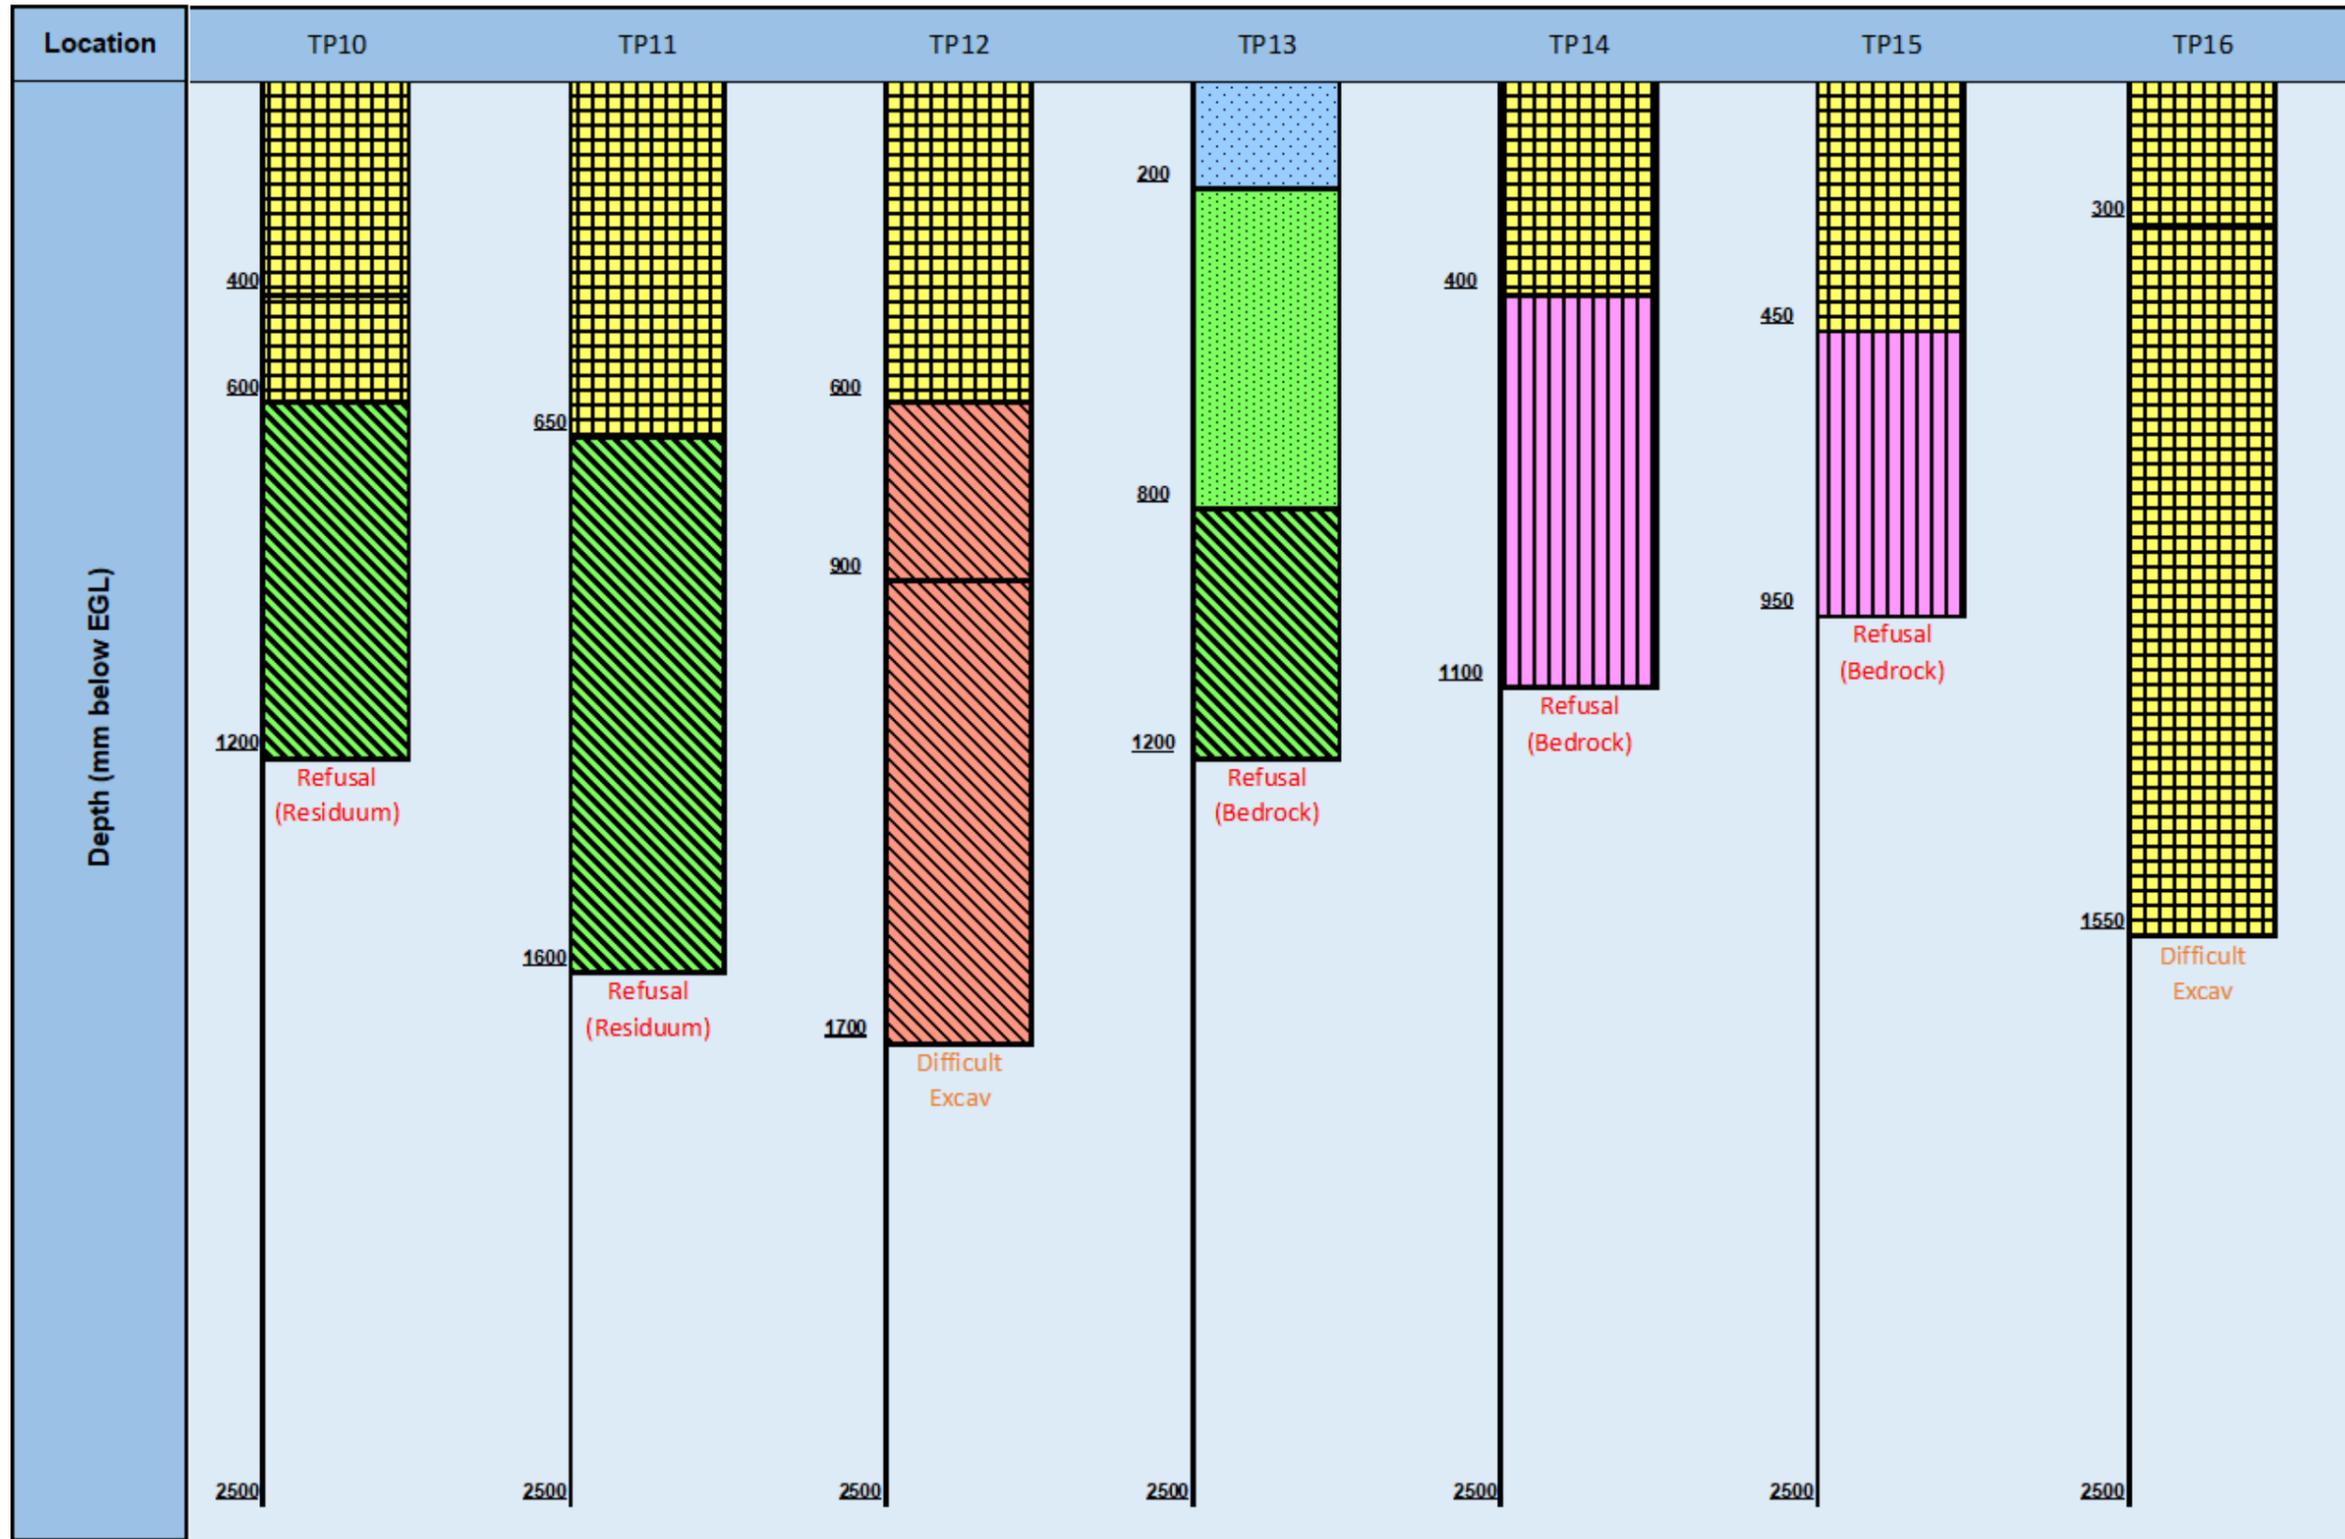
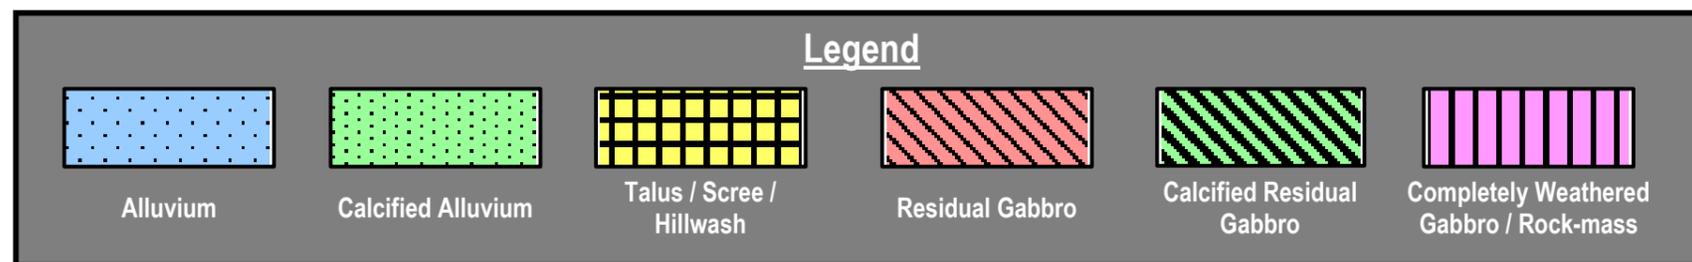
Graphic 3: Summarised Material Succession- Segment 2 (TP10-TP16)

The graphic is not to scale

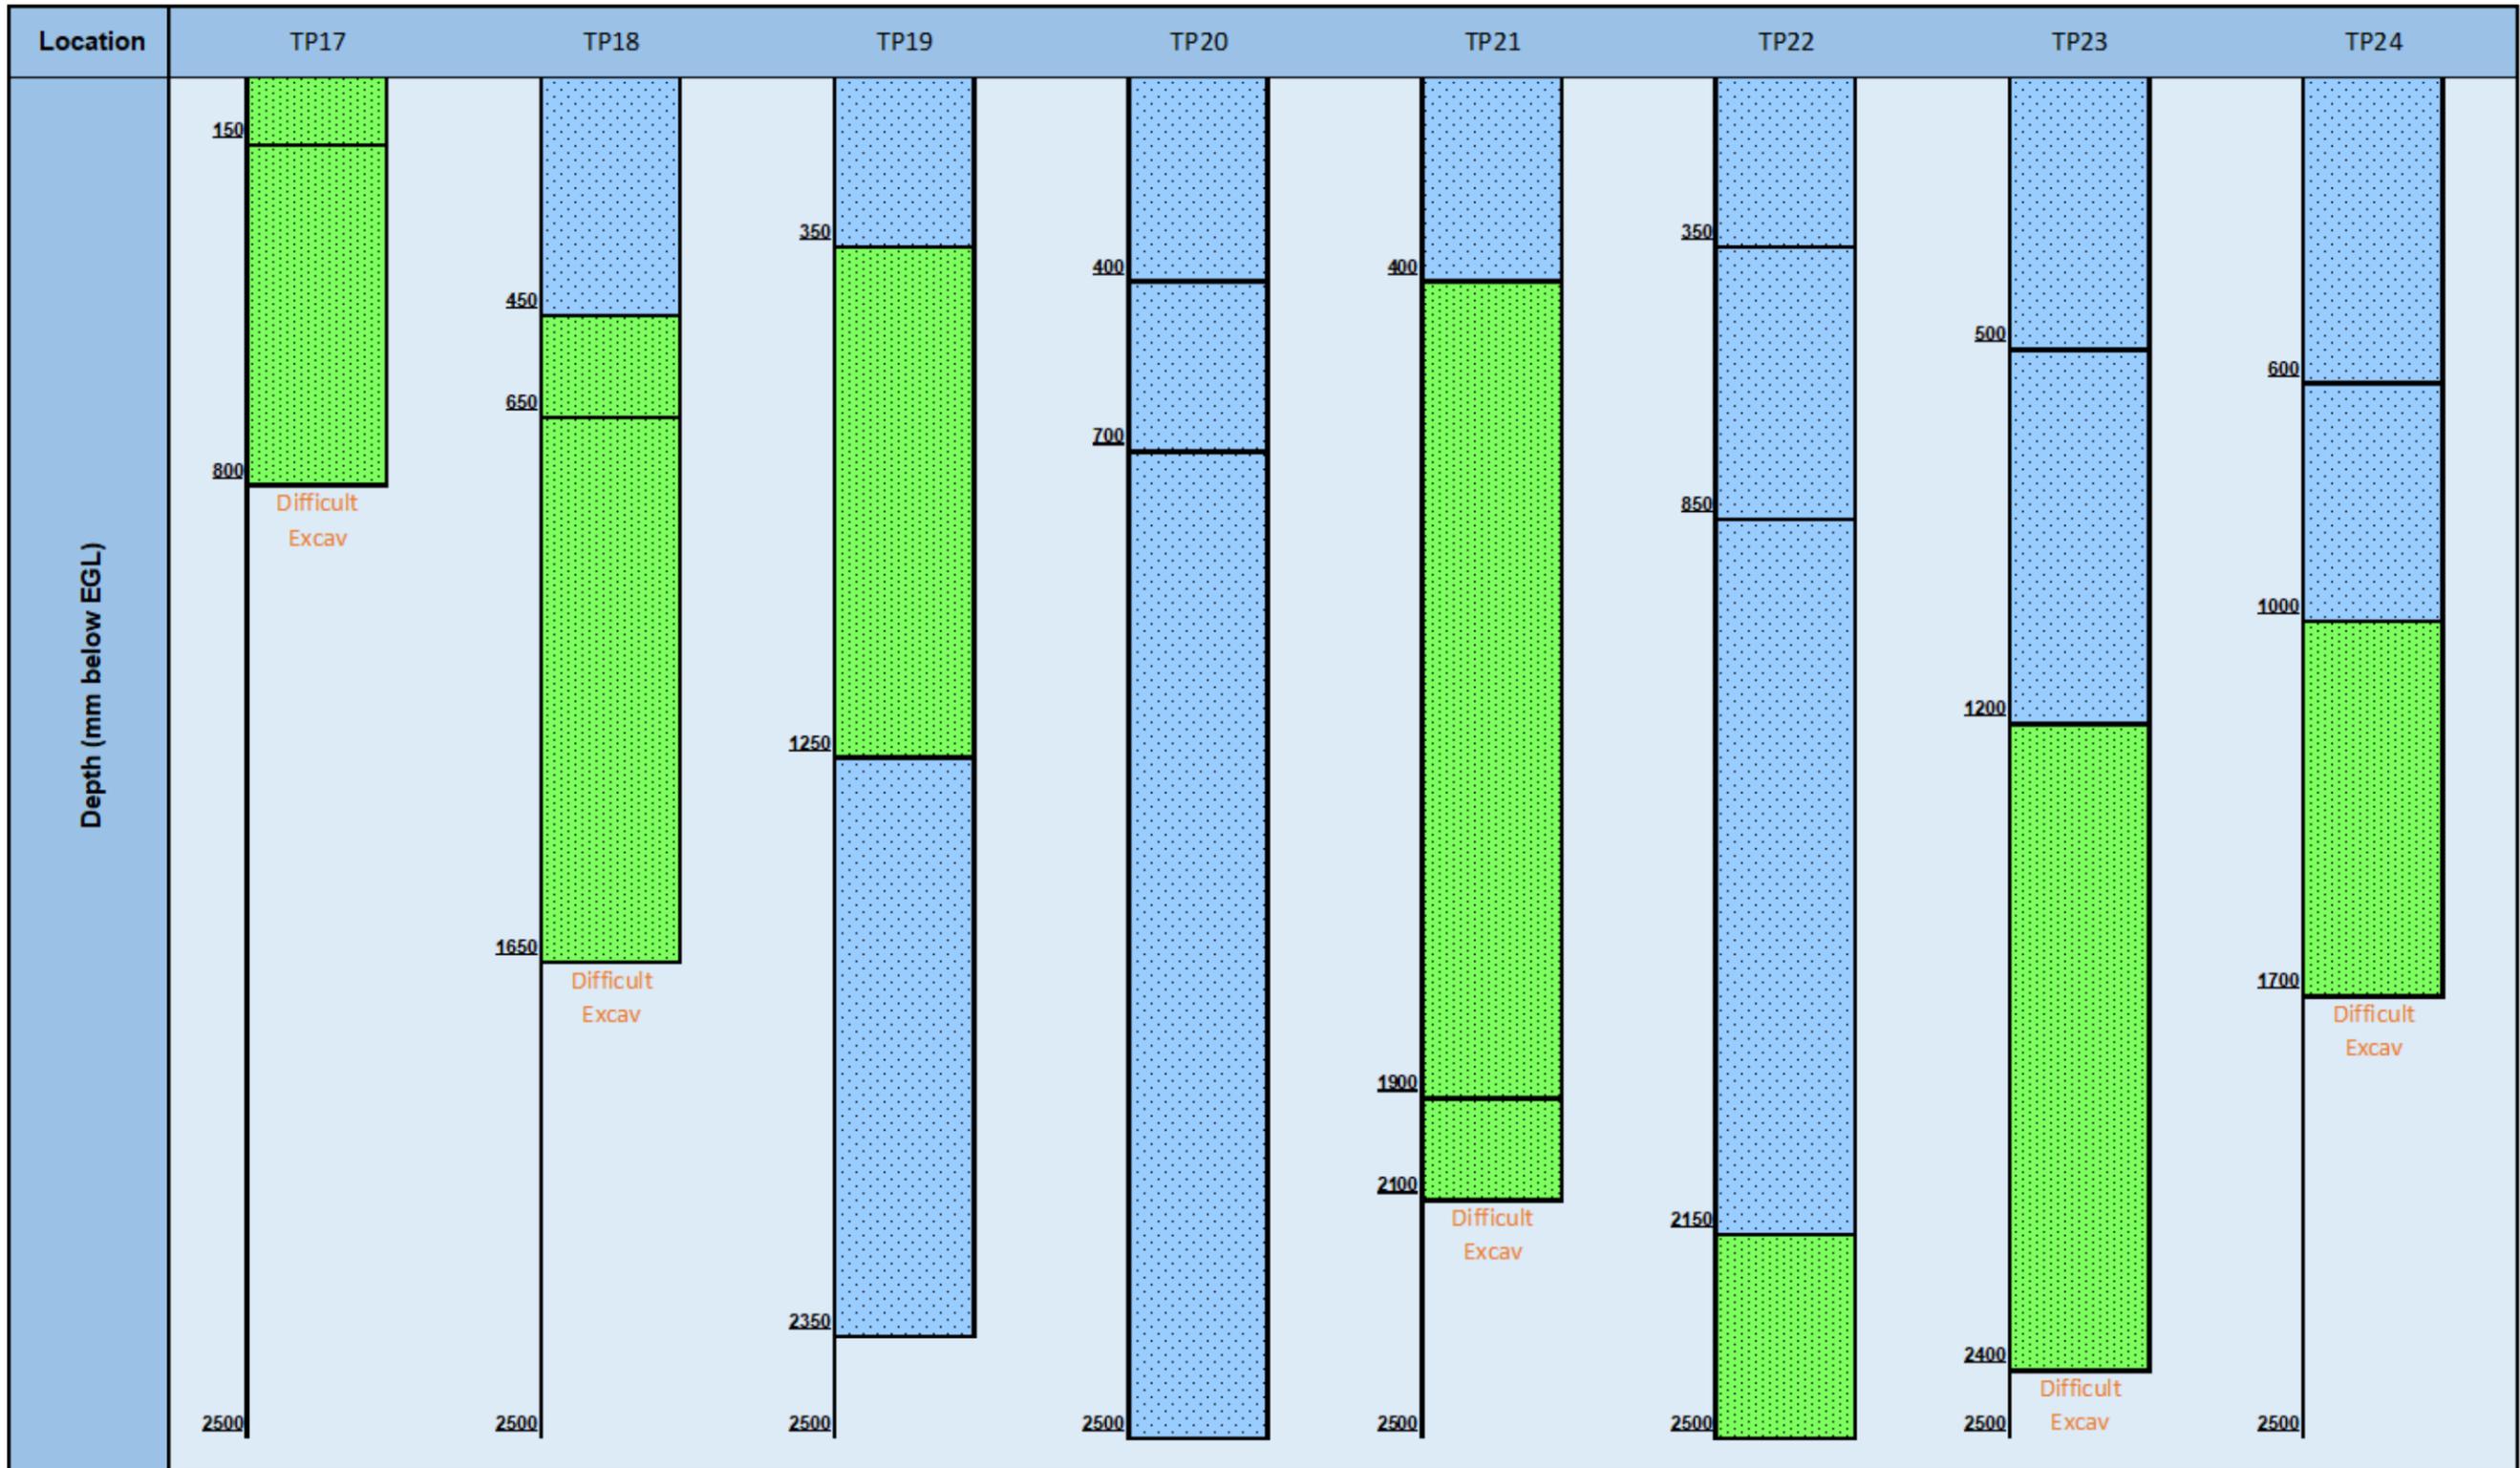
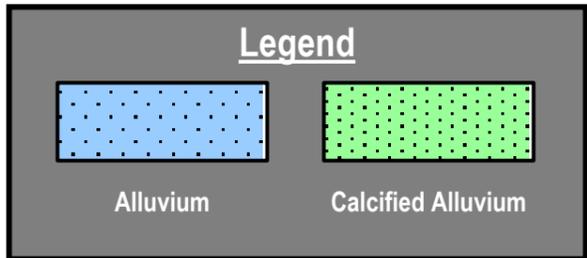
Graphic 4: Summarised Material Succession- Segment 3 (TP17-TP24)

The graphic is not to scale

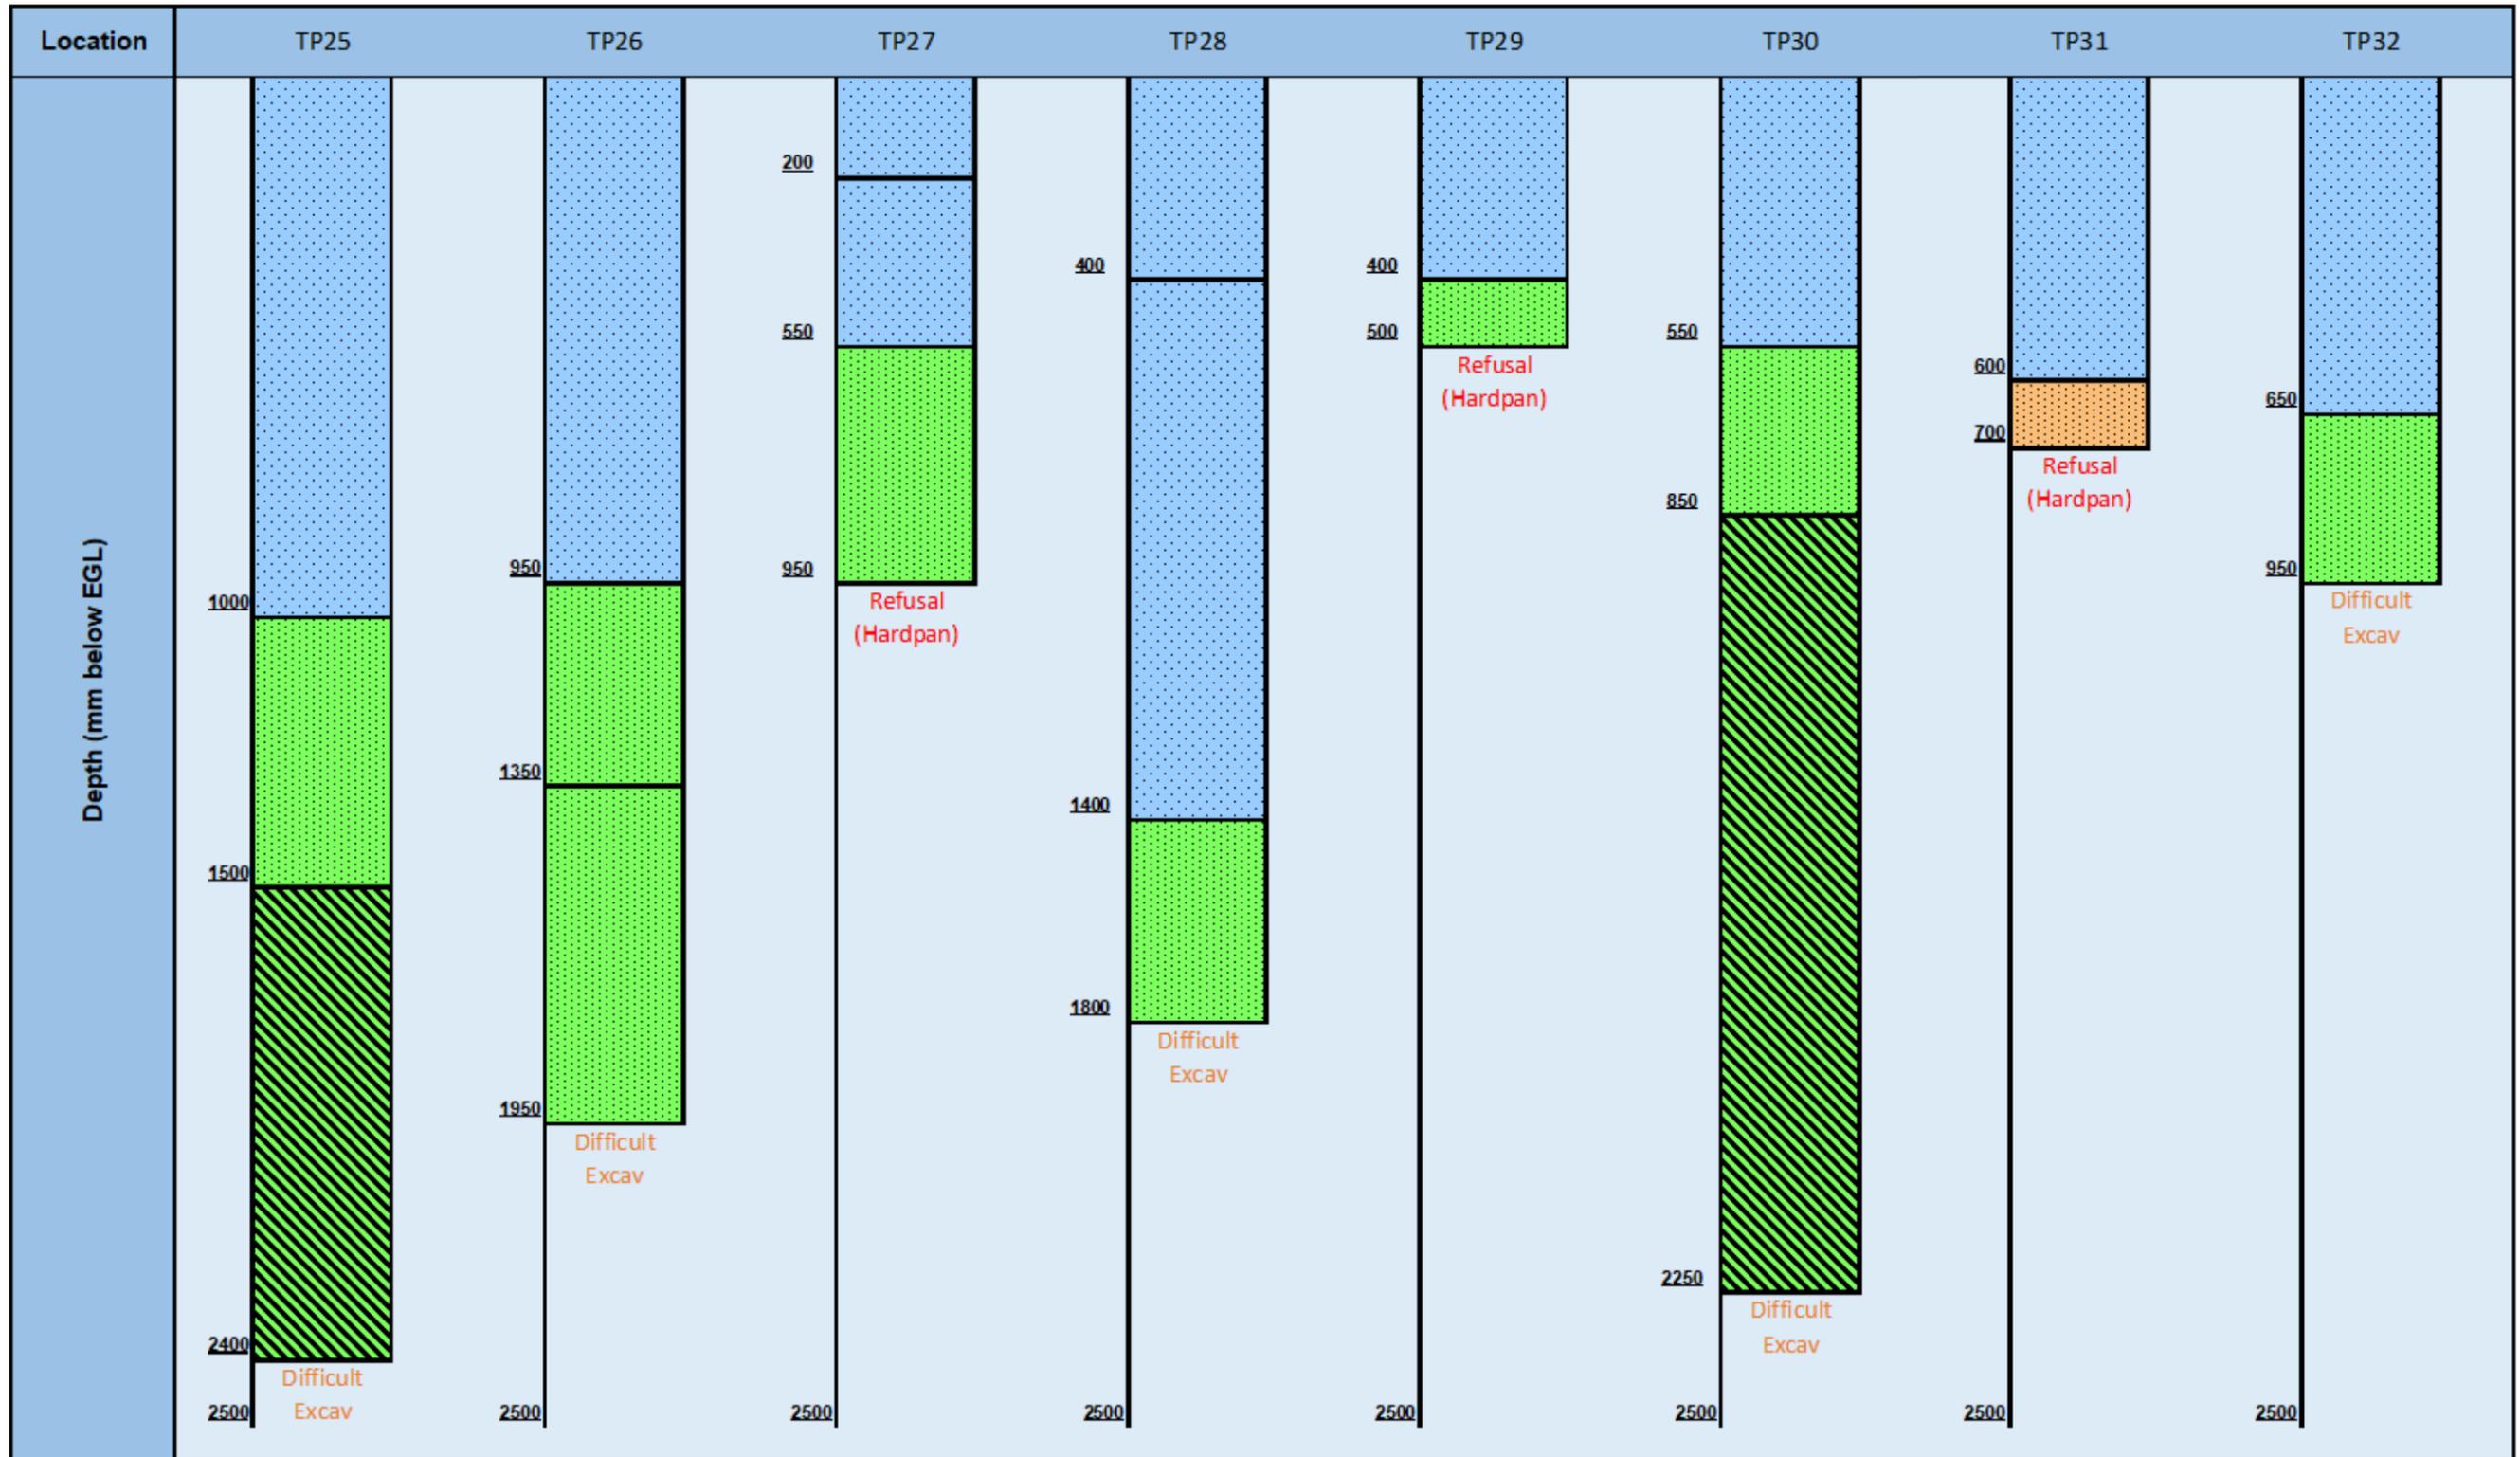
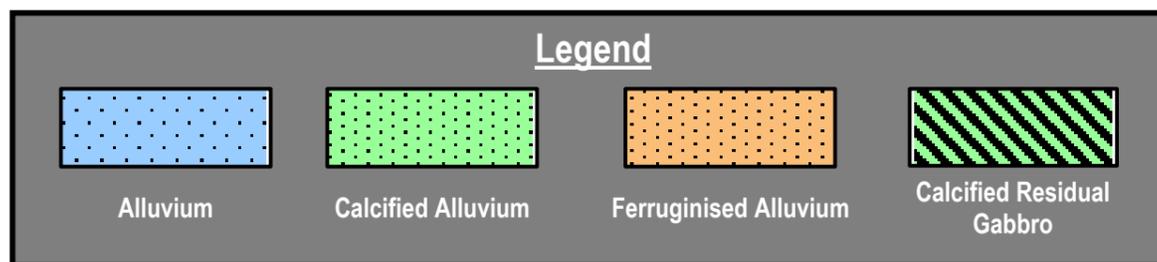
Graphic 5: Summarised Material Succession- Segment 3 (TP25-TP32)

The graphic is not to scale

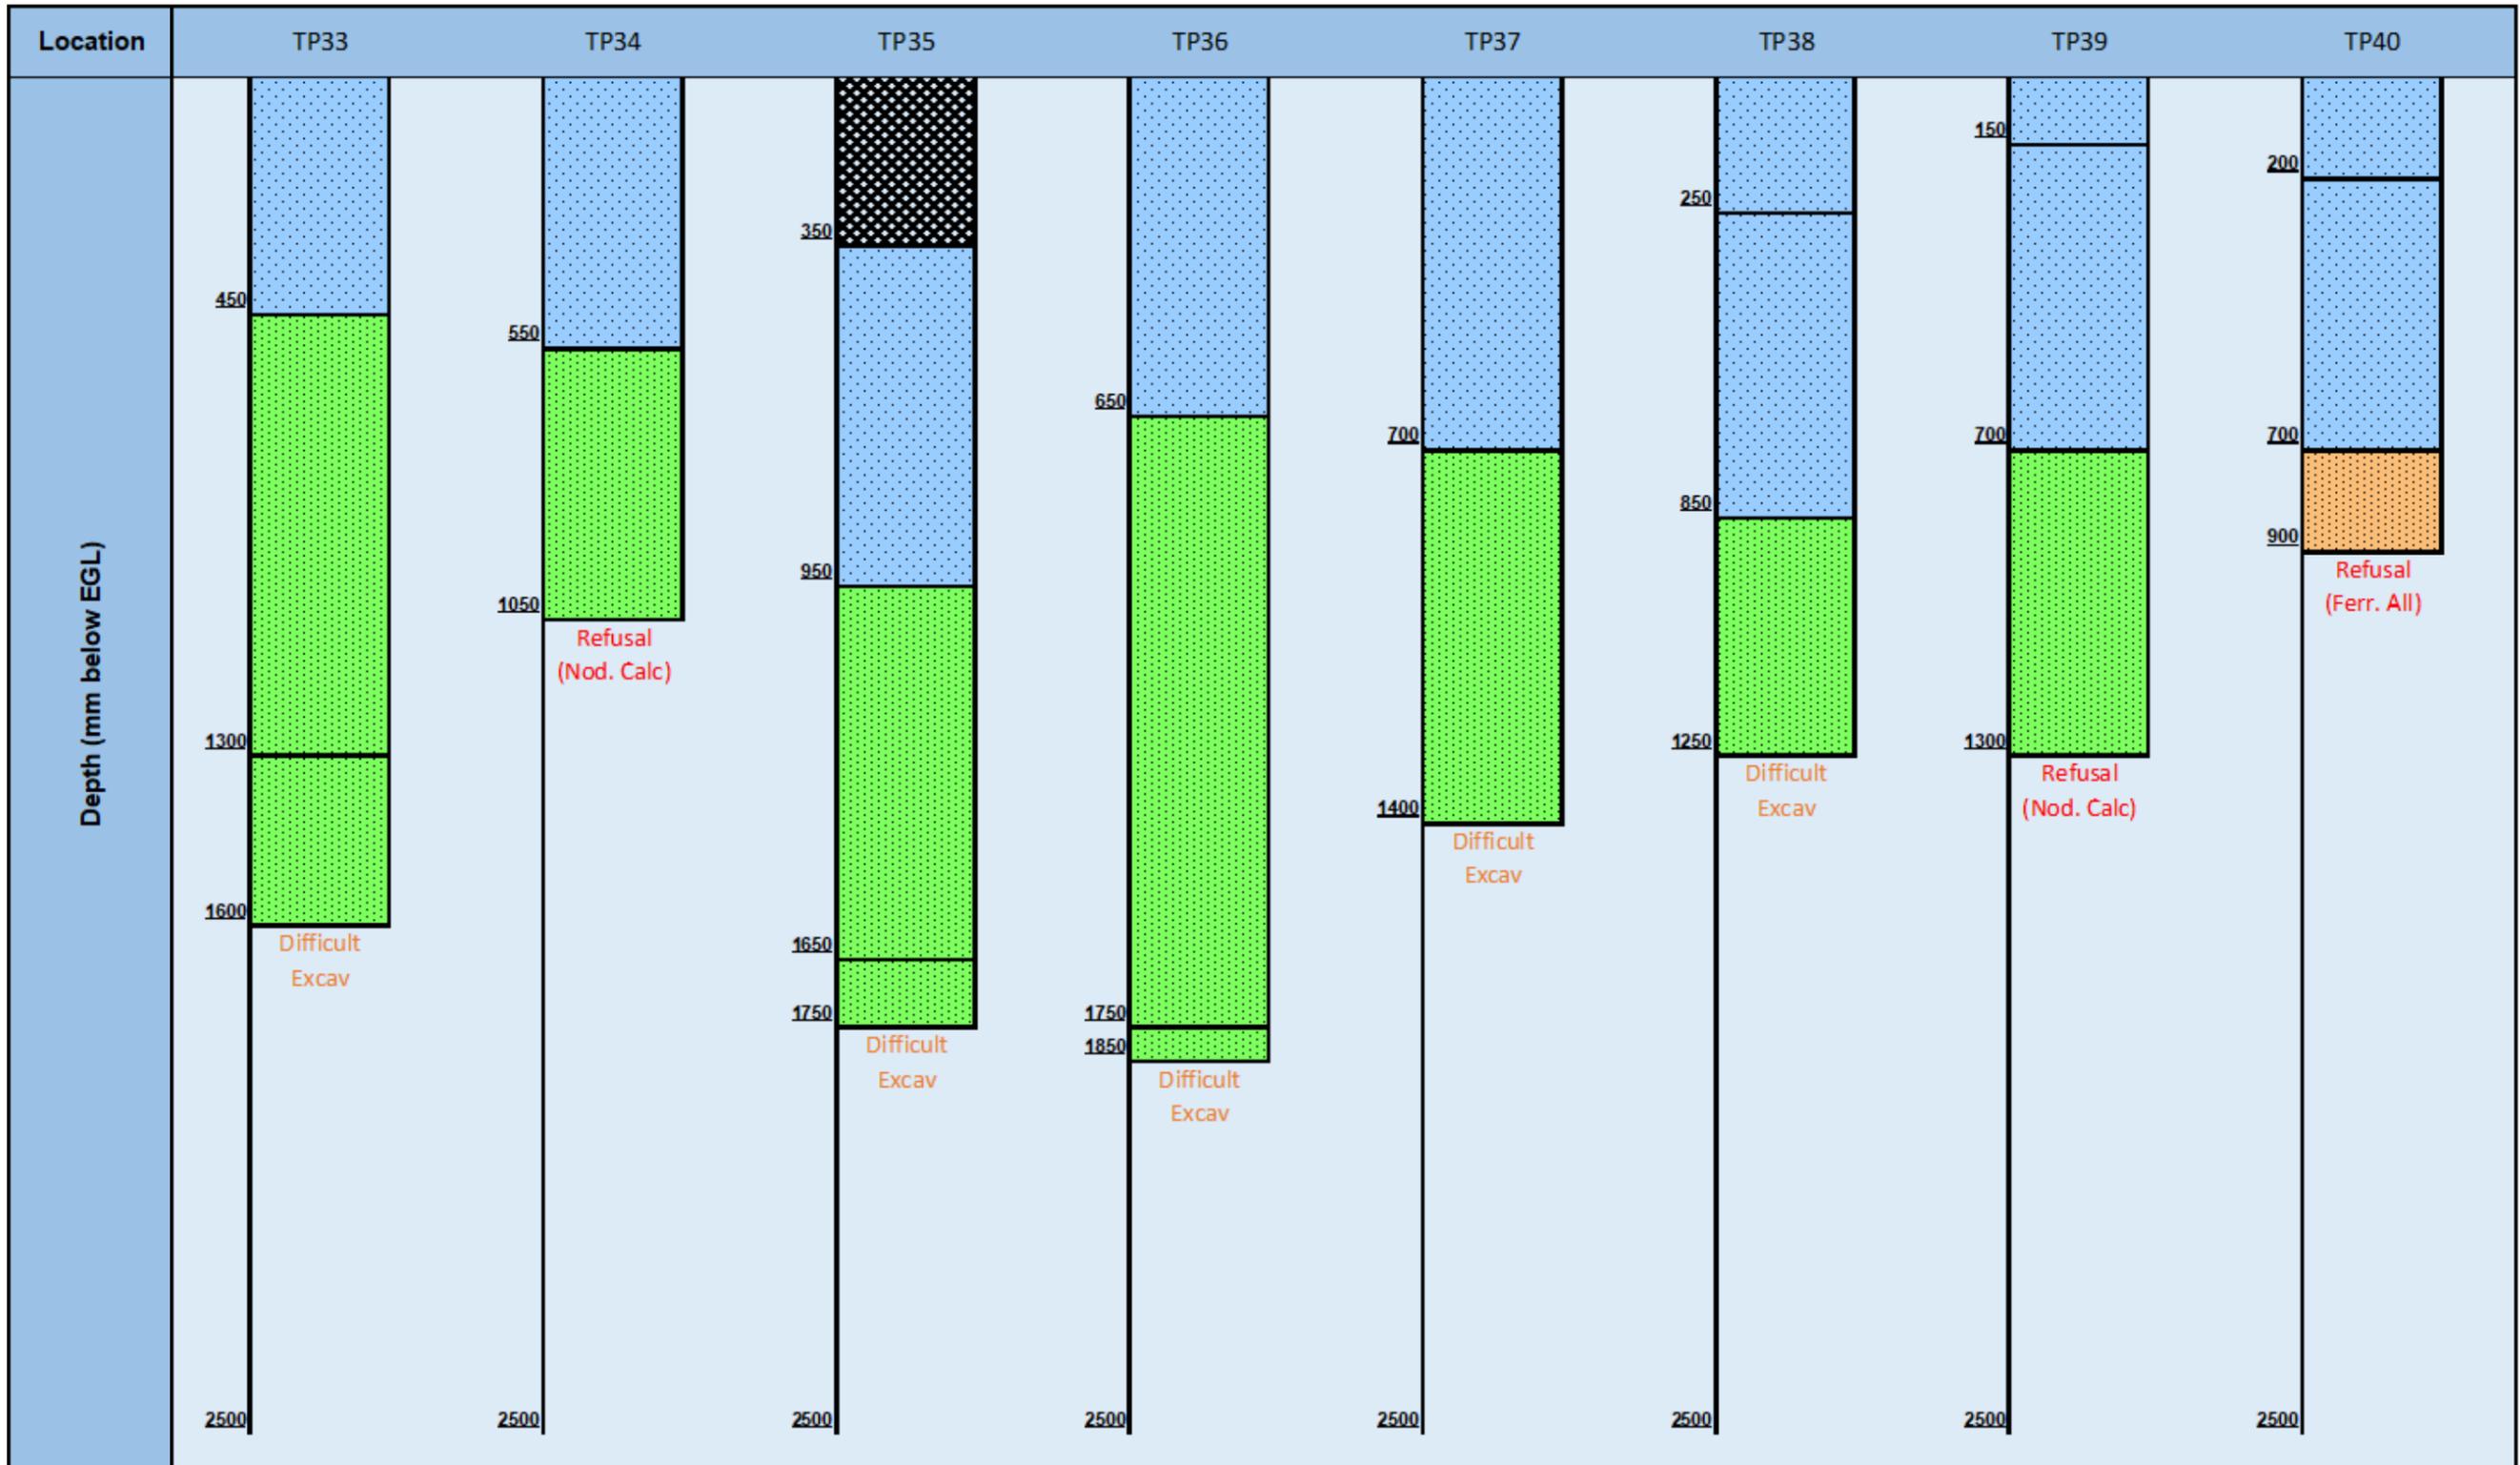
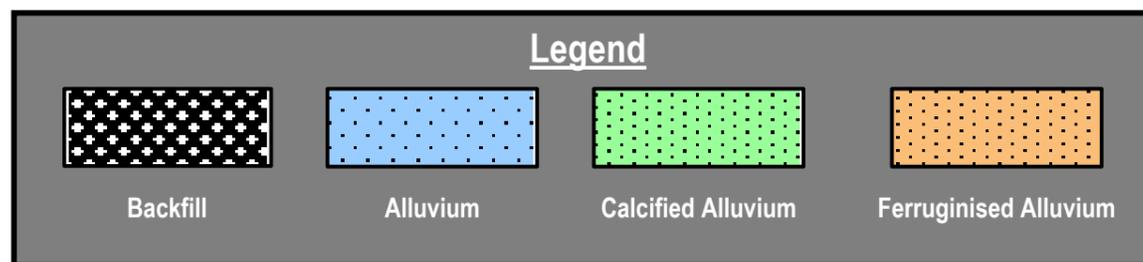
Graphic 6: Summarised Material Succession- Segment 3 (TP33-TP40)

The graphic is not to scale

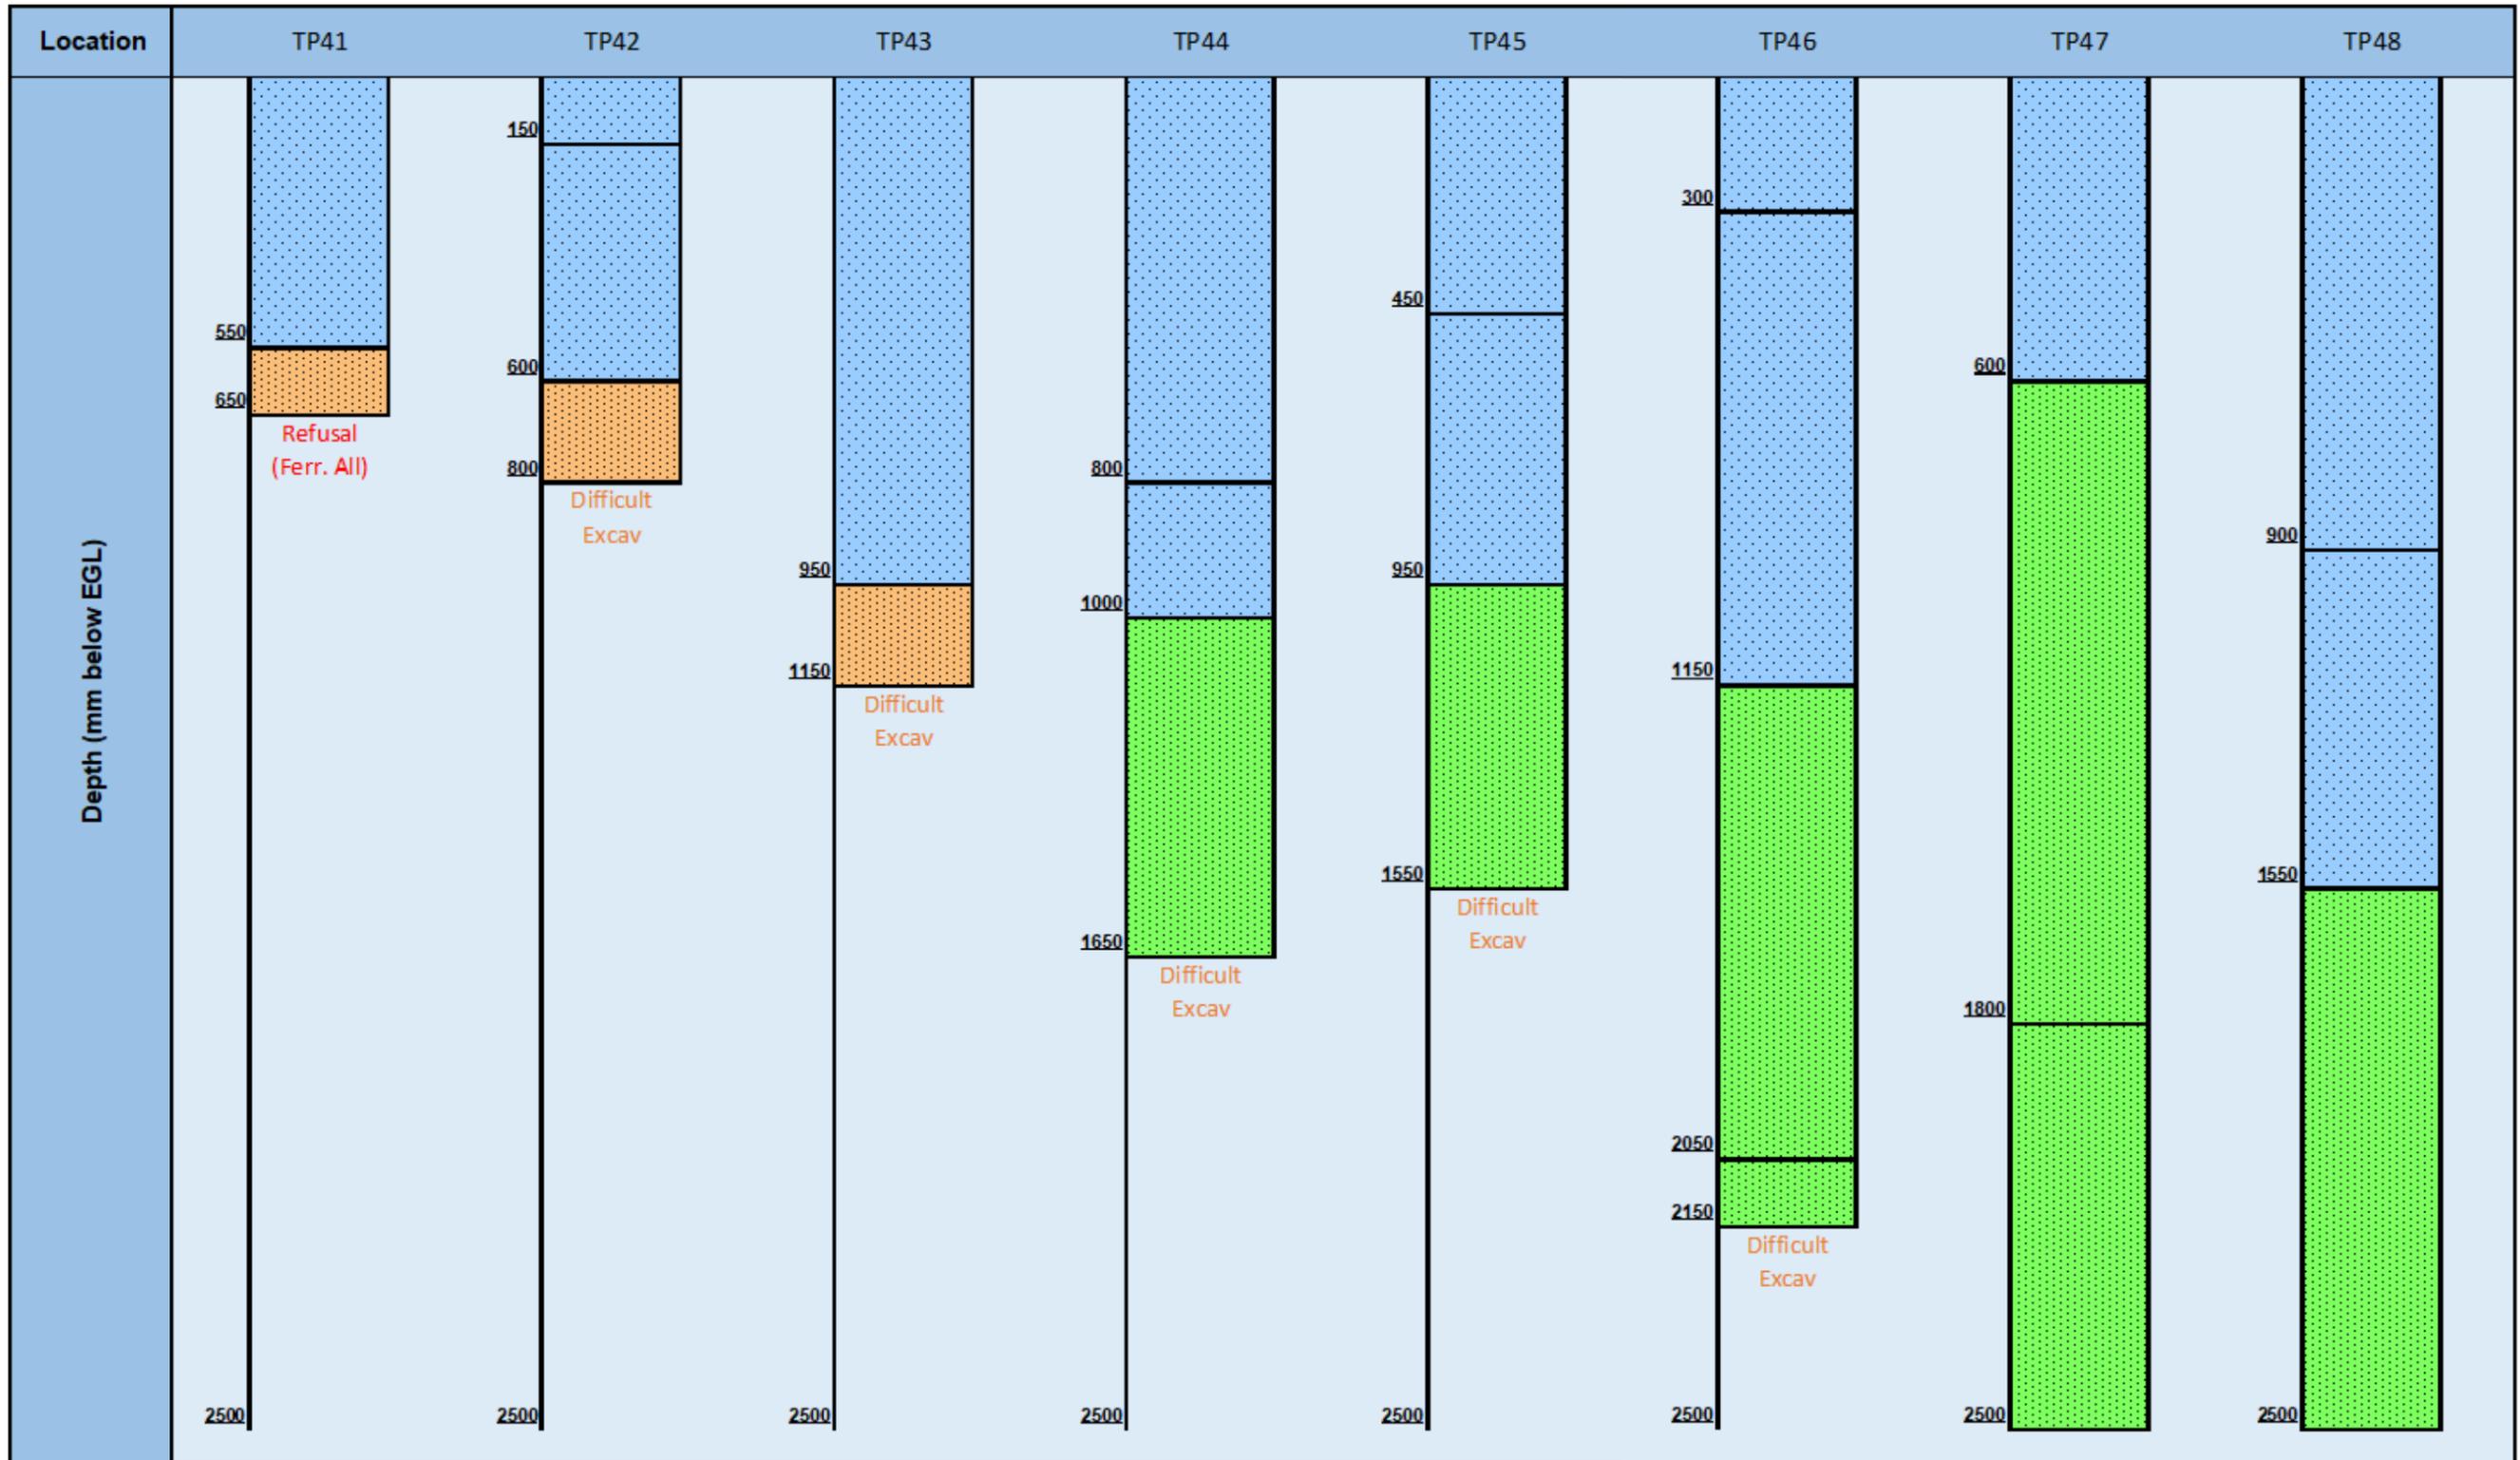
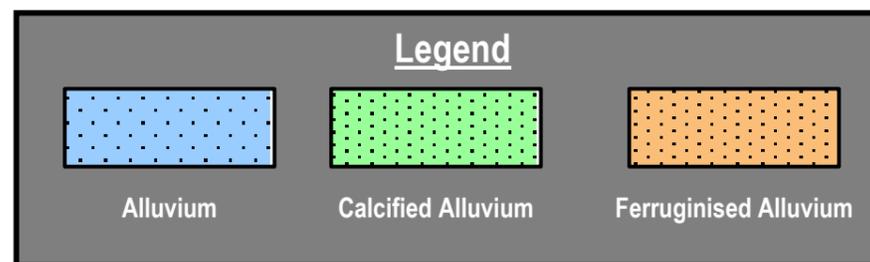
**Graphic 7: Summarised Material Succession- Segment 3 (TP41-TP48)**

The graphic is not to scale
