## C5.1-1: *SPECON PIPELINE REPLACEMENT PHASE 3*

## C5.1-2: REHABILITATION OF MEGORING AND THAKGALANG RIVER CROSSINGS

DOCUMENT NO.  
M-21-146D  
10/05/2022

**CENTERLINE AND MATERIALS INVESTIGATION  
OLIFANTSPOORT WATER SUPPLY SCHEME  
OLIFANTSPOORT WTW TO SPECON RESERVOIR  
LIMPOPO PROVINCE- SOUTH AFRICA**

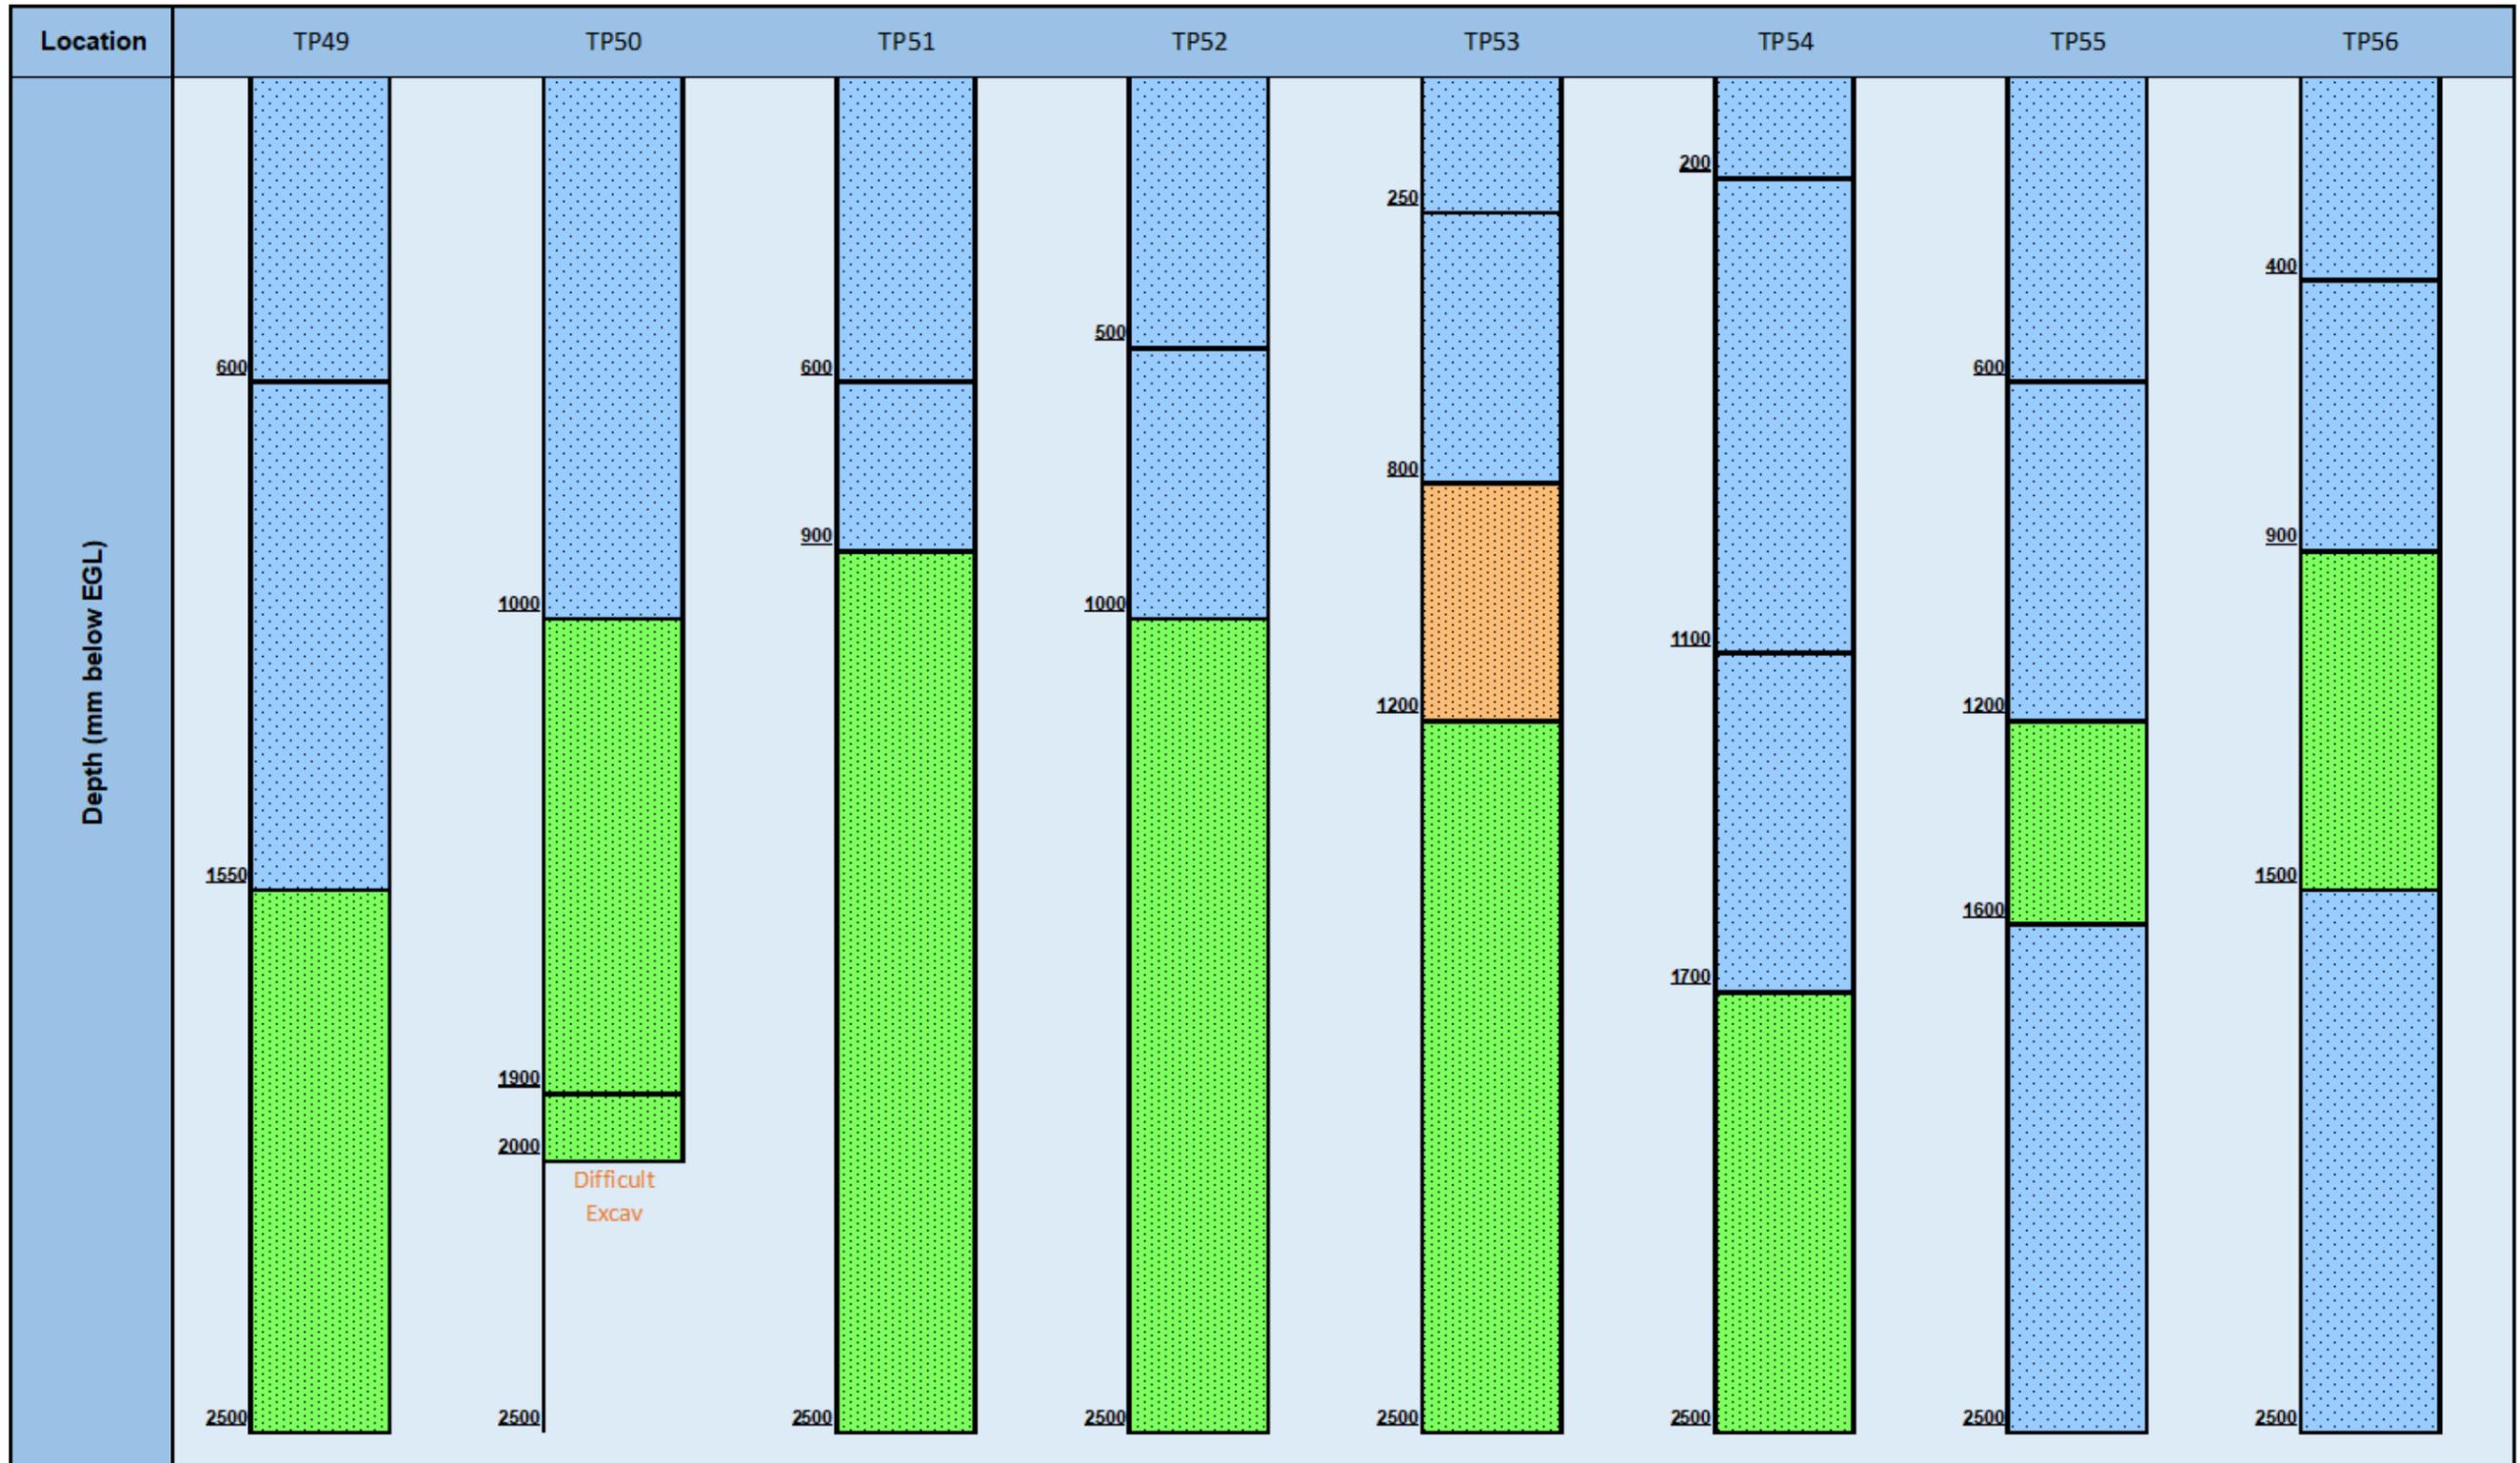
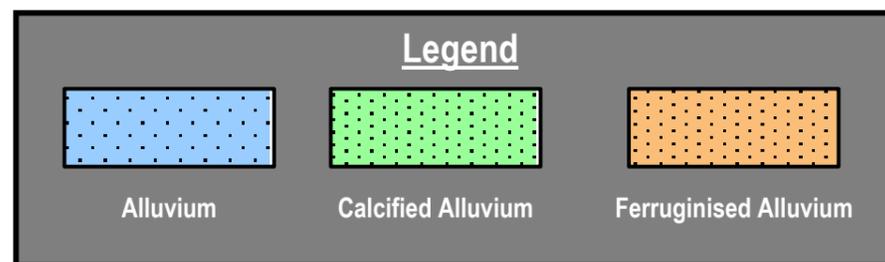
Graphic 8: Summarised Material Succession- Segment 3 (TP49-TP56)

The graphic is not to scale

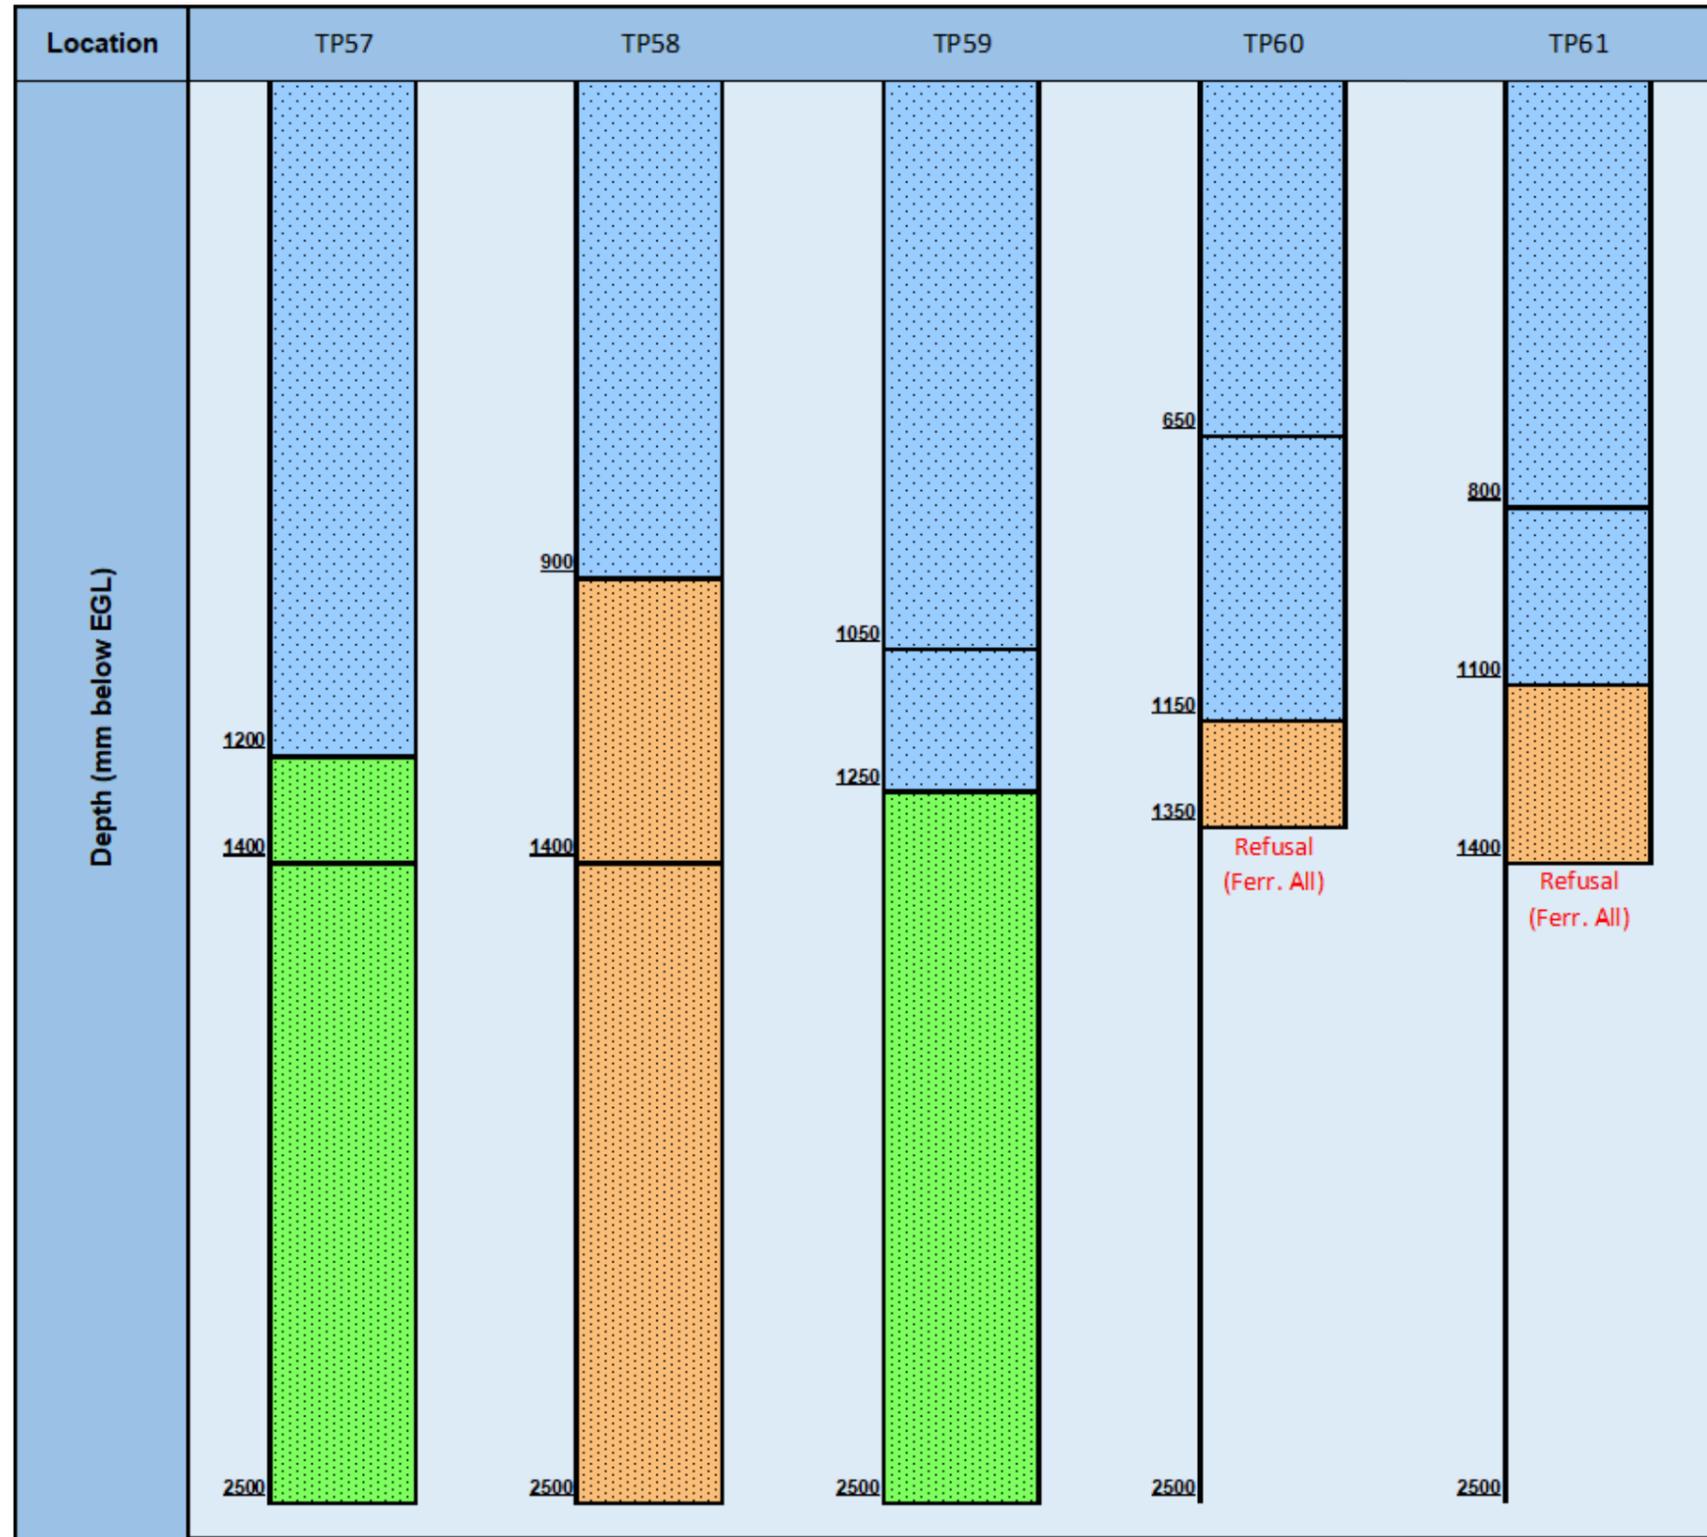
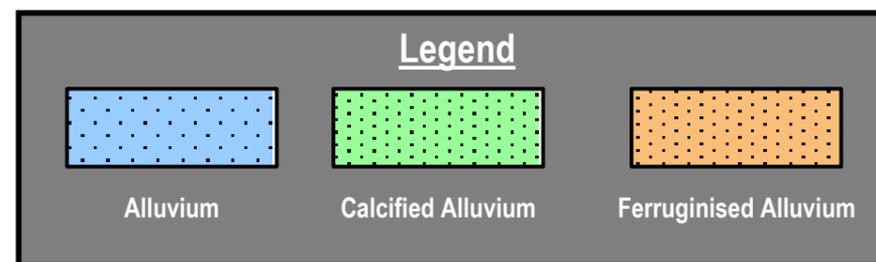
**Graphic 9: Summarised Material Succession- Segment 3 (TP57-TP61)**

The graphic is not to scale

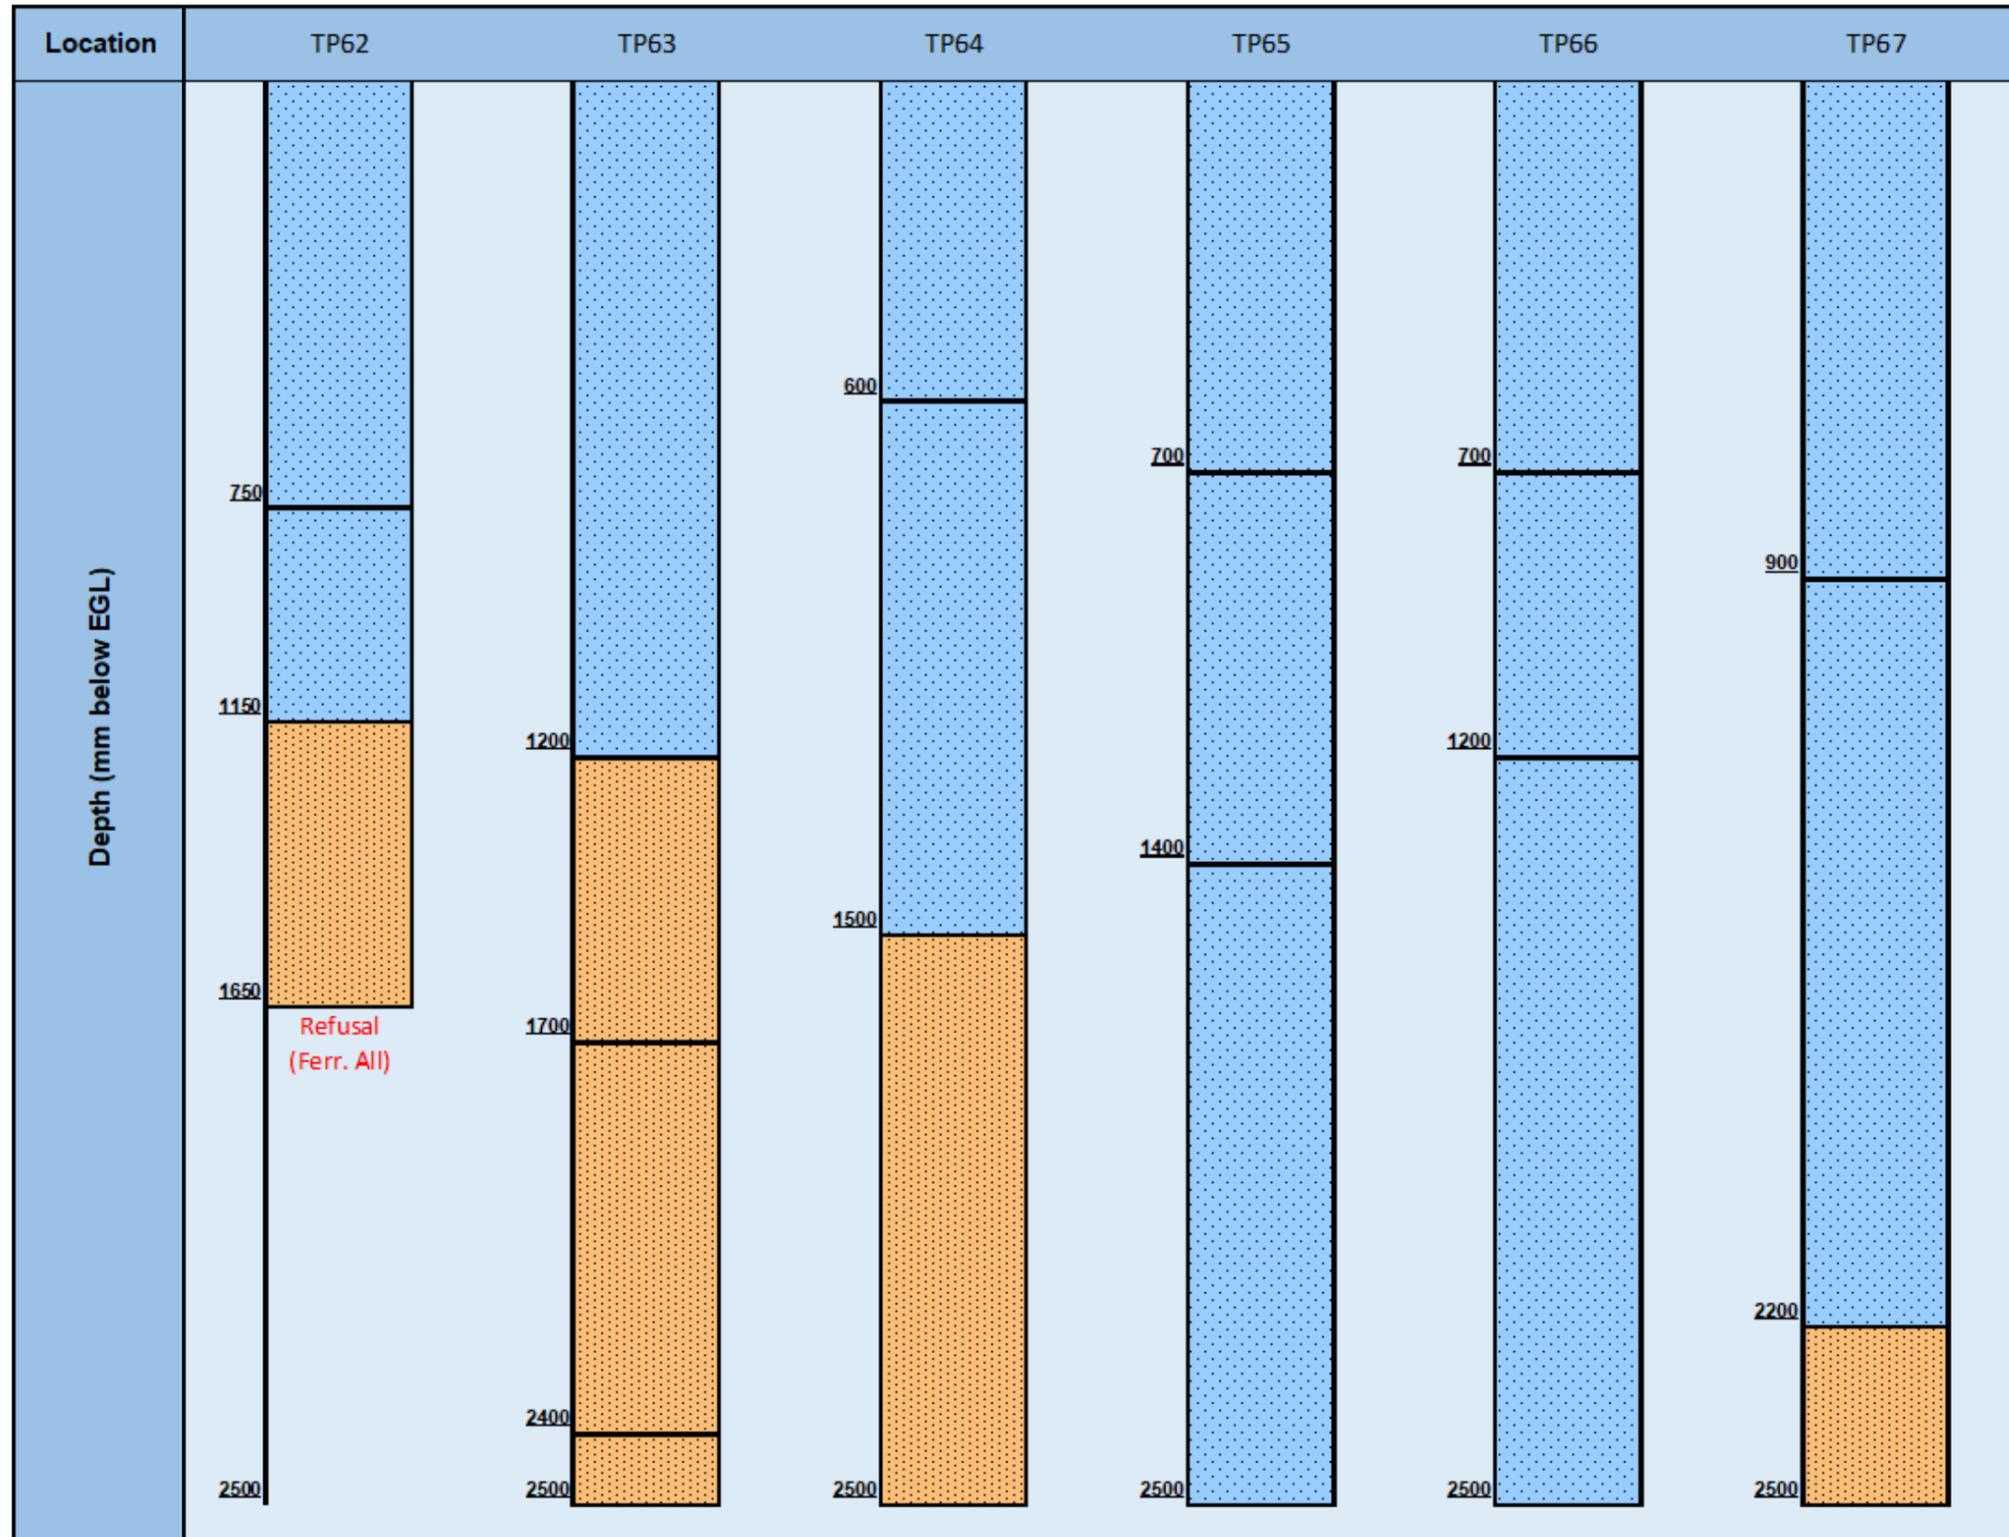
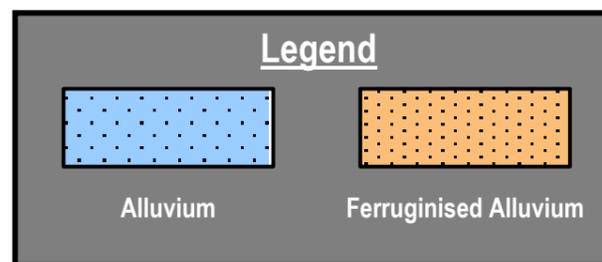
**Graphic 10: Summarised Material Succession- Segment 3 (TP62-TP67)**

The graphic is not to scale

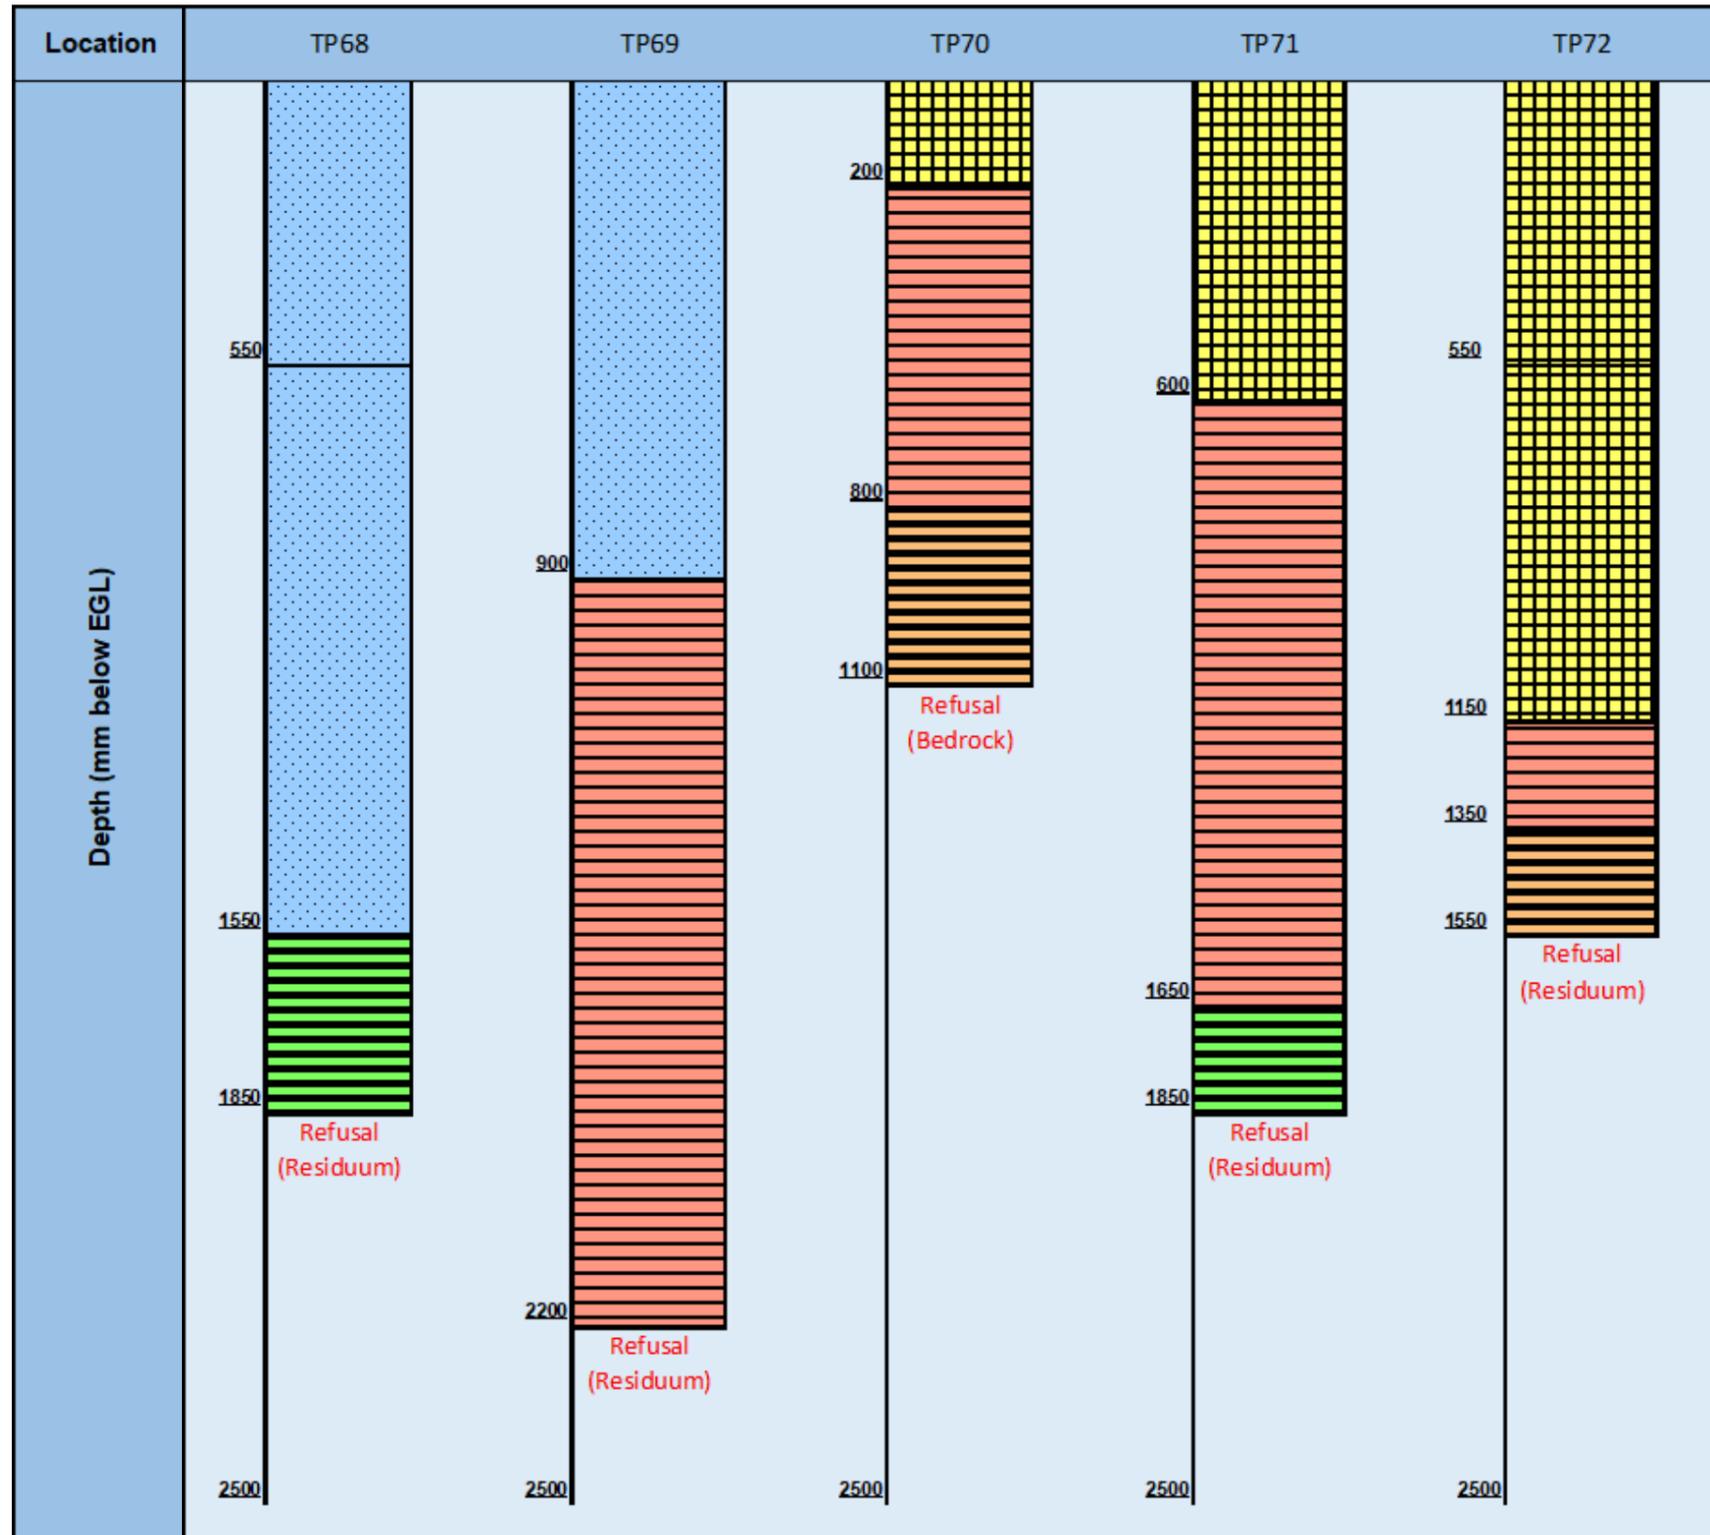
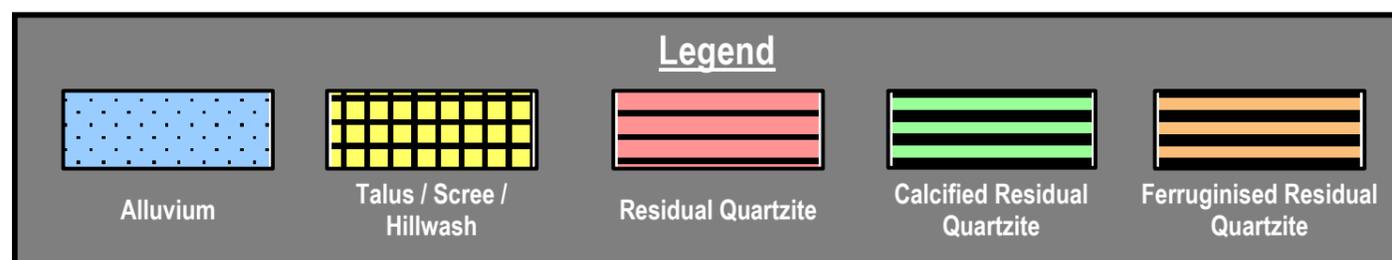
**Graphic 11: Summarised Material Succession- Segment 4 (TP68-TP72)**

The graphic is not to scale

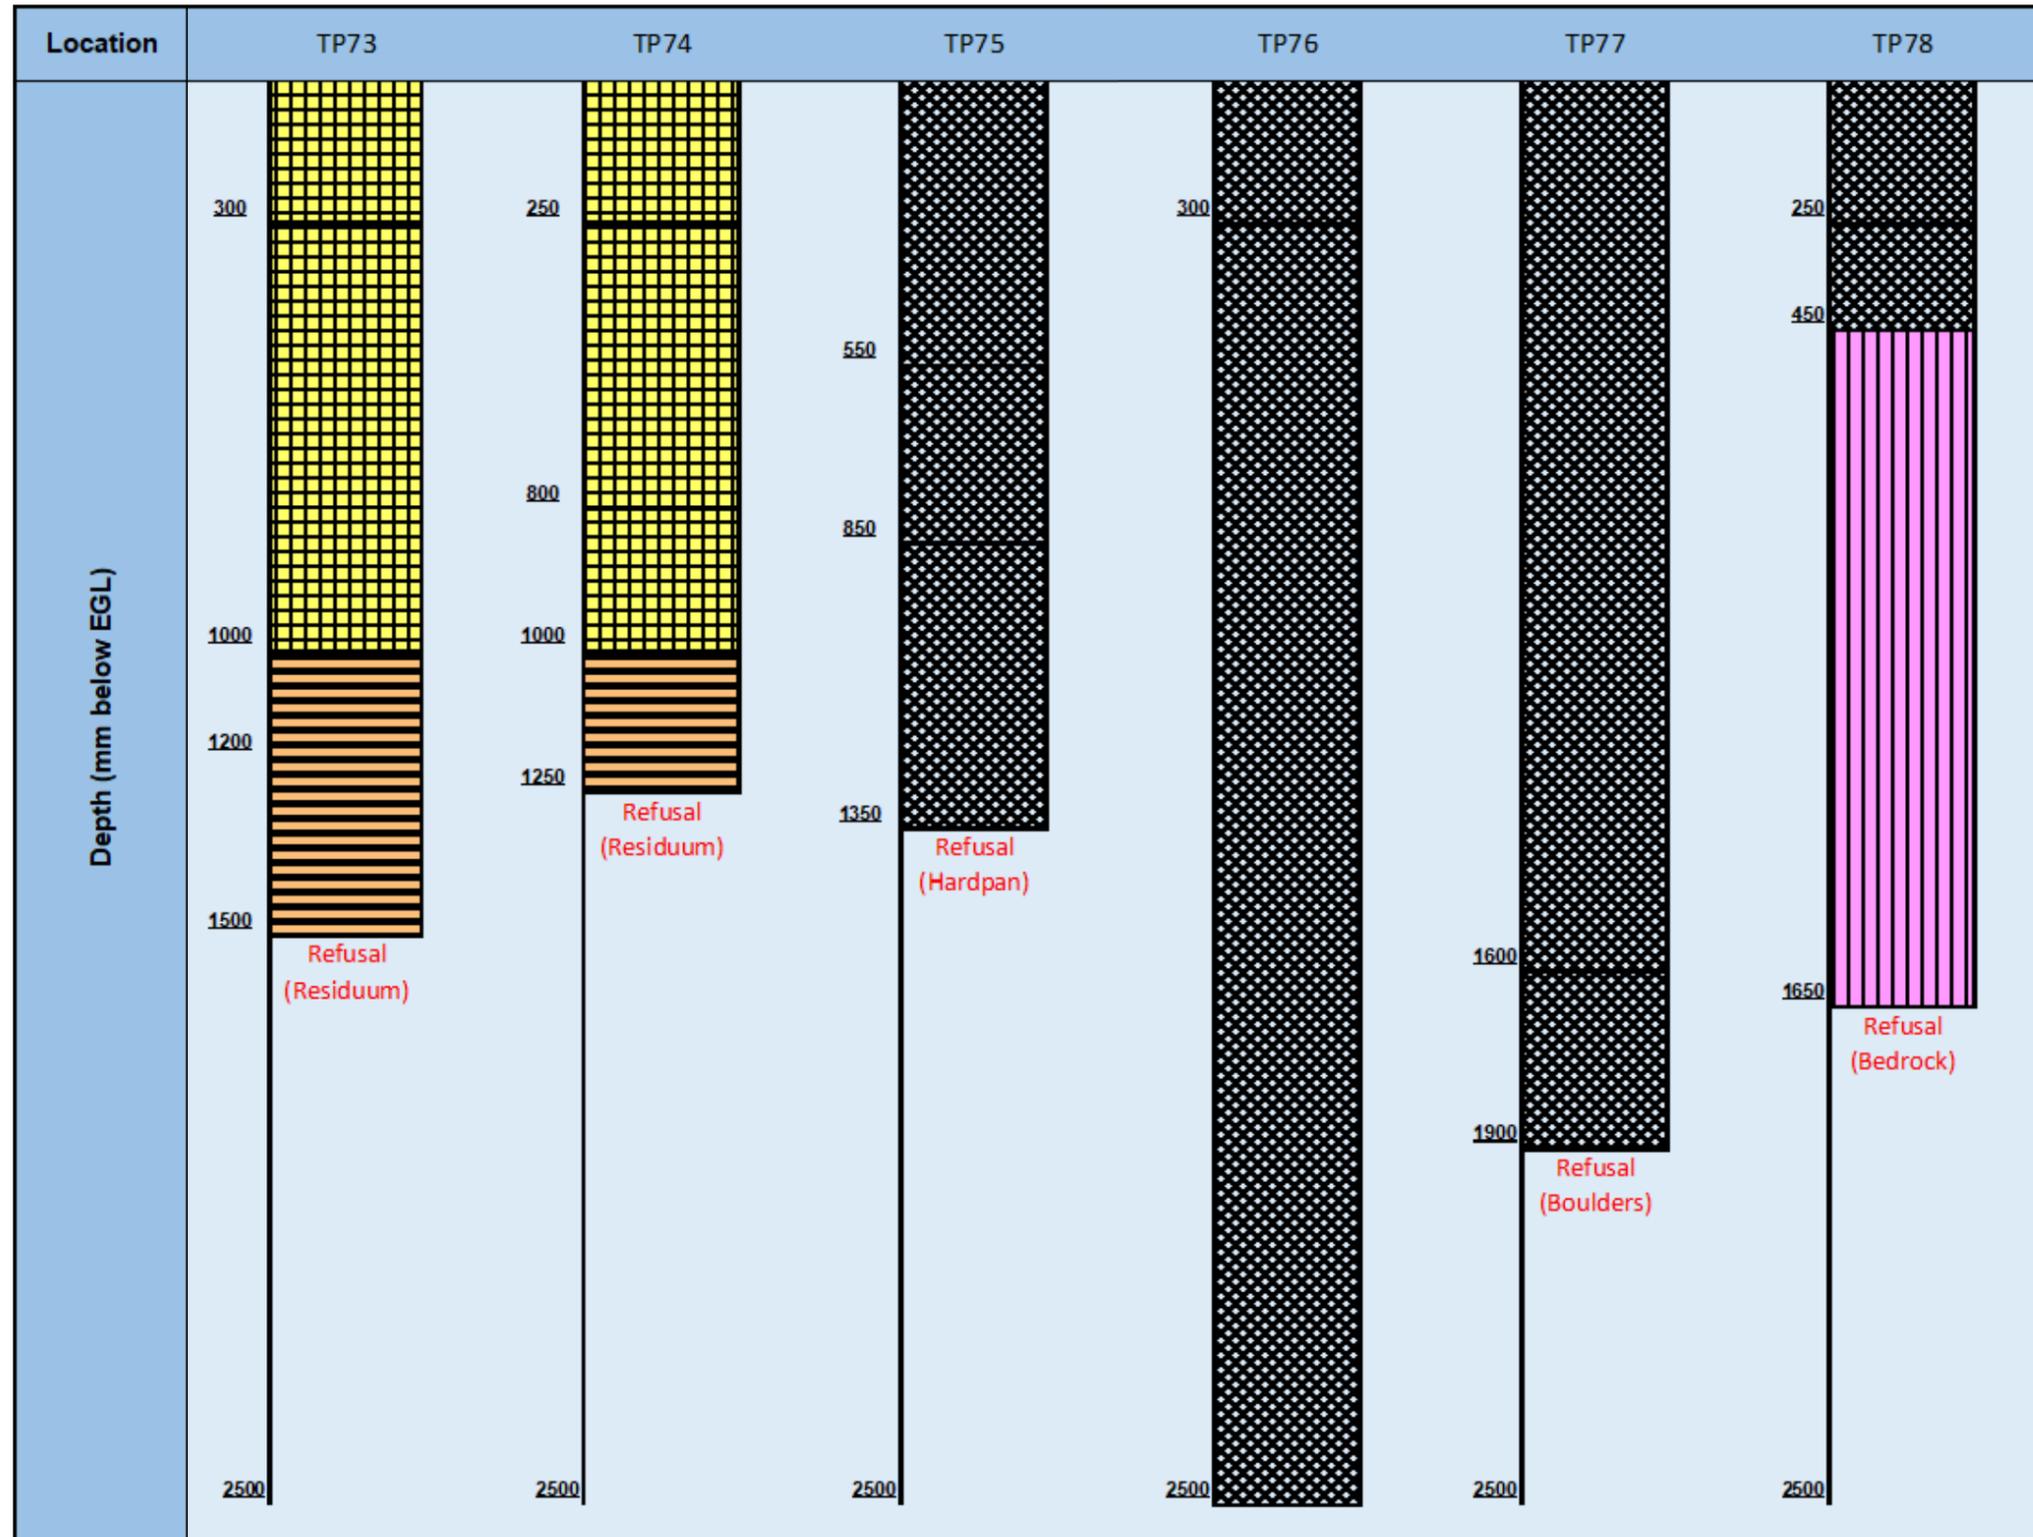
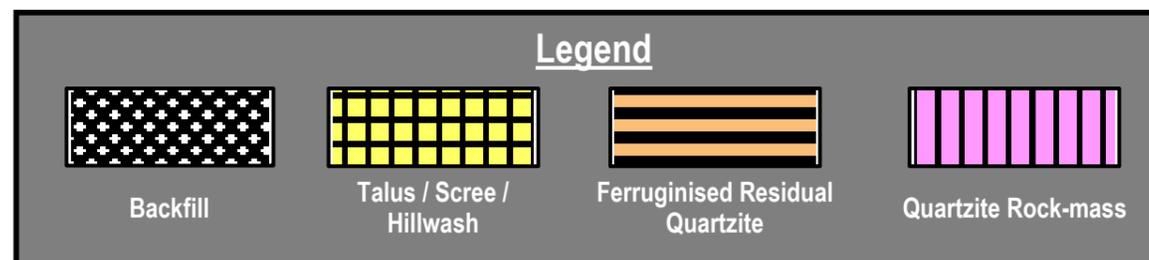
Graphic 12: Summarised Material Succession- Segment 4 (TP73-TP78)

The graphic is not to scale

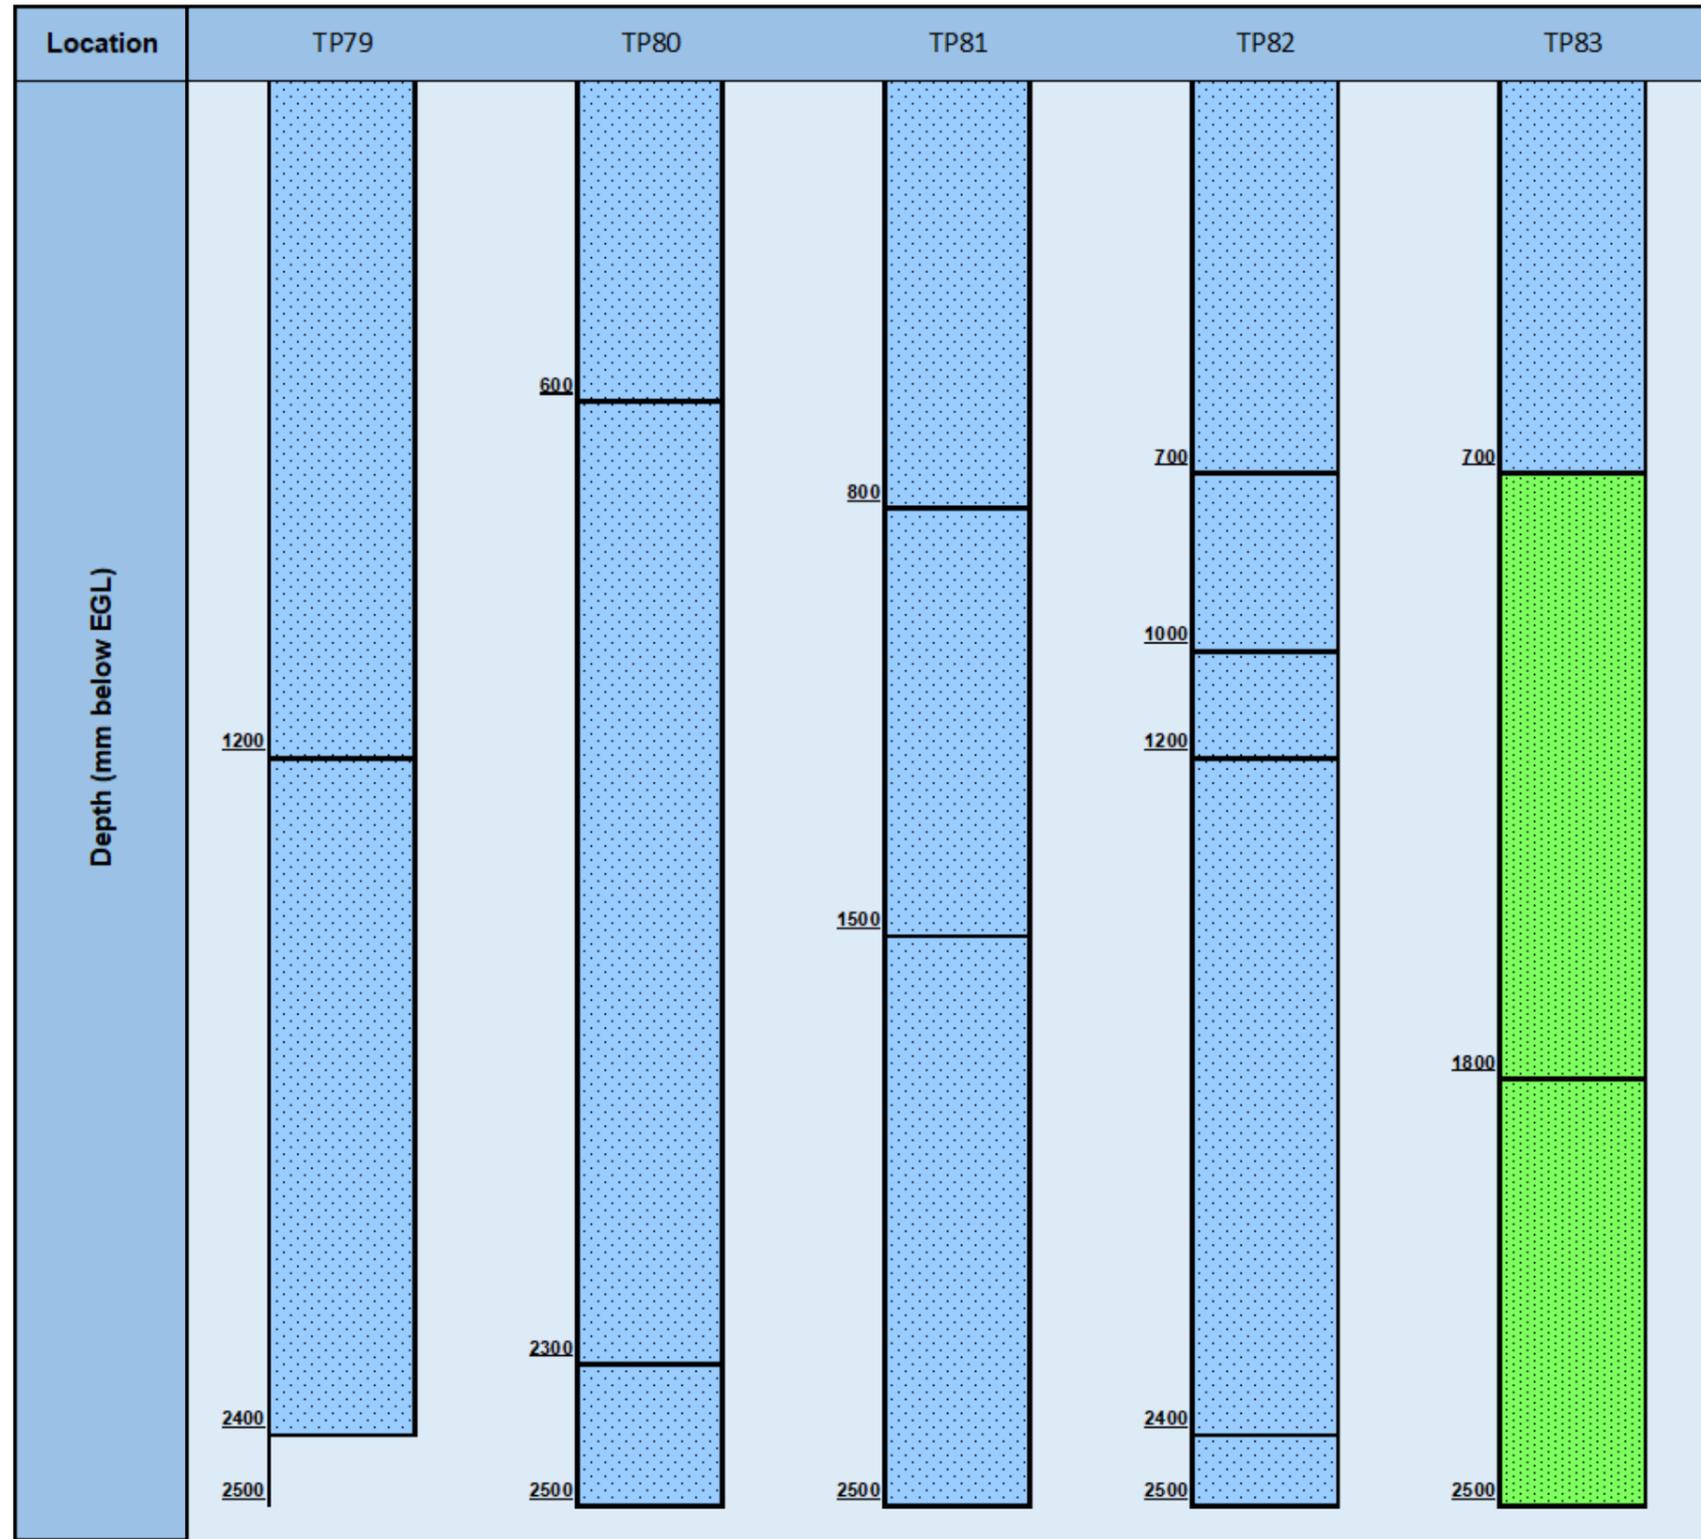
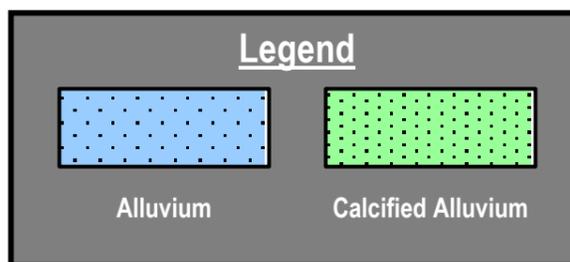
**Graphic 13: Summarised Material Succession- Segment 5 (TP79-TP83)**

The graphic is not to scale

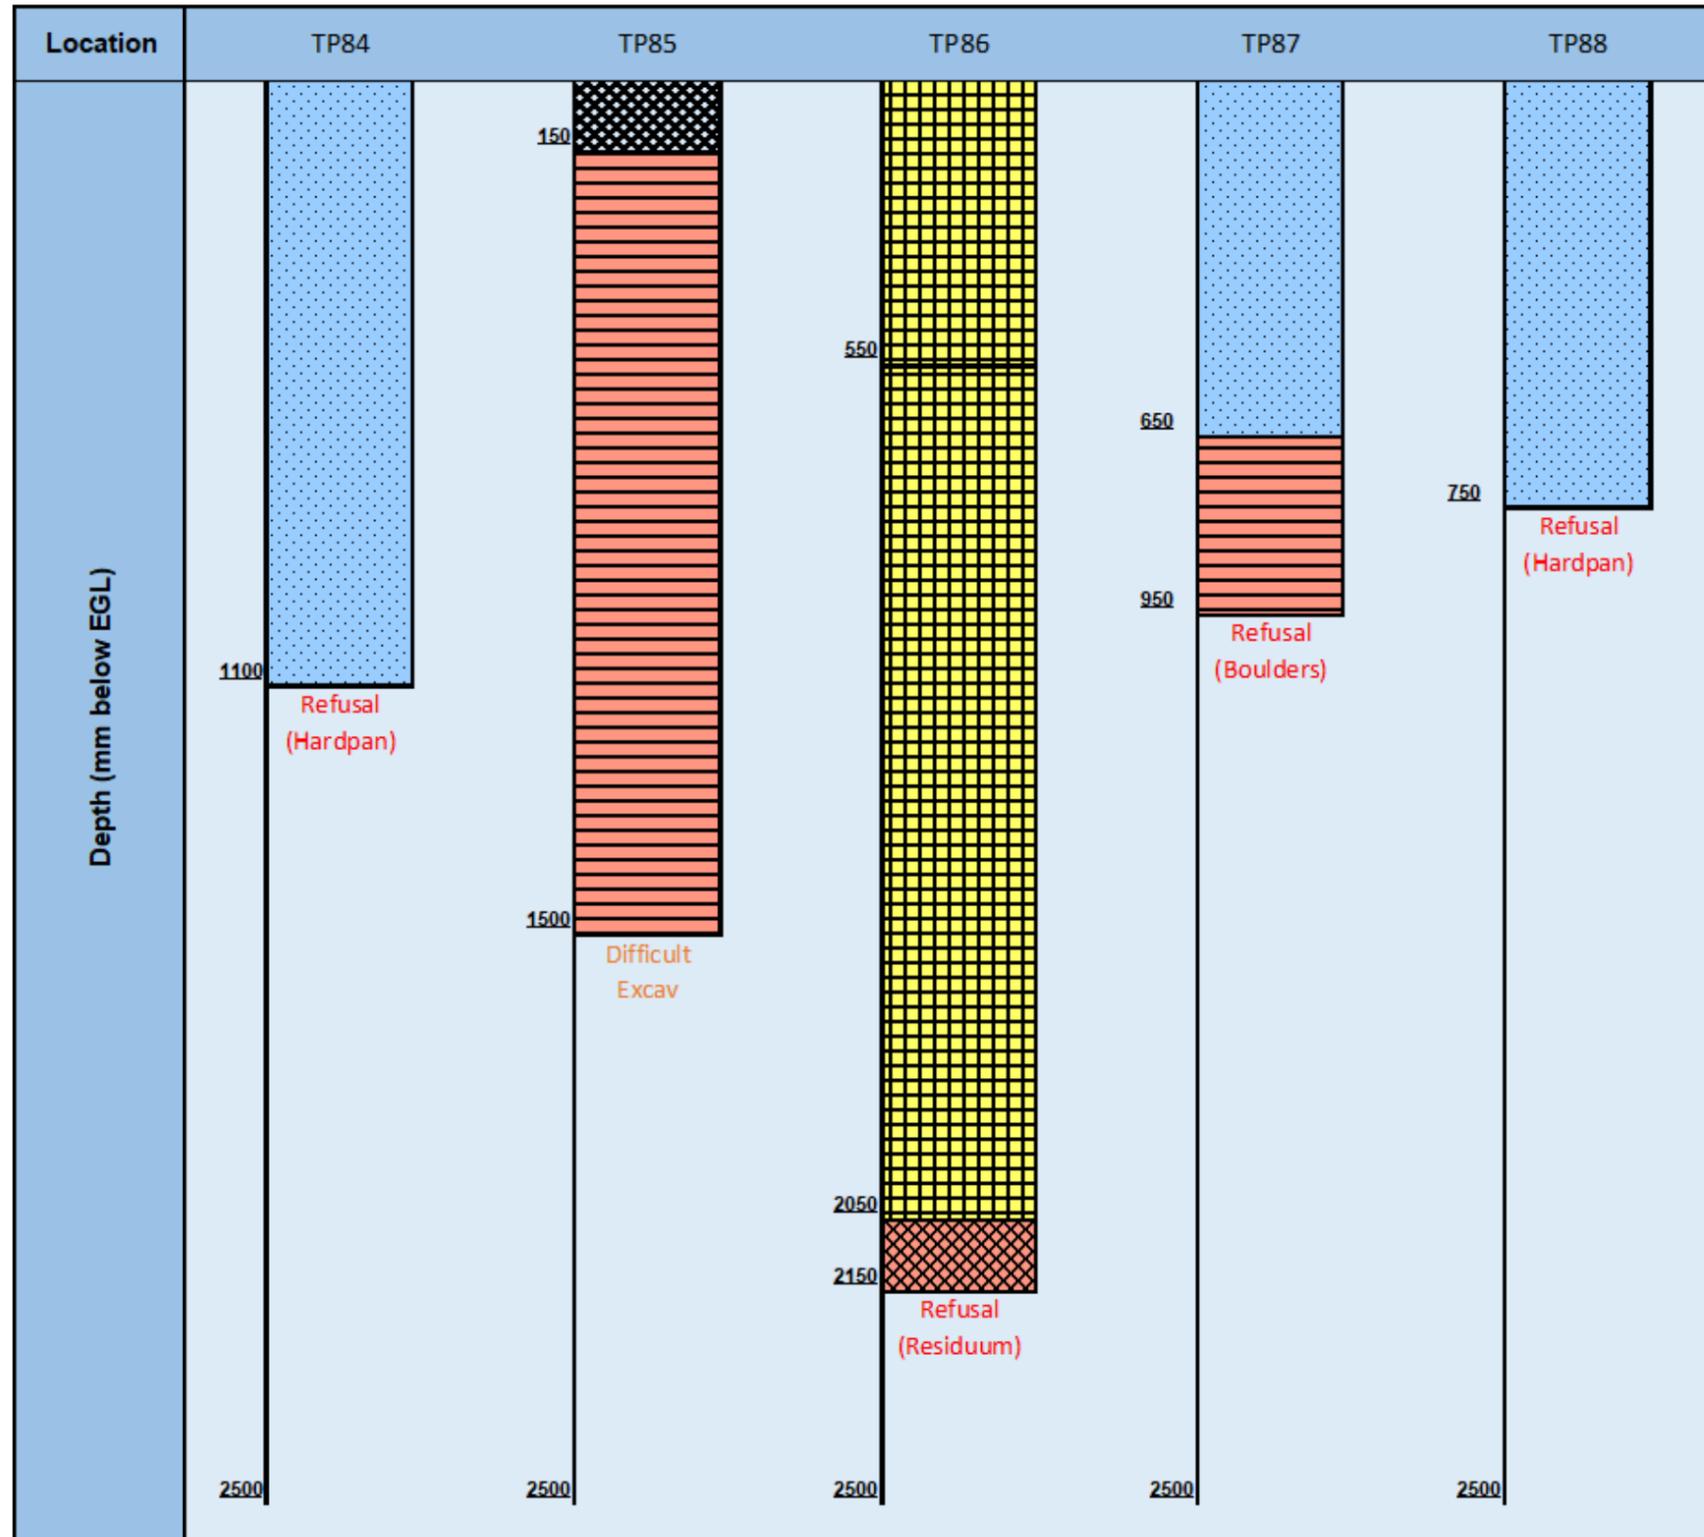
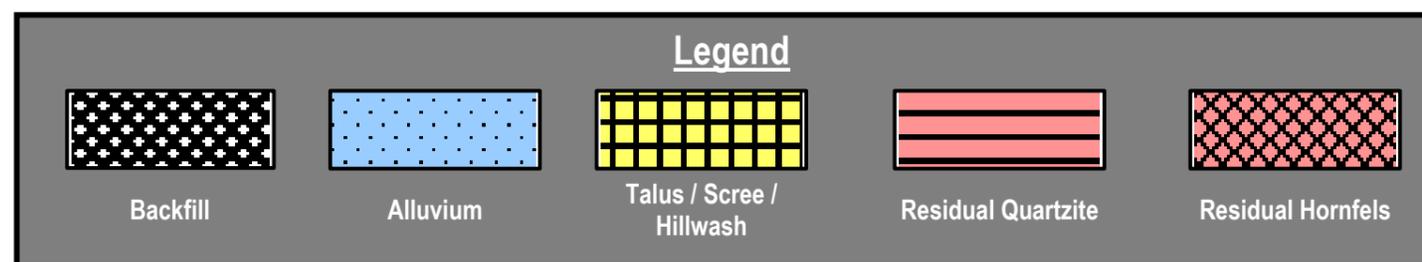
**Graphic 14: Summarised Material Succession- Segment 6 (TP84-TP88)**

The graphic is not to scale
