## C5.1-1: *SPECON PIPELINE REPLACEMENT PHASE 3*

## C5.1-2: REHABILITATION OF MEGORING AND THAKGALANG RIVER CROSSINGS

DOCUMENT NO.  
M-21-146D  
10/05/2022

**CENTERLINE AND MATERIALS INVESTIGATION  
OLIFANTSPOORT WATER SUPPLY SCHEME  
OLIFANTSPOORT WTW TO SPECON RESERVOIR  
LIMPOPO PROVINCE- SOUTH AFRICA**

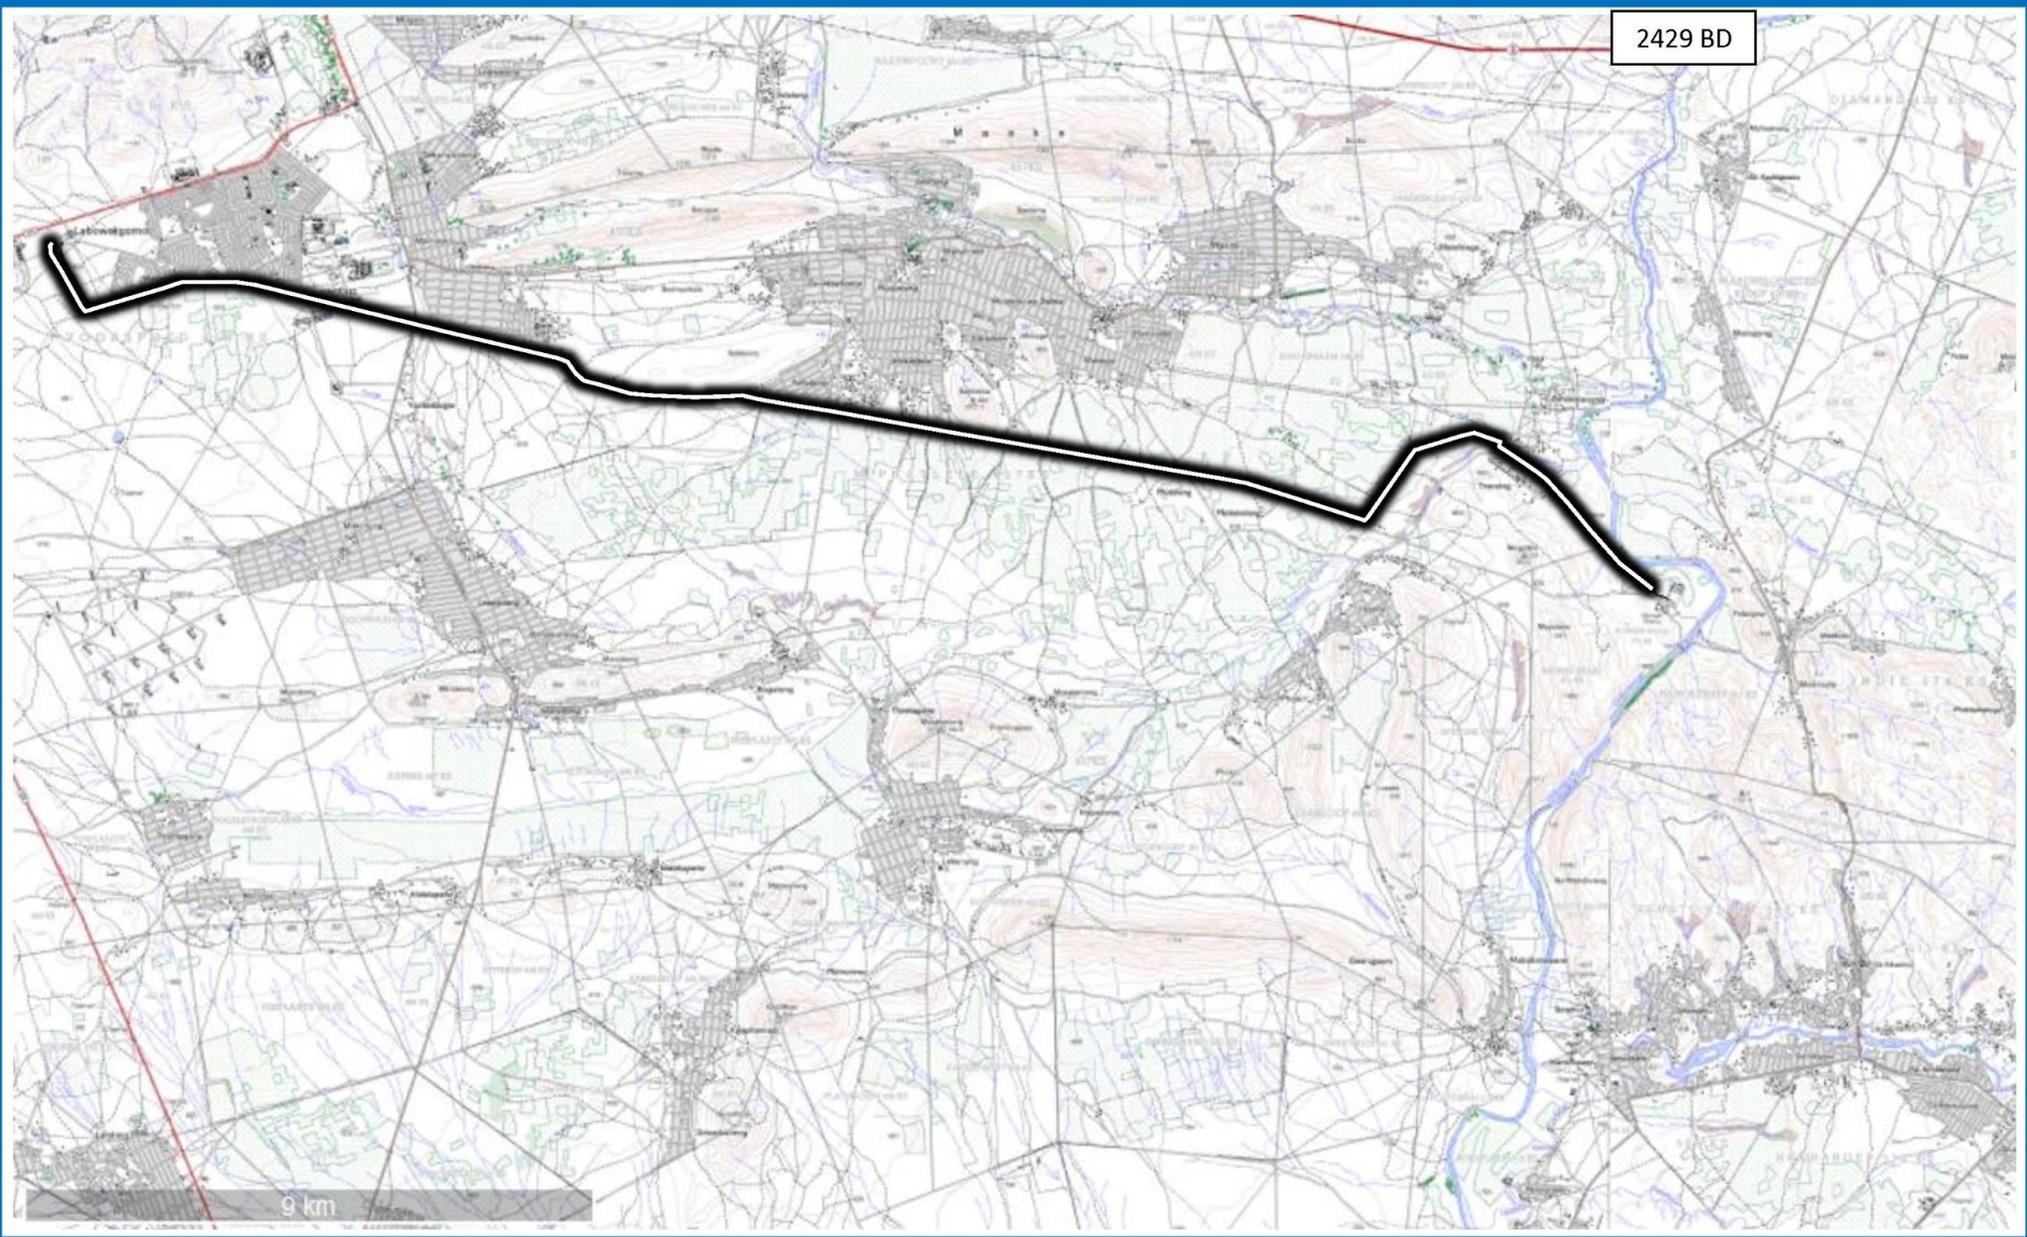
# FIGURE 4

Site Segmentation

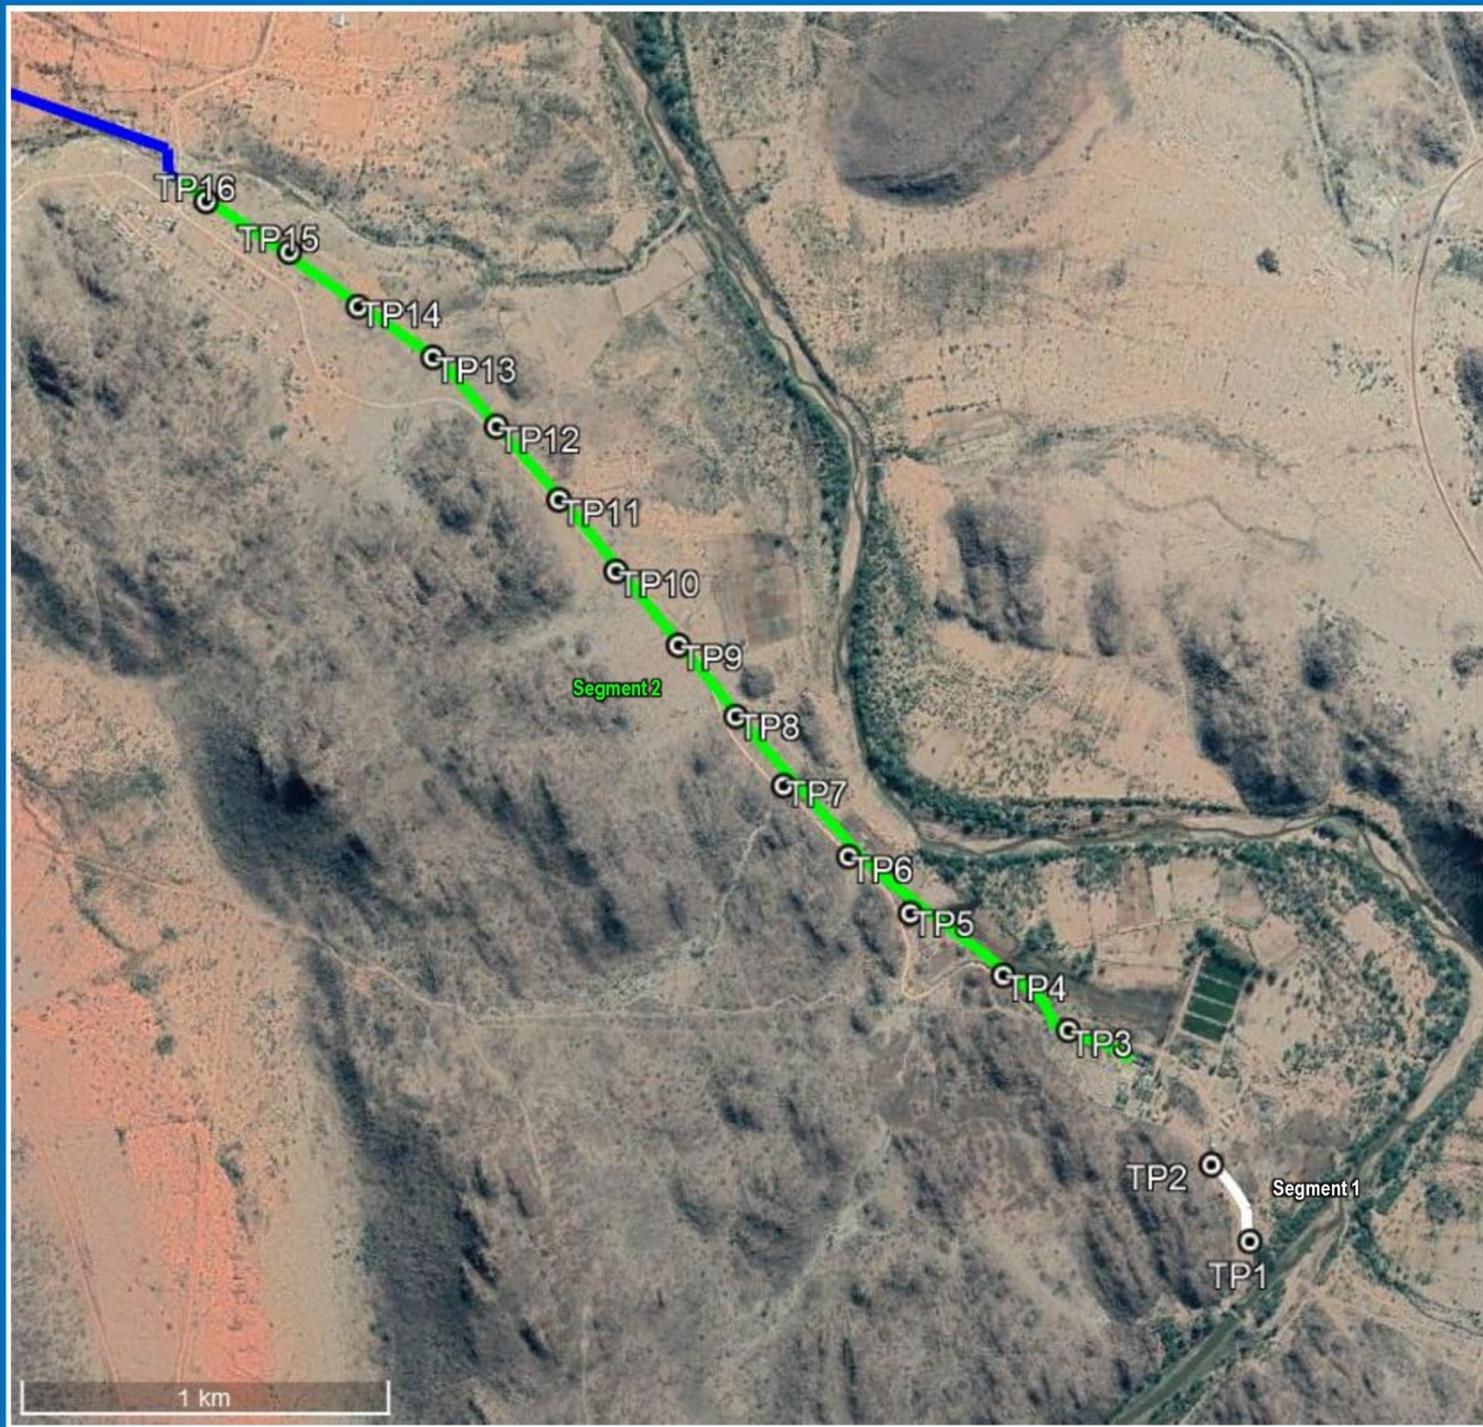
⊙ Test Pits

(Note: odd number TPs excluded for better image quality)

Test pit locations can be viewed in Figure 5 to Figure 8 and detailed soil profile logs are presented in **Appendix A**.
