### PHASE 1- HOERSKOOL CENTURION.

The firm, Geopractica Pty (Ltd) (GP) submitted their report: "Phase 1 dolomite stability investigation at Hoërskool Centurion", dated August 2018 to this office for comment on behalf of their client, Mr V. Musungaie of PM Plus, on 21 September 2018. This office acts as an agent to state authorities in reviewing dolomite stability investigations on their behalf.

**PHASE 1 DOLOMITE STABILITY INVESTIGATION**  
at  
**Hoërskool Centurion**

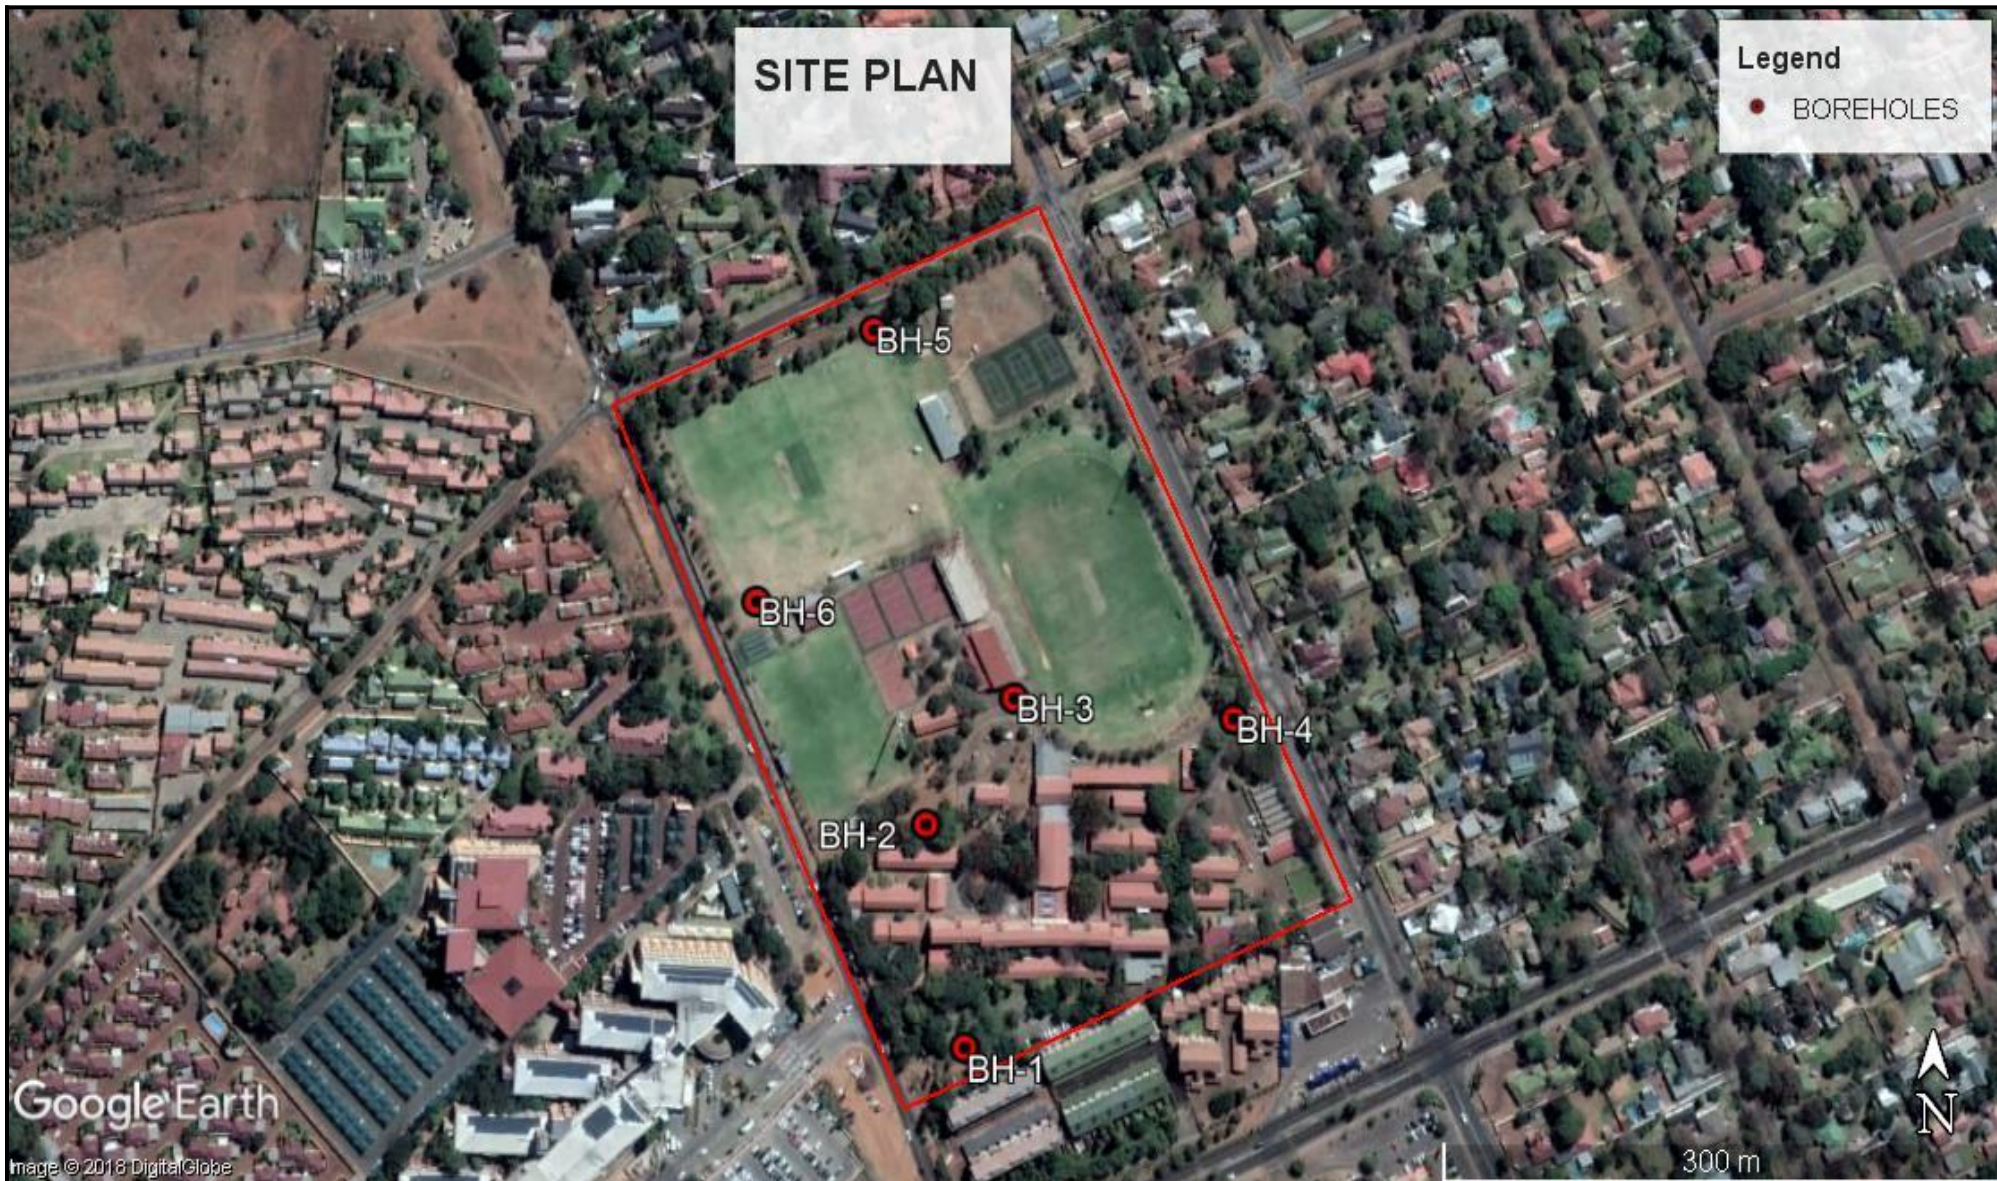
Figure: 1

## SITE PLAN

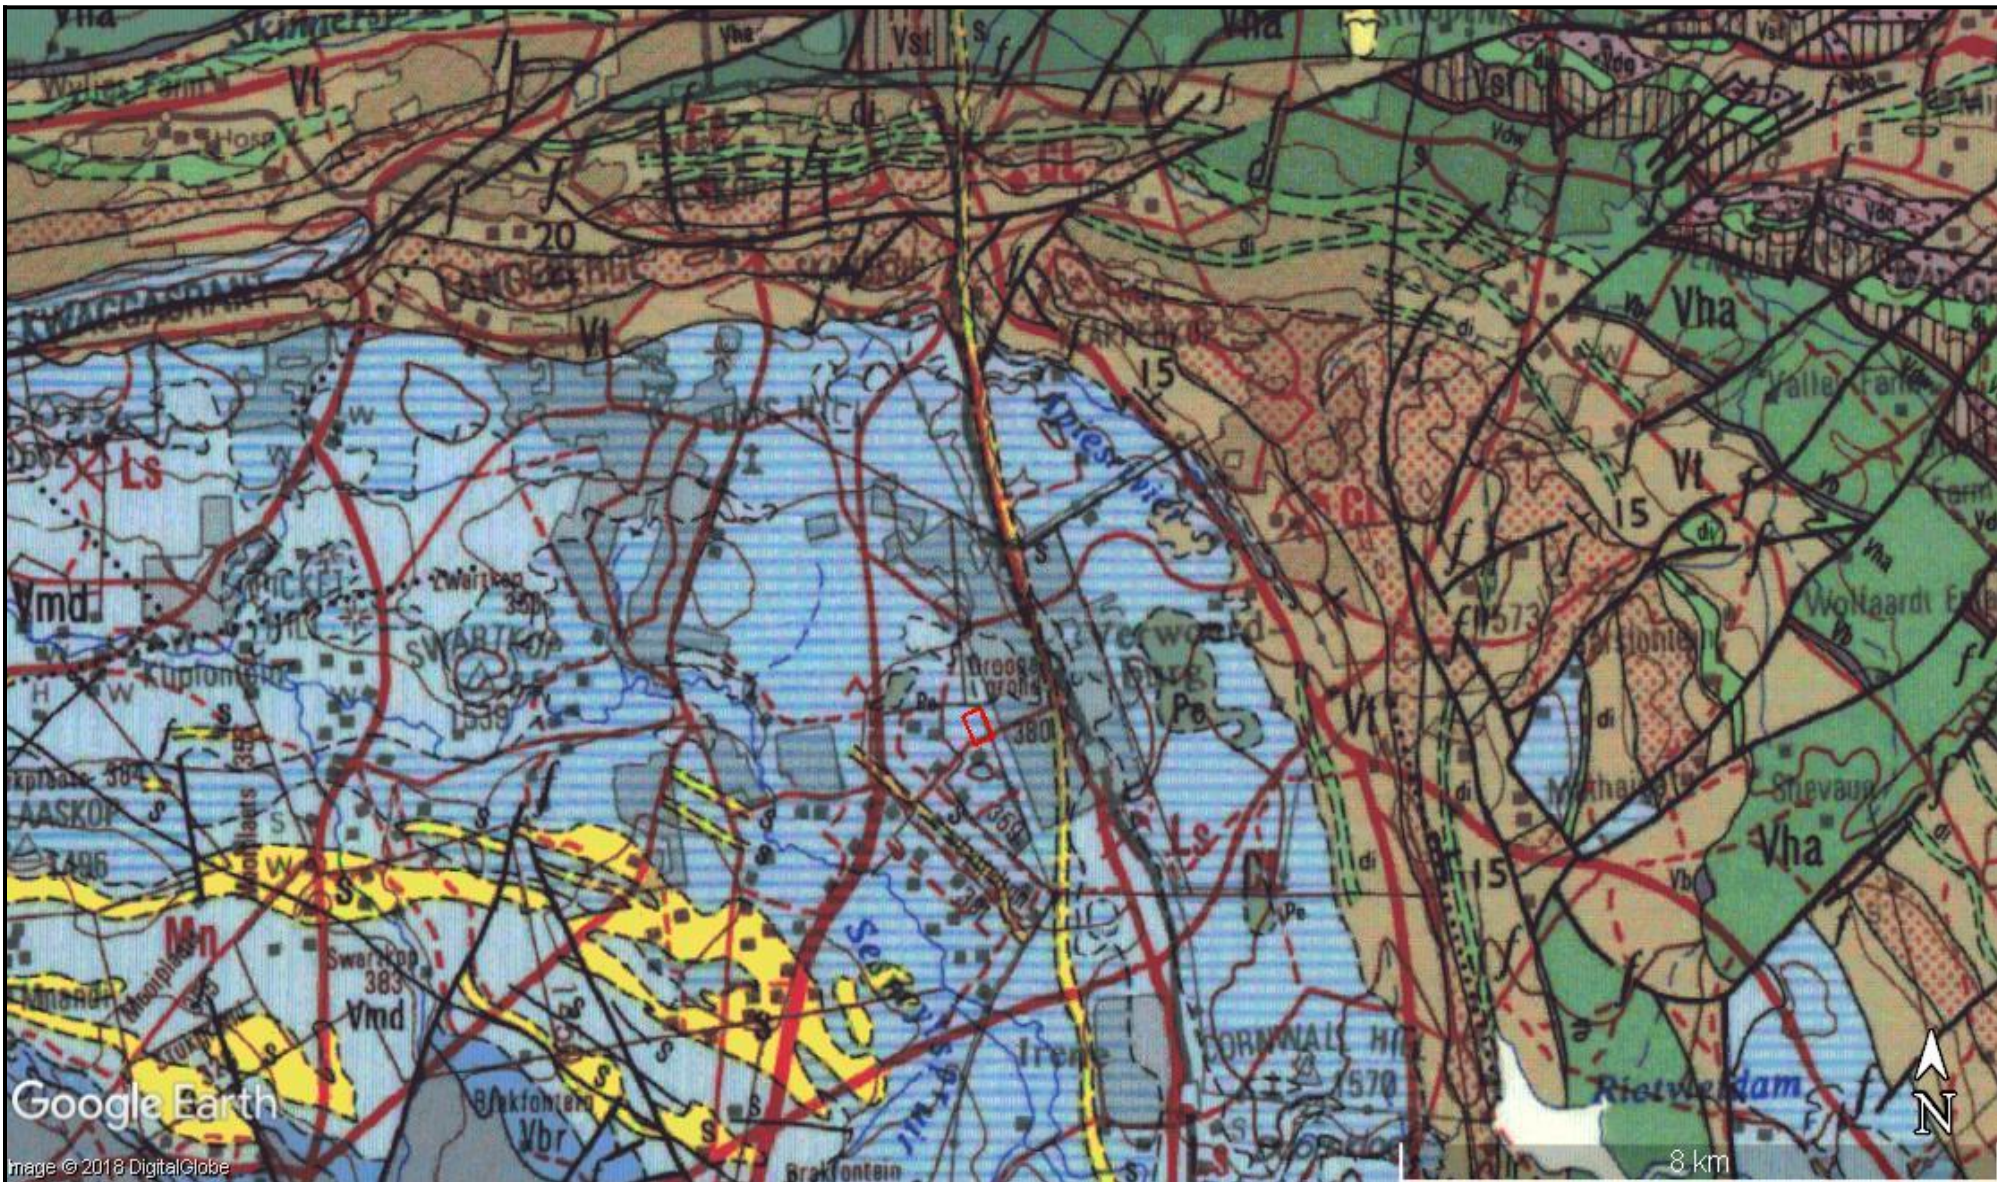
Figure: 2

## GEOLOGICAL MAP

Within the south western portion of the site, sedimentary deposits, belonging to the Vryheid Formation of the Karoo Supergroup were encountered, below the transported soils. Typically these Karoo sediments were found to be variable in thickness, ranging from nothing to 20m.

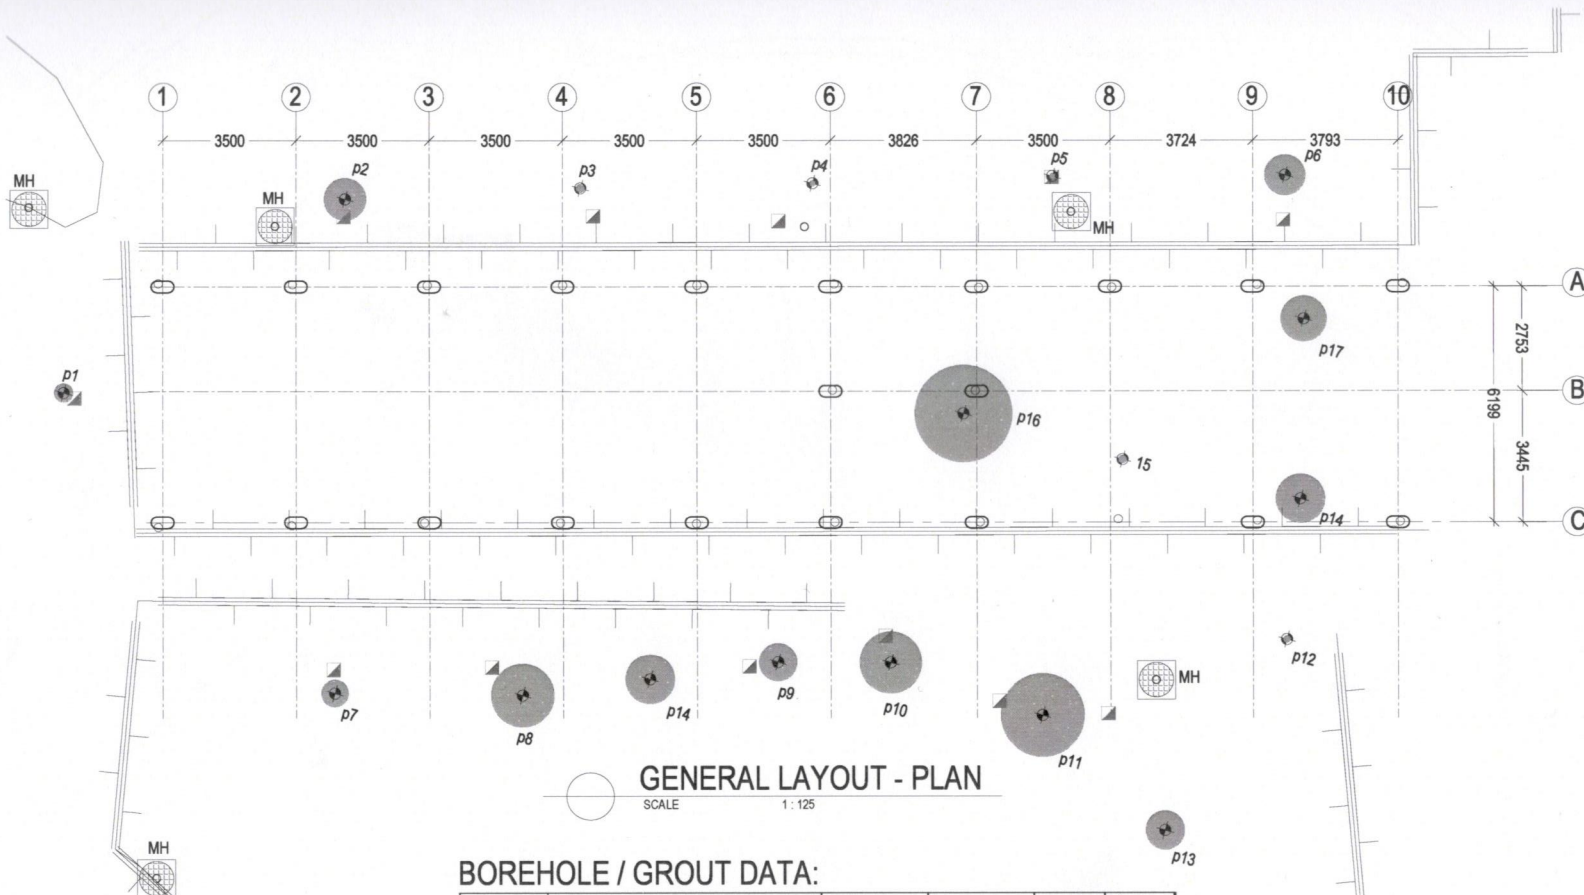
GENERAL LAYOUT - PLAN

**Grouting to Hoërskool  
Centurion**

**Summary of Dolomitic Void  
Filling To Sinkhole**

The sinkhole rehabilitation was conducted by Stefanutti Stock Geotechnical, during the period May 2017 to July 2017. The details of the rehabilitation are included in appendix 9. It should be noted that Geopractica were not involved during this rehabilitation project.
