***Report to Ukuza Consulting (Pty) Ltd on the Results of a
Feasibility Hydrogeological Investigation for the
Abstraction of Groundwater at the Proposed Makhaza
Police Station Site on Erf 75169 Portion of Erf 59037
Khayelitsha, Makhaza, Western Cape Province***

Reference: GW007-23.R01

Dated: 13 October 2023

GEOSURE GROUNDWATER (PTY) LTD

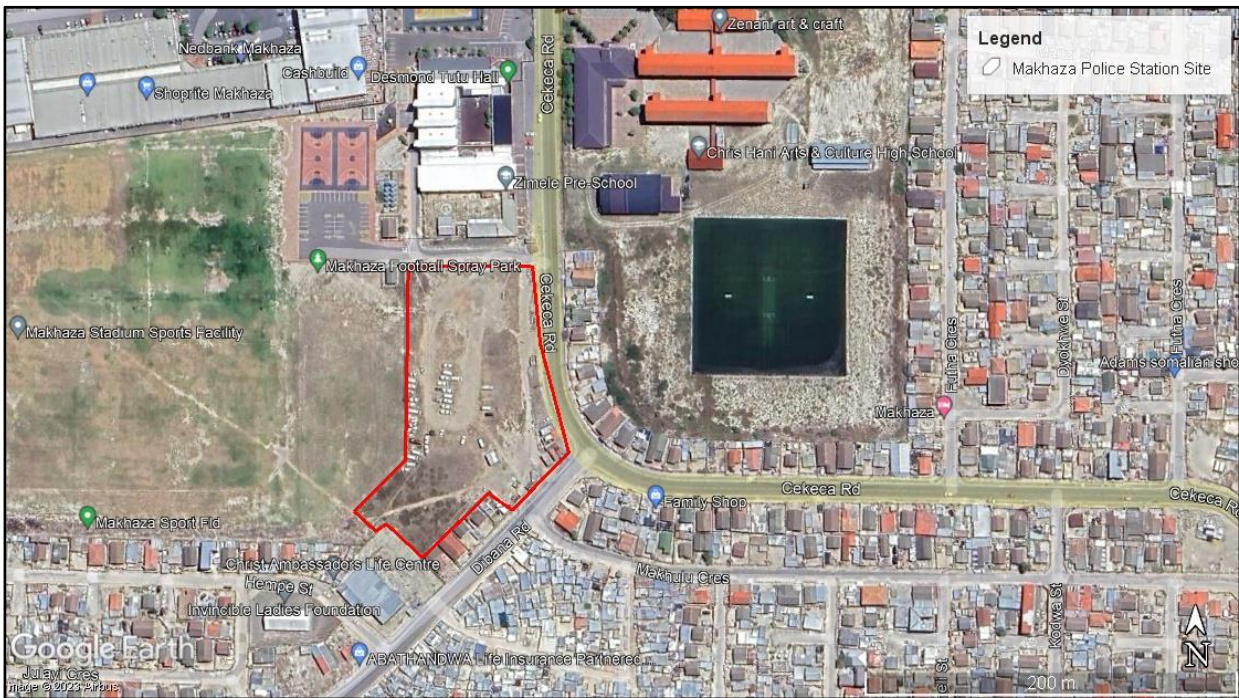
The site is relatively flat lying and is covered with grass and shrubs.

Figure 1: Site Plan (sourced from Google Earth, 2023)

Figure 1 shows the general layout of the site.

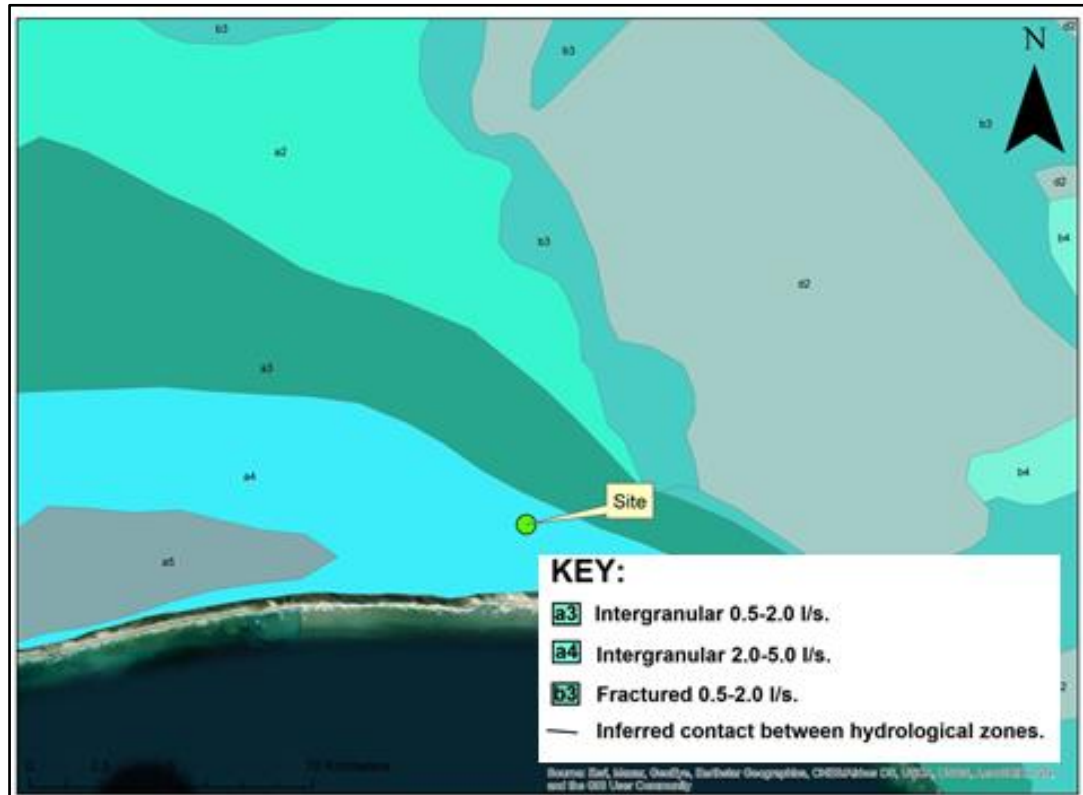
According to the hydrogeological map given in Figure 3 published by the Department of Water Affairs (DWA, 1998), the area's regional hydrogeology features an intergranular aquifer system (a4) with median borehole yields ranging from 2.0L/s to 5.0L/s. The site is underlain by the Cape Flats Aquifer, with a maximum thickness of approximately 55 metres and an average groundwater level situated between 1-3 metres below EGL. The aquifer demonstrates an average hydraulic conductivity of 30-40 m/d (Umvoto, 2014).

This aquifer is classified as a major aquifer according to the South African Aquifer Classification System and is highly susceptible to contamination, as indicated by the Aquifer Susceptibility of South Africa classification.

Figure 3: Hydrogeology Map of the study area sourced from 1:500 000 hydrogeological map series (DWA, 1998)

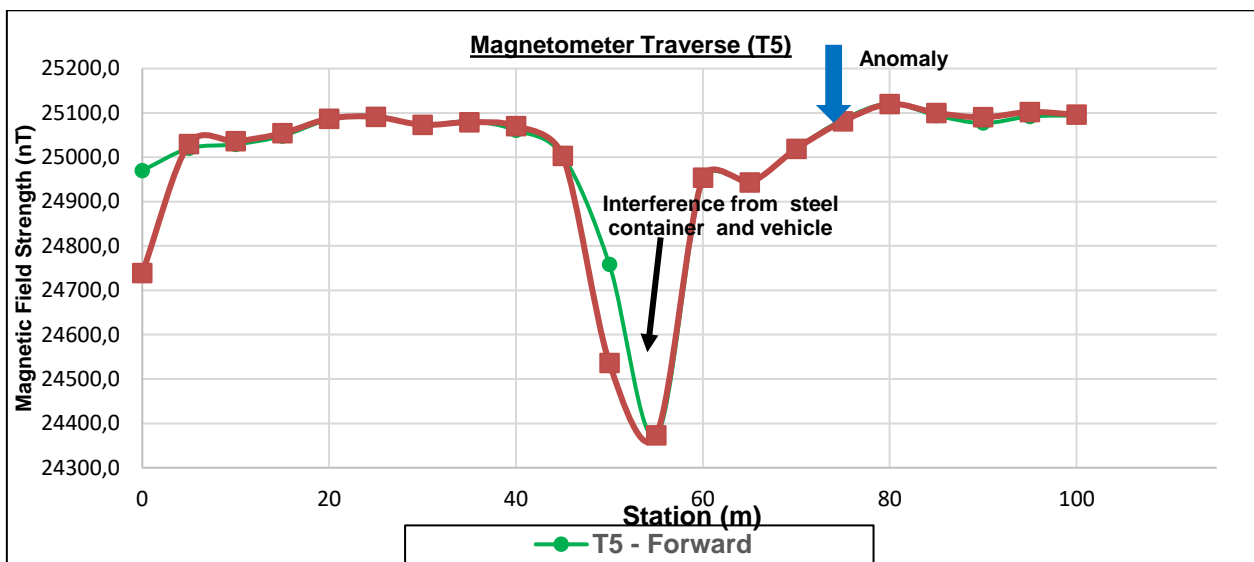
Figure 5 below provides a summary of traverse 5. Anomalies were observed between intervals 75m and 85m.

These are assumed to be fractures beneath the surface and are considered a suitable drilling target for further investigation.

Figure 5: Geophysical Survey results, Traverse 5 at the proposed Makhaza Police station.

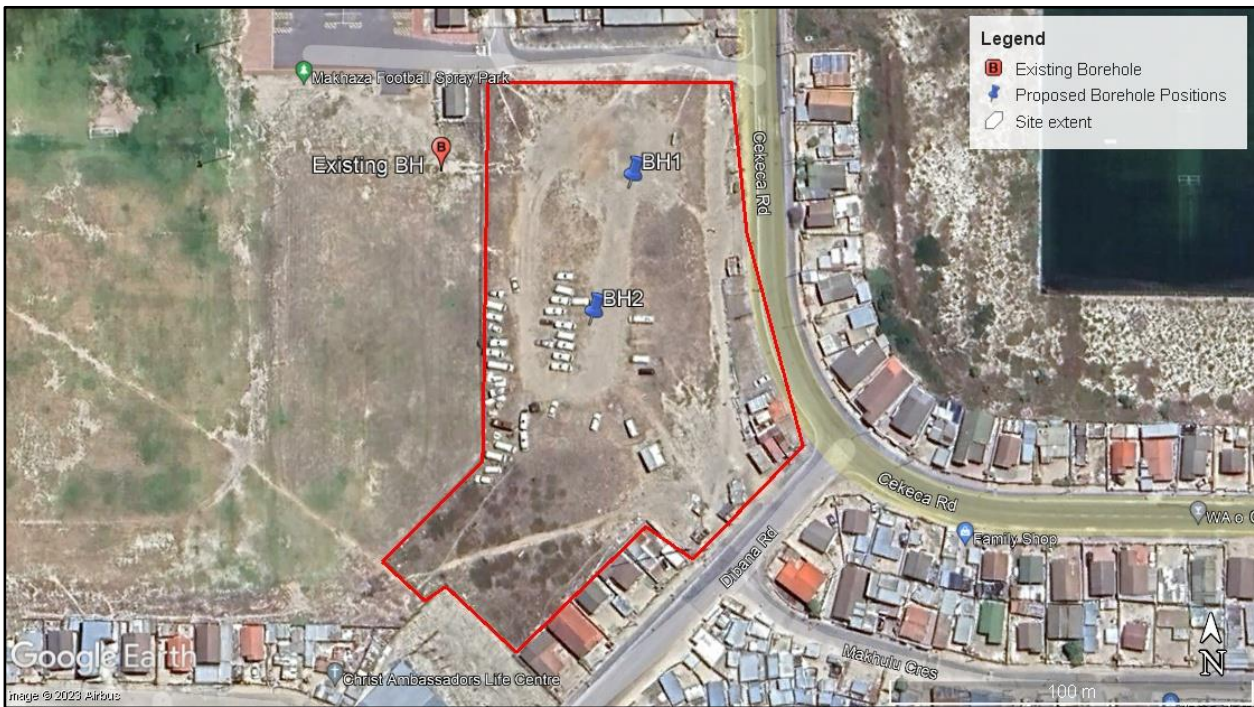
Based on the results of the geophysical investigation, two suitable drilling targets, designated BH1 and BH2, was identified and the approximate position is shown in Figure 7 below with the co-ordinates provided in Table 2.

Figure 7: Locality of proposed borehole BH1 and BH2 (sourced from Google Earth, 2023)

One borehole was identified approximately 100m to the west of the site in the neighbouring sports field (refer to Figure 7 on Page 8). According to the site caretaker, the borehole is equipped with a submersible pump and is currently not in use due to the pump being “faulty”.

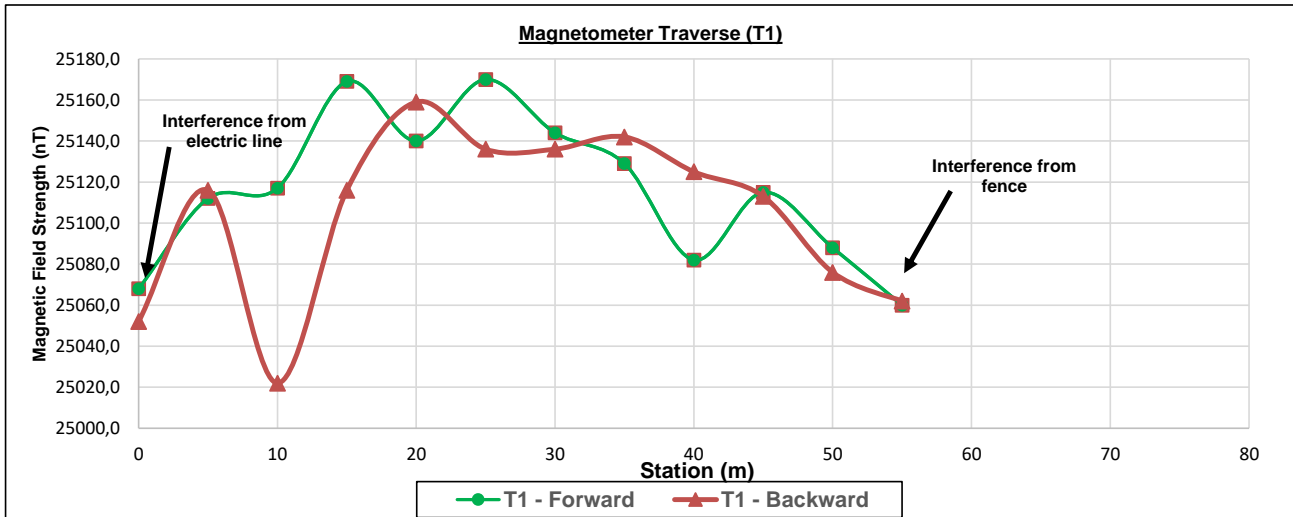
TRAVERSE ID - T1

Remarks: The drill position was selected on interpretation of the anomalies detected during the magnetometer traverse. Anomalies indicate the presence of a geological structure that may be water-bearing. The presence of groundwater is not guaranteed.

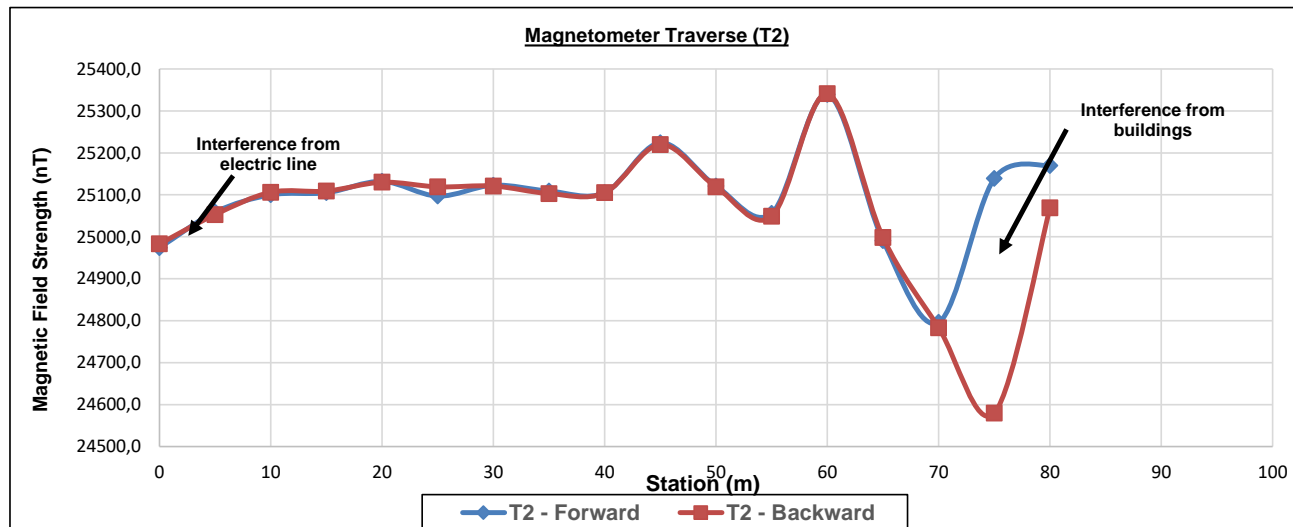
TRAVERSE ID - T2

Remarks: The drill position was selected on interpretation of the anomalies detected during the magnetometer traverse. Anomalies indicate the presence of a geological structure that may be water-bearing. The presence of groundwater is not guaranteed.

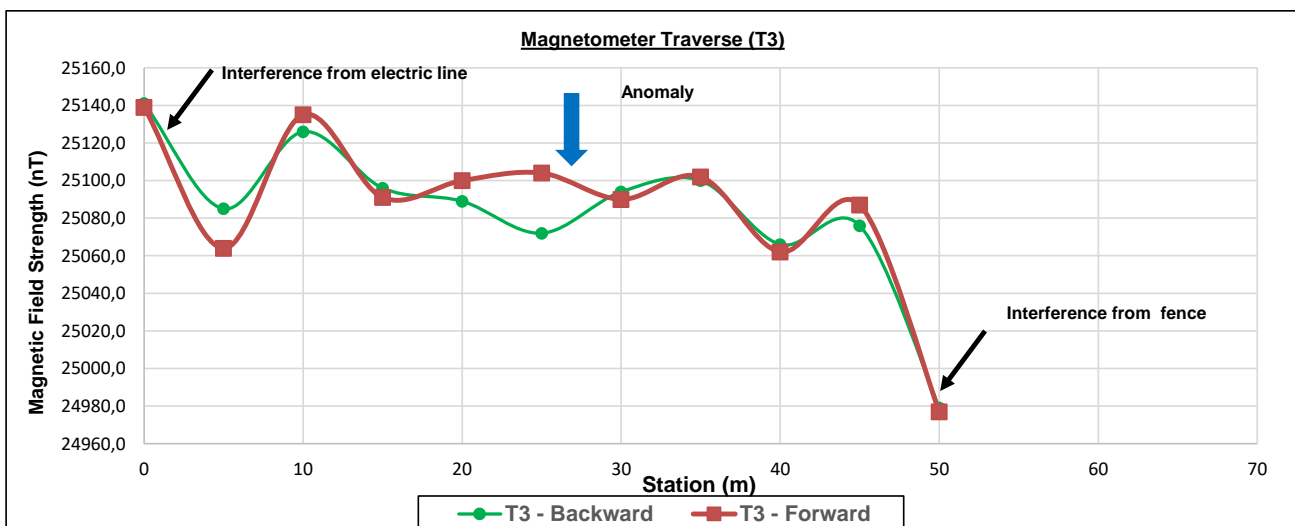
TRAVERSE ID - T3

Remarks: The drill position was selected on interpretation of the anomalies detected during the magnetometer traverse. Anomalies indicate the presence of a geological structure that may be water-bearing. The presence of groundwater is not guaranteed.

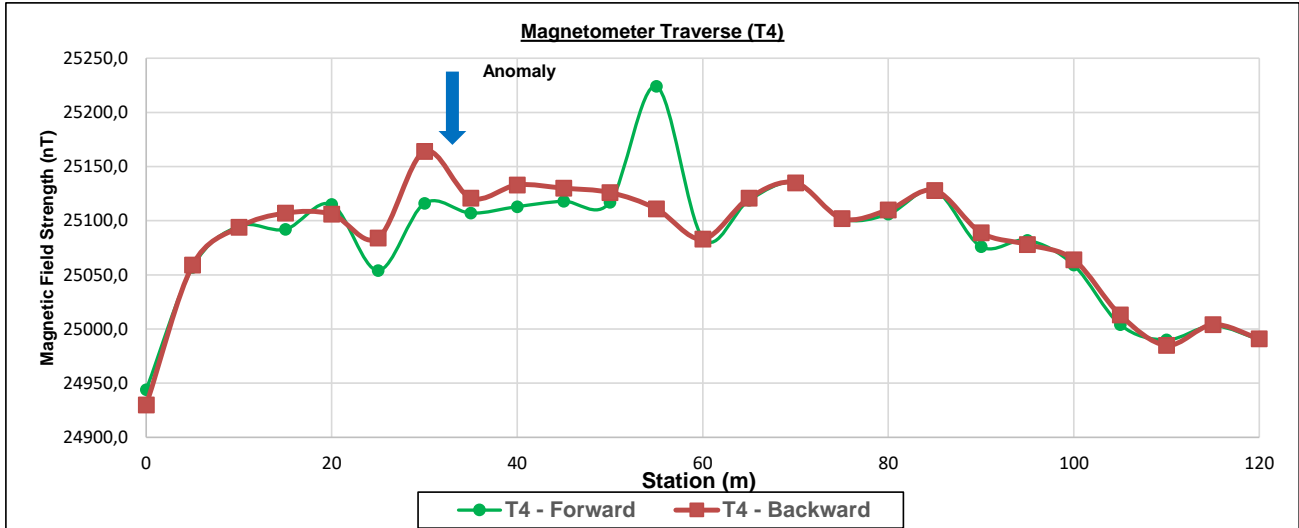
TRAVERSE ID - T4

Remarks: The drill position was selected on interpretation of the anomalies detected during the magnetometer traverse. Anomalies indicate the presence of a geological structure that may be water-bearing. The presence of groundwater is not guaranteed.

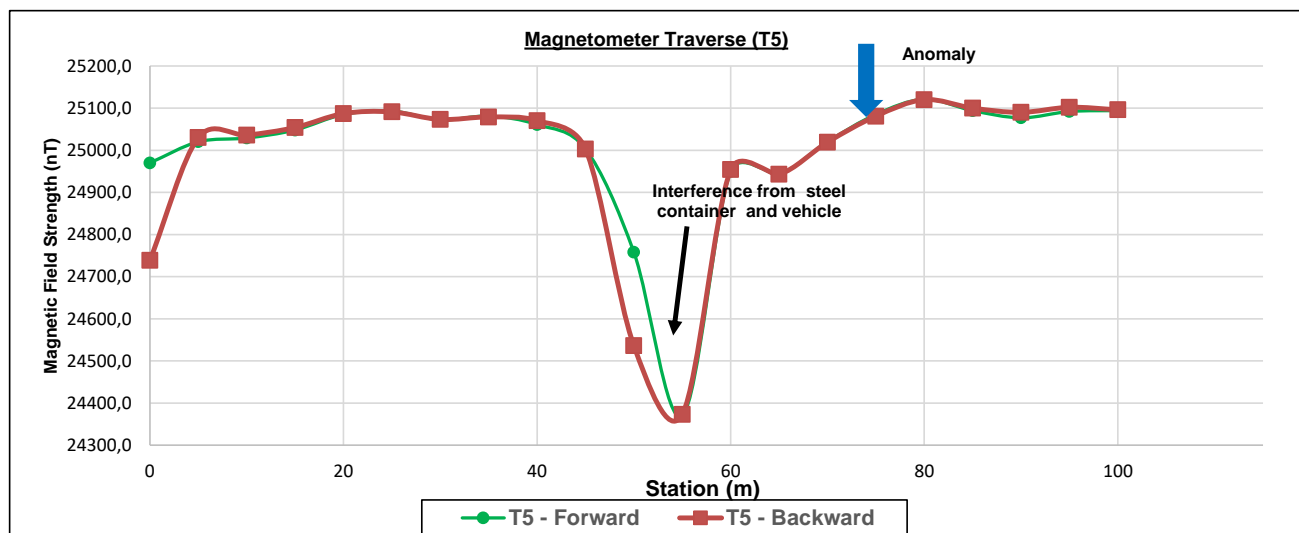
TRAVERSE ID - T5

Remarks: The drill position was selected on interpretation of the anomalies detected during the magnetometer traverse. Anomalies indicate the presence of a geological structure that may be water-bearing. The presence of groundwater is not guaranteed.
