FSOU PLANNING PROPOSAL	Unique Identifier	240-47009069
		Revision	0.0
		Effective Date	12 November 2019
		Page	1 of 26

Welkom Sector Asbestos Trench covers
replacement

1. PROJECT SUMMARY

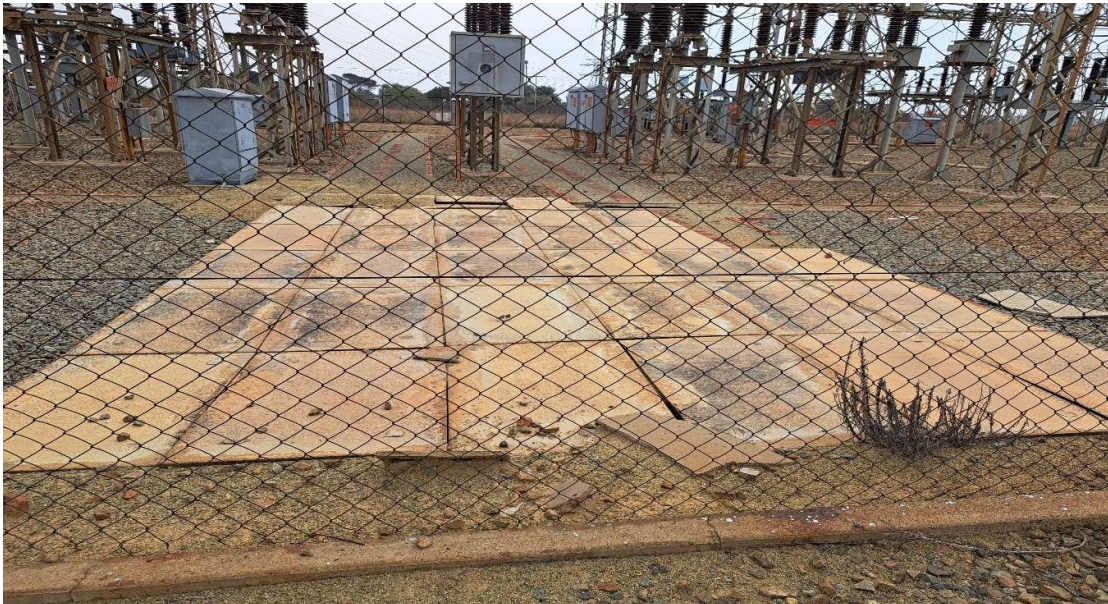
Asbestos trench covers

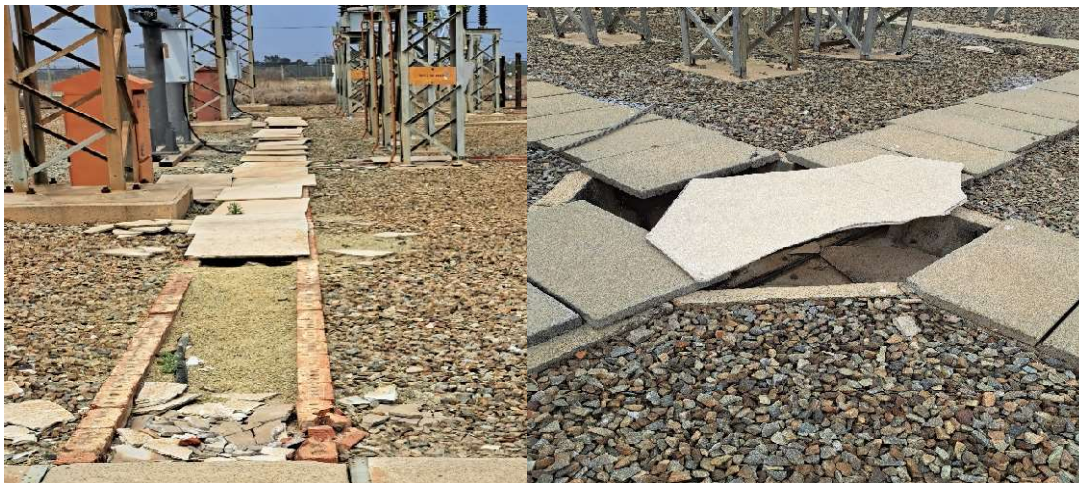
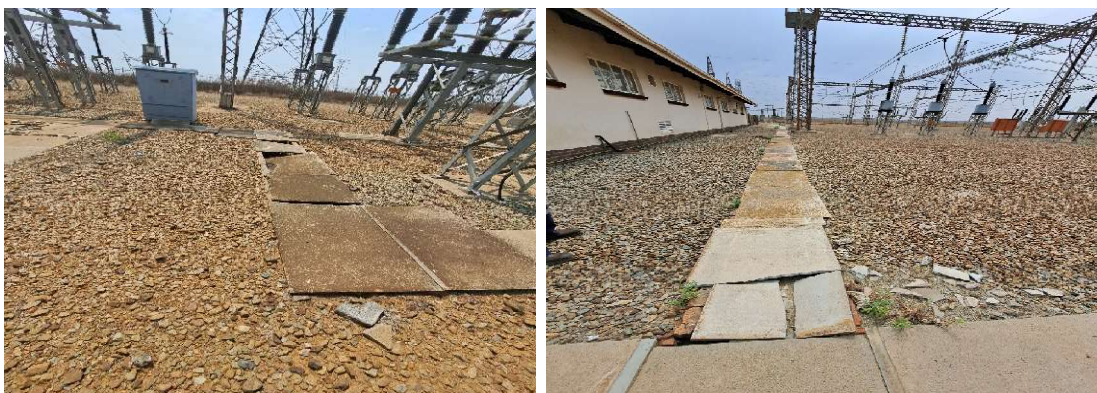
Current condition of the trench covers

- Some of the trench covers are broken although they are concrete slabs.
- Some of the asbestos trench covers are not in place of the trench covers, they are lying in around the substation.
- Some other trench covers are asbestos and broken and trench covers are filled with sand.

6.1.2. **Alternative 2: Remove asbestos trench covers and replace with new trench covers**

- Remove asbestos trench covers and replace with new trench covers
- Manufacture the single cable trench covers as per the Eskom specification

- Transport the trench covers to the substation.
- Remove asbestos trench covers and replace with new trench covers. NB!! It is to be noted that at no time the trench cover holes must be left open. If due to unforeseen circumstances the trench covers must be left open, it must be demarcated, and an open trench covers sign placed at the site.
