Title: **Scope of Work for the Dredging of the Dams at Tutuka Power Station**

Document Identifier: **15ENG GEN-2317**

Area of Applicability: **Tutuka Power Station**

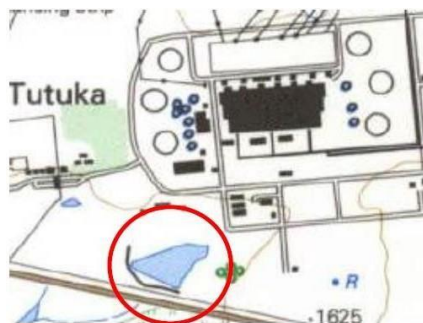
Figure 1: DB Thermal Dam

The DB Thermal Dam is one of several terrace dams at Tutuka Power Station and forms part of the dirty water recovery system at the station. It is located within the perimeter of the power station at the southwest of the station as shown in Figure 1.

Large amounts of silt and ash deposition at the dam have ultimately decreased the capacity of the dam and is currently posing a major risk of the dam overflowing. The inadequate capacity of the dam was evident when the dam overflowed during the rainy season from 2019-2021 and during March 2022 due to high inflows from the station. On the respective dam overflow investigations, the incident has been identified and classified as an environmental contravention and a deviation to Tutuka's Water Use License (Licence No: 08/C11K/ABCFG/1016).

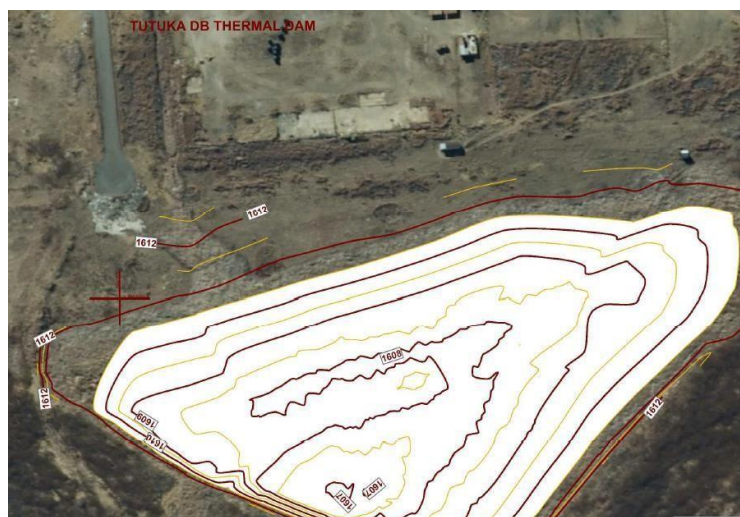
Figure 2: DB Thermal Dam Survey

The Tutuka Rain Readiness report, which was compiled in 2014 by Jeffares and Green, stated that the DB Dam Capacity was $99141.7m^3$ after a bathymetric survey was conducted. Figure 2 illustrates the DB Thermal dam survey showing the contours, which formed part of the Tutuka Rain Readiness Report.

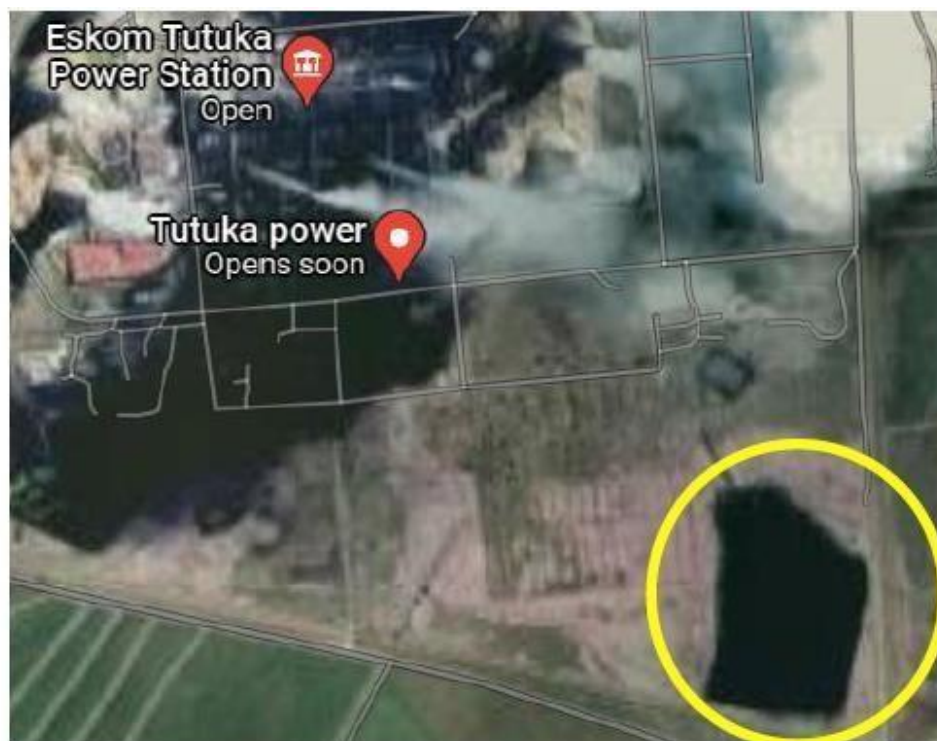
Figure 4: Steinmuller Water Dam

The Steinmuller Water dam is located within the perimeter of the power station at the southeast of the station [Figure 4]. Furthermore, the water recovery system is composed of two electric pumps. Diesel pumps are used when required under emergency circumstances to lower the dam level to prevent overflowing. Measuring/Stilling wells have been constructed which will aid in monitoring the dam level ultimately promoting healthy dam management. An assessment of Steinmuller Dam integrity and water quality as well as a bathymetric survey were conducted in October 2019. The original capacity of the dam was 204 857 m³ and according to the bathymetric survey conducted in 2019 the dam capacity was 182 835 m³ [Figure 5]. This proves that there is siltation occurring at the dam and dredging will be required. Furthermore, over 55% of the dam has been covered in dam weed and reeds which has limited the capacity of the dam. The dam bed has been silted up over the years which has contributed to the overall decrease in capacity of the dam. It would be in the interest of the Power station to increase the capacity of the dam by dredging the dam and removing the current dam weed and reed beds. The dam is also a catchment of any overflowing water from cooling tower 4 & 5, rainwater, mine transfer house (wet coal and washing effluent), coal settling ponds overflow and water leaks from the dust suppression pipe to ash disposal to name a few.

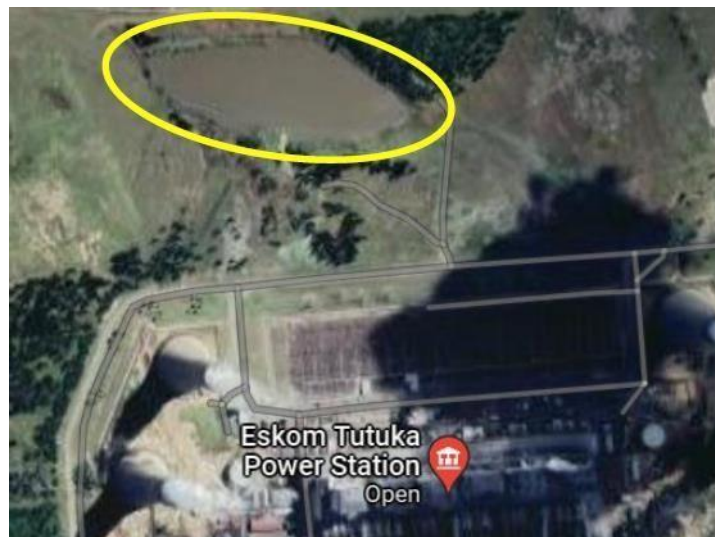
Figure 6: North Clean Dam

The North Clean Dam is located to the north side of the station [Figure 6]. The dam receives storm water runoff from areas adjacent to the Power Station. The original capacity of the dam was 191 400 m³. The dam is also a catchment of any overflowing water from cooling tower 3 & 6 and rainwater. There is currently no permanent recovery infrastructure at the Dam. Furthermore, the water recovery system is composed of two electric pumps. Diesel pumps are used when required under emergency circumstances to lower the dam level to prevent overflowing. Measuring/Stilling well has been constructed which will aid in monitoring the dam level ultimately promoting healthy dam management. A bathymetric survey of the dam was conducted in November 2019 and the dam volume below the dam waterline was 38767 m³.

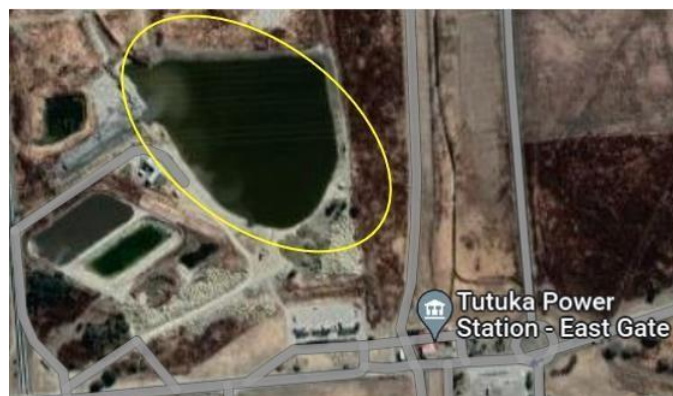
Figure 8: Dirty Water Dam

The Dirty Water Dam (DWD) is located towards the west of the station not far from the East Gate at Tutuka Power Station [Figure 8]. The DWD has overflowed quite a number of times with the identified failure mechanisms being the lack of DWD storage capacity which was compromised by historic ash inflow to the DWD. The Dirty water dam was dredged in 2021 due large amounts of ash ingress into the dam which led to minimum storage capacity. The situation led to an environmental contravention as dirty water was then diverted to flow into the environment. It is fundamental that the DWD is regularly dredged to prevent a reoccurrence of the above contravention.

The main source of water inflow into the DWD is from the station drains with rainwater also flowing into the DWD. It's an integral component at the station which needs to be running at optimum levels in keeping up with production and environmental targets and regulations. The DWD was recently dredged and rehabilitated between the years 2021 and 2022. A survey of the DWD was conducted in December 2014 ,2019 and 2022. According to the latest June 2022 DWD Survey, the capacity up to the overflow was 95 741 m³. The DWD was brought back in service(commisioned) in June 2022. It must be noted that since then siltation has occurred due ash inflow into the dam hence the dam capacity has already decreased which poses a threat to healthy dam management during the rainy season.

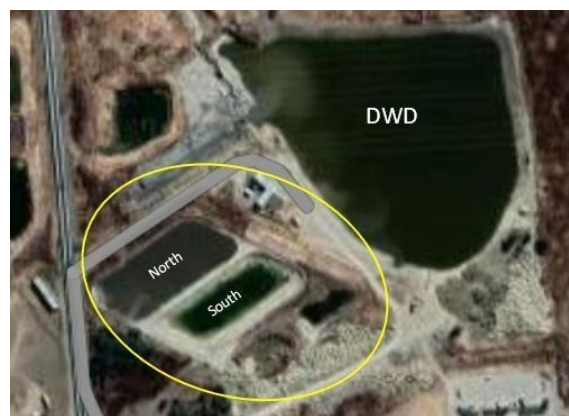
Figure 10: Ash Sedimentation Ponds

The sedimentation ponds are located adjacent to the DWD and form part of the water recovery system at the station [Figure 10]. The sedimentation ponds are composed of the primary, secondary and tertiary sedimentation ponds.

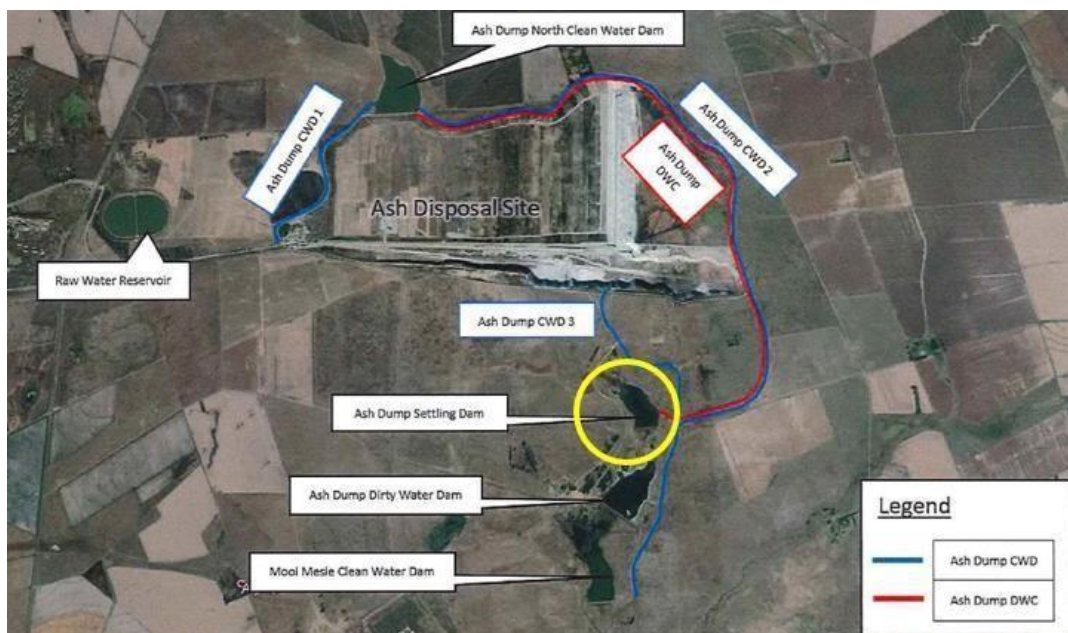
Figure 14: Ash Dump Settling/South Dam

The Ash Dump Settling/South Dam is located to the south of the ash dump and its capacity is 80812m³. A bathymetric and lidar survey of the dam was conducted in August 2020 and its capacity at that time was found to be 37875.5m³. Inflow into the dam is from the Ash Dump Dirty Water channel(DWC) and from surface run from the adjacent catchment areas. Figure 15 displays the Ash Dump Settling/South Dam and the DWC.

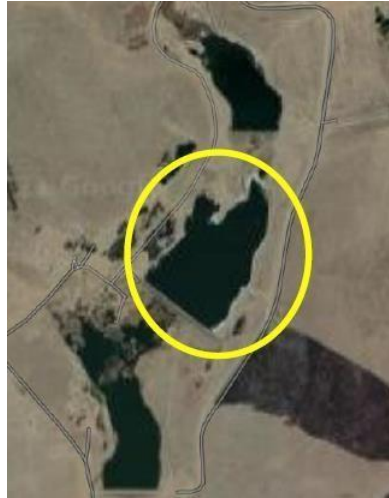
Figure 15: Ash Dump Dirty Water/South Ash Retention Dam

The Ash Dump Dirty Water/South Ash Retention Dam is located adjacent to the Ash Dump Settling/South Dam and its capacity is 157259m³. A lidar survey of the dam was conducted in August 2020 and its capacity at that time was found to be 141747.1m³. Figure 16 displays the Ash Dump Dirty Water/South Ash Retention Dam.

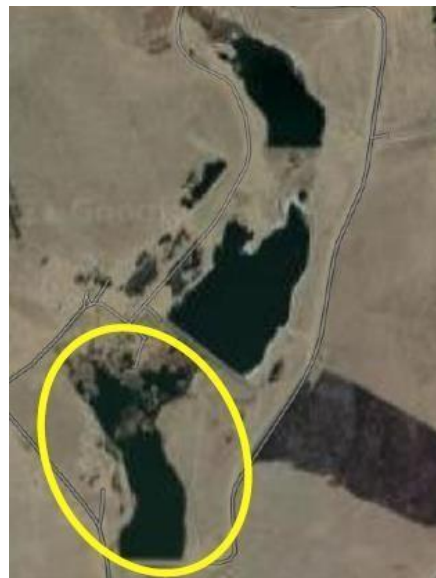
Figure 16: Mooi Messie/South Clean Water Dam

The Mooi Messie/South Clean Water dam is located adjacent to the Ash Dump Dirty Water/South Ash Retention Dam and its capacity is 167689m³. A bathymetric and lidar survey of the dam was conducted in August 2020 and its capacity at that time was found to be 156645.6m³. Inflow into the dam is from the Ash Dump Dirty Water channel and from surface run from the adjacent catchment areas. Figure 17 displays the Mooi Messie/South Clean Water dam.
