## **ANNEXURE 3.2**

### **MAIN PUMP 18 - PLINTH ANCHOR REPLACEMENT AND CONCRETE REPAIRS**

#### **SUMMARY**

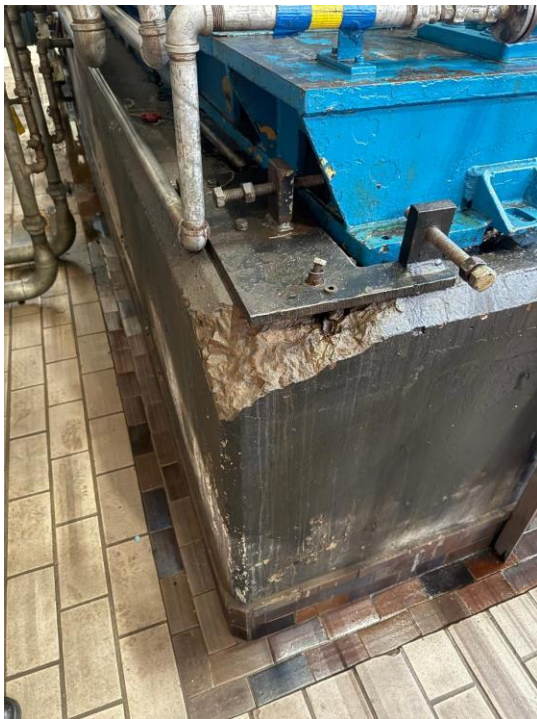
The objective of the works is to repair a pump plinth that was damaged during the removal of a pump, where an anchor bolt was dislodged and subsequently caused the concrete to spall (Figure 1).

*Figure 1: Spalled Concrete and Dislodged Anchor Bolt*

The scope of work therefore includes the removal of three existing anchors and replacement with three correctly positioned 260 mm mechanical heavy-duty (HD) anchors. The scope also covers the repair of the spalled concrete.

- Carefully remove the anchors bolts from their current position without causing further damage to the pump baseplate or surrounding concrete.
- Clean out the damaged anchor pockets and surrounding cone-shaped void, removing all loose and friable material to expose sound concrete.
- Prepare the area for drilling and reinstallation of a new anchors.

- Drill a new hole to ensure adequate embedment of the anchor.
- Install the new mechanical anchor, with a diameter that will allow easy placement through the existing baseplate holes.
- Anchor installation shall follow the manufacturer's installation guidelines and relevant standards for cleaning, insertion, and torque tightening.

- Prepare the spalled concrete by roughening/scabbling the surface and removing loose material to ensure a sound substrate that is free from grease.
- Form up and reinstate the damaged area using non-shrink grout with a compressive strength of at least 30 MPa or higher.
- Finish the surface flush with the surrounding plinth such that no grout encroaches on moving pump components.

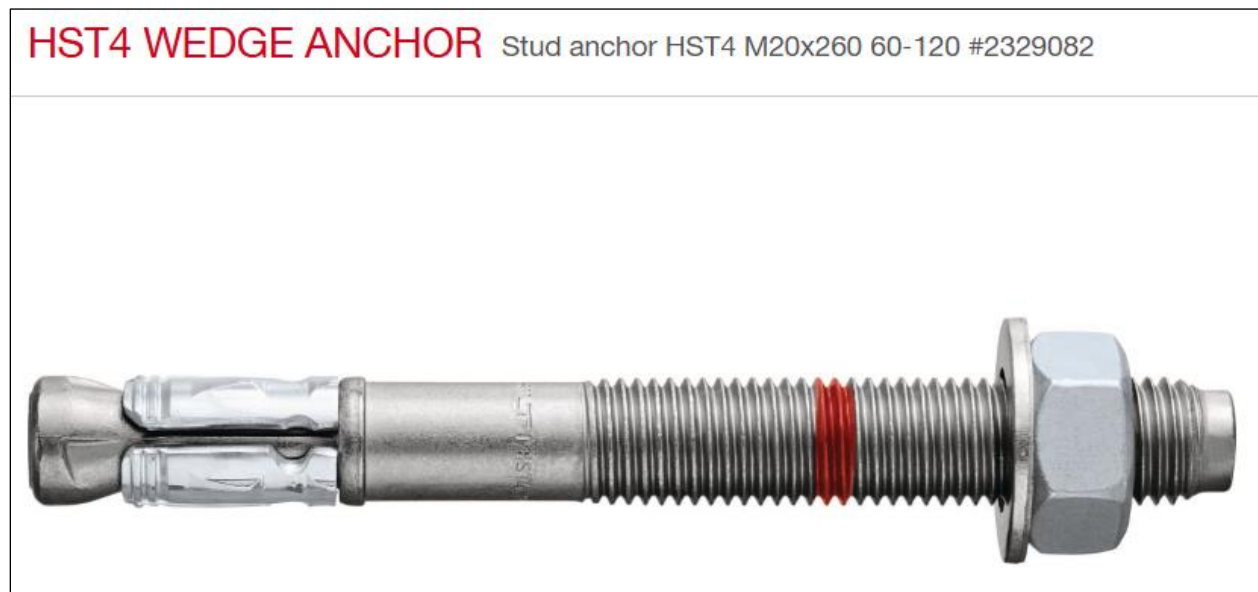
The replacement anchor for Pump Set 18 shall be a Hilti HST4 M20x260 Stud Anchor (or a Engineer-approved equivalent), suitable for dynamic loading and retrofit installation:
