**ECDOH PMU-2**

**2025 PRF-5**  
**SS GIDA HOSPITAL**

**WINDOW AND DOOR REPAIRS:  
KEY PLAN & SCHEDULES -  
STAFF ACCOMMODATION  
BUILDINGS**

**240028-25PRF-05-251**

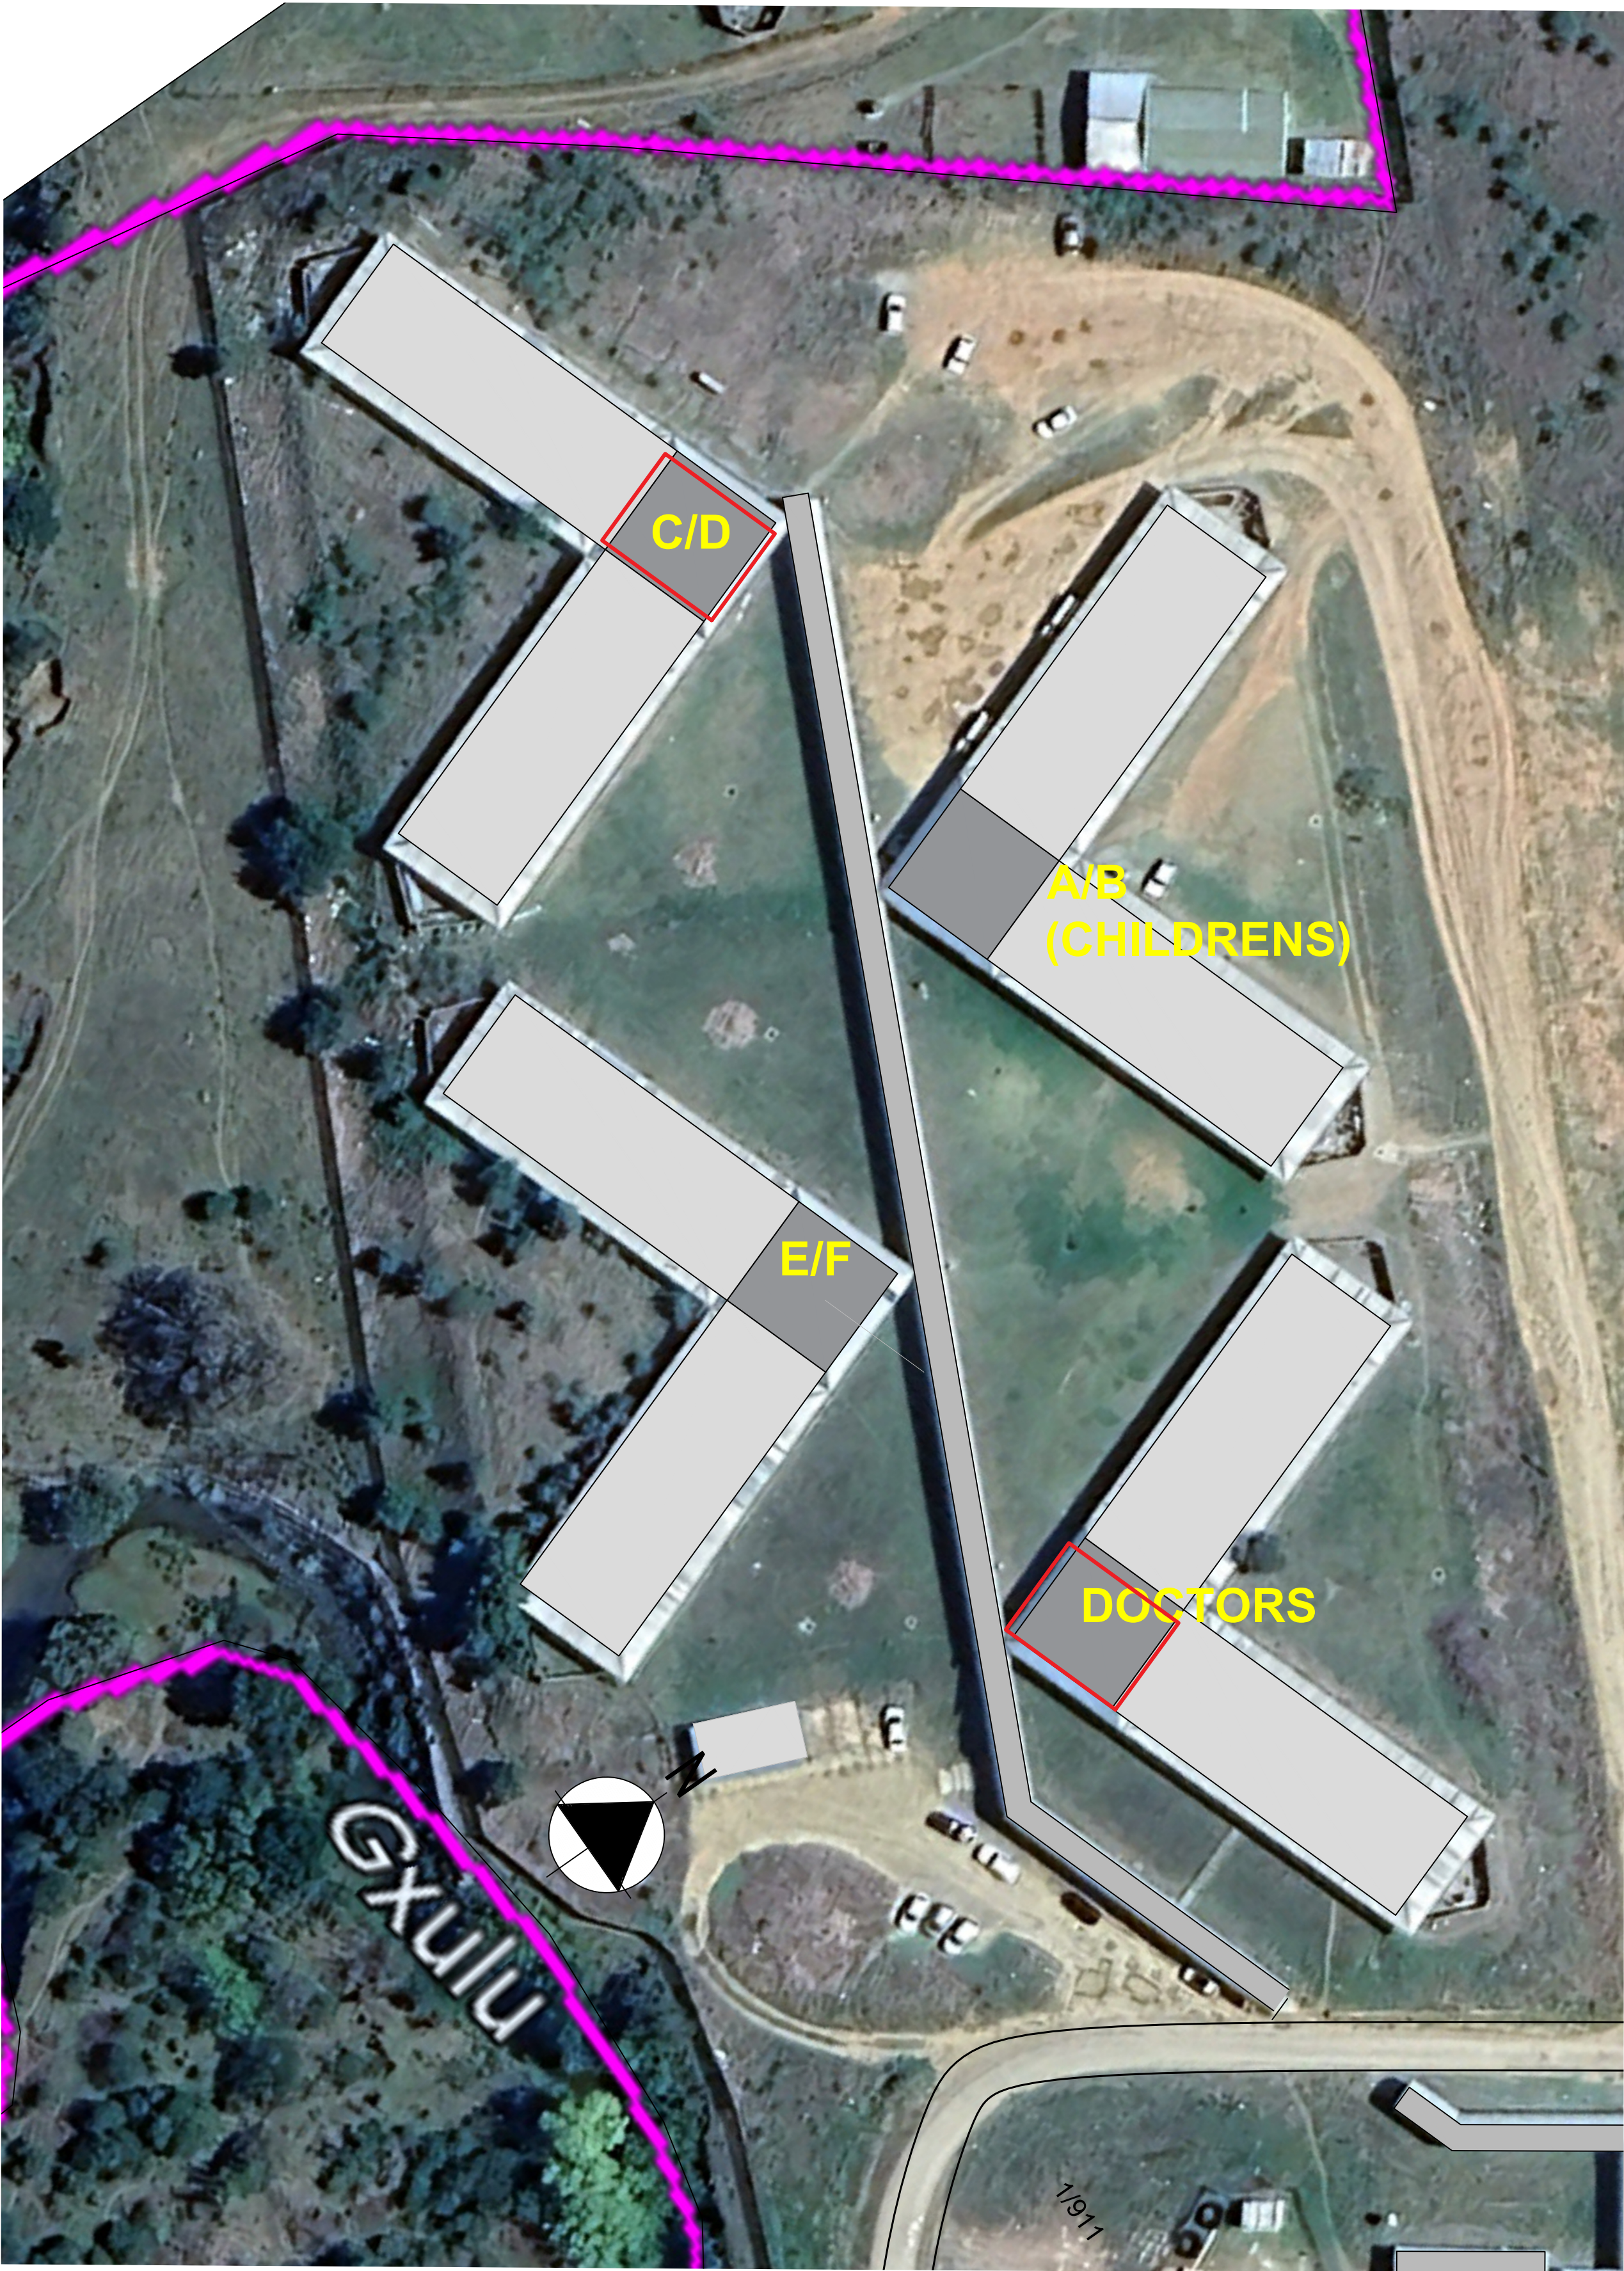
ACCOMODATION BUILDING WINDOWS -  
PANES TO BE REPLACED  
SCALE 1-50

| | W1 | W2 | W3 | W4 |
|---|---|---|---|---|
| BUILDING | TOTAL OF BROKEN PANES | TOTAL OF BROKEN PANES | TOTAL OF BROKEN PANES | TOTAL OF BROKEN PANES |
| A/B | 5 | | 2 | 1 |
| C/D | 26 | | 4 | 4 |
| E/F | 10 | | 4 | 7 |
| DOC | 10 | | 2 | 2 |
| TOTAL | 51 | | 12 | 14 |

| | W1 | W2 | W3 | W4 |
|---|---|---|---|---|
| | | | | <div>All broken glass is to be replaced with 6,38mm Intruderprufe Clear NS glass OR Obscure (Arctic Snow) glazing to match existing.</div> 77 |
