LEPELLE NORTHERN WATER

CONDITION ASSESMENT ON 9.5KM PIPELINE AT PHALABORWA WTW.

COASTTECH PROJECTS (PTY) LTD.

15 March 2024

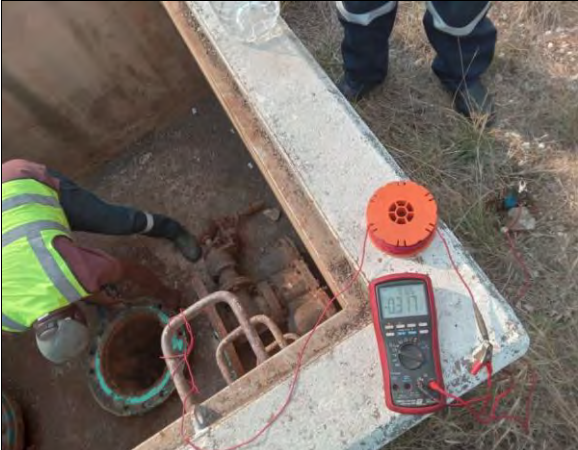
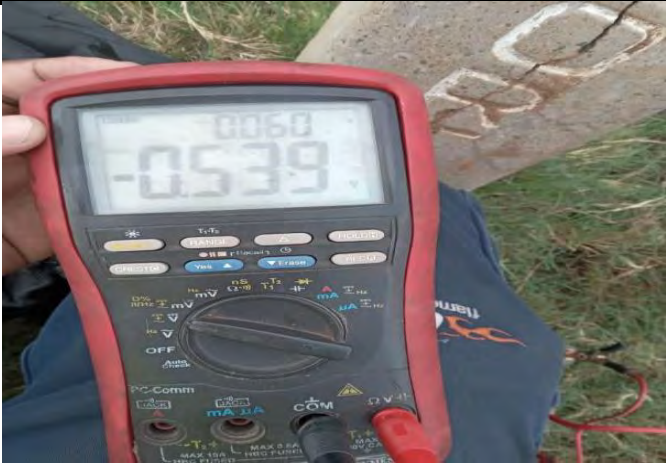
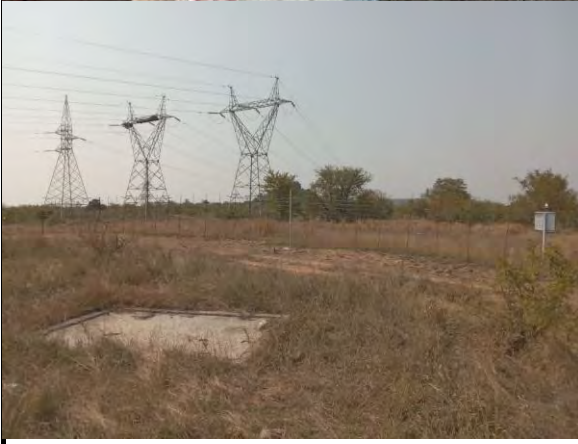
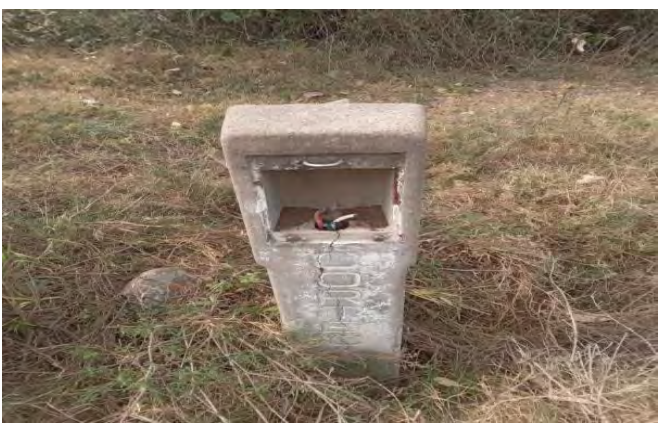
| | | Photo Gallery | | |

| 16 | Leaks | leaks observed. | | |

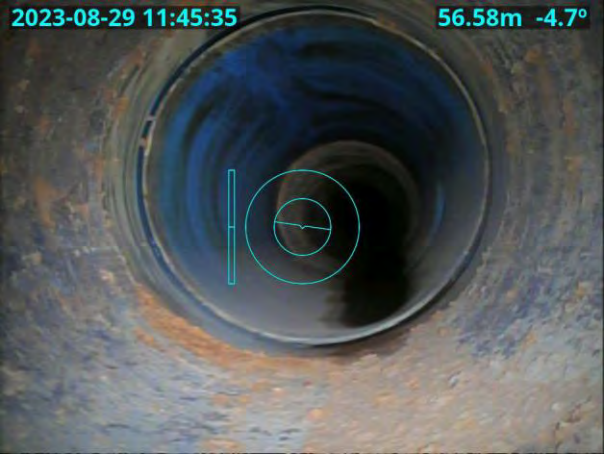
(CN) Connection at ... o'clock, diameter ...mm

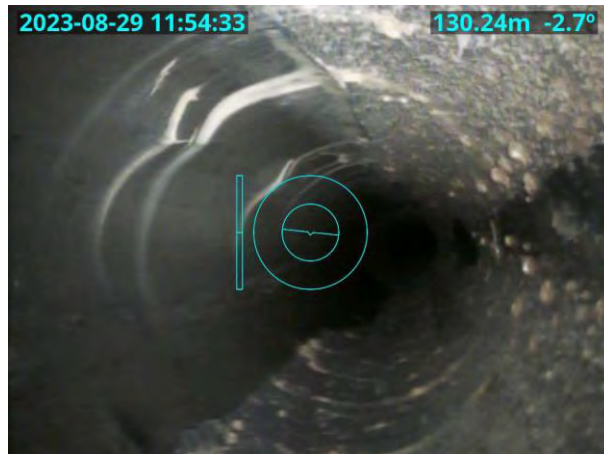
(D) Deformed sewer ...% . /2023-08-29-11-35-09/2023-08-29-11-35-
2023-08-29 11:54:33 130.24m -2.7% 02.jpg

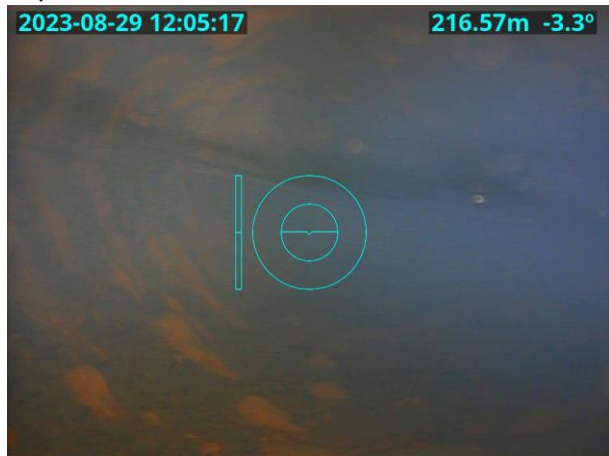
(SA) Survey abandoned

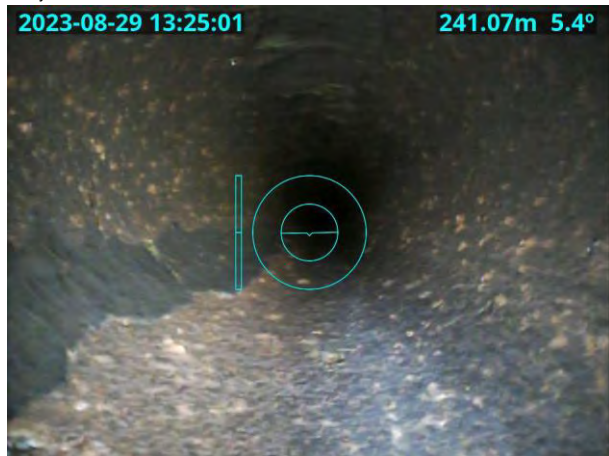
(SA) Survey abandoned

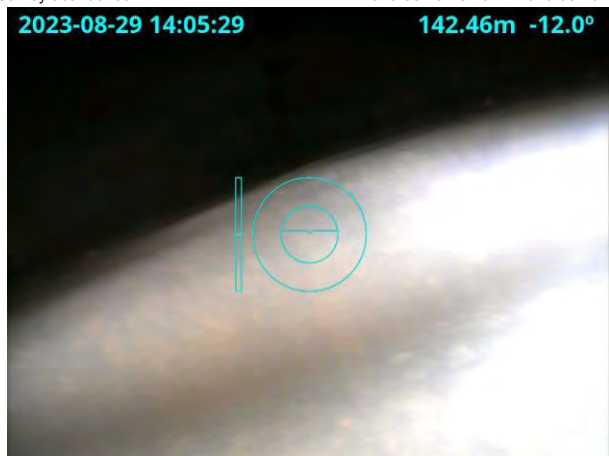
(SA) Survey abandoned

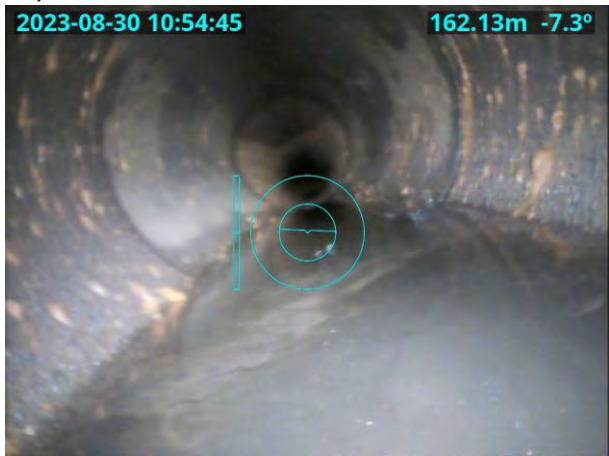
(SA) Survey abandoned

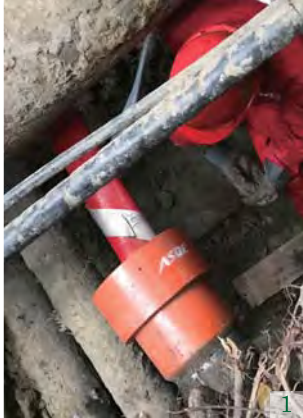
1. Gas pipeline rehabilitation in Mianyang, Sichuan, China.

Pipe-in Liner G series were installed in the gas pipelines with the ID 200mm. Totally two sections of gas pipes were rehabilitated with the total length 450 meters.
