MULTI-DISCIPLINE CONDITION ASSESSMENT REPORT

REFURBISHMENT OF CARGO WAREHOUSE AND CARGO OFFICES: CONTRACT NO 560.04/2015

Project number: ORT.560.04/2015

Date prepared: 15 October 2018

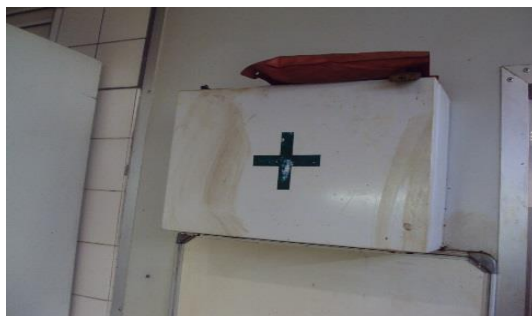
- Fire detection system has never been tested (no records)
- No signage, contact name and number for the First Aid box –
Ref GR.3(6)
- REF: SANS 10400

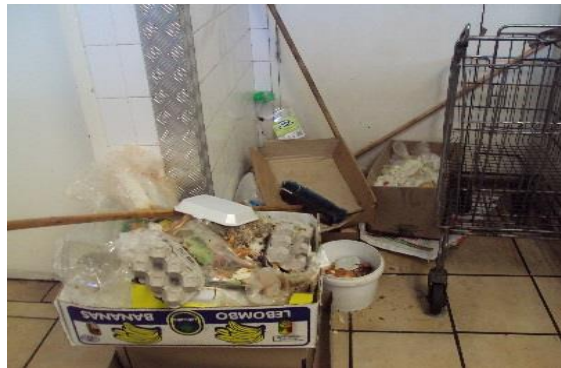
- Poor housekeeping

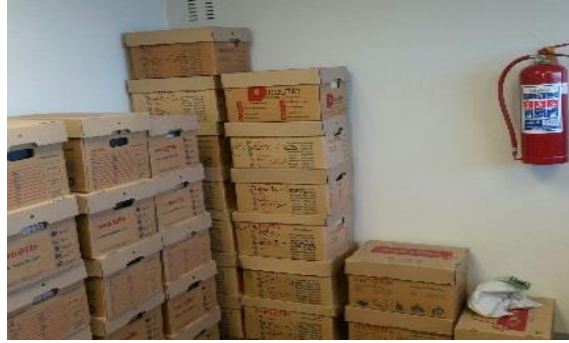
- Inadequate stacking & storage space

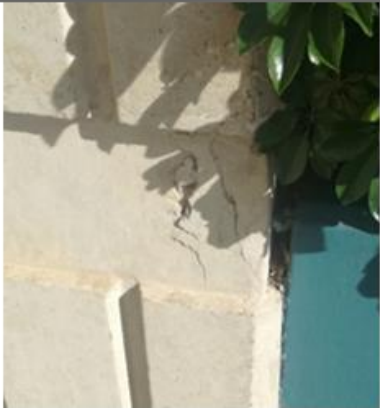
Defect no	Defect image example	Defect description, possible causes and modification
D1

<p>Concrete surface cracks can form where no proper vibration happened during casting, the concrete over tensions in these areas. The weak spots can then cause a scaling effect (freezing and thawing of the weak spots). The failure is a surface crack failure, the reinforcement cover decreases. In some areas the reinforcement is exposed.</p> <p>Remedial: The concrete must be repaired with a high strength quick setting and approved concrete repair mortar, applied as per manufacturer's specifications.</p>

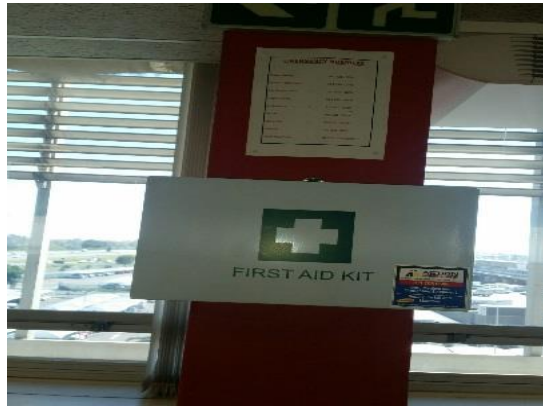
- Fire detection system has never been tested (no records)
- First Aid box was to be in order

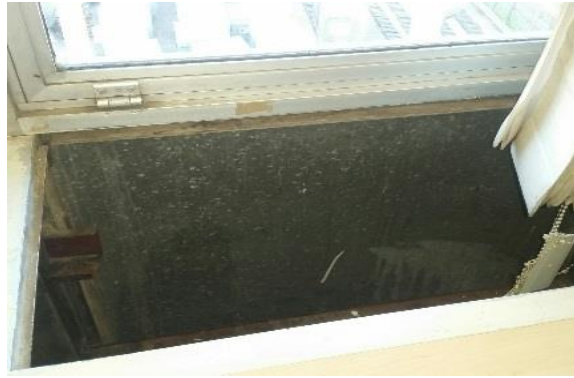
- Poor maintenance, renovation is needed

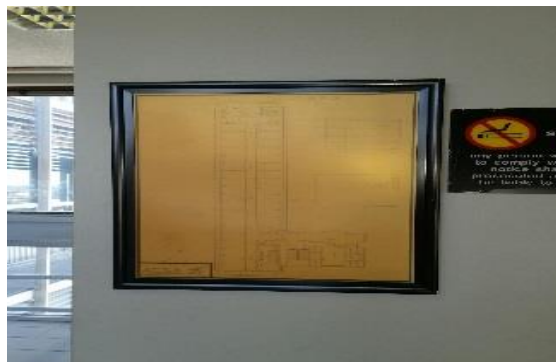
- Fire detection system has never been tested (no records)
- No signages and notices
- Emergency Exit Floor plan in order

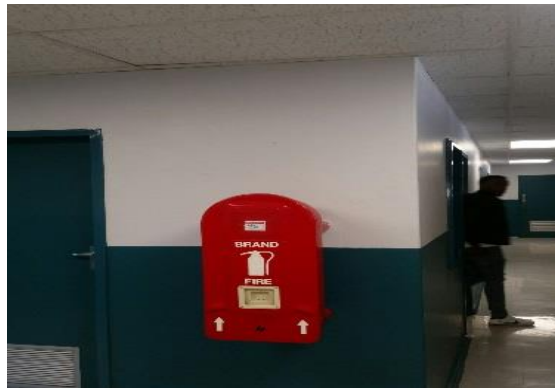
- No signages and notices

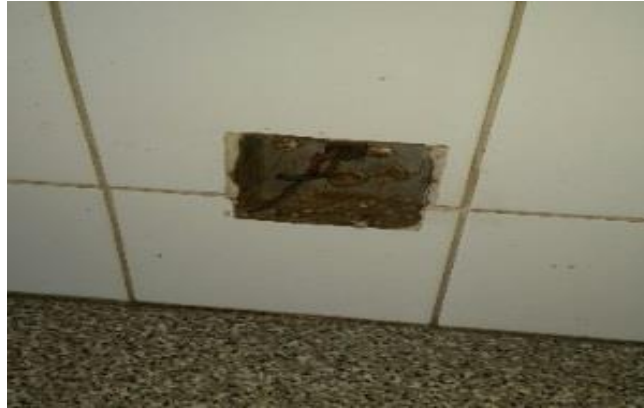
- Poor maintenance, renovation is needed
- Exposed live electrical wires

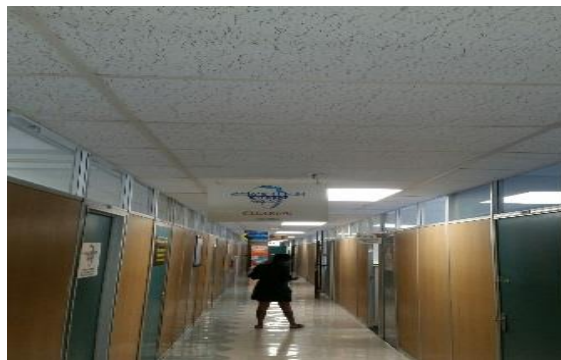
- Fire detection system has never been tested (no records)

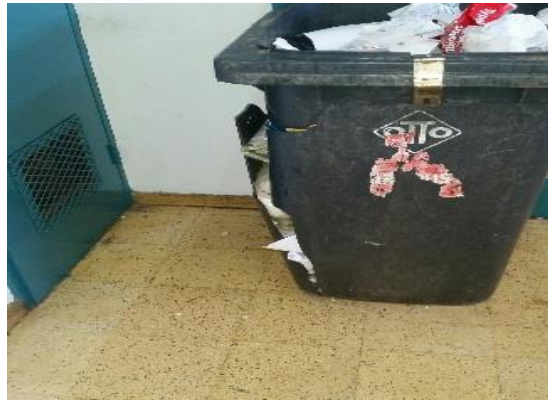
- Inadequate waste storage area

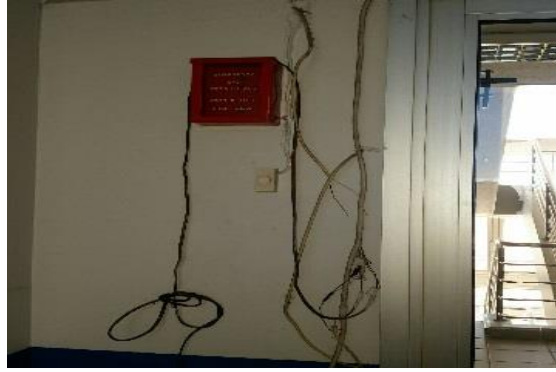
- Fire detection system has never been tested (no records)
- No emergency door keys
- Exposed electrical wiring

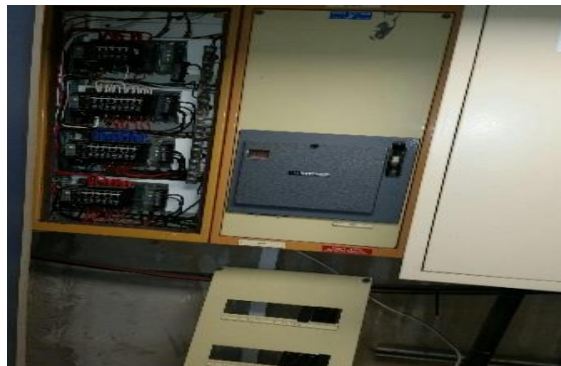
- Poor maintenance
- No labelling

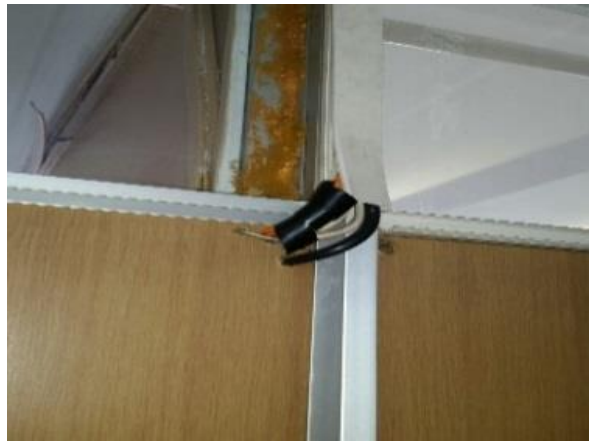
- Poor maintenance, exposed electrical wires

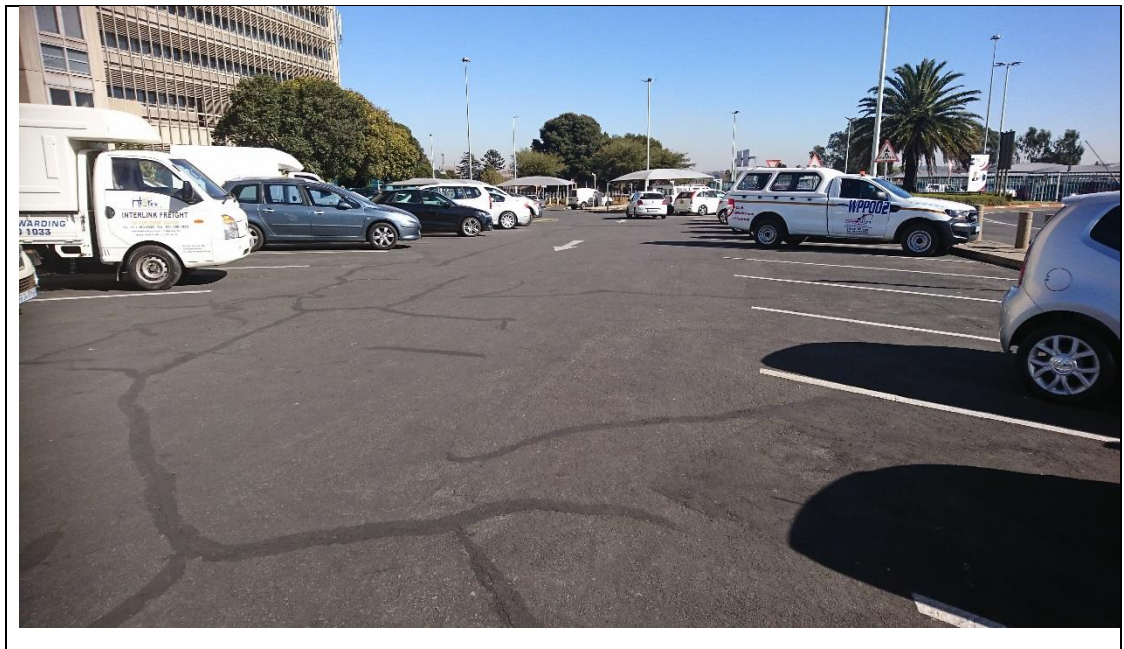
- **Findings:** The asphalt surfaced area has cracks with visible previous crack repairs.
- **Recommendations:** Seal surface cracks and construct a new asphalt overlay

Figure 7 Cargo Parking Area 2

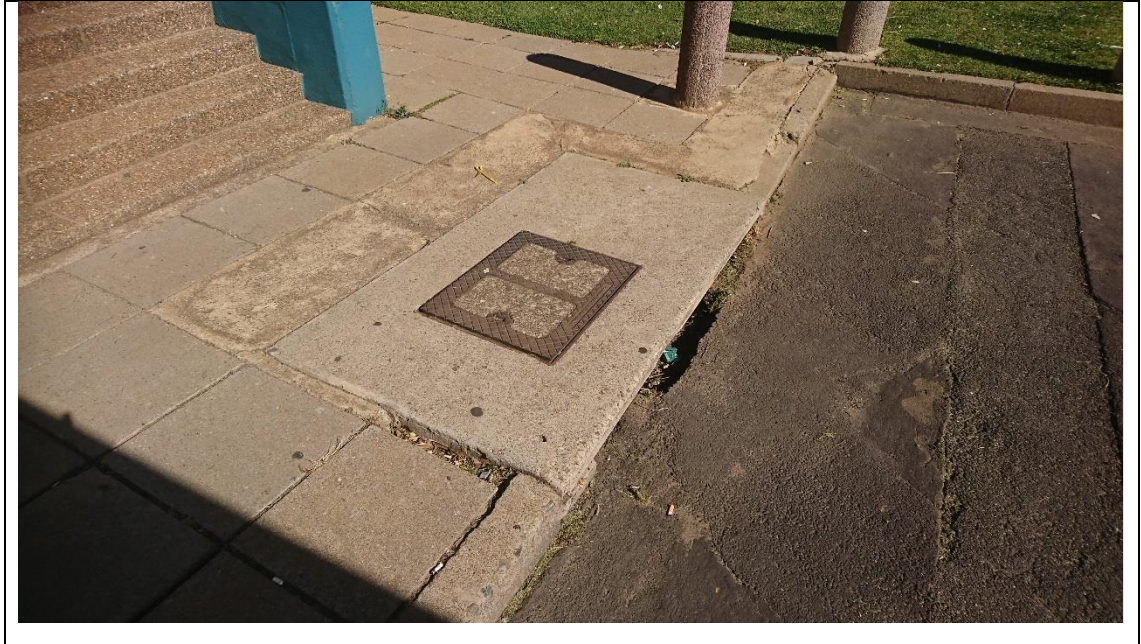
Figure 13 Parking Area Kerb Inlet

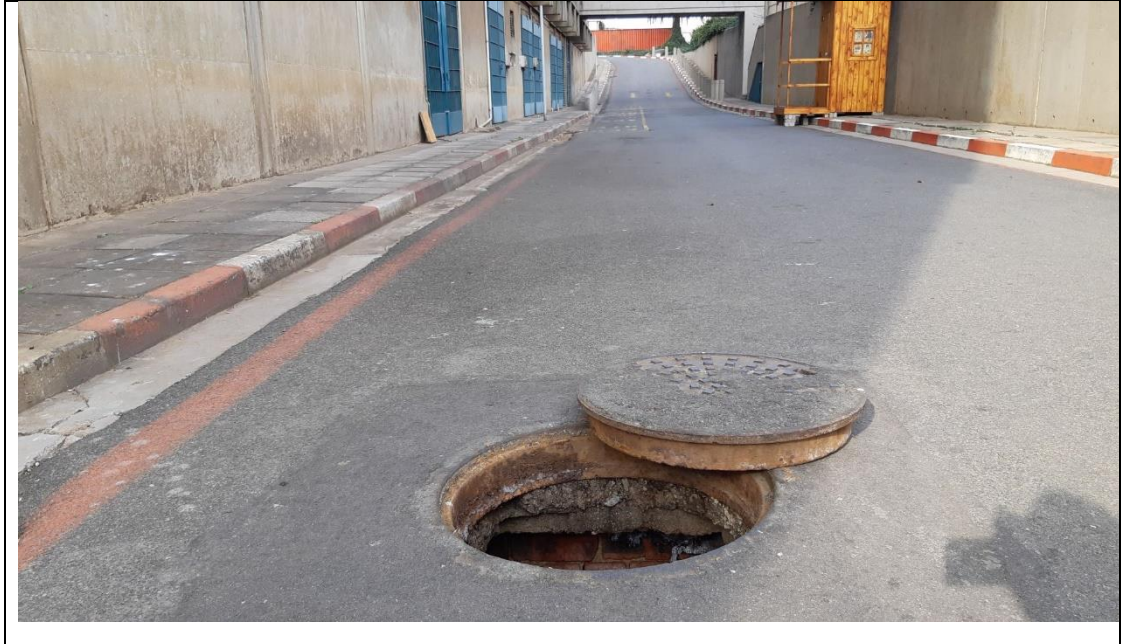
- **Findings:** The sewer system is in a fair external and internal condition as shown one of the manholes in the area.
- **Recommendations:** Minor repairs are need inside and outside the manholes. The manholes need to be made water tight. The condition of the underground sewer pipes is unknown and further tests, in the form of camera inspections etc, are recommended.

Figure 14 Fair external sewer condition

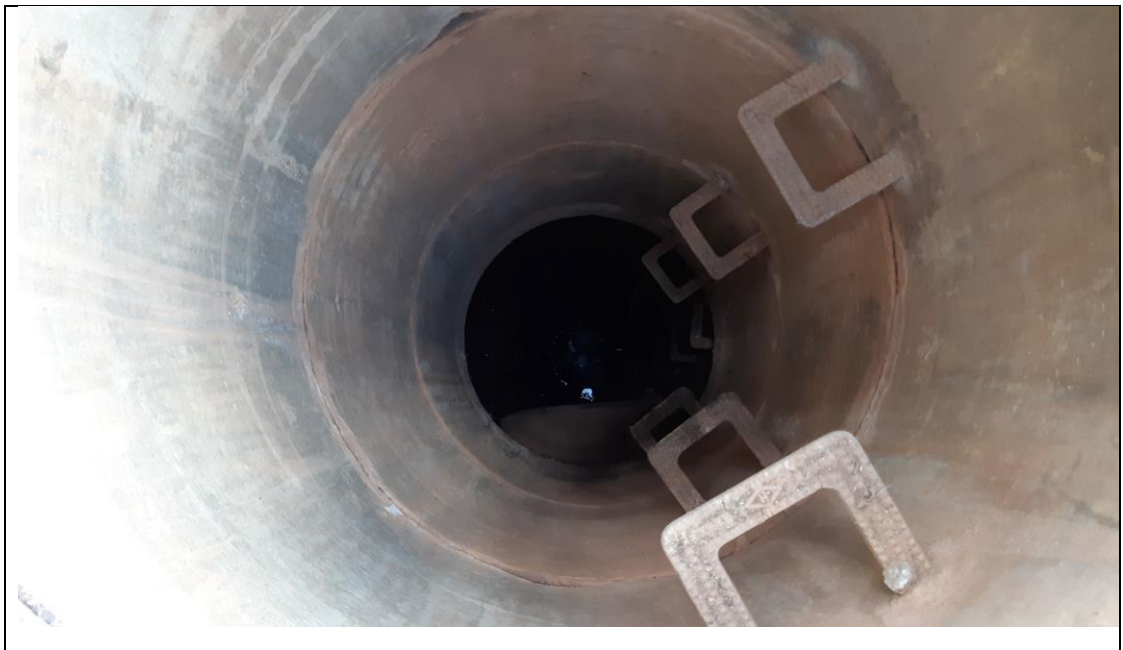
Figure 15 Fair internal manhole condition

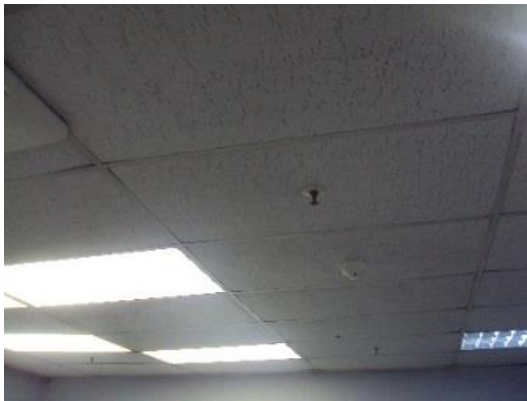
- Fire detection system has never been tested (no records)

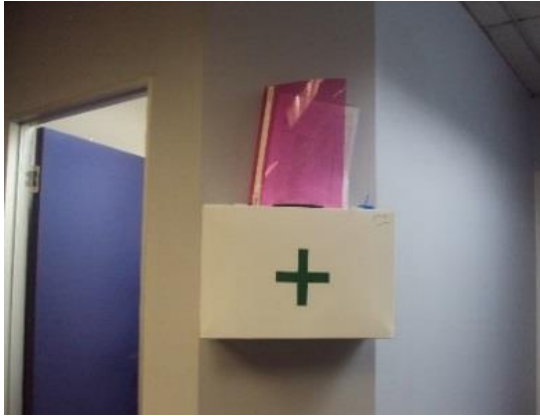
- Signages and notices are missing
- First Aid box was in place

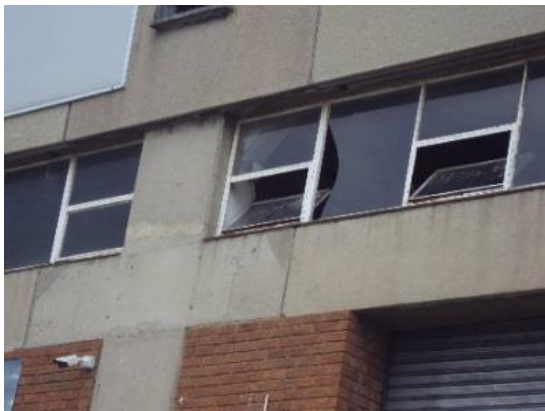
- Poor maintenance, renovation is needed

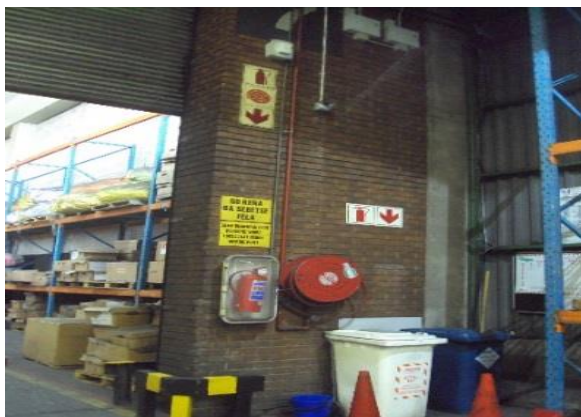
- In some areas signage and fire-fighting equipment were distracted

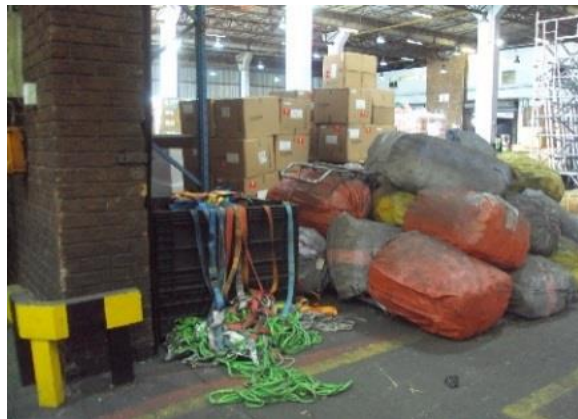
- Storage was not in order

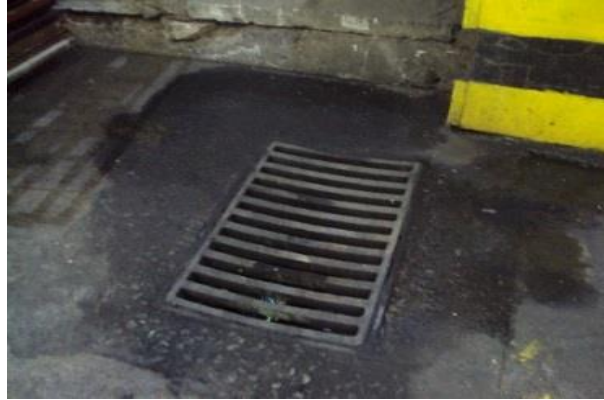
- Poor maintenance, drainage was blocked

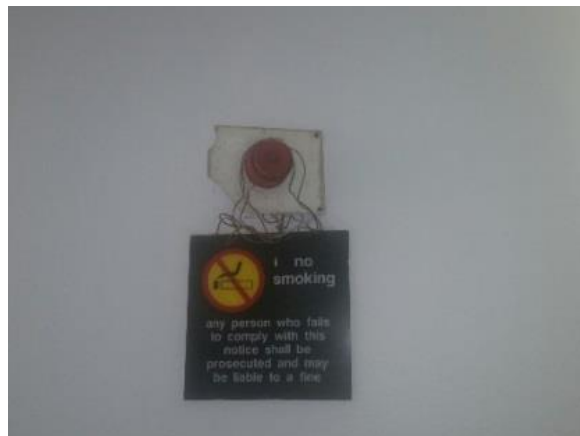
- Fire detection system has never been tested (no records)

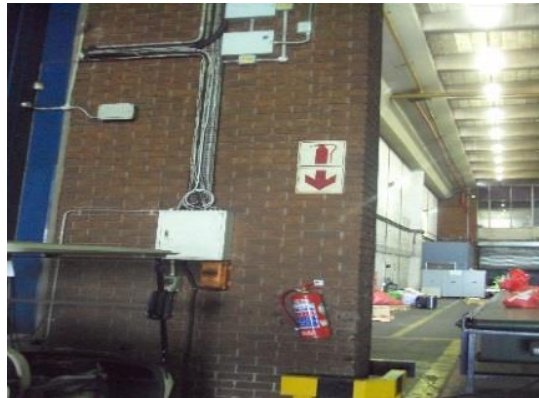
- Signs and notices not in order

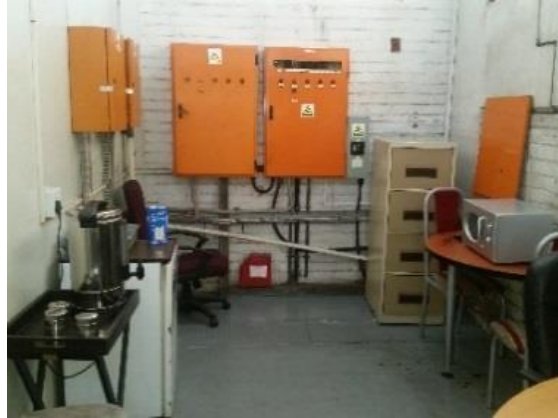
- Poor stacking and storage (Articles stacked in front of the DB Box)

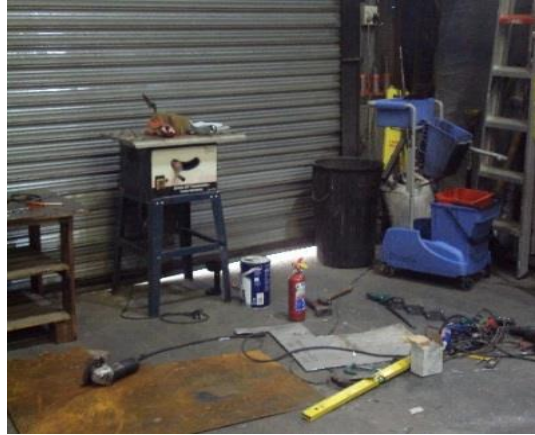
- Poor house keeping

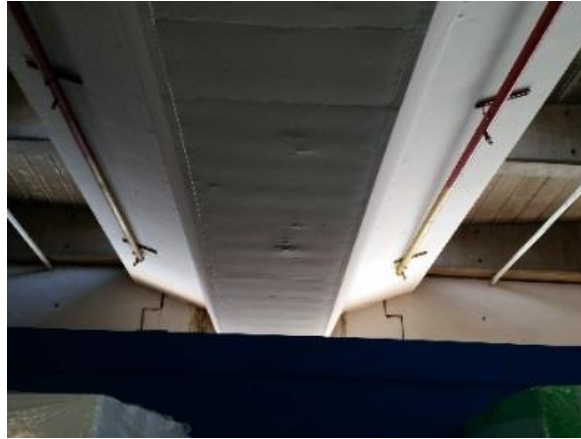
- Fire detection system has never been tested (no records)

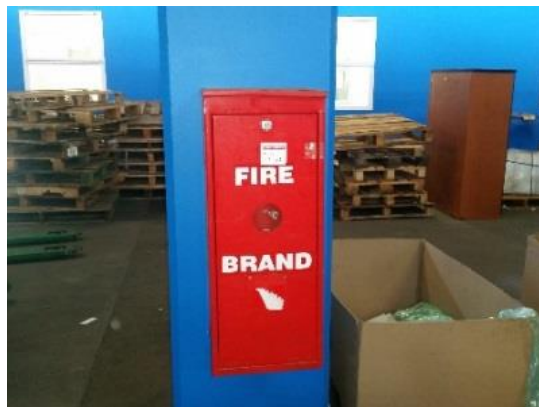
- Fire fighting equipment not in place

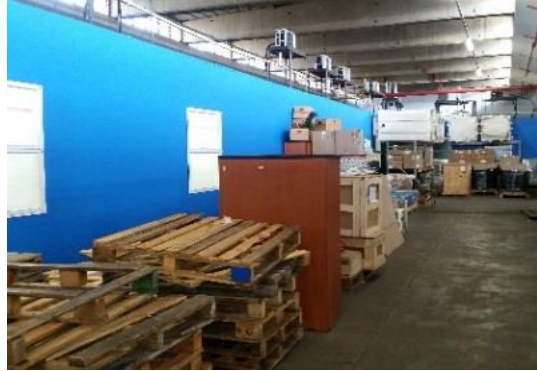
- Good housekeeping was observed

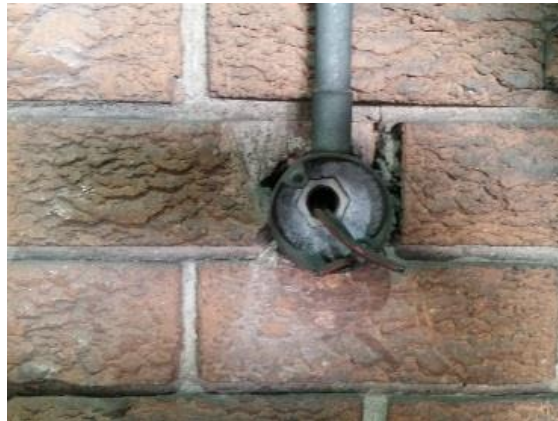
- Poor maintenance

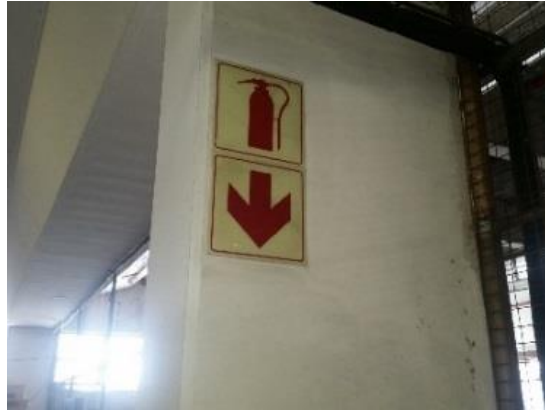
- In some areas signages and notices were in place

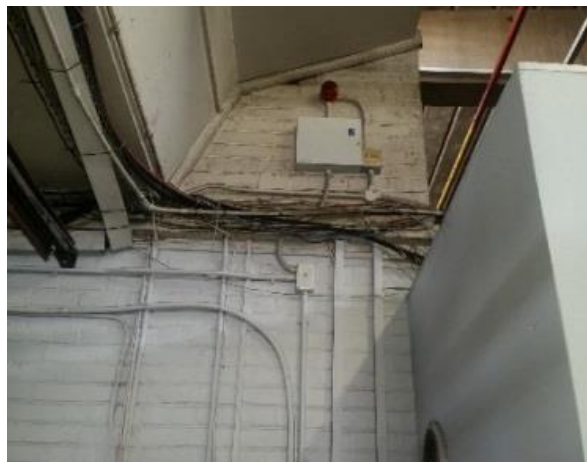
- Poor maintenance.

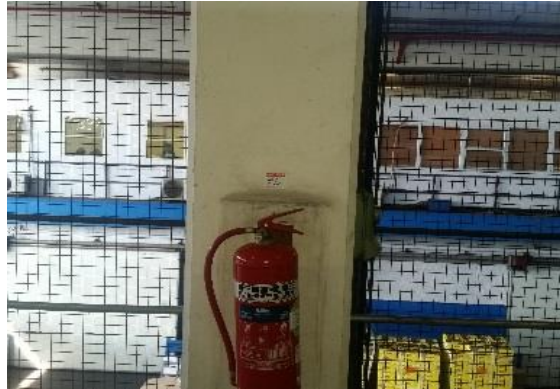
- Fire-fighting equipment's in order, however signages and notices were not in order

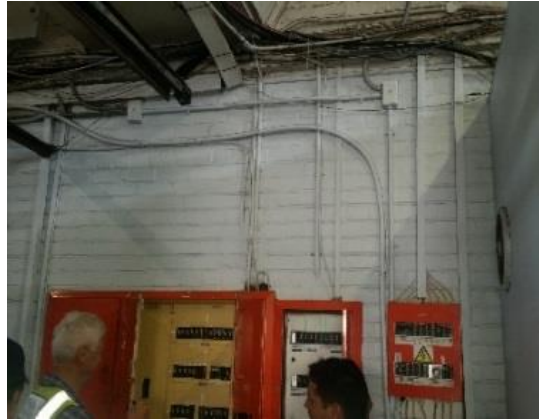
- Poor maintenance, renovation is needed

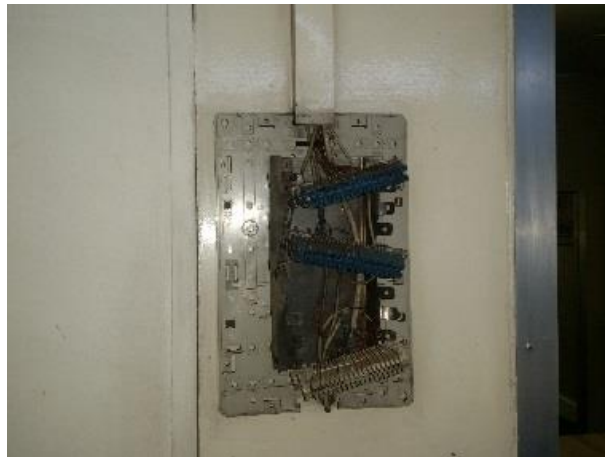
- Poor maintenance

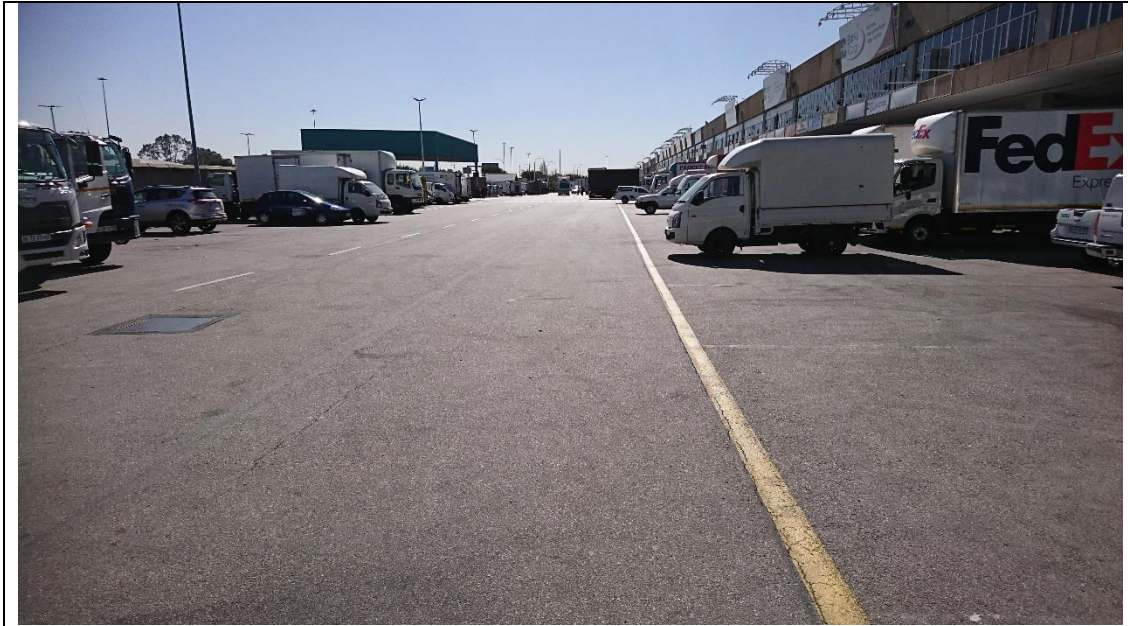
Figure 25 Typical view of Cargo Warehouse loading area.

- **Findings:** This access road together with the delivery areas needs remedial works to fix the longitudinal cracks, stabilization cracks, local pavement failure, and section pavement failure. These failures are limited and localised to the loading zones of the trucks. In some places the structural road layer works below has been damaged.
- **Recommendations:** Seal cracks and construct new asphalt overlay.

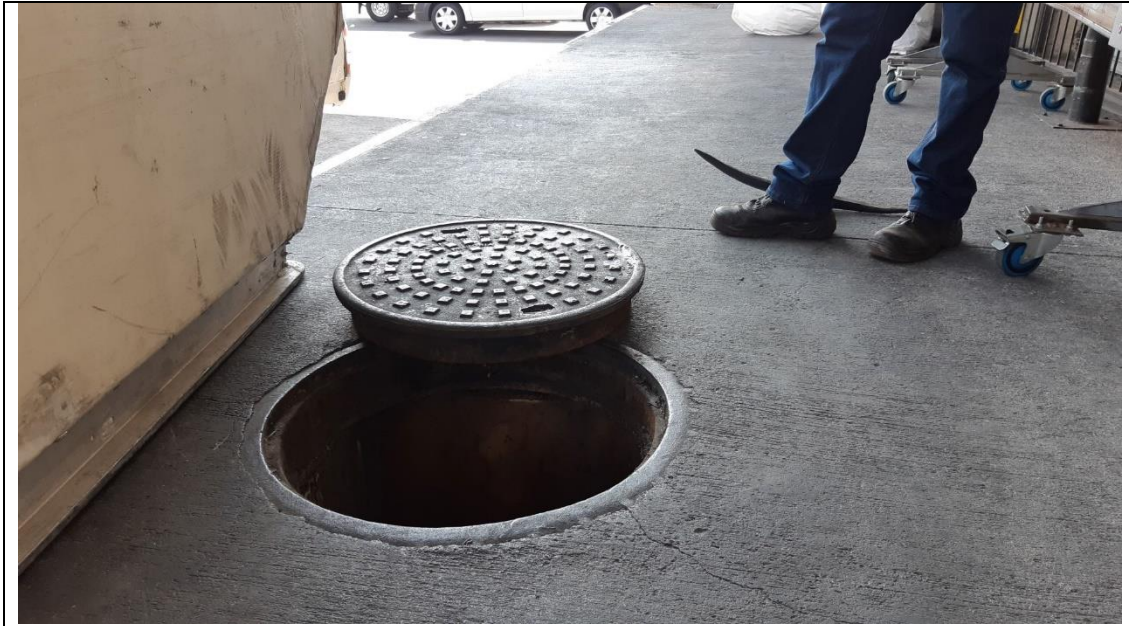
Figures 34 and 35 below show the typical external and internal condition of the stormwater manholes in the Cargo Warehouse loading area. The external condition is fair and the internal condition poor.

Figure 34 External condition of manhole

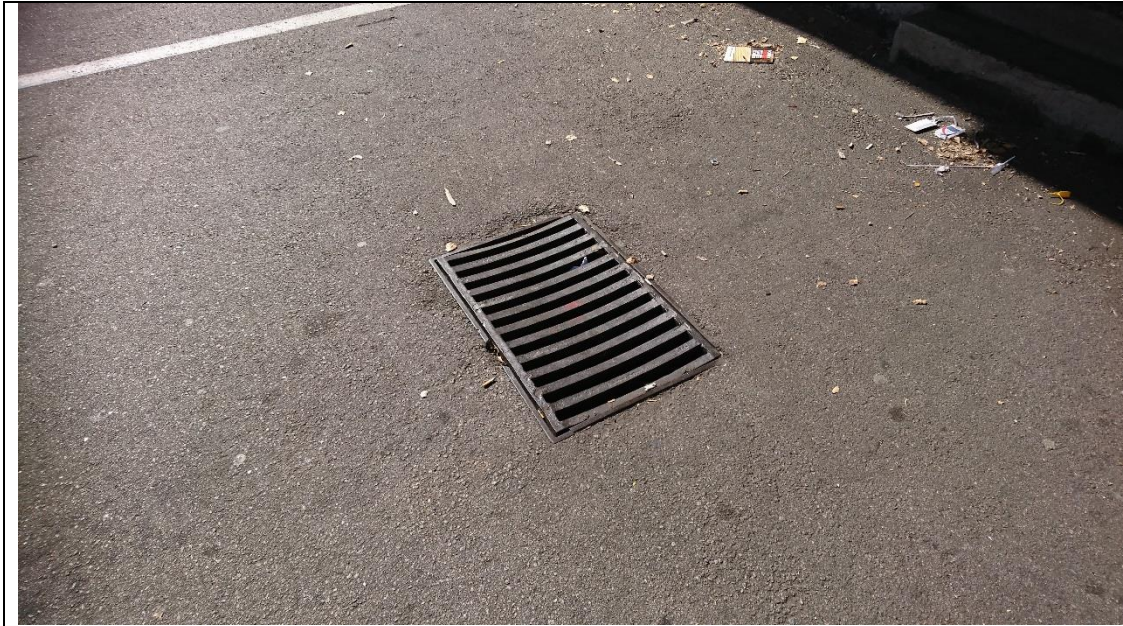
Generally the grid inlets internally show signs of partial blockage due to the presence of debris. Externally the grids on the inlets show little or no sign of damage. A typical grid inlet is shown in Figures 36 and 37 below.

Figure 36 Stormwater Grid Inlet

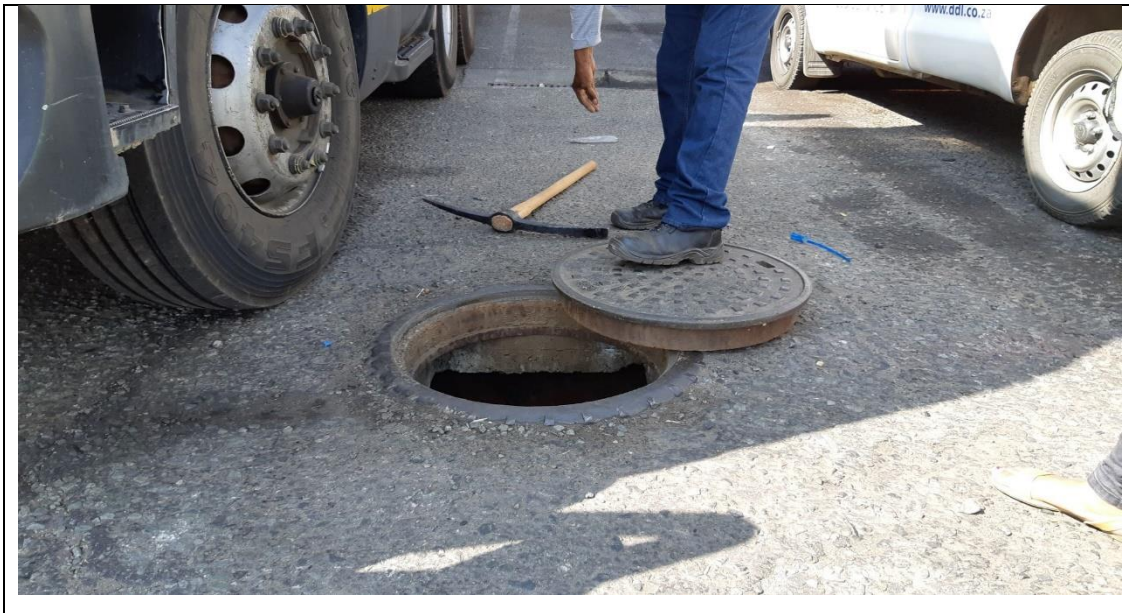
Figures 24 and 25 show the typical good external and fair internal condition most of the stormwater manholes. Although generally the brickwork is in a good condition, lack of a free draining manhole results in a weakened manhole structure. The stormwater pipe projections in the manhole have minor edge breaks which needs repair.

Figure 38 Good external condition

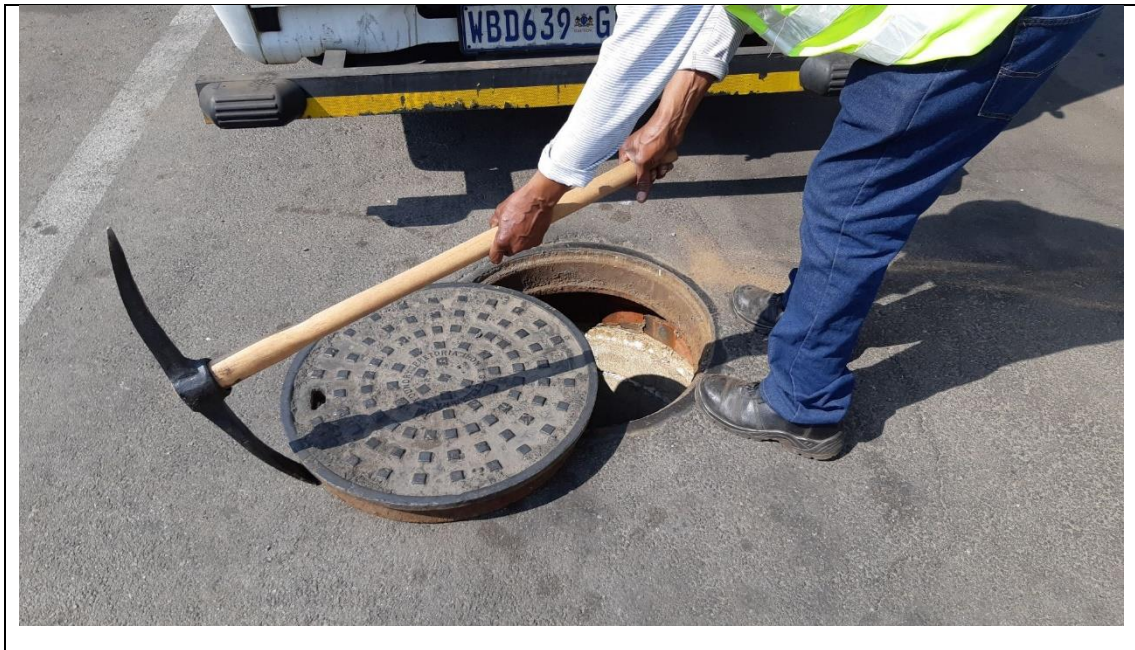
Figures 45 and 46 show the good sewer manhole external condition and the fair internal condition. The joints between the sewer manhole rings need repairs. Since the manhole is very deep, the condition of the benching and sewer pipes could not be established. Further investigations in the form of camera inspections are recommended. Some joints between manhole rings need repair.

Figure 45 Good external manhole condition

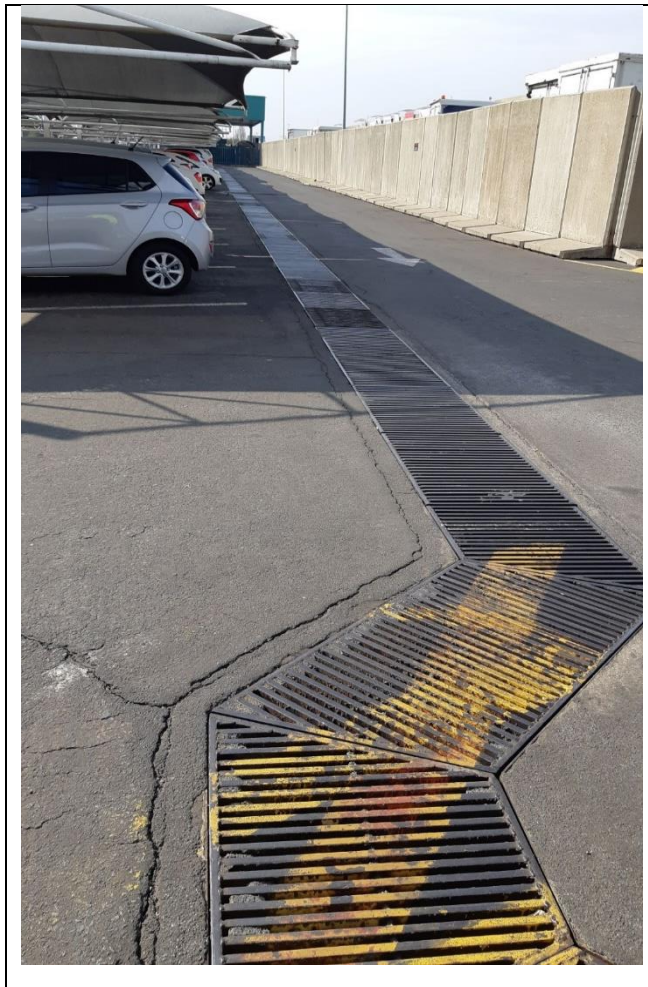
- **Findings:** The asphalt surfaced Cargo Warehouse Parking Area drains as sheet runoff towards a shallow concrete channel. The channel collects the surface runoff from most of the southern portion of the Cargo Warehouse Loading Area into the underground pipe system. The spaces in between the precast Cargo Warehouse Loading Area boundary wall units allows the surface runoff to pass into this car parking area. See Figure 51 below.
- **Recommendations:** The open channel is in a fair condition. Repairs will be required to fix damaged concrete and asphalt edges of the stormwater channel.

Figure 51 Box drain with grid cover
